Daneringwolf  
Estates

## GEOLOGIC HAZARD INVESTIGATION

**40 ACRE SUBDIVISION  
N.E. CORNER OF HWY 83 AND HODGEN ROAD  
PART OF THE SOUTH 1/2 OF THE SOUTHEAST 1/4 OF SECTION 22,  
TOWNSHIP 11 SOUTH, RANGE 66 WEST  
EL PASO COUNTY, COLORADO**

Job No. 26710GEO

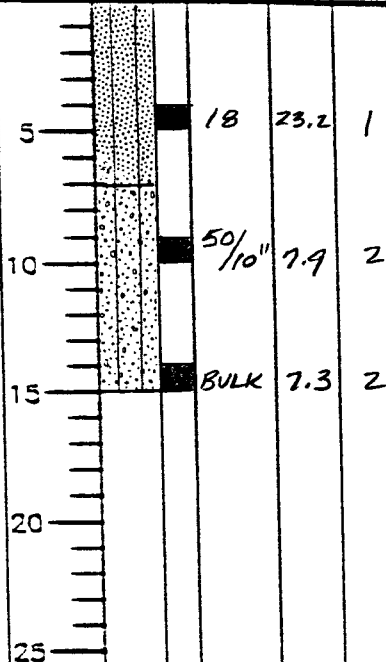
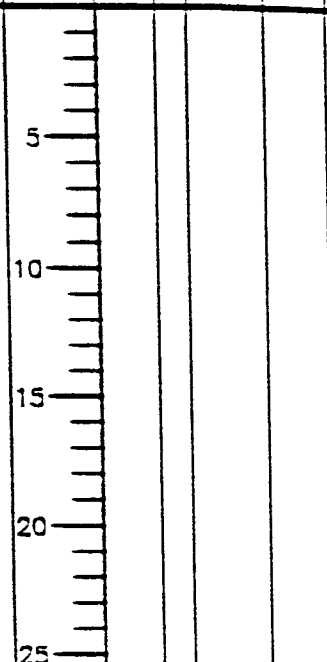
5

*SAND, SILTY TO  
CLAYEY, BROWN,  
MEDIUM DENSE,  
MOIST**SANDSTONE, SILTY  
TO CLAYEY, BROWN,  
DENSE, MOIST*

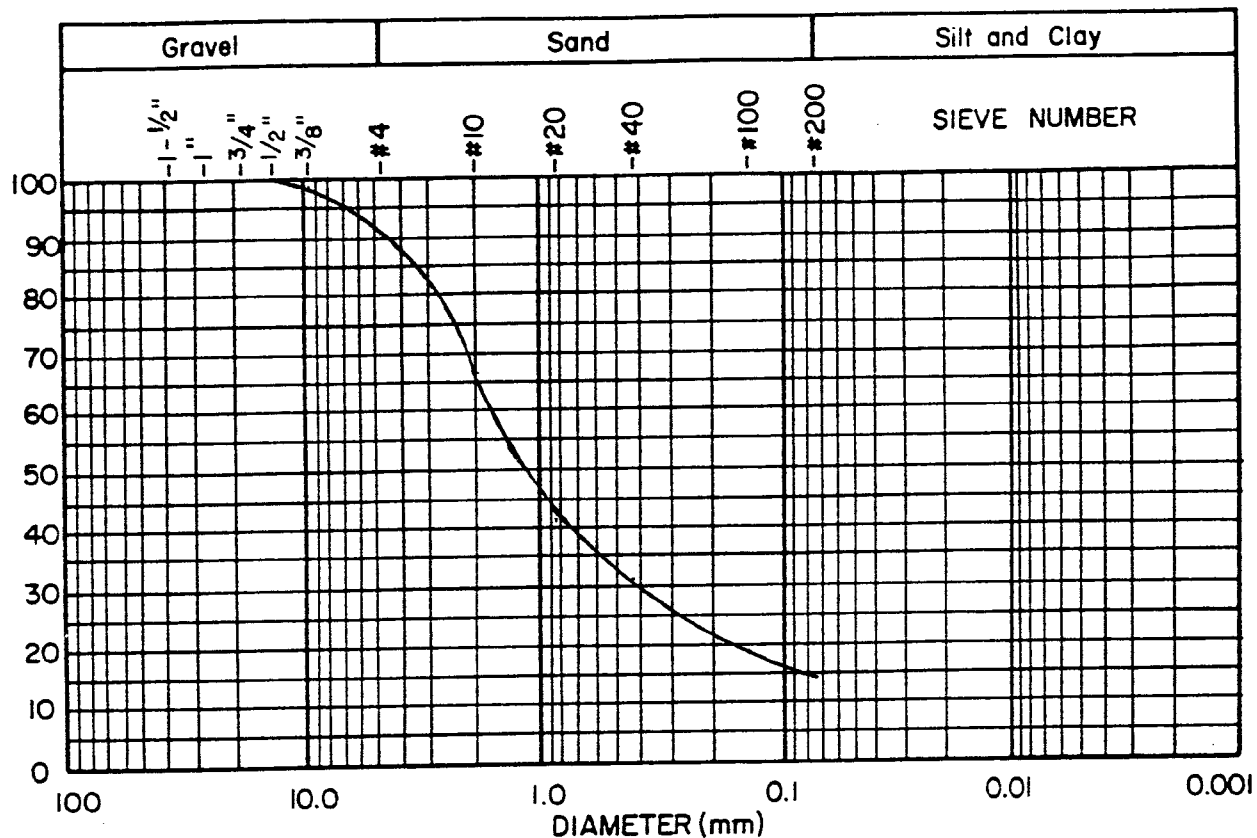
11

SOIL TYPE NO. 1 P2 @ 9' UNIFIED CLASSIFICATION SM TEST BY KBS

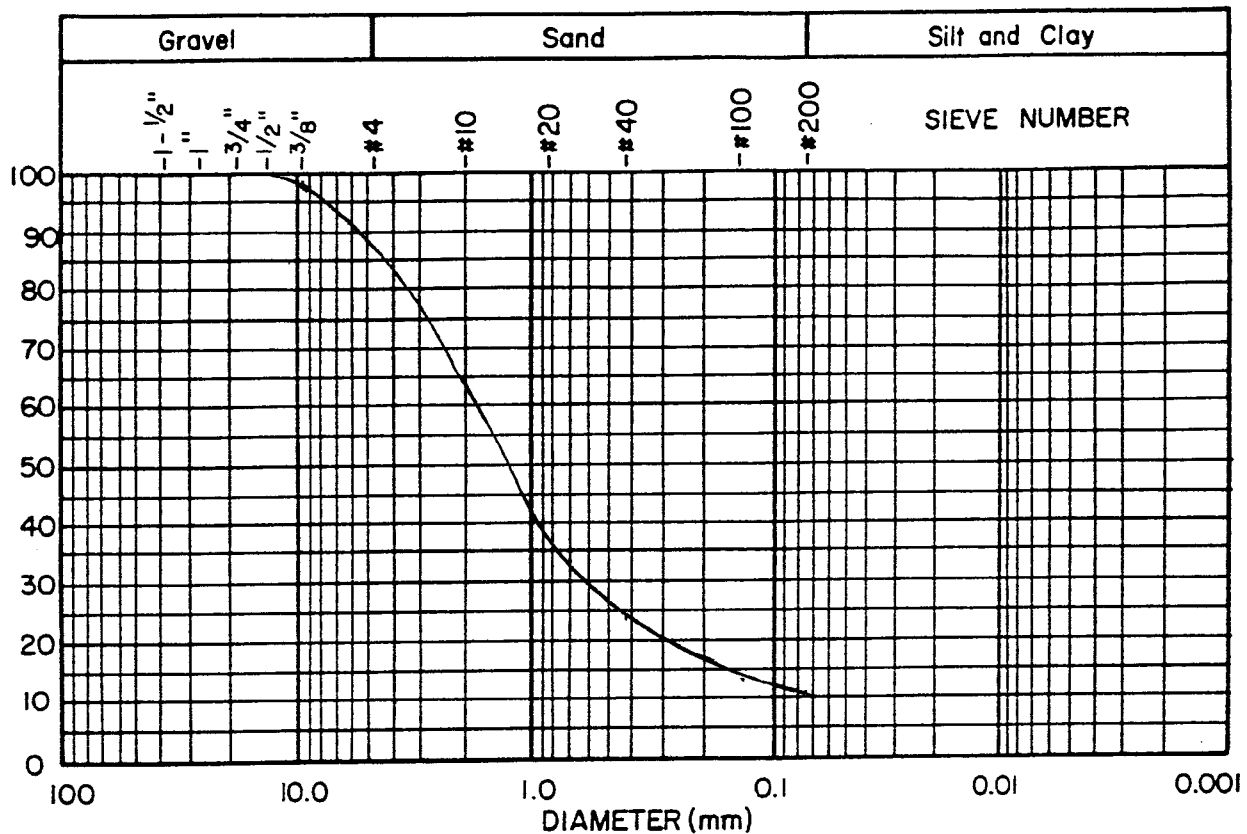
Job No.  
26710  
 Fig. No.  
12

SOIL TYPE NO. 2 P409 UNIFIED CLASSIFICATION SP/SM TEST BY KBS
