**SOIL, GEOLOGY, GEOLOGIC HAZARD,
AND WASTEWATER STUDY,
DANCING WOLF ESTATES SUBDIVISION FILING NO. 4
NE OF HODGEN ROAD AND HIGHWAY 83
EL PASO COUNTY, COLORADO**

David and Alyce McElhoes
16605 Dancing Wolf Way
Colorado Springs, Colorado 80908

March 12, 2019
Revised September 19, 2019

Entech Job No. 182043
AAprojects/2018/182043 countysoil/geo/ww

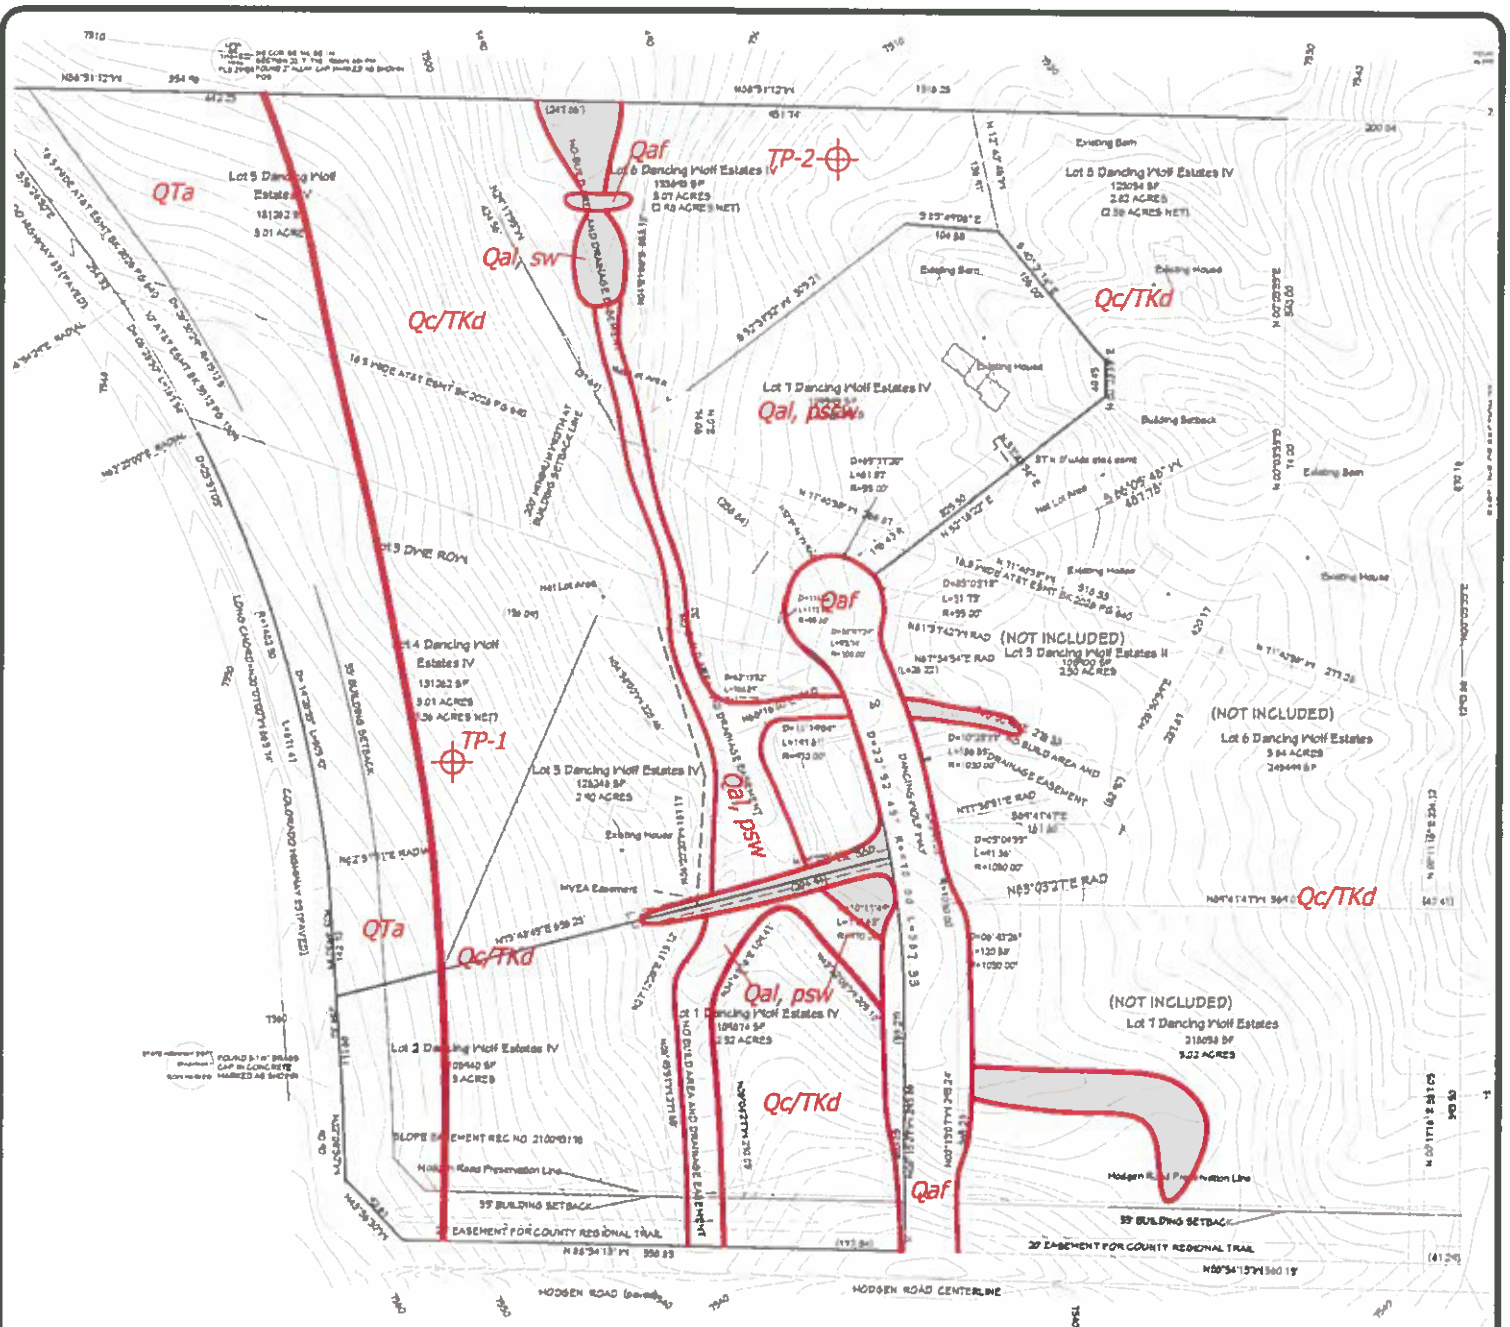
FIG NO.:
7

As mentioned previously, detailed mapping has been performed on this site to produce an Geology/Engineering Geology Map (Figure 7). This map shows the location of various geologic conditions of which the developers should be cognizant during the planning, design and construction stages of the project. These hazards and the recommended mitigation techniques are as follows:

Artificial Fill

Expansive soils were encountered in the test pits excavated on-site. Additionally, expansive soils were encountered in some of the test borings drilled by others (Appendix D). Expansive clay soils and claystone commonly encountered within the Dawson Formation and the overlying residual soils. These occurrences are typically sporadic; therefore, none have been indicated on the maps. These expansive, if encountered beneath foundations, can cause differential movement in the structure foundation. These occurrences should be identified and mitigated on an individual lot basis.

The site is not mapped within any floodplains according to the FEMA Map No. 08041CO285G, dated December 7, 2018 (Figure 8, Reference 7). Areas of potentially seasonal shallow and seasonal shallow groundwater were observed across the site. In these areas, we would anticipate the potential for periodically high subsurface moisture conditions and frost heave potential. These areas lie within low-lying areas and along the drainage in the central portion of the site. Water was not observed in any of the drainages or the pond at the time of our site investigation. These areas can likely be avoided or properly mitigated by development. The potential exists for high groundwater levels during high moisture periods and should structures encroach on these areas the following precautions should be followed.

Mitigation: The earthen dam and roadway embankments will be avoided by the development. Should any uncontrolled fill be encountered beneath foundations, removal and recompaction at 95% of its maximum Modified Proctor Dry Density, ASTM D-1557 will be required.

Mitigation: Should expansive soils be encountered beneath the foundation, mitigation will be necessary. Mitigation of expansive soils will require special foundation design. Overexcavation and replacement with non-expansive soils at a minimum of 95% of its maximum Modified Proctor Dry Density, ASTM D-1557 is a suitable mitigation, which is common in the area. Another alternative in areas of highly expansive soils is the use of drilled pier foundation

Mitigation: Foundations must have a minimum 30-inch depth for frost protection. In areas where high subsurface moisture conditions are anticipated periodically, subsurface perimeter drains are recommended to help prevent the intrusion of water into areas below grade. Typical drain details are presented in Figure 9. Any grading in these areas should be done to direct surface flow around construction to avoid areas of ponded water. All organic material would be completely removed prior to any fill placement. Specific drainage studies are beyond the scope of this report.

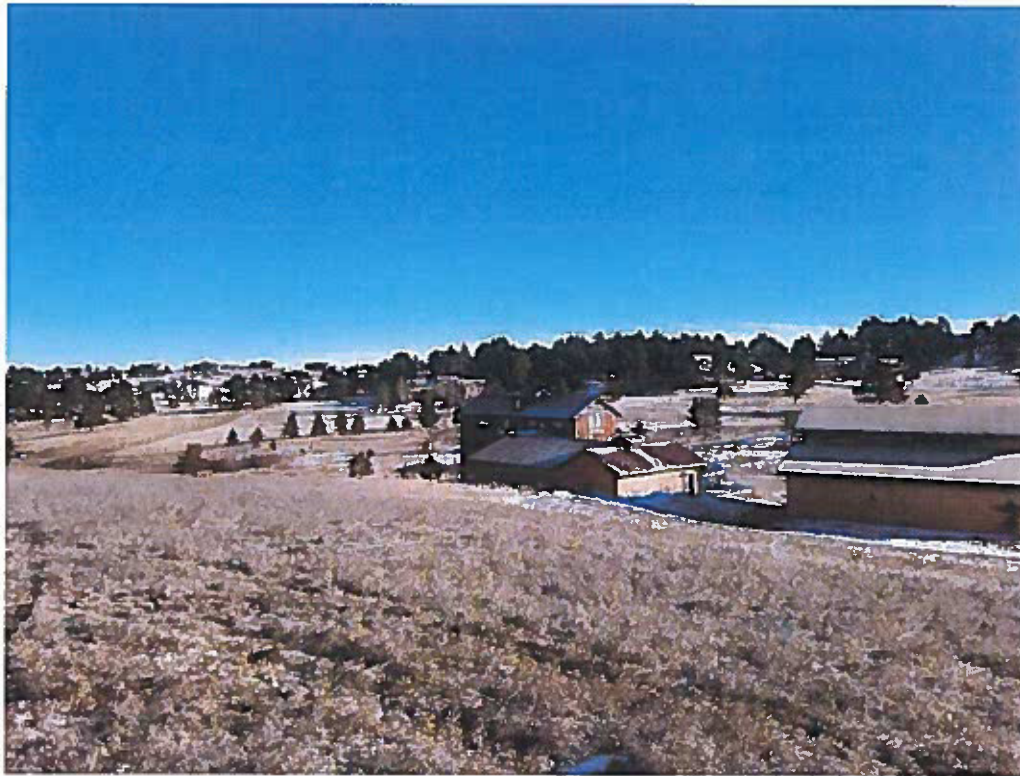
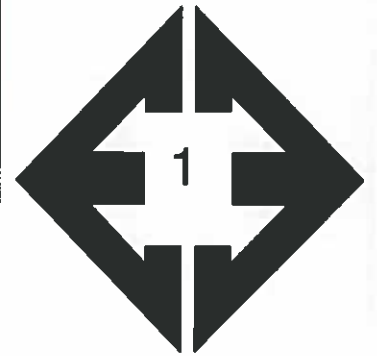
**Looking northeast
from the southwestern
portion of the site.**

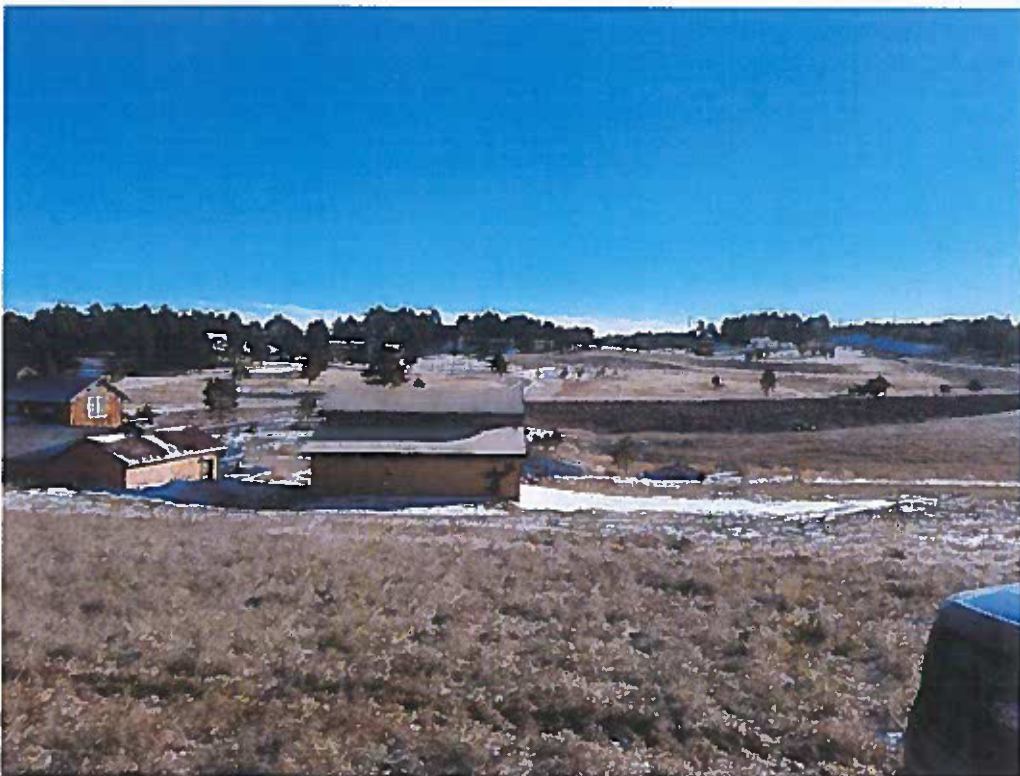
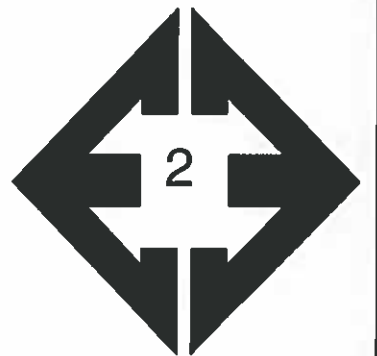
**Looking east from the
southwestern portion
of the site.**

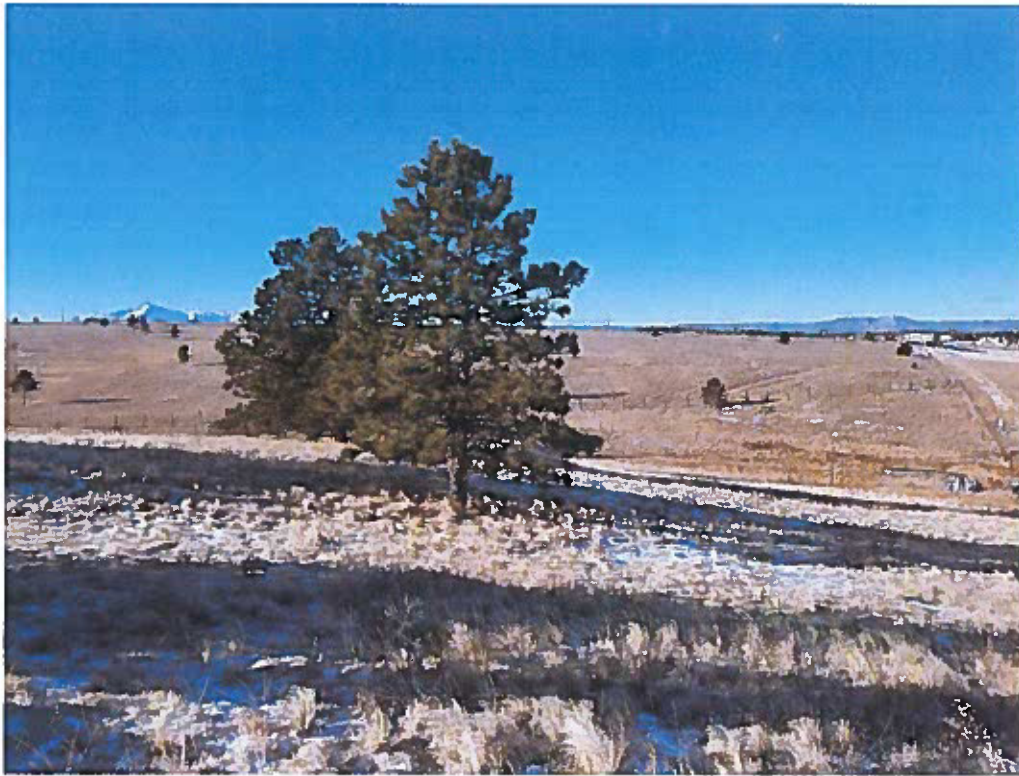
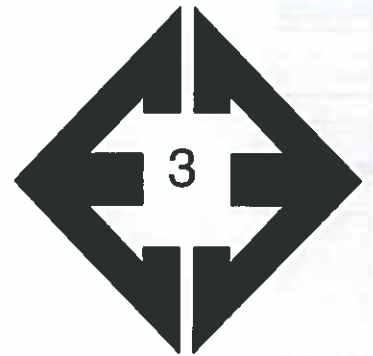
**Looking west from the
northern portion of the
site.**

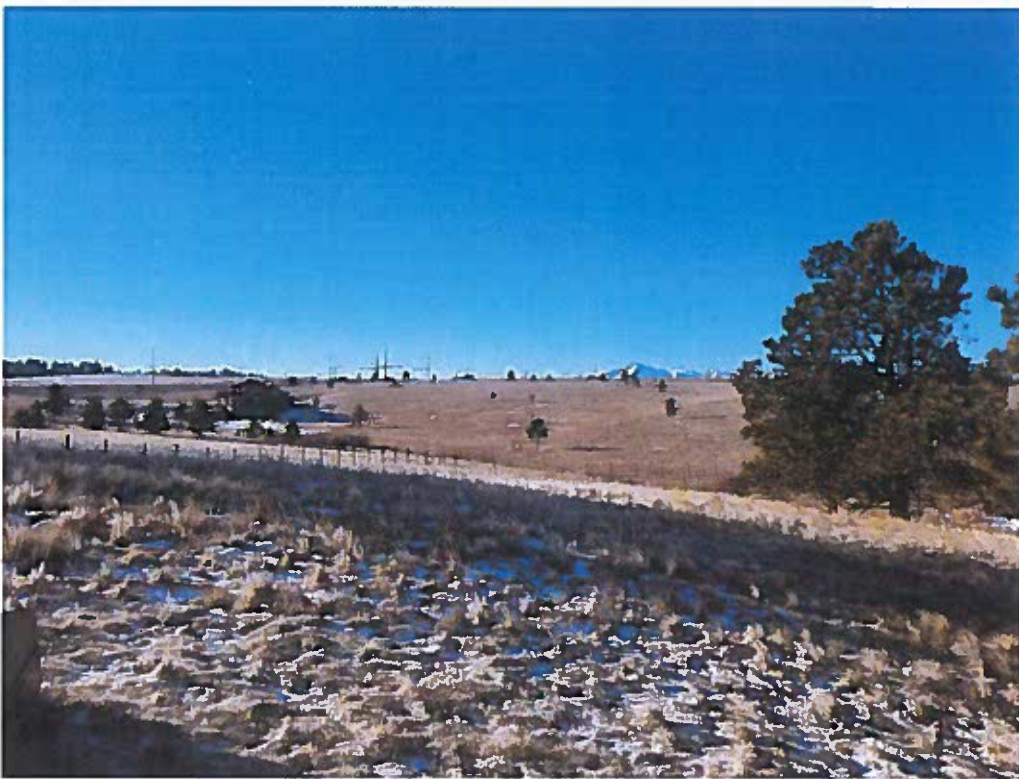
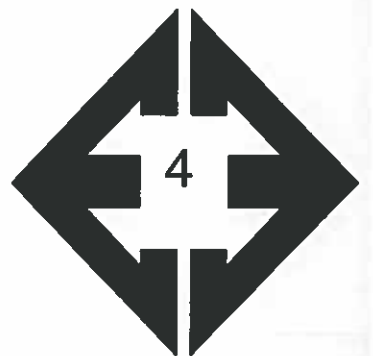
**Looking southwest
from the northern
portion of the site.**

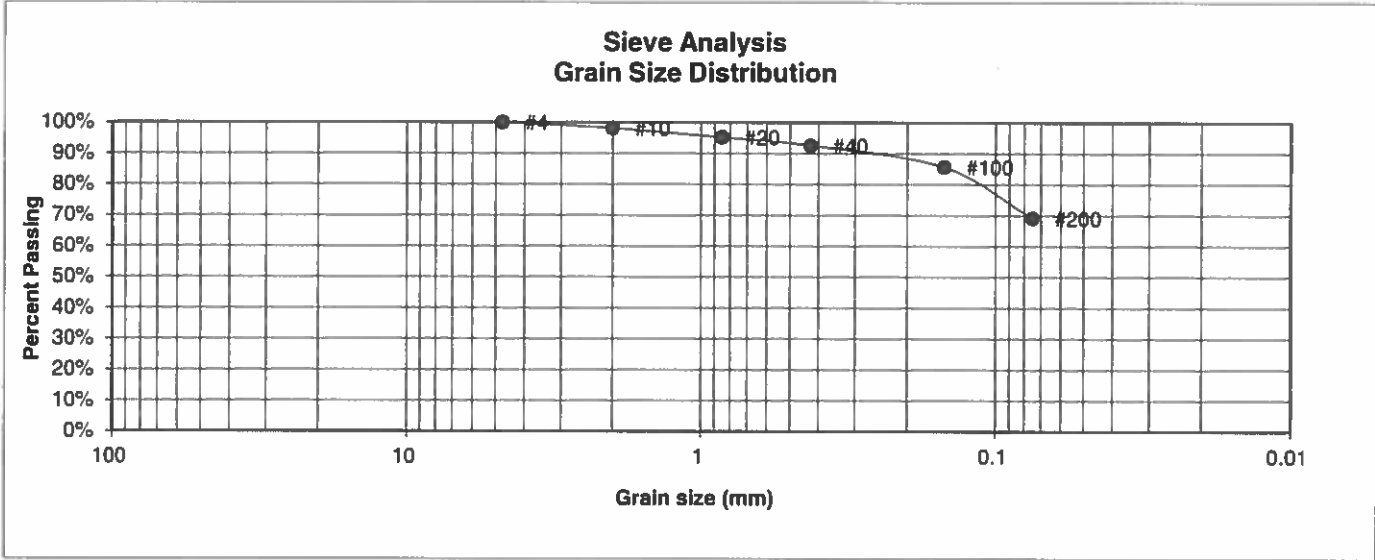
TEST PIT NO. 1	UNIFIED CLASSIFICATION	CL	TEST BY	BL
DEPTH(ft) 5-6	AASHTO CLASSIFICATION		JOB NO.	182043
CLIENT	DAVID & ALYCE MCELHOES			
PROJECT	DANCING WOLF ESTATES

Soil Type 2 is very sandy clay-silt and sandy clay (CL-ML, CL). This material was encountered in Test Pit No. 1. The clay was encountered at the existing surface grade and extended to the termination of the test pit (8 feet). The clay was encountered at firm consistencies and dry to moist conditions. Samples tested had 57 to 69 percent of the soil sized particles passing the No. 200 sieve. Atterberg limits testing resulted in liquid limits of 21 and 27 and plastic indexes of 7 and 12. FHA Swell Testing on a sample of clay resulted in an expansion pressure of 670 psf, which is in the low expansion range.

Swell	
Moisture at start	10.9%
Moisture at finish	21.6%
Moisture increase	10.8%
Initial dry density (pcf)	98
Swell (psf)	670
