**SOIL, GEOLOGY, & GEOLOGIC HAZARD STUDY  
THE VILLAGES AT STERLING RANCH EAST  
PRELIMINARY PLAN NO. 3 – PARCEL NOS. 14, 15, 20, & 21  
EL PASO COUNTY, COLORADO**

SF2439

April 13, 2022

Entech Job No. 220573

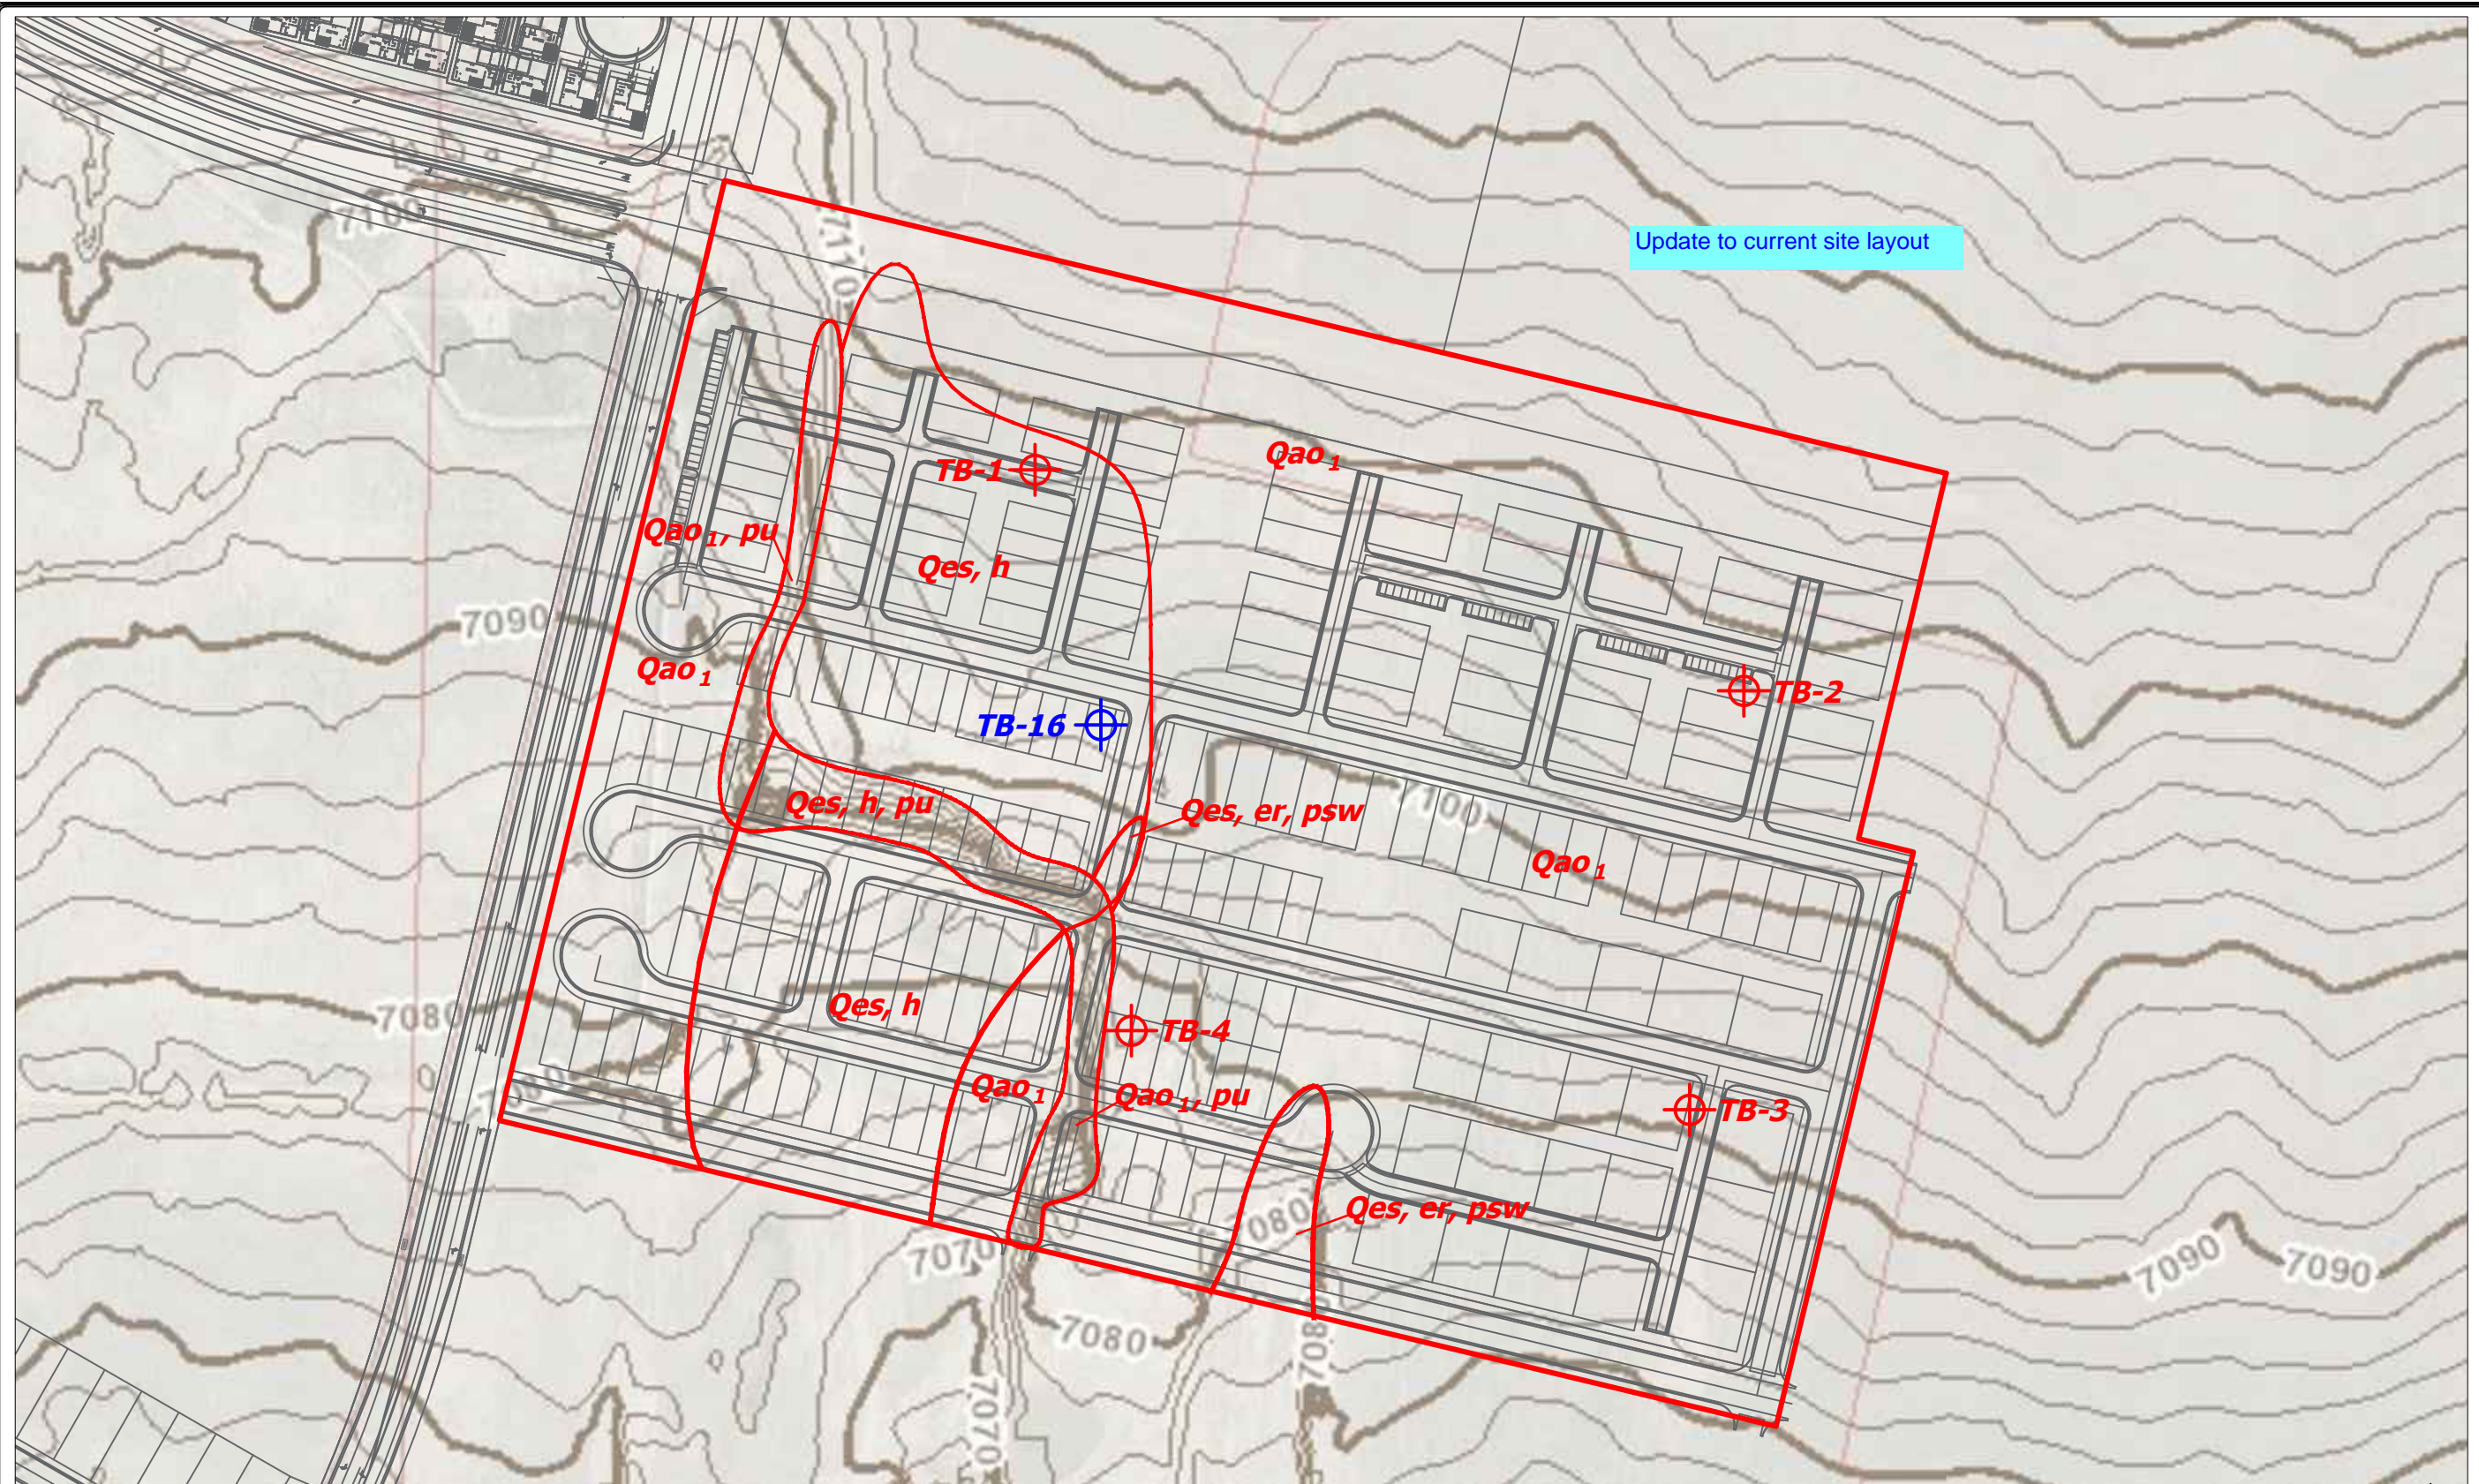
DRAWN L.L.
CHECKED
DATE 4/8/22
SCALE AS SHOWN
JOB NO. 220573
FIGURE No. 7

As mentioned previously, detailed mapping has been performed on this site to produce an Engineering Geology Map Figure 7. This map shows the location of various geologic conditions of which the developers should be cognizant during the planning, design and construction stages of the project. These hazards and the recommended mitigation techniques are as follows:

The majority of the soils encountered on-site do not exhibit collapsible characteristics, however, areas of loose soils were encountered in the test borings drilled on site. Additionally, areas mapped as Qes (eolian sand) have the potential for hydrocompaction.

These are areas that are undergoing erosion by water and sheetwash producing gullies and rill erosion. The areas significant erosion observed on the site are located in the former borrow areas where most of the vegetation had been removed.

The site is not mapped within floodplain zones according to the FEMA Map No. 08041CO535G, Figure 8 (Reference 7). Areas within the minor drainage swales on-site have been identified as areas of potentially seasonal groundwater areas, but were dry at the time of our site observations. Standing water was observed in a pond to the south of the site, and to the west of the site at the northwest corner of future Briargate Parkway and Sterling Ranch Road. These areas are discussed as follows:

In these areas, we would anticipate the potential for periodically high subsurface moisture conditions, frost heave potential and highly organic soils. These areas lie within minor drainage swales which will likely be regraded during grading of the development.

Potentially Unstable Slope Areas - hazard

These slopes are considered stable in their present condition; however, considerable care must be exercised in these areas not to create a condition which would tend to activate instability. These areas are primarily located along the cut slope of the former borrow area in the western portion of the site.

Mitigation: Should loose or collapsible soils be encountered beneath foundations, recompaction and moisture conditioning of the upper 2 feet of soil at 95% of its maximum Modified Proctor Dry Density ASTM D-1557 will be required. Exterior flatwork and parking areas may also experience movement. Proofrolling and recompaction of soft areas should be performed during site work.

Mitigation: Due to the nature of the soils on this site, virtually all the soils are subject to erosion by wind and water. Other minor areas of erosion were observed on site other than those mapped, particularly where some rill erosion has occurred. Areas of erosion can occur across the entire site, particularly if the soils are disturbed during construction. Vegetation reduces the potential for erosion. The areas identified where erosion is actually taking place may require check dams, regrading and revegetation using channel lining mats to anchor vegetation. Further recommendations for erosion control are discussed under Section 8.0 "Erosion Control" of this report. Recommendations pertaining to revegetation may require input from a qualified

Mitigation: Foundations must have a minimum 30-inch depth for frost protection. In areas where high subsurface moisture conditions are anticipated periodically, subsurface perimeter drains are recommended to help prevent the intrusion of water into areas below grade. Typical drain details are presented in Figure 9. Any grading in these areas should be done to direct surface flow around construction to avoid areas of ponded water. Structures should not block drainages. All organic material should be completely removed prior to any fill placement. Finished floor levels must be located a minimum of one foot above floodplain levels.

Mitigation: Building should be avoided in these areas unless properly mitigated. These areas will likely be regraded during the site development. Fill placed along these slopes should be properly benched into the slope as to not create unstable conditions.

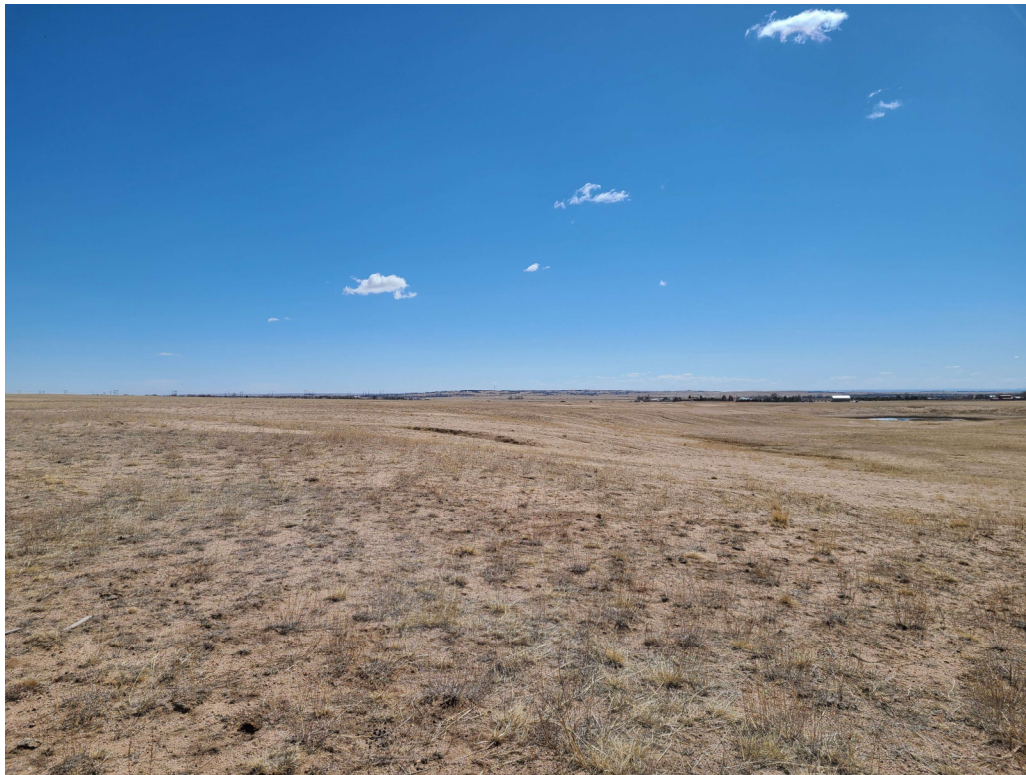
**Looking east from the western portion of the site.**

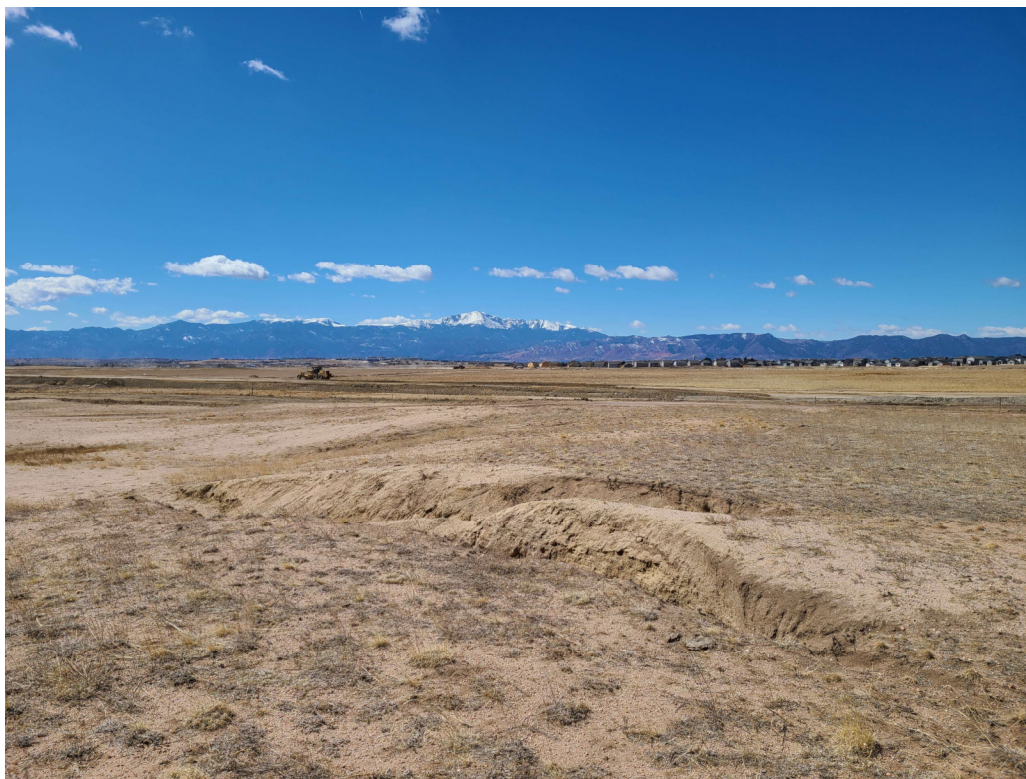
**Looking west from the central portion of the site.**

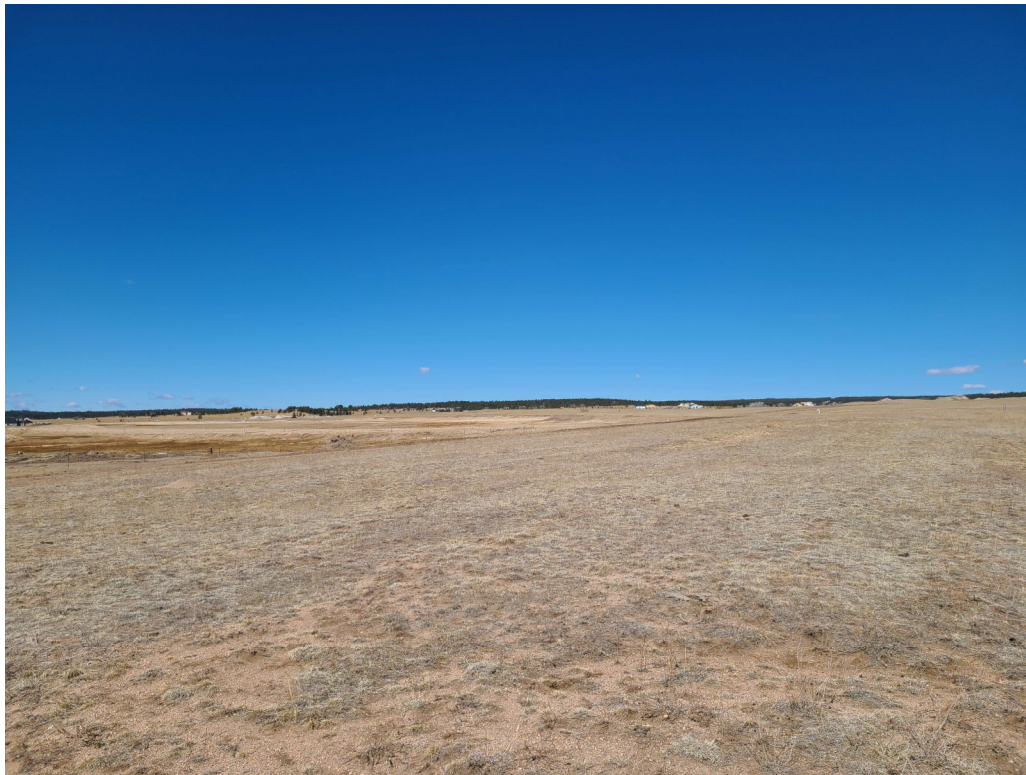
**Looking north from the west-central portion of the site.**

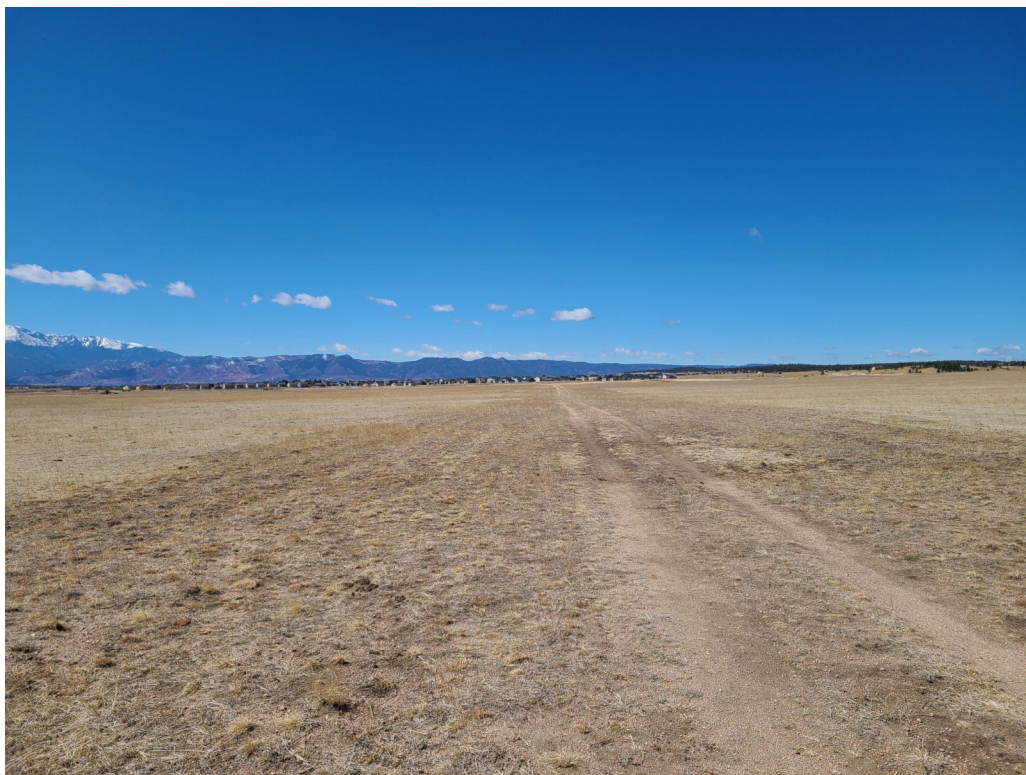
**Looking west from the northeastern portion of the site.**
