**SOIL, GEOLOGY AND
GEOLOGIC HAZARD STUDY
CLOVERLEAF DEVELOPMENT
EL PASO COUNTY, COLORADO**

April 7, 2020
Revised November 9, 2020
Revised March 22, 2021
Revised April 12, 2021

Entech Job No. 200100
AAProjects/2020/200100 soil geo

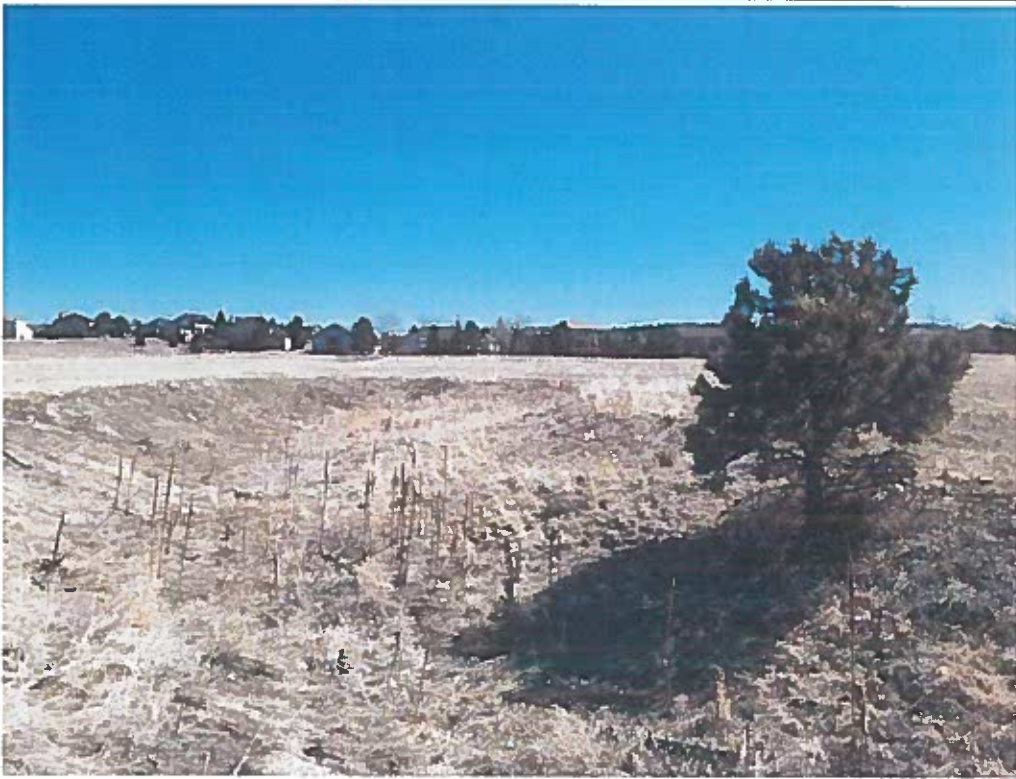
These are areas that are undergoing erosion by water and sheetwash producing gullies and rill erosion. Areas of erosion were observed in the Teachout Creek drainage in the northern portion of the site, and an area along eastern side of the site along Cloverleaf Road.

**Looking northeast
along Teachout Creek
in the northwestern
portion of the stie.**

Mitigation: Due to the nature of the soils on this site, virtually all the soils are subject to erosion by wind and water. Other minor areas of erosion were observed on site other than those mapped, particularly where some rill erosion has occurred. Areas of erosion can occur across the entire site, particularly if the soils are disturbed during construction. Vegetation reduces the potential for erosion. The areas identified where erosion is actually taking place may require check dams, regrading and revegetation using channel lining mats to anchor vegetation. Further recommendations for erosion control are discussed under Section 9.0 "Erosion Control" of this report. Recommendations pertaining to revegetation may require input from a qualified landscape architect and/or the Natural Resource Conservation Service (previously Soil Conservation Service).

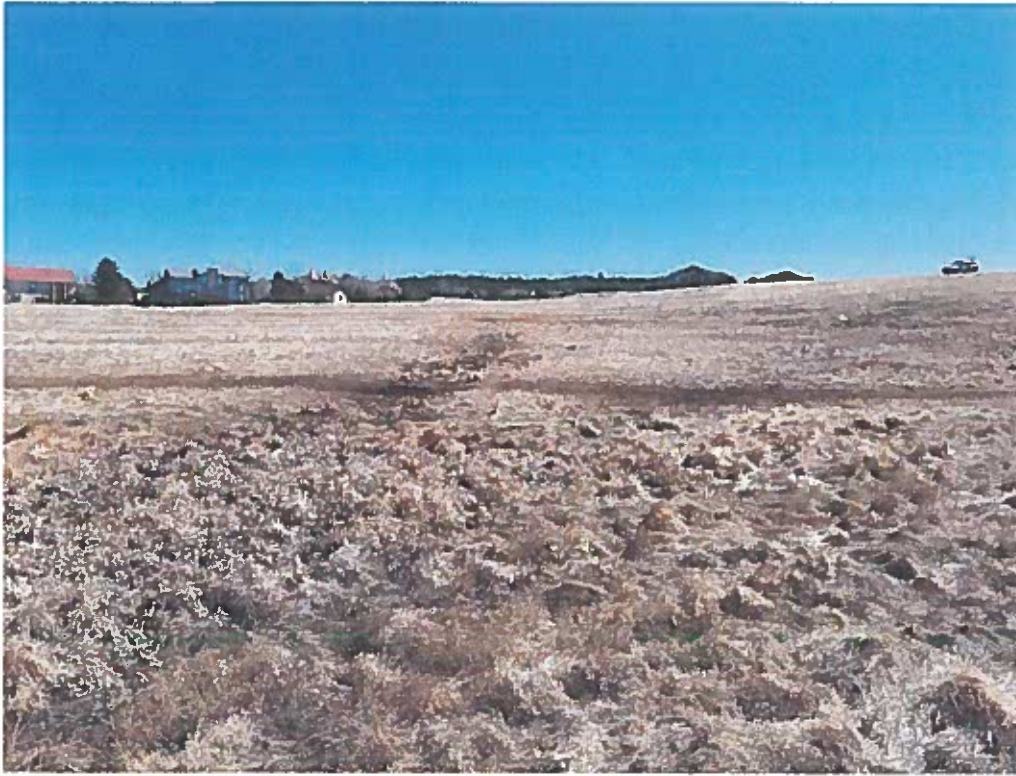
In these areas, we would anticipate the potential for periodically high subsurface moisture conditions and possible frost heave potential, depending on the soil conditions. Areas within the drainages on-site have been identified as potentially seasonal shallow groundwater, and the seasonal shallow groundwater area is located in a minor drainage area in the south-central portion of the site, and is also identified as a wetland in the National Wetland Inventory. In this wetland area we would anticipate the potential for surface and near surface groundwater conditions depending on seasonal changes in precipitation and runoff. This area had saturated surface conditions and minor areas of standing water during our field mapping. The areas identified as potentially seasonal and seasonal shallow groundwater lie within drainages and low-lying areas that will be regraded during overlot grading. Where structures or utility trenches encroach on, or lie within these areas, the following mitigation is recommended:

**Looking east along
seasonally wet area in
the central portion of
the site.**

Mitigation: In these locations, foundations in areas subject to severe frost heave potential should penetrate sufficient depth so as to discourage the formation of ice lenses beneath foundations. Preliminary grading plans indicate the seasonally wet area will be filled. At this location and elevation, a foundation depth for frost protection of 30 inches is recommended. In areas where high subsurface moisture conditions are anticipated periodically, a subsurface perimeter drain will be necessary to help prevent the intrusion of water into areas located below grade. A typical perimeter drain detail is presented in Figure 8. Where shallow groundwater is encountered, additional drains, such as capillary breaks and/or interceptor drains may be necessary typical drain details are presented in Figures 9 and 10. Unstable conditions should be expected where excavations approach the groundwater level. The use of rock, shotcrete, or geo-grids may be necessary to stabilize excavations. Additionally, swales should be created to intercept surface runoff and carry it safely around and away from structures. The drainages will be filled during site grading mitigating the seasonal shallow and potentially seasonally shallow groundwater hazards. The water table may be of sufficient depth to minimize the effects on buildings; however, groundwater may be encountered during utility trenches during site development. All soft and organic soils should be removed prior to fill placement. Stabilization of the subgrade with rock and fabric prior to placing fill may be necessary if saturated unstable conditions are encountered.

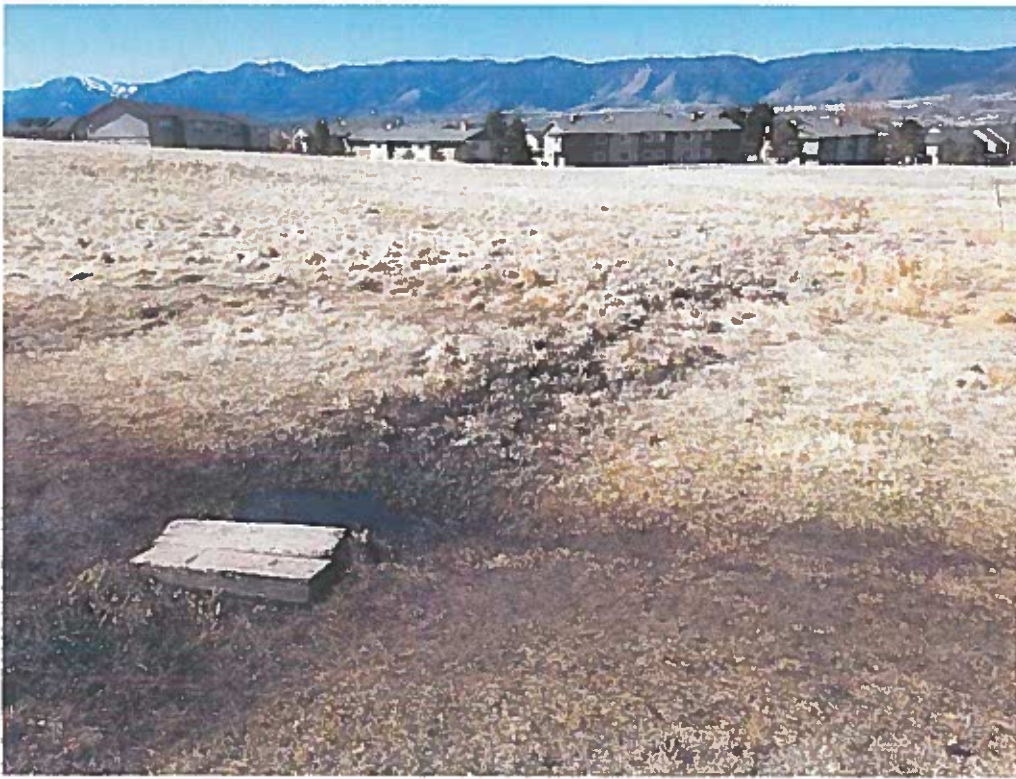
**Looking west along
seasonally wet area in
the central portion of
the site.**
