**SOIL, GEOLOGY, AND GEOLOGIC HAZARD
SPRINGS AT WATERVIEW
GRINNELL BOULEVARD AND BRADLEY ROAD
EL PASO COUNTY, COLORADO**

Dakota Springs Engineering, Inc.
31 North Tejon Street, Suite 500
Colorado Springs, Colorado 80903

March 15, 2017
Revised March 21, 2018

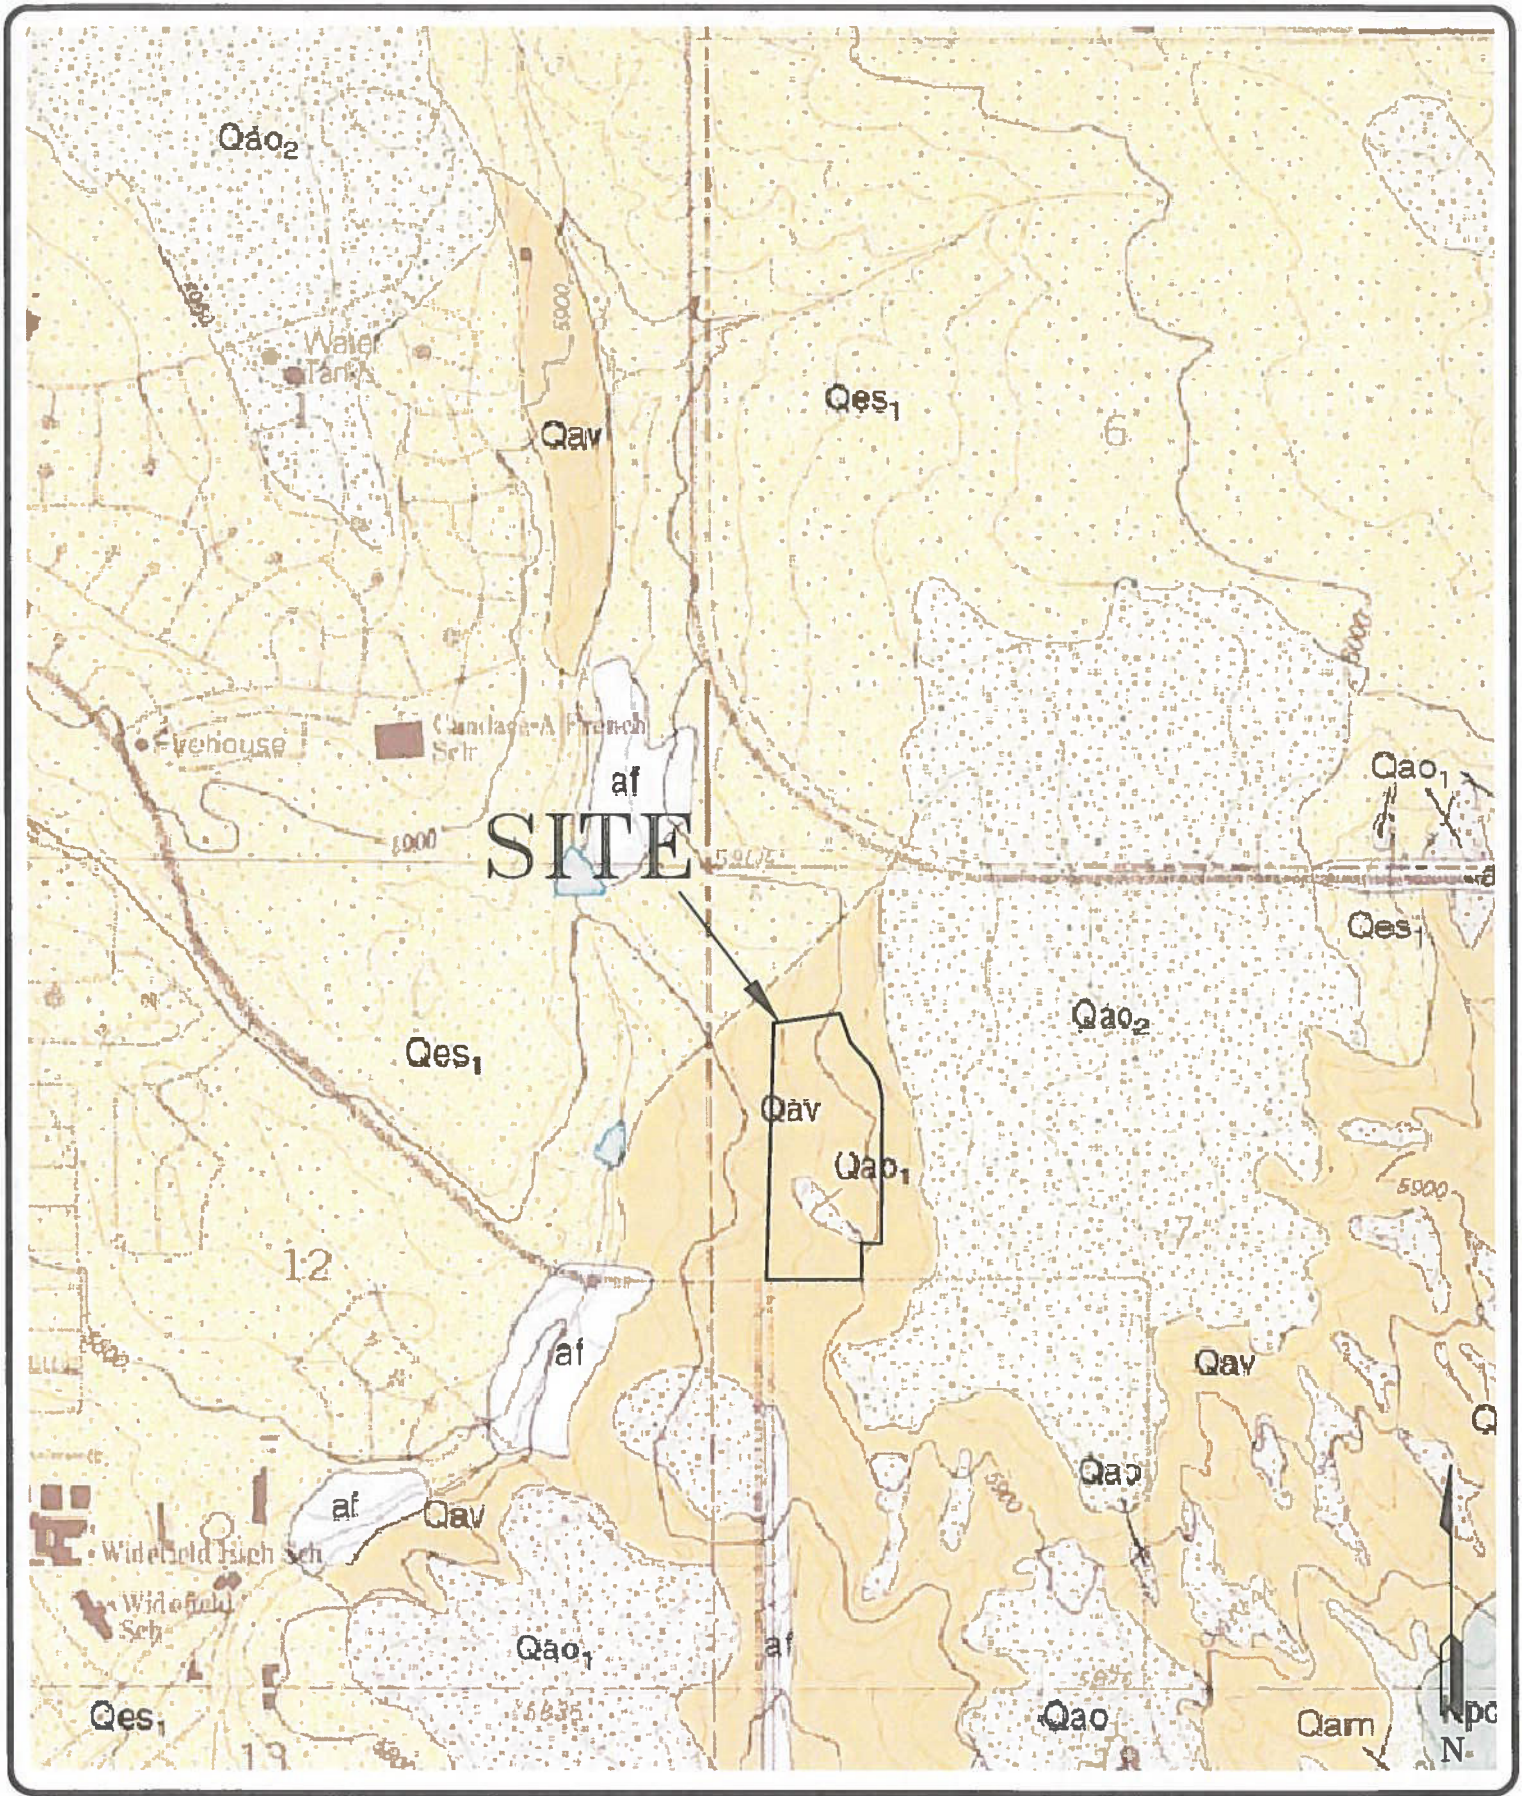
The Elsmere Quadrangle Geology Map showing the site is presented in Figure 5 (Reference 4). The Geology Map prepared for the site is presented in Figure 6. Four mappable units were identified on this site which are described as follows:

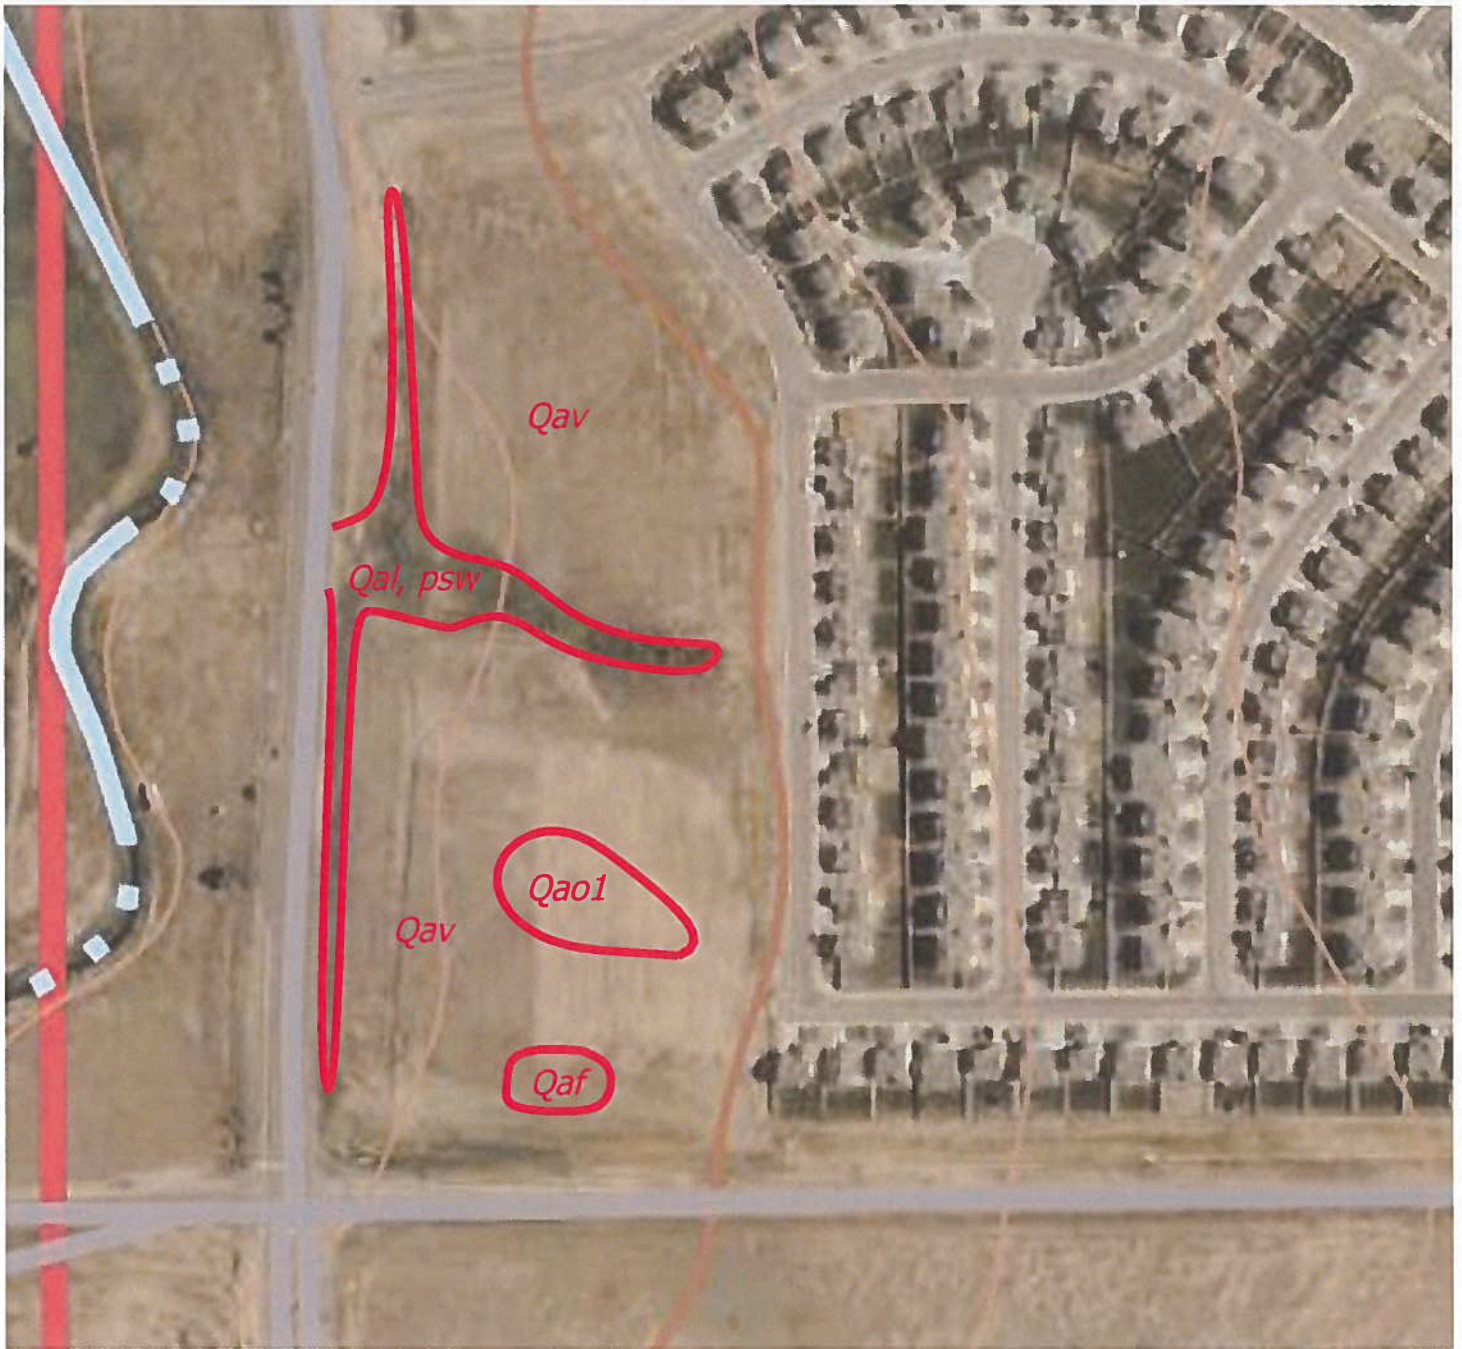
Areas within the drainages on-site have been identified as areas of seasonally high groundwater areas. Water was not flowing in the any of the drainages at the time of this investigation. The site is not mapped within floodplain zones according to the FEMA Map No. 08041CO764F, Figure 9 (Reference 7). These areas are discussed as follows:

Mitigation In these locations, foundations in areas subject to severe frost heave potential should penetrate sufficient depth so as to discourage the formation of ice lenses beneath foundations. At this location and elevation, a foundation depth for frost protection of 2.5 feet is recommended. In areas where high subsurface moisture conditions are anticipated periodically, a subsurface perimeter drain will be necessary to help prevent the intrusion of water into areas located below grade. A typical perimeter drain detail is presented in Figure 16. Additionally, swales should be created to intercept surface runoff and carry it safely around and away from structures. It is anticipated that the site grading will likely mitigate the drainages on site.

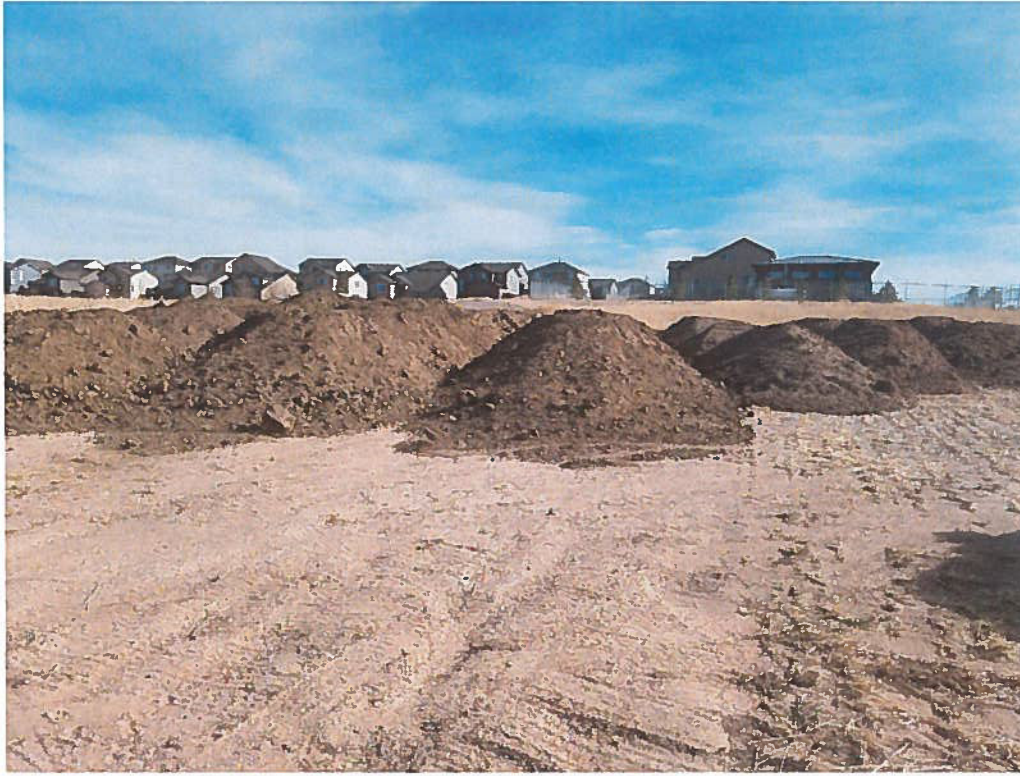
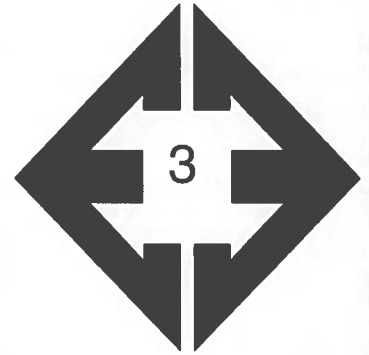
These are recent man-made fill deposits associated with fill piles located in the southern portion of the site.

Looking east from the southern portion of the site towards fill piles.

Mitigation This area will likely be mitigated by site grading. All uncontrolled fill encountered beneath foundation members will require removal and recompaction at 95% of Modified Proctor Dry Density, ASTM D-1557.

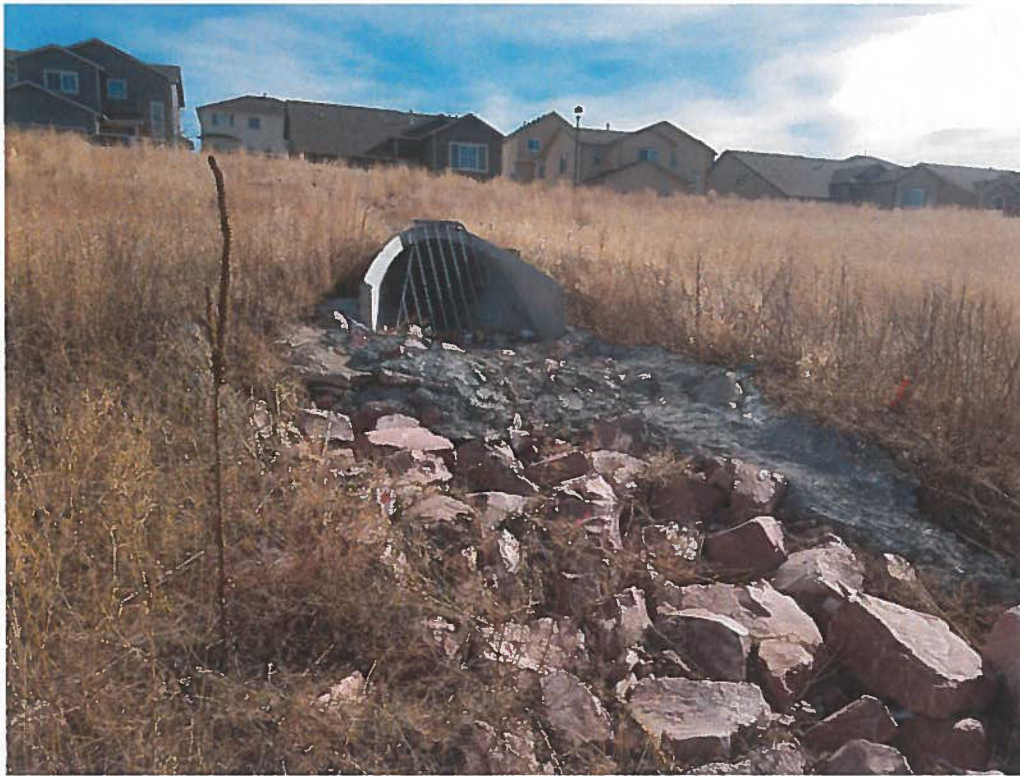
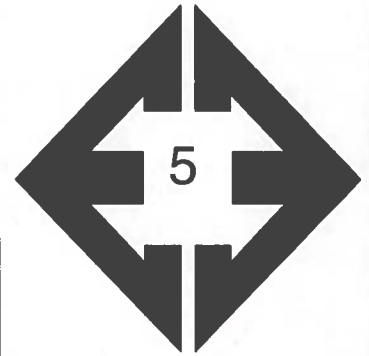
**48" stormwater outlet
in the eastern side of
the site.**
