ENTECH
ENGINEERING, INC.

Re: Soil and Geology Study
5740 Burgess Road
Tax Schedule No. 62130-00-050
El Paso County, Colorado

The Renehan's
Soils and Geology Study
5740 Burgess Road
Tax Schedule No. 62130-00-050
El Paso County, Colorado

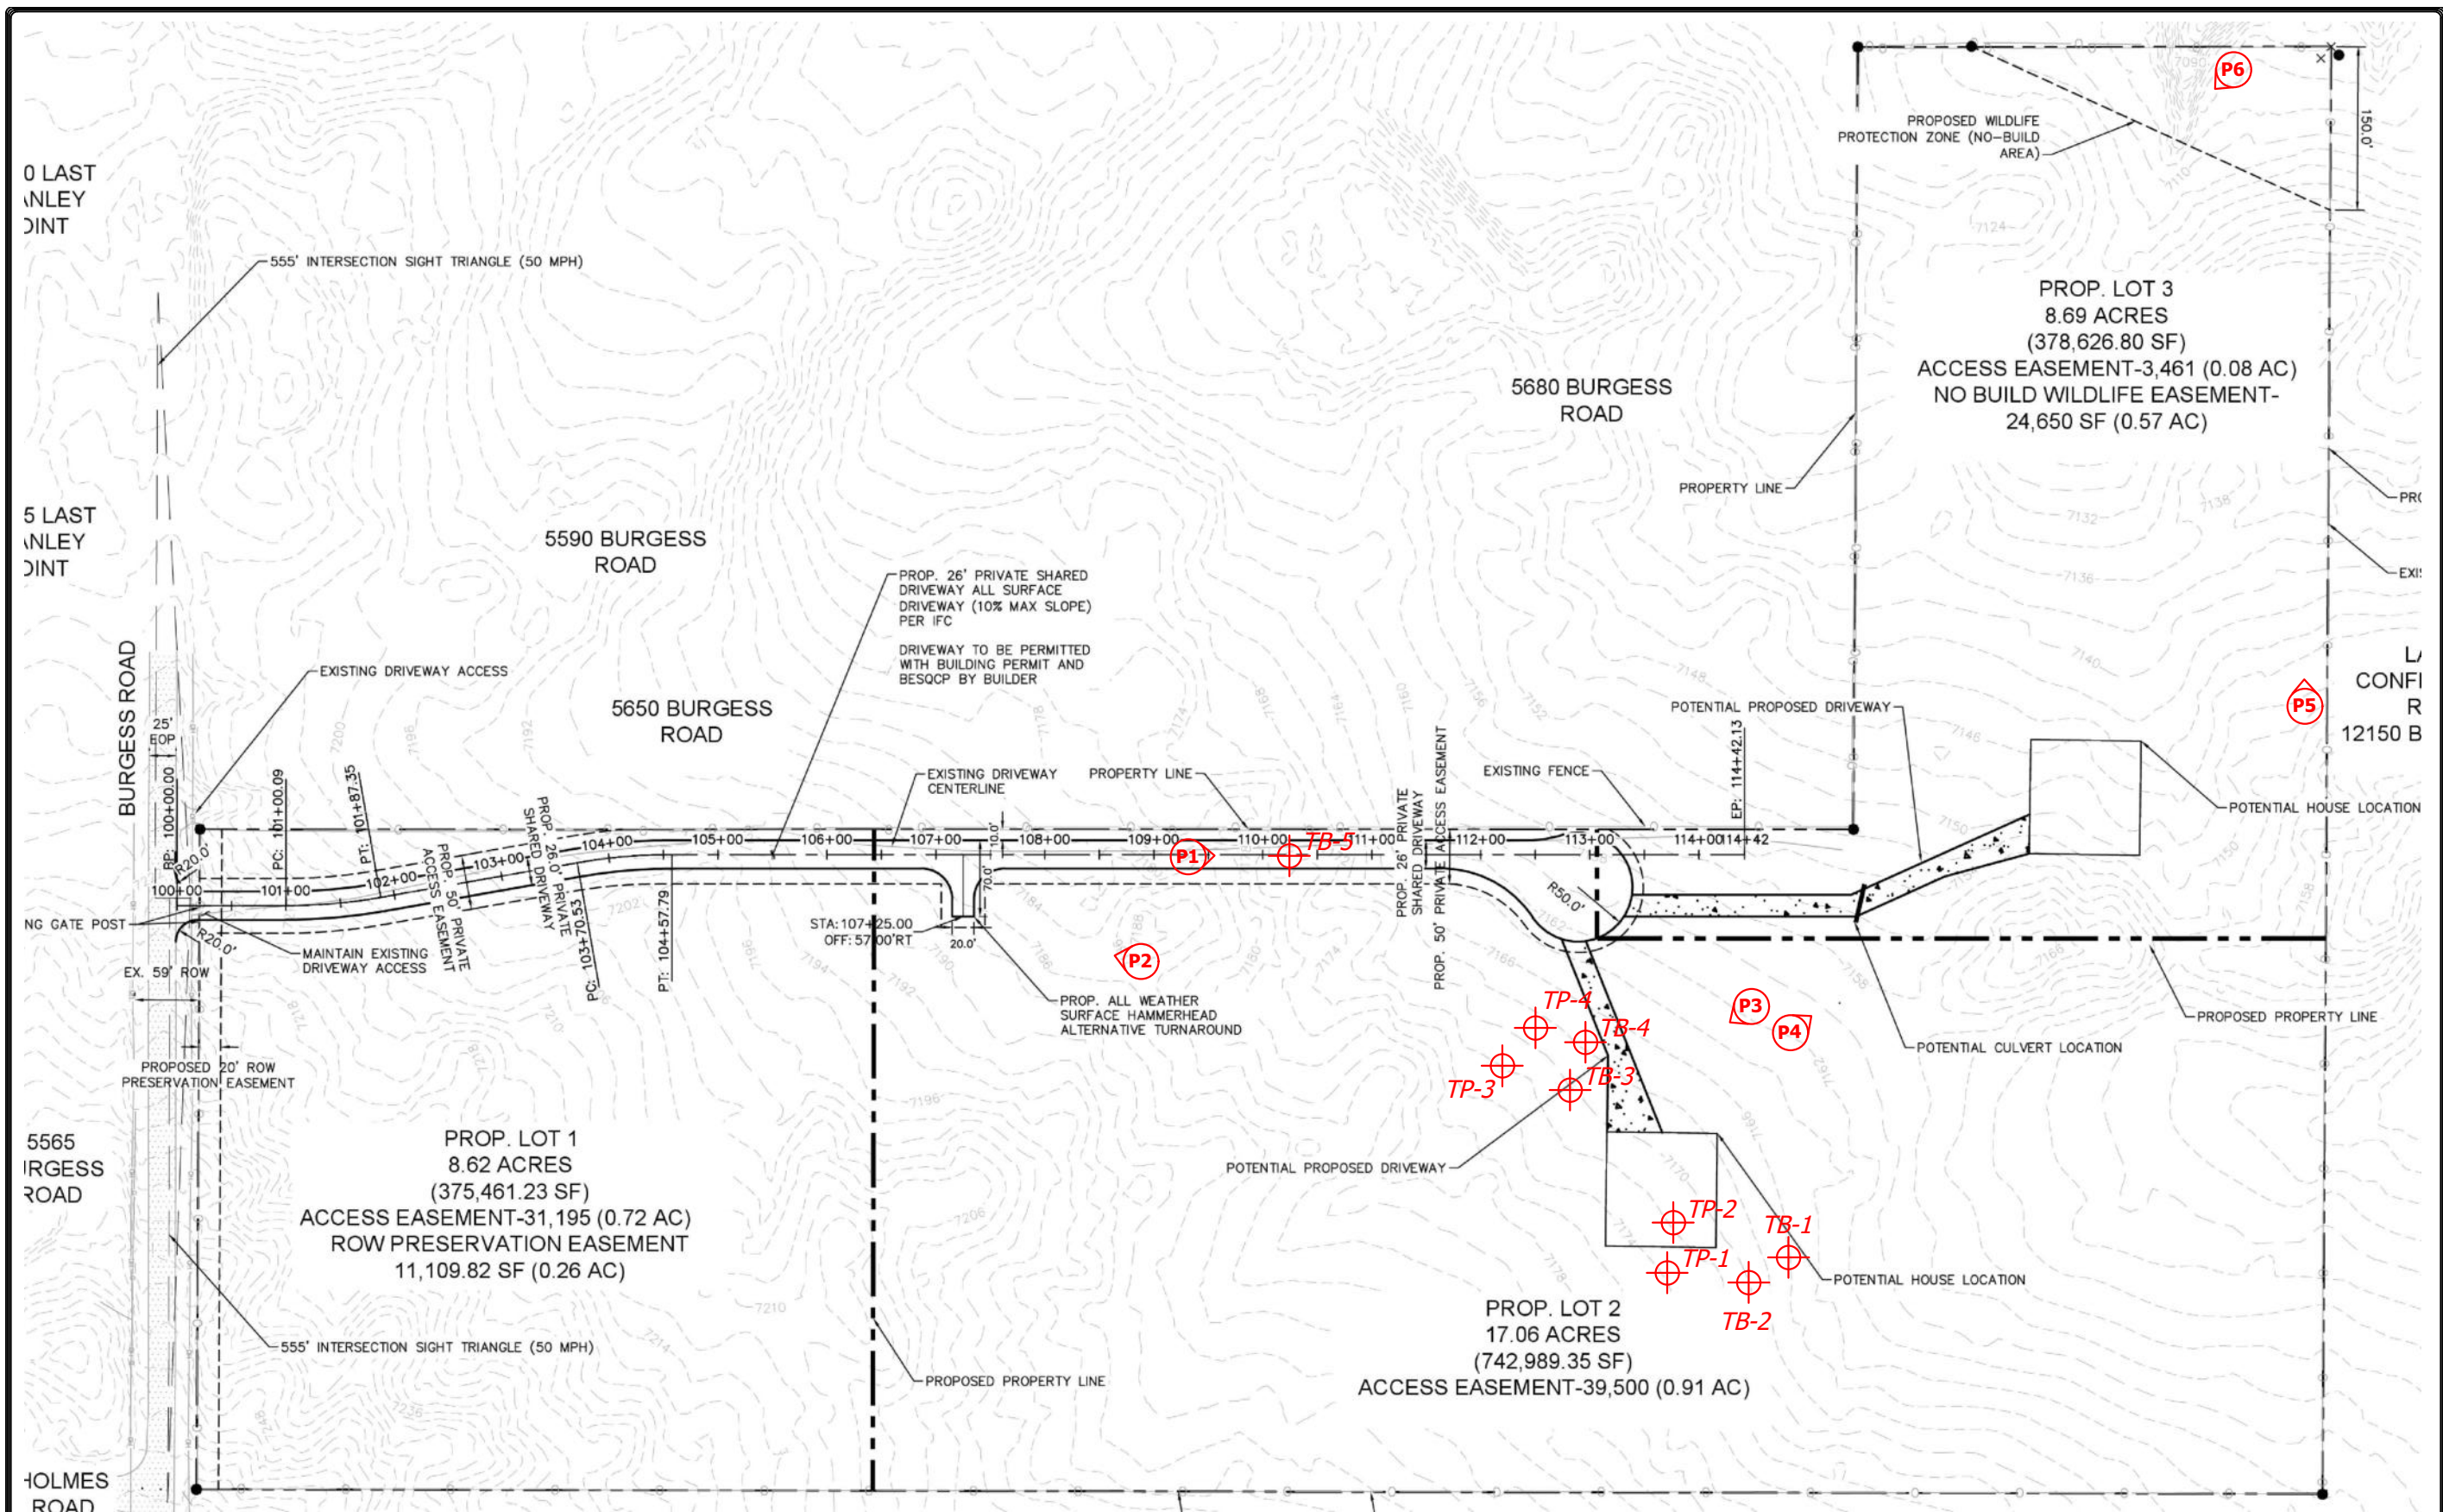
DRAWN L.L.L. CHECKED
DATE 2/1/23
SCALE AS SHOWN
JOB NO. 222084
FIGURE No. 3

Total acreage of the site is 34.28-acres. Three rural residential lots are proposed as part of the replat which vary in size from 8.62 to 17.06 acres. The new lots will be serviced by an individual wells and on-site wastewater treatment systems. The Site Plan with the proposed replat is presented in Figure 3.

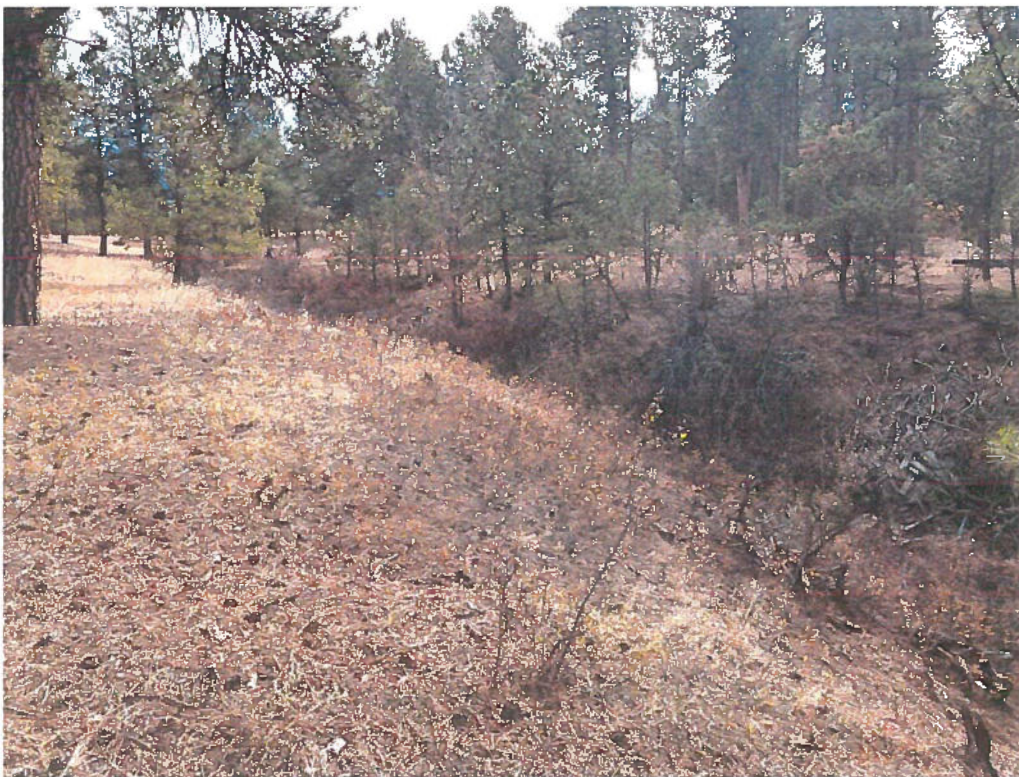
The seasonally wet area has been mapped in the head of the drainage located in the northwestern portion of Lot 3. Construction is not recommended in this area and is located within a no-build area. Mitigation for seasonally wet areas is discussed in the following section.

**Looking east along the
head of the drainage in
the northwestern
portion of Lot 3.**
