**ENTECH**  
ENGINEERING, INC.

February 3, 2023  
Revised November 30, 2023

Re: Soil and Geology Study  
5740 Burgess Road  
Tax Schedule No. 62130-00-050  
El Paso County, Colorado

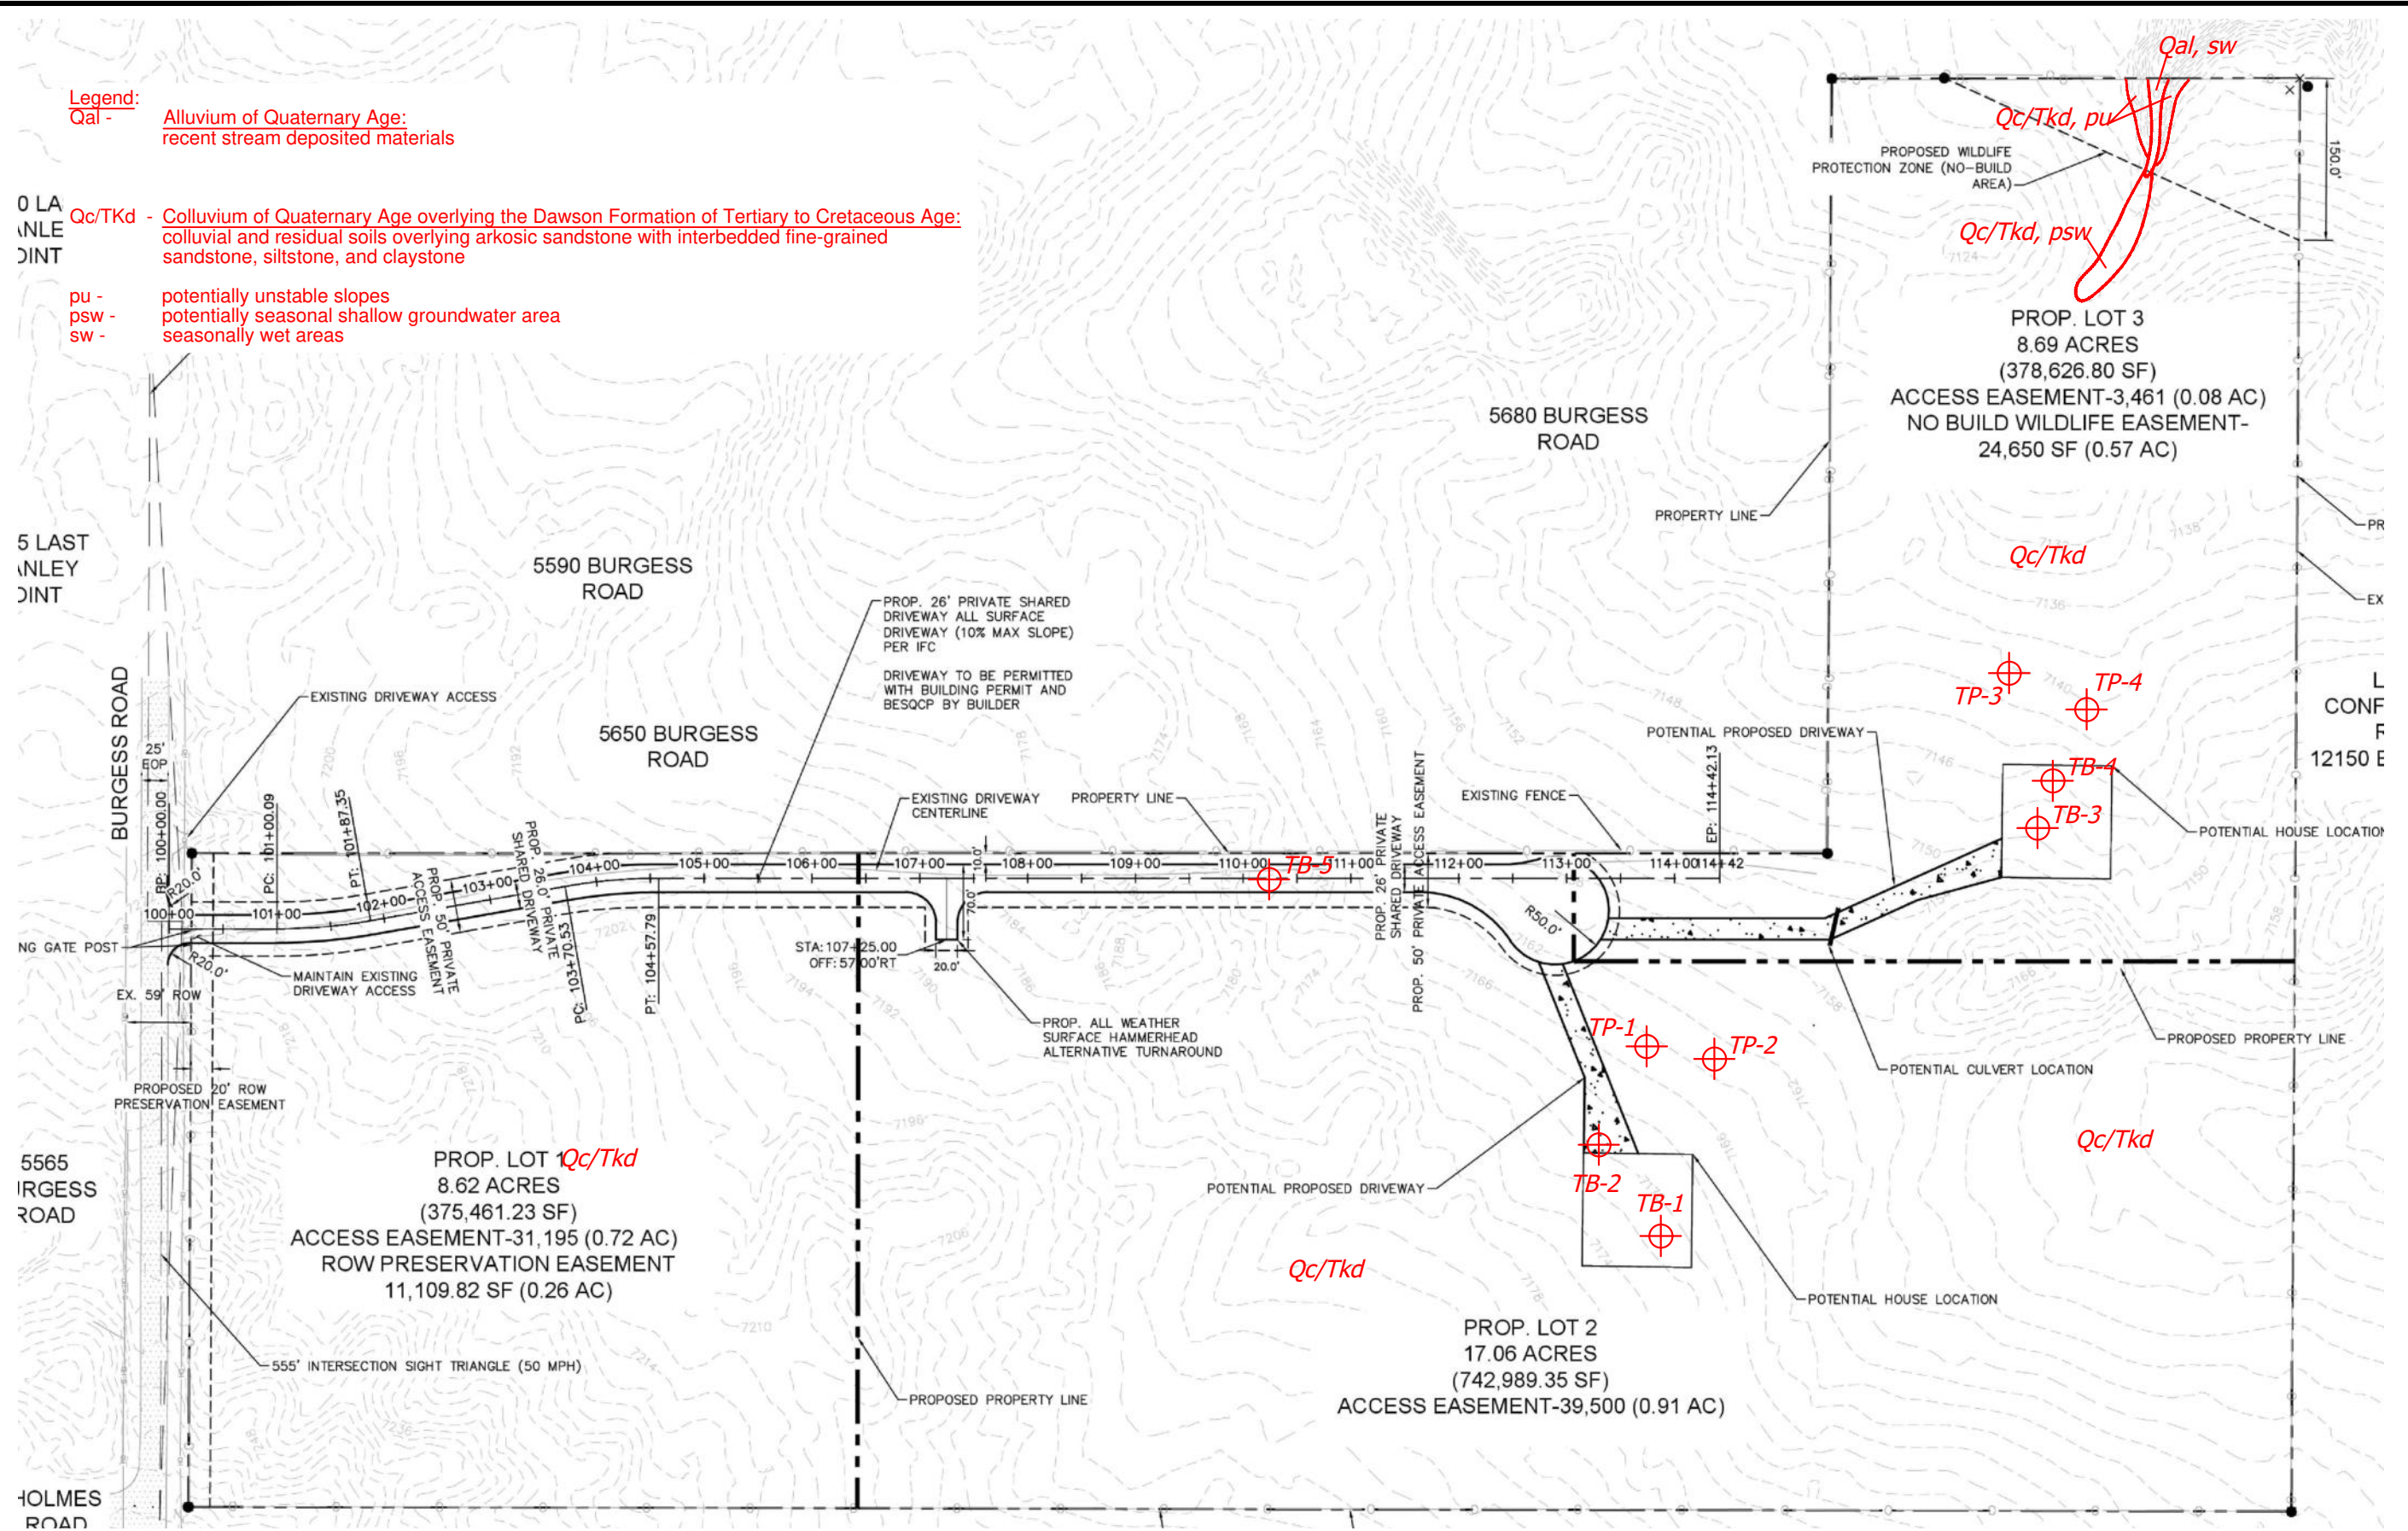
**FIG. 6**

The seasonally wet area has been mapped in the head of the drainage located in the northwestern portion of Lot 3. Construction is not recommended in this area and is located within a no-build area. Mitigation for seasonally wet areas is discussed in the following section.

A low lying area above the head of the drainage located in the northwestern portion of Lot 3 was identified as a potentially seasonally wet area. Water was not observed in this area; however, this area has the potential for seasonal shallow groundwater, and is indicated on the Geology/Engineering Geology Map (Figure 6). Due to the size of the proposed lots these areas can either be avoided by the proposed structures or proposed soil treatment areas. Signs of seasonally occurring groundwater were encountered in three of test pits at depths ranging from 4.5 to 5 feet. The pits were placed in anticipated OWTS soil treatment field areas. The test borings were drilled on Lots 2 and 3 in anticipated building locations. These test borings were dry to depths of 15 to 20 feet. The potential for seasonally perched groundwater on the shallow bedrock exist on the site. A minimum separation of 3 feet between foundation components and potential groundwater levels is recommended. Should groundwater or signs of groundwater be encountered in building excavations additional drains consisting of interceptor installed on the uphill side of the excavation or underslab drains may be needed.

The majority of the slopes in the building areas on site are generally gradually to moderately sloping and do not exhibit any past or potential unstable slopes or landslides. However, areas of downslope creep have been mapped in the northwestern portion of the site along the head of a drainage. These slopes are located within a no-build area and will be avoided by the proposed development. This area is identified on the Geology/Engineering Geology Map, Figure 6. The recommendations for these areas are as follows:

The areas identified with this hazard includes the steeper slopes along the drainage in the northwestern portion of Lot 3. In these areas we would anticipate lateral and vertical movement of the near surface soils in the downslope direction. These areas are located within a no-build area and will be avoided by the proposed development.

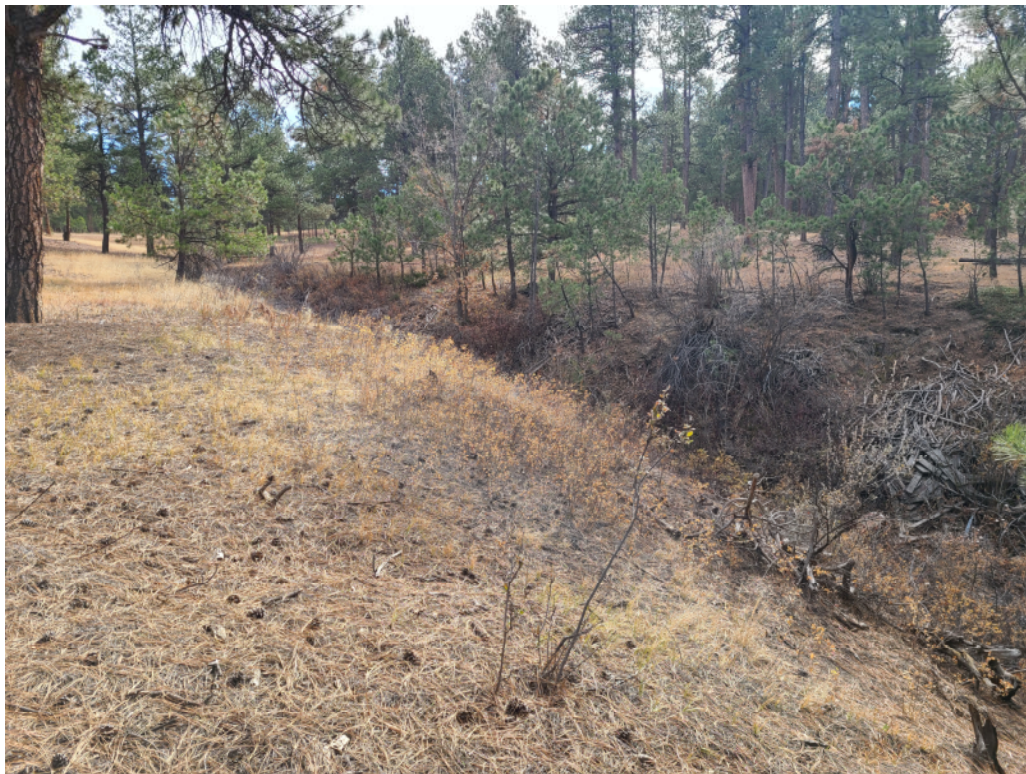
**Looking east along the  
head of the drainage in  
the northwestern  
portion of Lot 3.**
