February 3, 2023

**ENTECH**  
ENGINEERING, INC.

Re: OWTS – Wastewater Study  
5740 Burgess Road  
Tax Schedule No. 62130-00-050  
El Paso County, Colorado

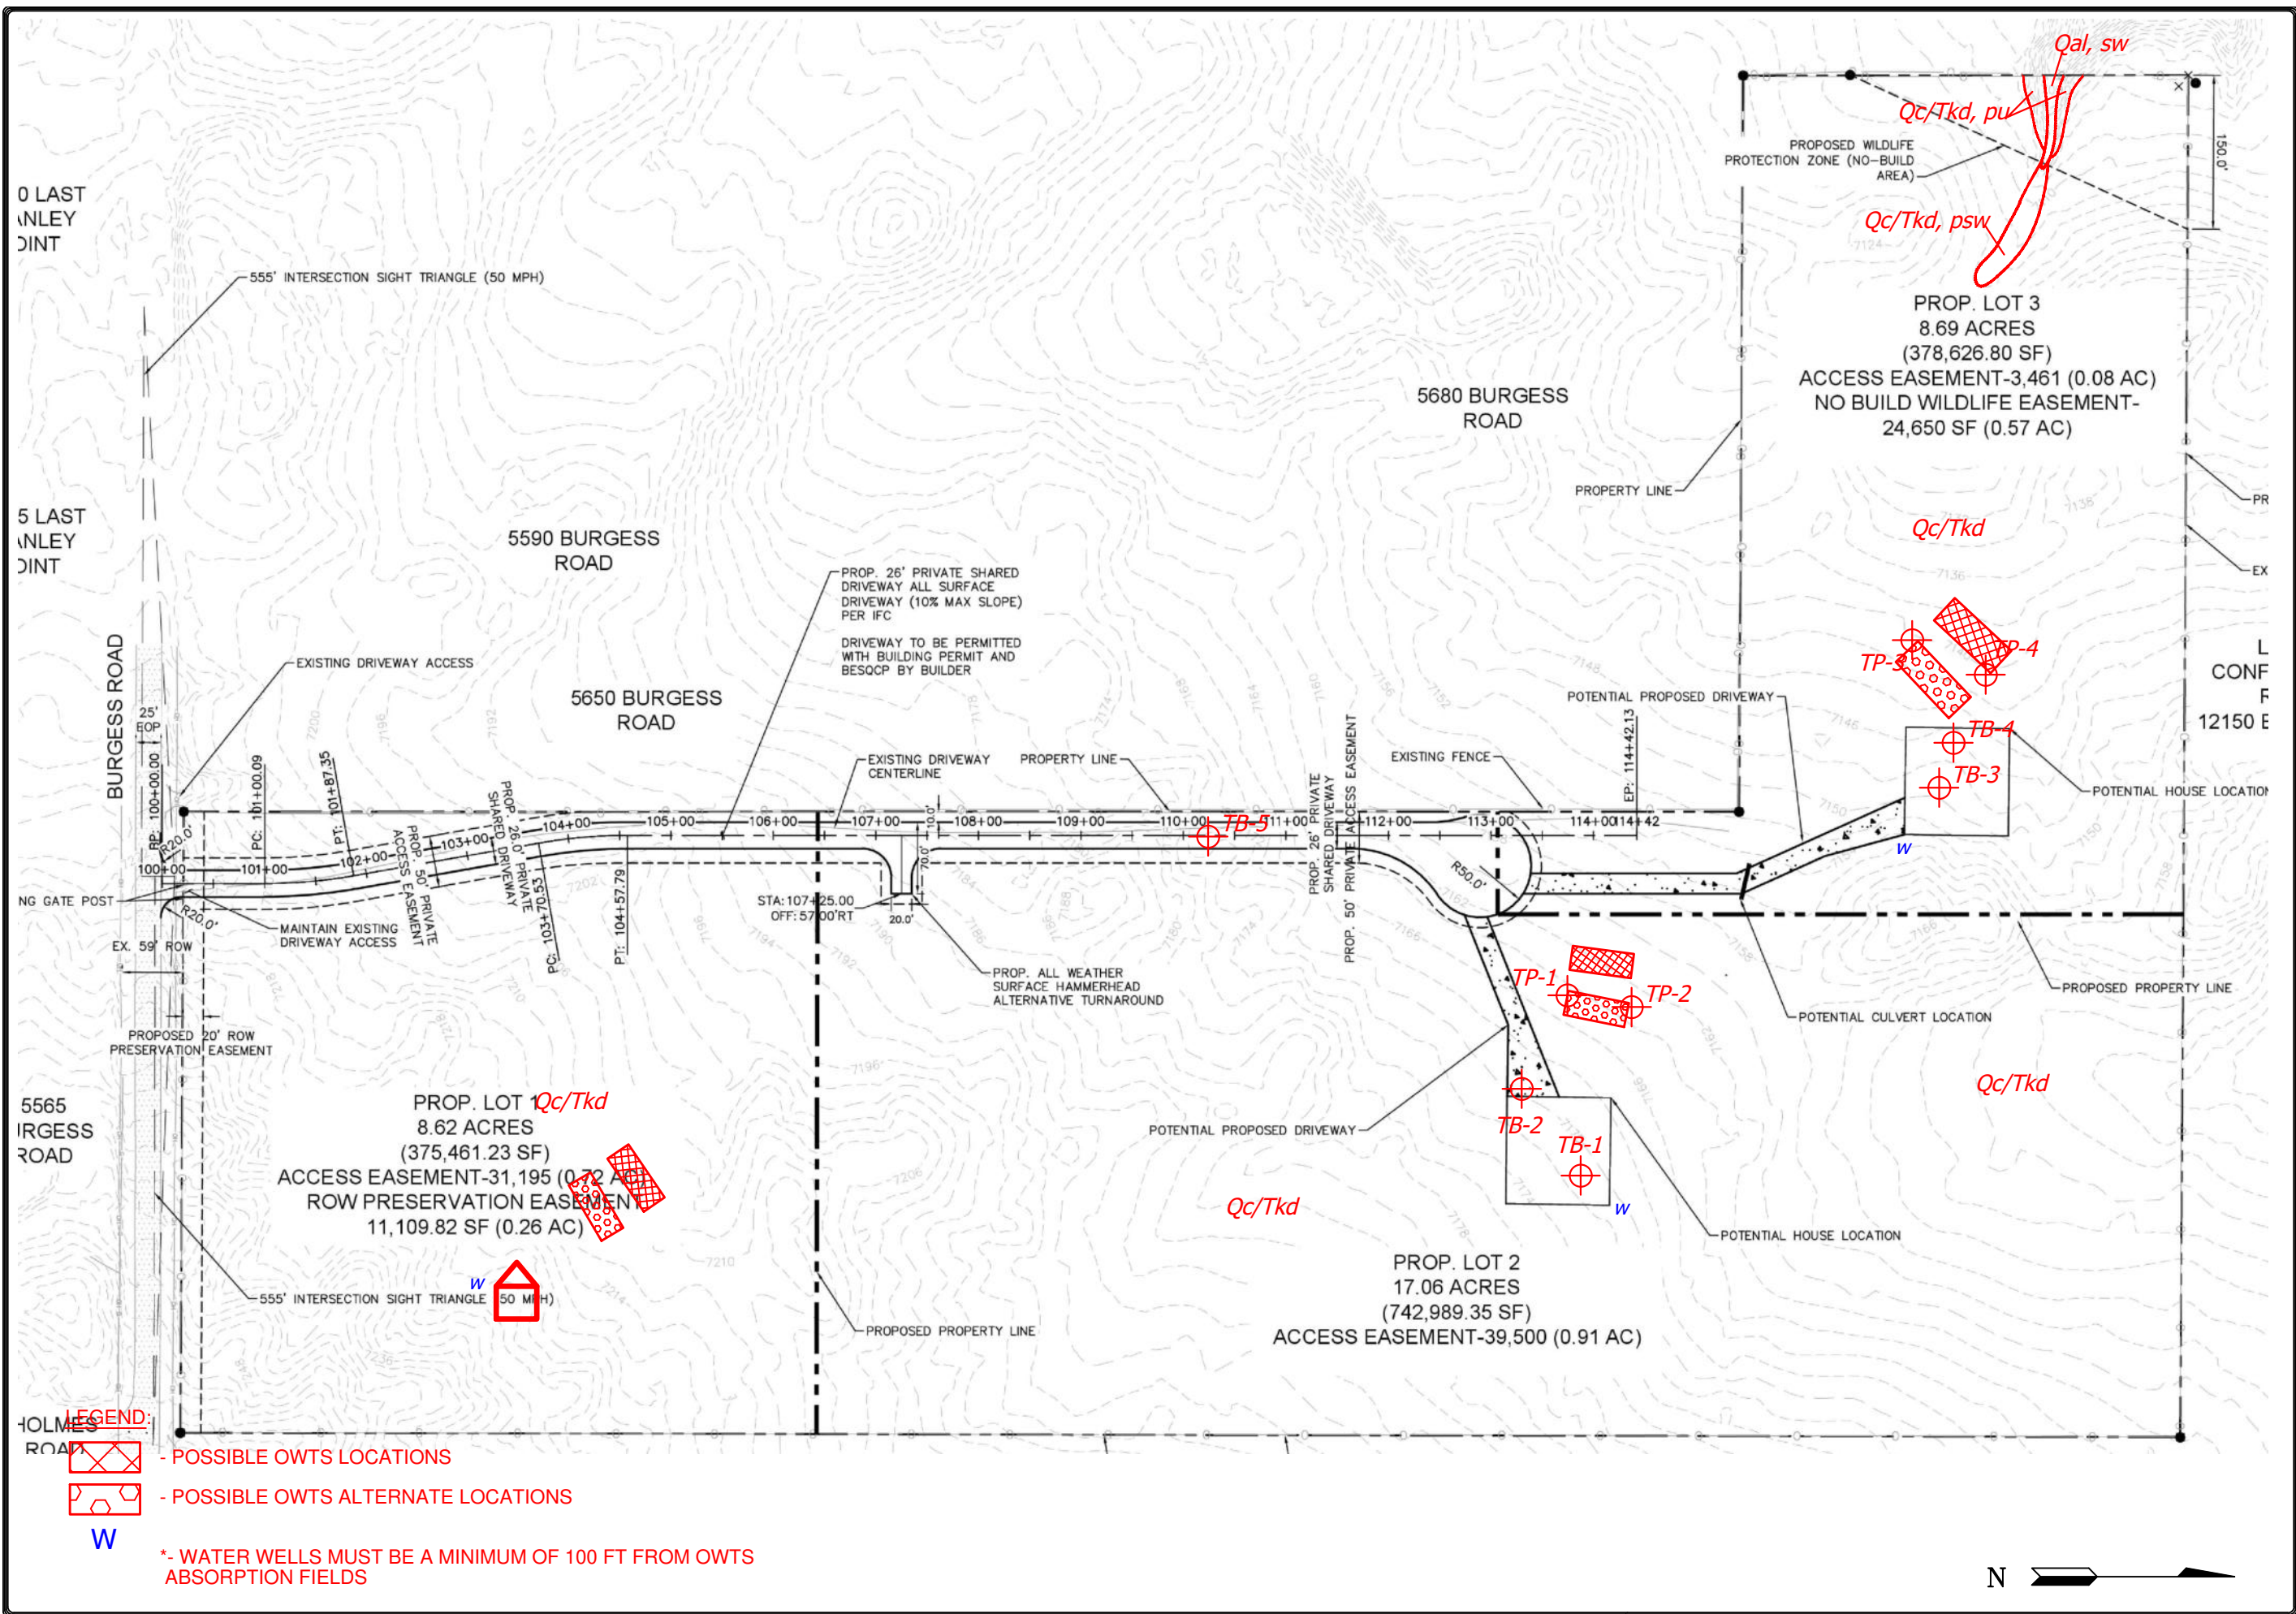
OWTS SUTABILITY MAP  
5740 BURGESS ROAD  
EL PASO COUNTY, CO.  
FOR: THE RENEHAN'S

Soils encountered in the tactile test pits consisted of sandy clay loam, sandy clay, sandy loam, gravelly sandy loam, and very clayey sandstone/sandy claystone. The limiting layers encountered in the test pits are the clay, gravelly sandy loam the bedrock, which corresponds with USDA Soil Types 4A and R-1 with an LTAR values of 0.15 and 0.60 gallons per day per square foot, respectively. Bedrock was encountered at 3.5 feet in Test Pit No. 4, and signs of seasonally occurring groundwater were observed at 4.5 to 5 feet in three of the test pits. Absorption fields must be maintained a minimum of 4 feet above groundwater, bedrock, or confining layers. Should groundwater or bedrock be encountered within 6 feet of the surface, designed systems will be required. Designed systems are anticipated for the lots on this site.

In summary, it is our opinion the site is suitable for individual on-site wastewater treatment systems (OWTS) and that contamination of surface and subsurface water resources should not occur provided the OWTS sites are evaluated and installed according to El Paso County and State Guidelines and properly maintained. Based on the testing performed designed systems will be required for lots. The Septic Suitability Map is presented in Figure 8. Proposed house locations, water wells, and two septic sites for the new lots are indicated. Absorption fields must be located a minimum of 100 feet from any well, including those on adjacent properties. Absorption fields must also be located a minimum of 50 feet from any drainages, floodplains or ponded areas and 25 feet from dry gulches.

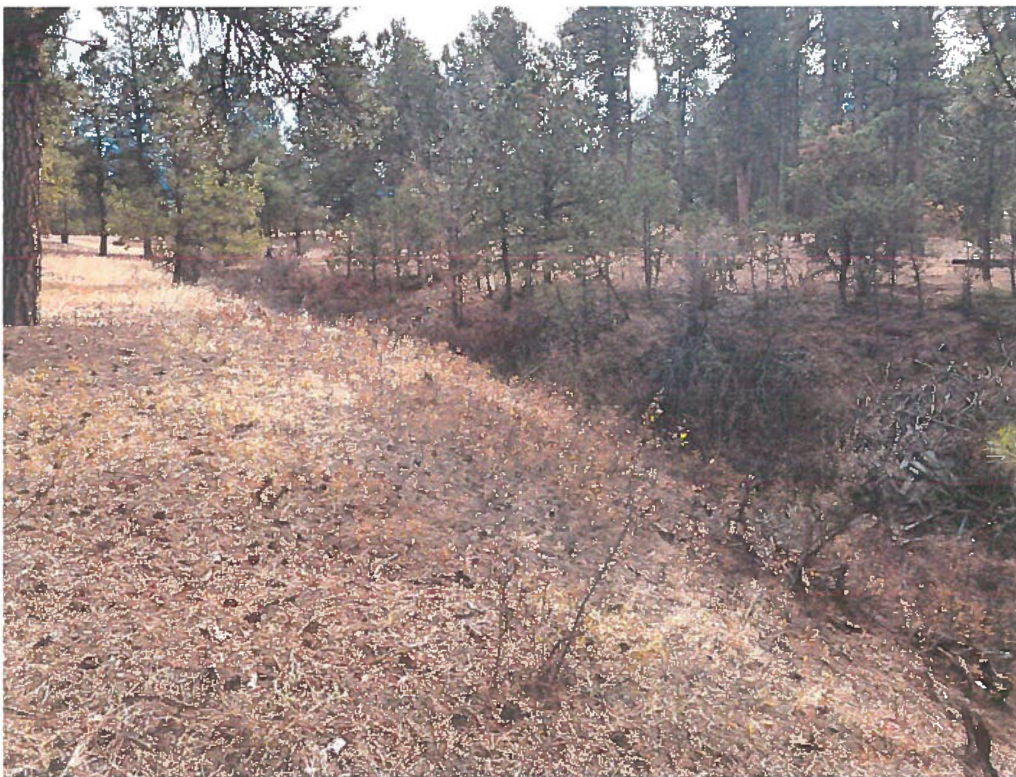
The seasonally wet area has been mapped in the head of the drainage located in the northwestern portion of Lot 3. Construction is not recommended in this area and is located within a no-build area. Mitigation for seasonally wet areas is discussed in the following section.

**Looking east along the  
head of the drainage in  
the northwestern  
portion of Lot 3.**
