**SOIL, GEOLOGY, & GEOLOGIC HAZARD STUDY
THE VILLAGES AT STERLING RANCH EAST
PRELIMINARY PLAN NO. 3 – PARCEL NOS. 14, 15, 20, & 21
EL PASO COUNTY, COLORADO**

April 13, 2022

Entech Job No. 220573

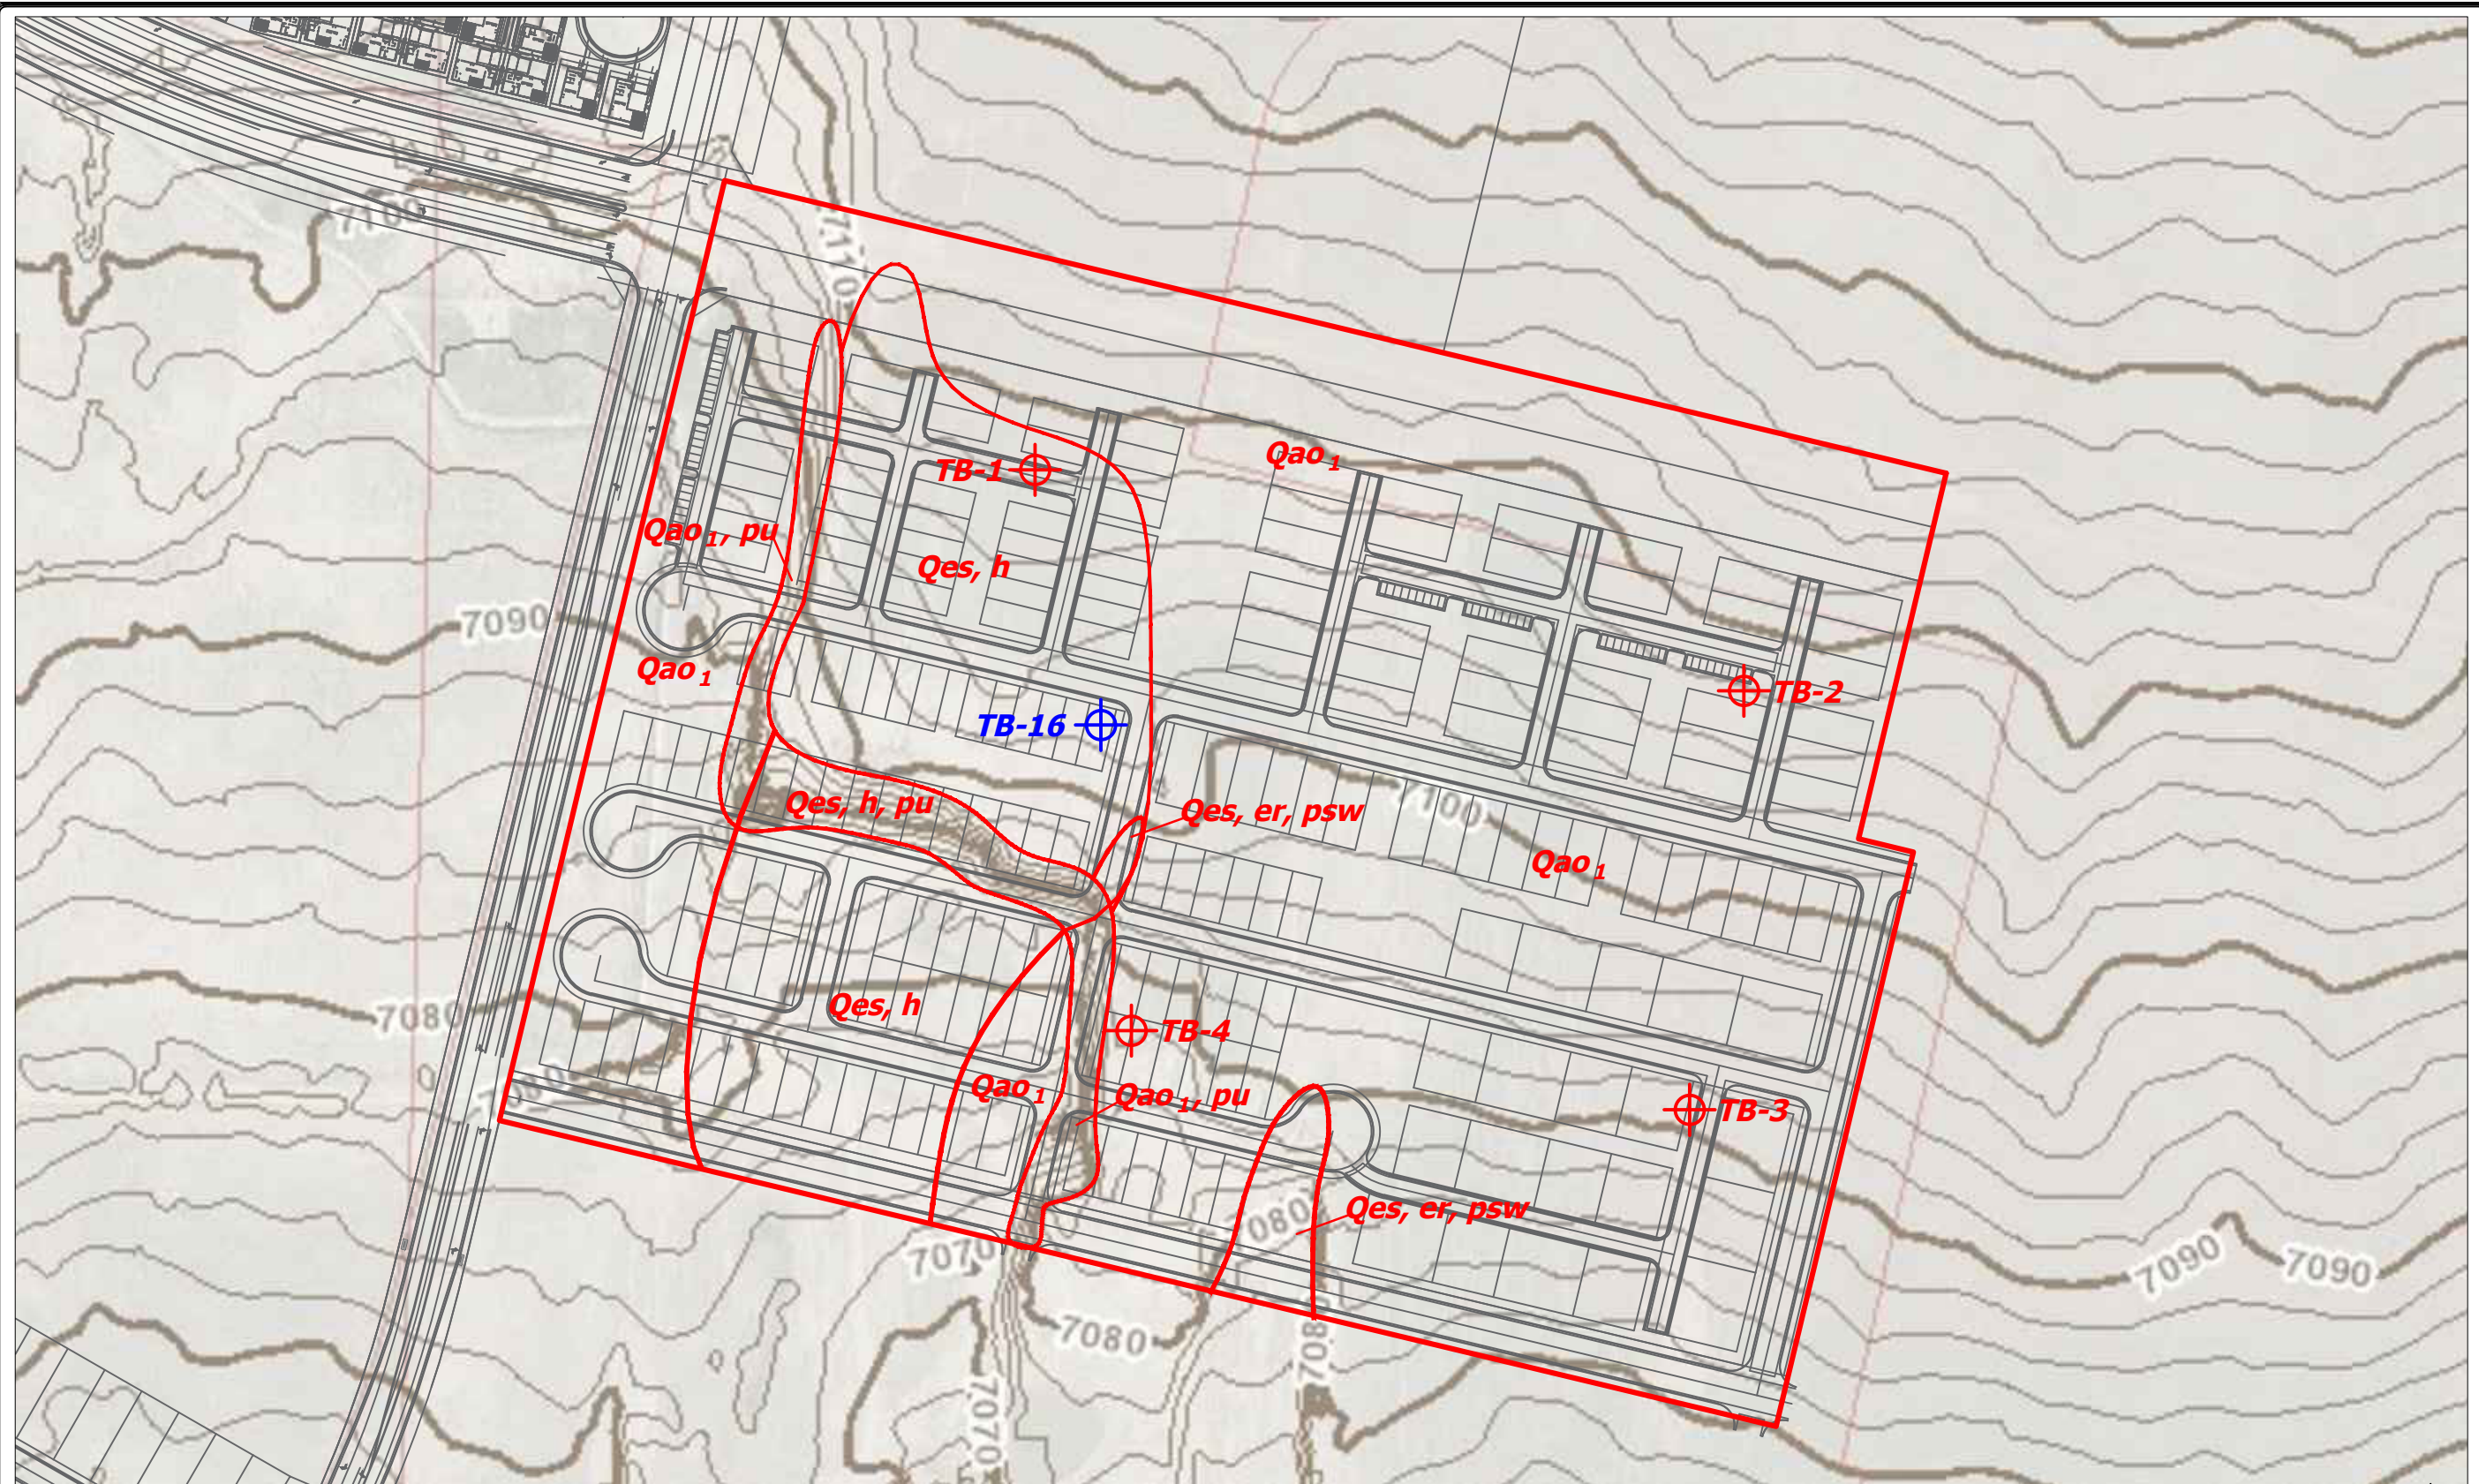
DRAWN L.L.
CHECKED
DATE 4/8/22
SCALE AS SHOWN
JOB NO. 220573
FIGURE No. 7

As mentioned previously, detailed mapping has been performed on this site to produce an Engineering Geology Map Figure 7. This map shows the location of various geologic conditions of which the developers should be cognizant during the planning, design and construction stages of the project. These hazards and the recommended mitigation techniques are as follows:

These are areas that are undergoing erosion by water and sheetwash producing gullies and rill erosion. The areas significant erosion observed on the site are located in the former borrow areas where most of the vegetation had been removed.

In these areas, we would anticipate the potential for periodically high subsurface moisture conditions, frost heave potential and highly organic soils. These areas lie within minor drainage swales which will likely be regraded during grading of the development.

These slopes are considered stable in their present condition; however, considerable care must be exercised in these areas not to create a condition which would tend to activate instability. These areas are primarily located along the cut slope of the former borrow area in the western portion of the site.

Mitigation: Due to the nature of the soils on this site, virtually all the soils are subject to erosion by wind and water. Other minor areas of erosion were observed on site other than those mapped, particularly where some rill erosion has occurred. Areas of erosion can occur across the entire site, particularly if the soils are disturbed during construction. Vegetation reduces the potential for erosion. The areas identified where erosion is actually taking place may require check dams, regrading and revegetation using channel lining mats to anchor vegetation. Further recommendations for erosion control are discussed under Section 8.0 "Erosion Control" of this report. Recommendations pertaining to revegetation may require input from a qualified

Mitigation: Foundations must have a minimum 30-inch depth for frost protection. In areas where high subsurface moisture conditions are anticipated periodically, subsurface perimeter drains are recommended to help prevent the intrusion of water into areas below grade. Typical drain details are presented in Figure 9. Any grading in these areas should be done to direct surface flow around construction to avoid areas of ponded water. Structures should not block drainages. All organic material should be completely removed prior to any fill placement. Finished floor levels must be located a minimum of one foot above floodplain levels.

Mitigation: Building should be avoided in these areas unless properly mitigated. These areas will likely be regraded during the site development. Fill placed along these slopes should be properly benched into the slope as to not create unstable conditions.

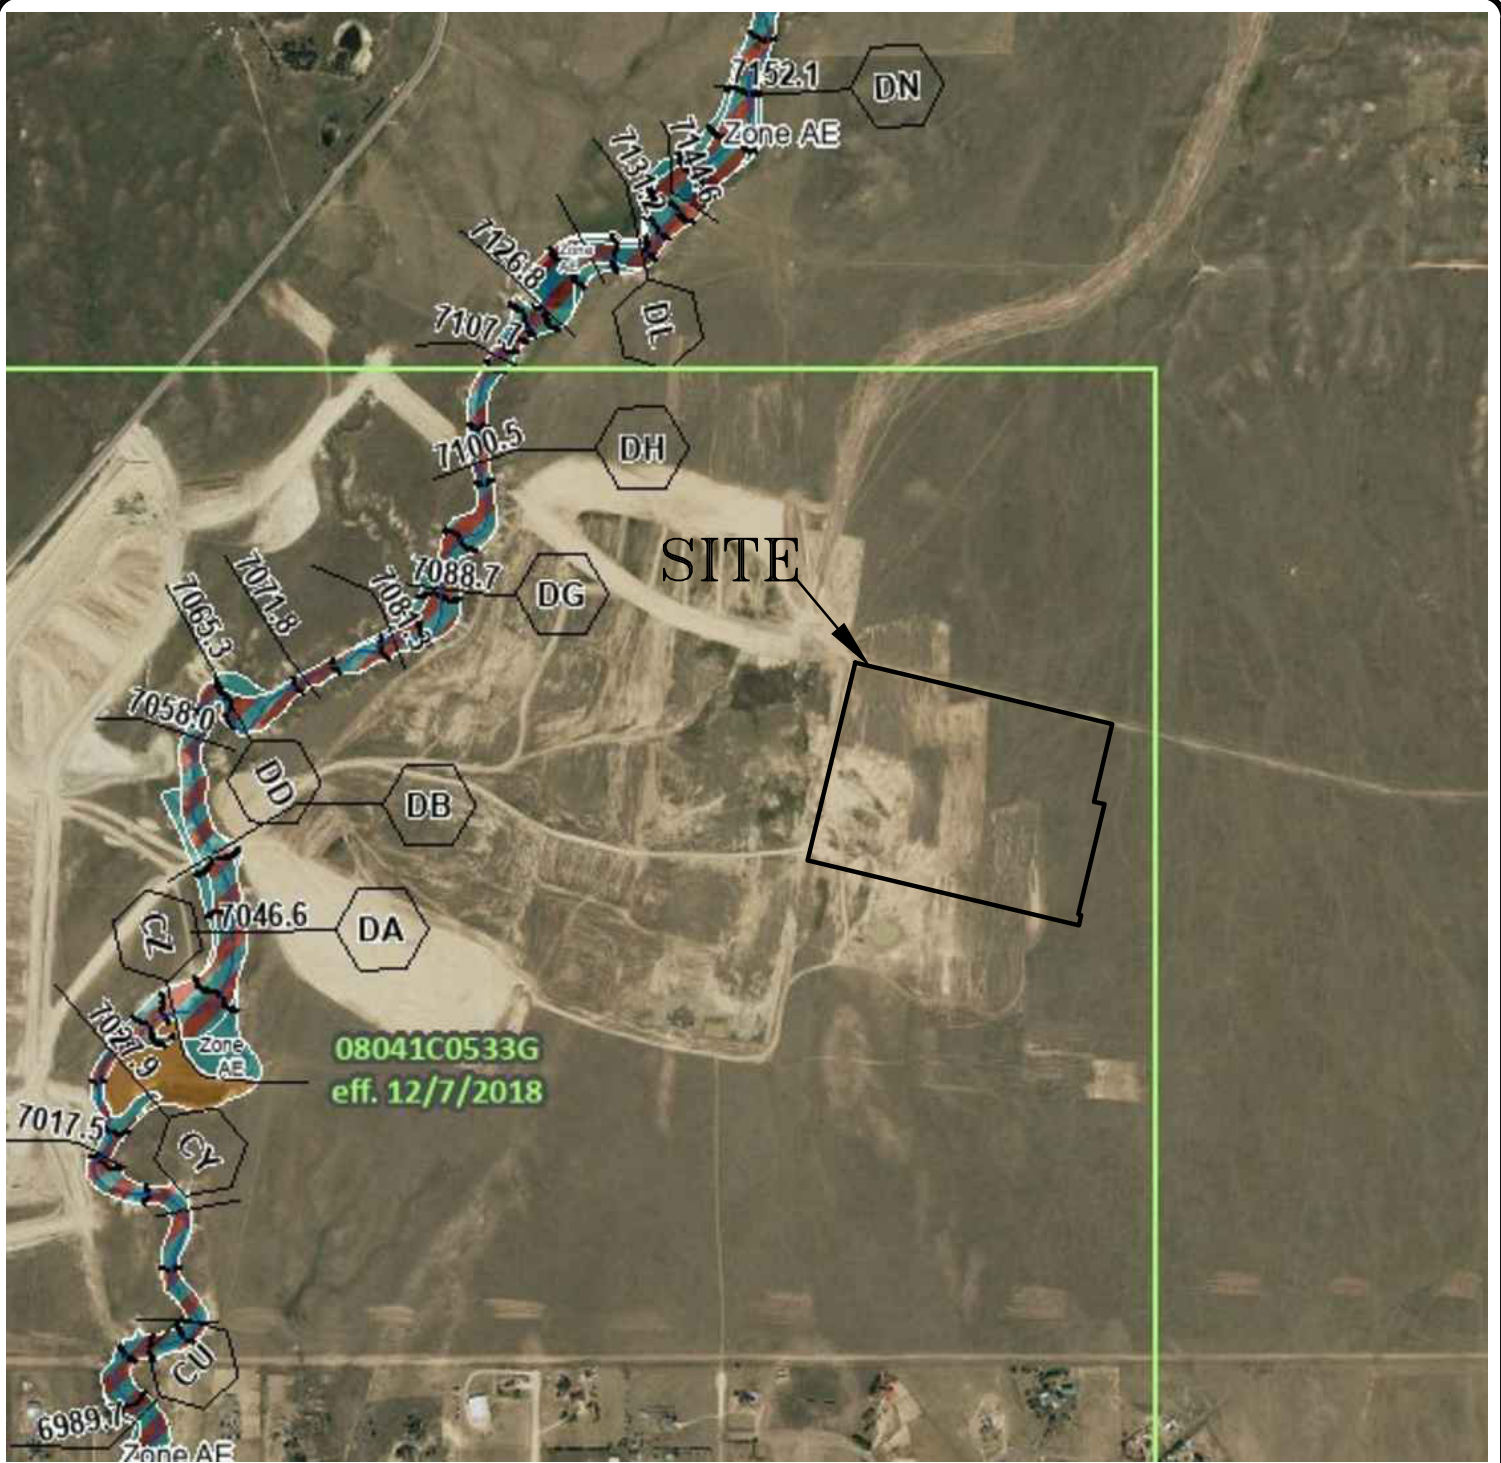
FLOODPLAIN MAP
 STERLING RANCH EAST
 PRELIMINARY PLAN NO. 3
 COLORADO SPRINGS, CO.
 FOR: CLASSIC SRJ

The site is not mapped within floodplain zones according to the FEMA Map No. 08041CO535G, Figure 8 (Reference 7). Areas within the minor drainage swales on-site have been identified as areas of potentially seasonal groundwater areas, but were dry at the time of our site observations. Standing water was observed in a pond to the south of the site, and to the west of the site at the northwest corner of future Briargate Parkway and Sterling Ranch Road. These areas are discussed as follows:
