October 30, 2020

Sonship Properties, LLC  
P.O. Box 511  
Rocky Ford, CO 81067

Re: Soil, Geology, and Geologic Hazard Study  
Prairie Ridge Subdivision  
Brown Road  
Parcel No. 61000-00-483  
El Paso County, Colorado

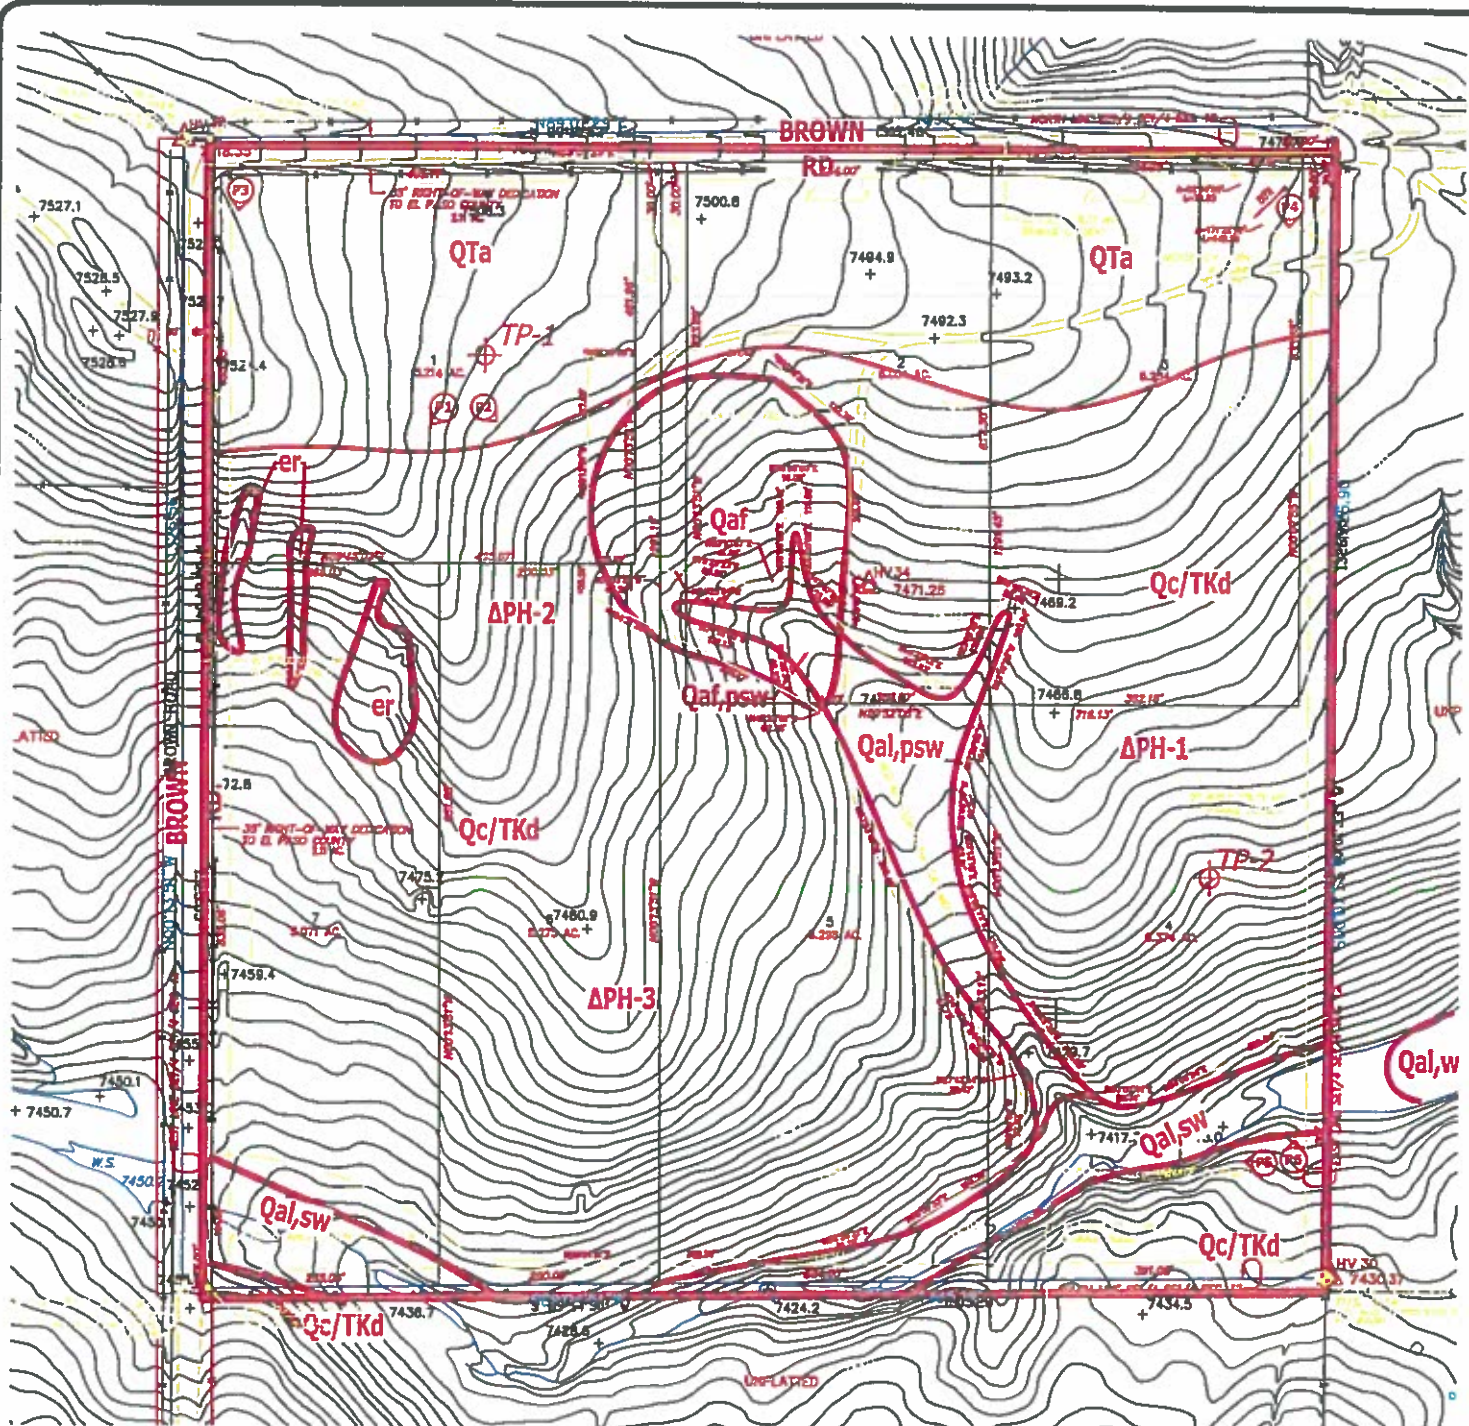
FIG NO.:  
6

The soils listed above were mapped from site-specific mapping, the *Geologic Map of the Black Forest Quadrangle* distributed by the Colorado Geologic Survey in 2003 (Reference 5, Figure 5), The *Geologic Map of the Colorado Springs-Castle Rock Area*, distributed by the US Geological Survey in 1979 (Reference 6), and the *Geologic Map of the Pueblo 1° x 2° Quadrangle*, distributed by the US Geological Survey in 1978 (Reference 7). The test borings and test pits were used in evaluating the site and is included in Appendices B and D. The Geology Map prepared for the site is presented in Figure 6.

The site is not mapped within any floodplains according to the FEMA Map No. 08041CO305G, dated December 7, 2018 (Figure 7, Reference 8). Areas of seasonal and potentially seasonal shallow groundwater were observed on the site (Figure 6). In these areas, we would anticipate the potential for periodically high subsurface moisture conditions and frost heave potential. These areas lie within low-lying areas and along the minor drainages in the central and southern portions of the site. Water was not observed in any of the drainages at the time of our site investigation. These areas can likely be avoided or properly mitigated by development. The potential exists for high groundwater levels during high moisture periods and should structures encroach on these areas the following precautions should be followed.

These are areas within the main drainage on the southern portion of the site. Water was not observed flowing in this area at the time of this investigation. These areas also contain frost heave potential and highly organic soils.

Mitigation: Because areas mapped as seasonally shallow groundwater lie within a defined drainage, we do not recommend structures be built within this area. Septic fields should be located a minimum of 25 feet away from the drainage or pond areas. Any construction in these areas should be done in a manner that does not create ponded water. Structures located immediately adjacent to the drainages any require drains to help prevent the intrusion of water with below-grade areas. Typical drain details are presented in Figure 8.

Mitigation: Foundations must have a minimum 30-inch depth for frost protection. In areas where high subsurface moisture conditions are anticipated periodically, subsurface perimeter drains are recommended to help prevent the intrusion of water into areas below grade. Typical drain details are presented in Figure 8. Any grading in these areas should be done to direct surface flow around construction to avoid areas of ponded water. All organic material would be completely removed prior to any fill placement. **Specific drainage studies are beyond the scope of this report.**

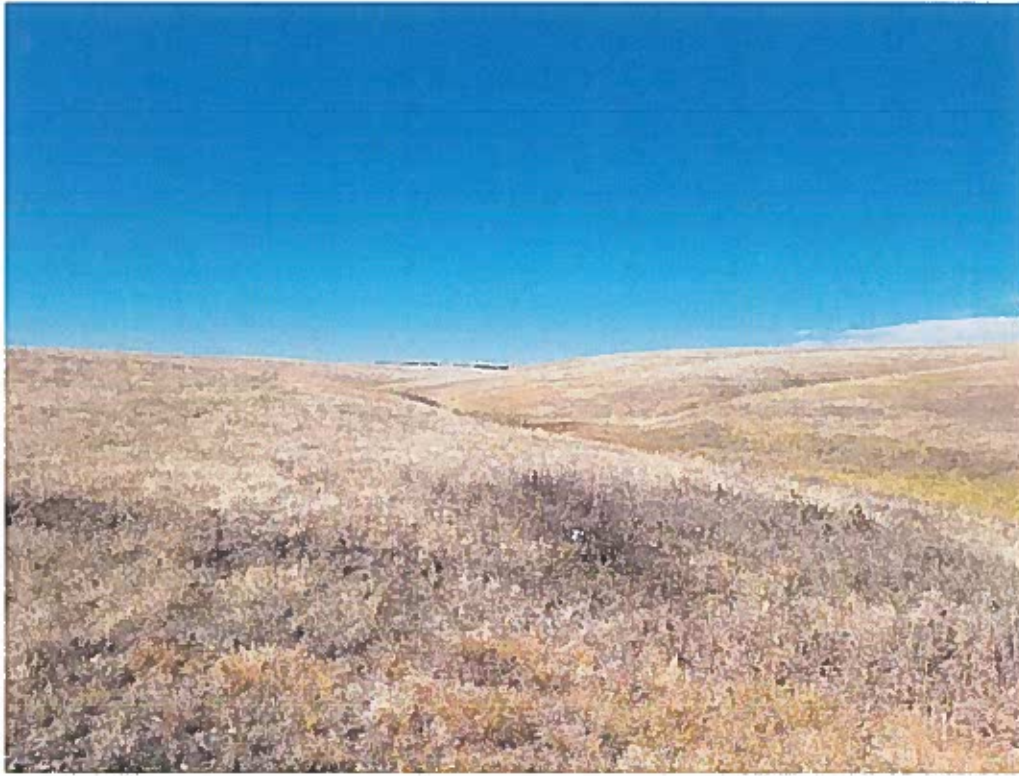
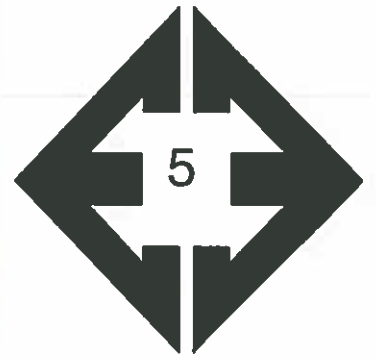
**Looking west along the drainage in the southern portion of the site.**
