ENTECH
ENGINEERING, INC.

October 16, 2024

Re: Soils and Geology Study
Berkheimer Subdivision Filing No. 1
Parcel No. 52060-00-063
14060 Black Forest Road
El Paso County, Colorado
Entech Job No. 241486

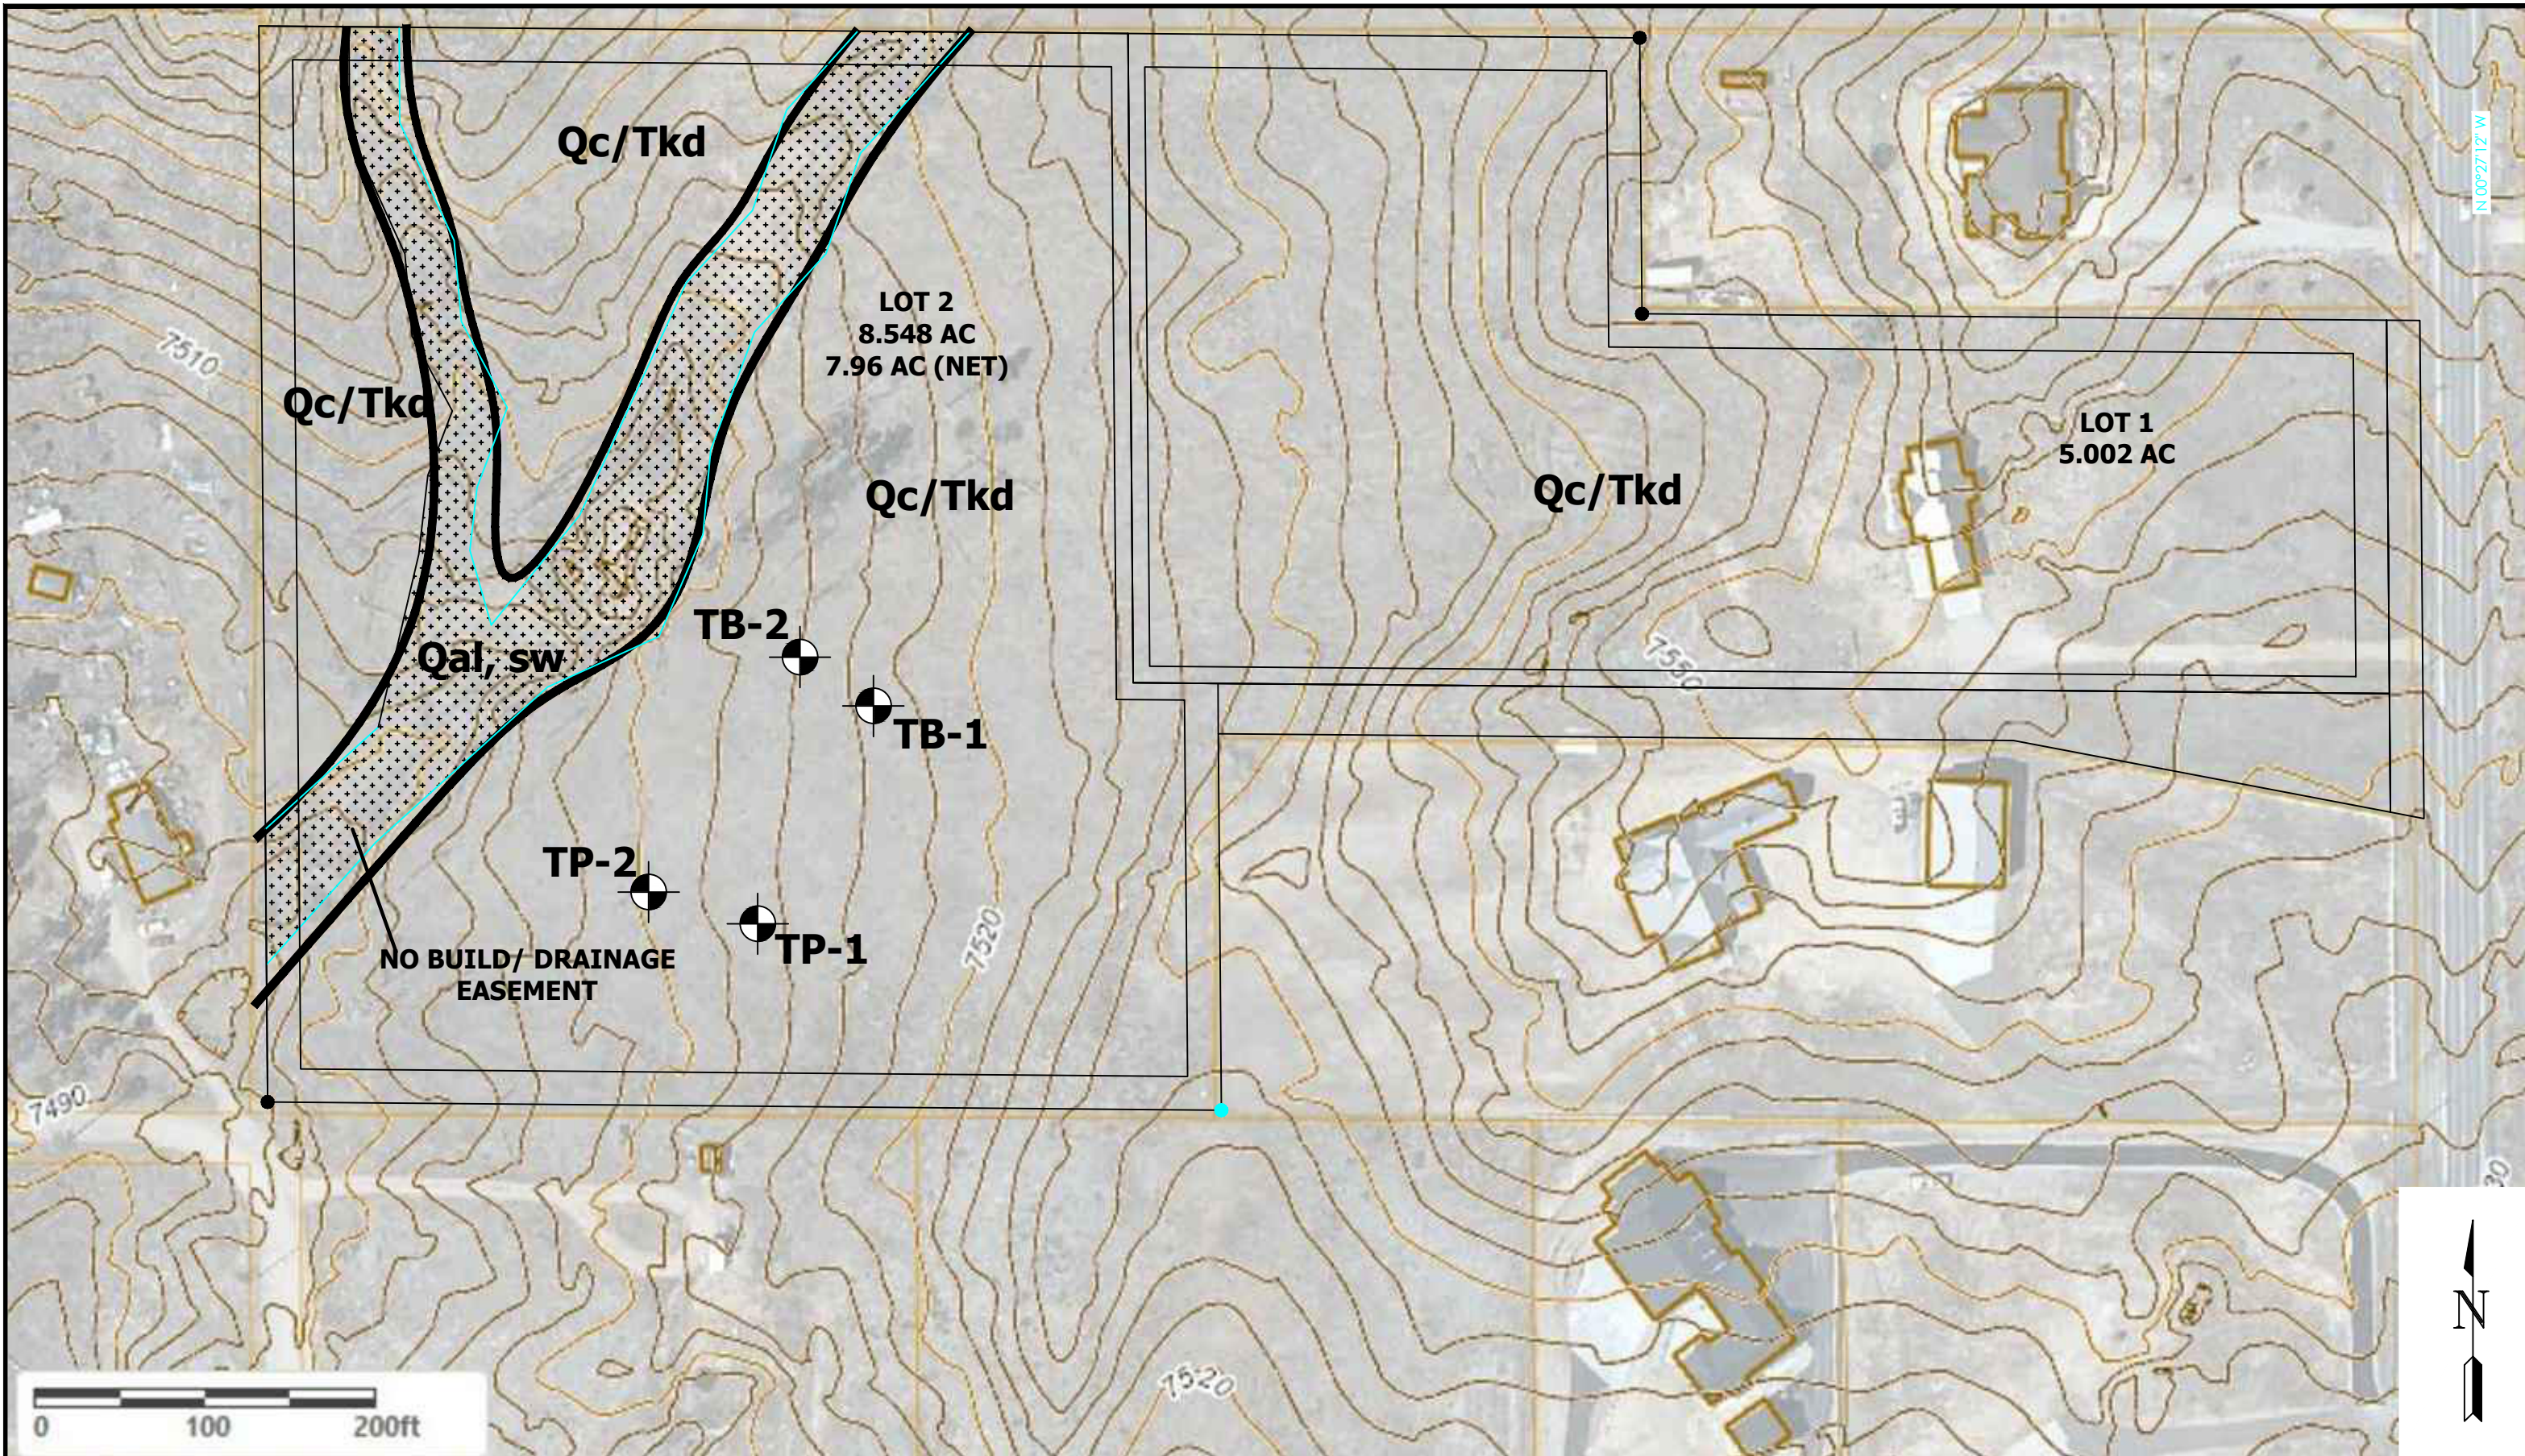
GEOLOGY / ENGINEERING MAP
14060 BLACK FOREST ROAD
ALTITUDE ADJUSTMENT CONSTRUCTION, LLC

In these areas, we would anticipate the potential for periodically high subsurface moisture conditions and frost heave potential. Water was not observed in any of the drainages at the time of our site investigation. These areas will be avoided by development. The potential exists for high groundwater levels during high moisture periods and should structures encroach on these areas the following precautions should be followed. A minimum separation of 3 feet between foundation components and groundwater levels are recommended.

Areas of seasonally shallow groundwater were observed on the site (Figure 6). In these areas, we would anticipate the potential for periodically high subsurface moisture conditions and frost heave potential. In these areas, we would anticipate the potential for periodically high subsurface moisture conditions and frost heave potential. These areas lie along minor drainages located in the western portion of the site. These areas lie within a no build/drainage area and will be avoided. Water was not observed in any of the drainages at the time of our site investigation. Subsurface perimeter drains are recommended should structures with any useable below grade spaces. Typical drain details are presented in Figure 8. If shallow groundwater is encountered, underslab drains or interceptor drains may be necessary Figures 9 and 10. Specific drainage details and recommendations should be made once building locations and plans are finalized.

Mitigation: Foundations must have a minimum 30-inch depth for frost protection. In areas where high subsurface moisture conditions are anticipated periodically, subsurface perimeter drains are

recommended to help prevent the intrusion of water into areas below grade. Typical drain details are presented in Figure 8. If shallow groundwater is encountered, underslab drains or interceptor drains may be necessary Figures 9 and 10. Specific drainage details and recommendations should be made once building locations and plans are finalized. Any grading in these areas should be done to direct surface flow around construction to avoid areas of ponded water. All organic material would be completely removed prior to any fill placement. Specific drainage studies are beyond the scope of this report.

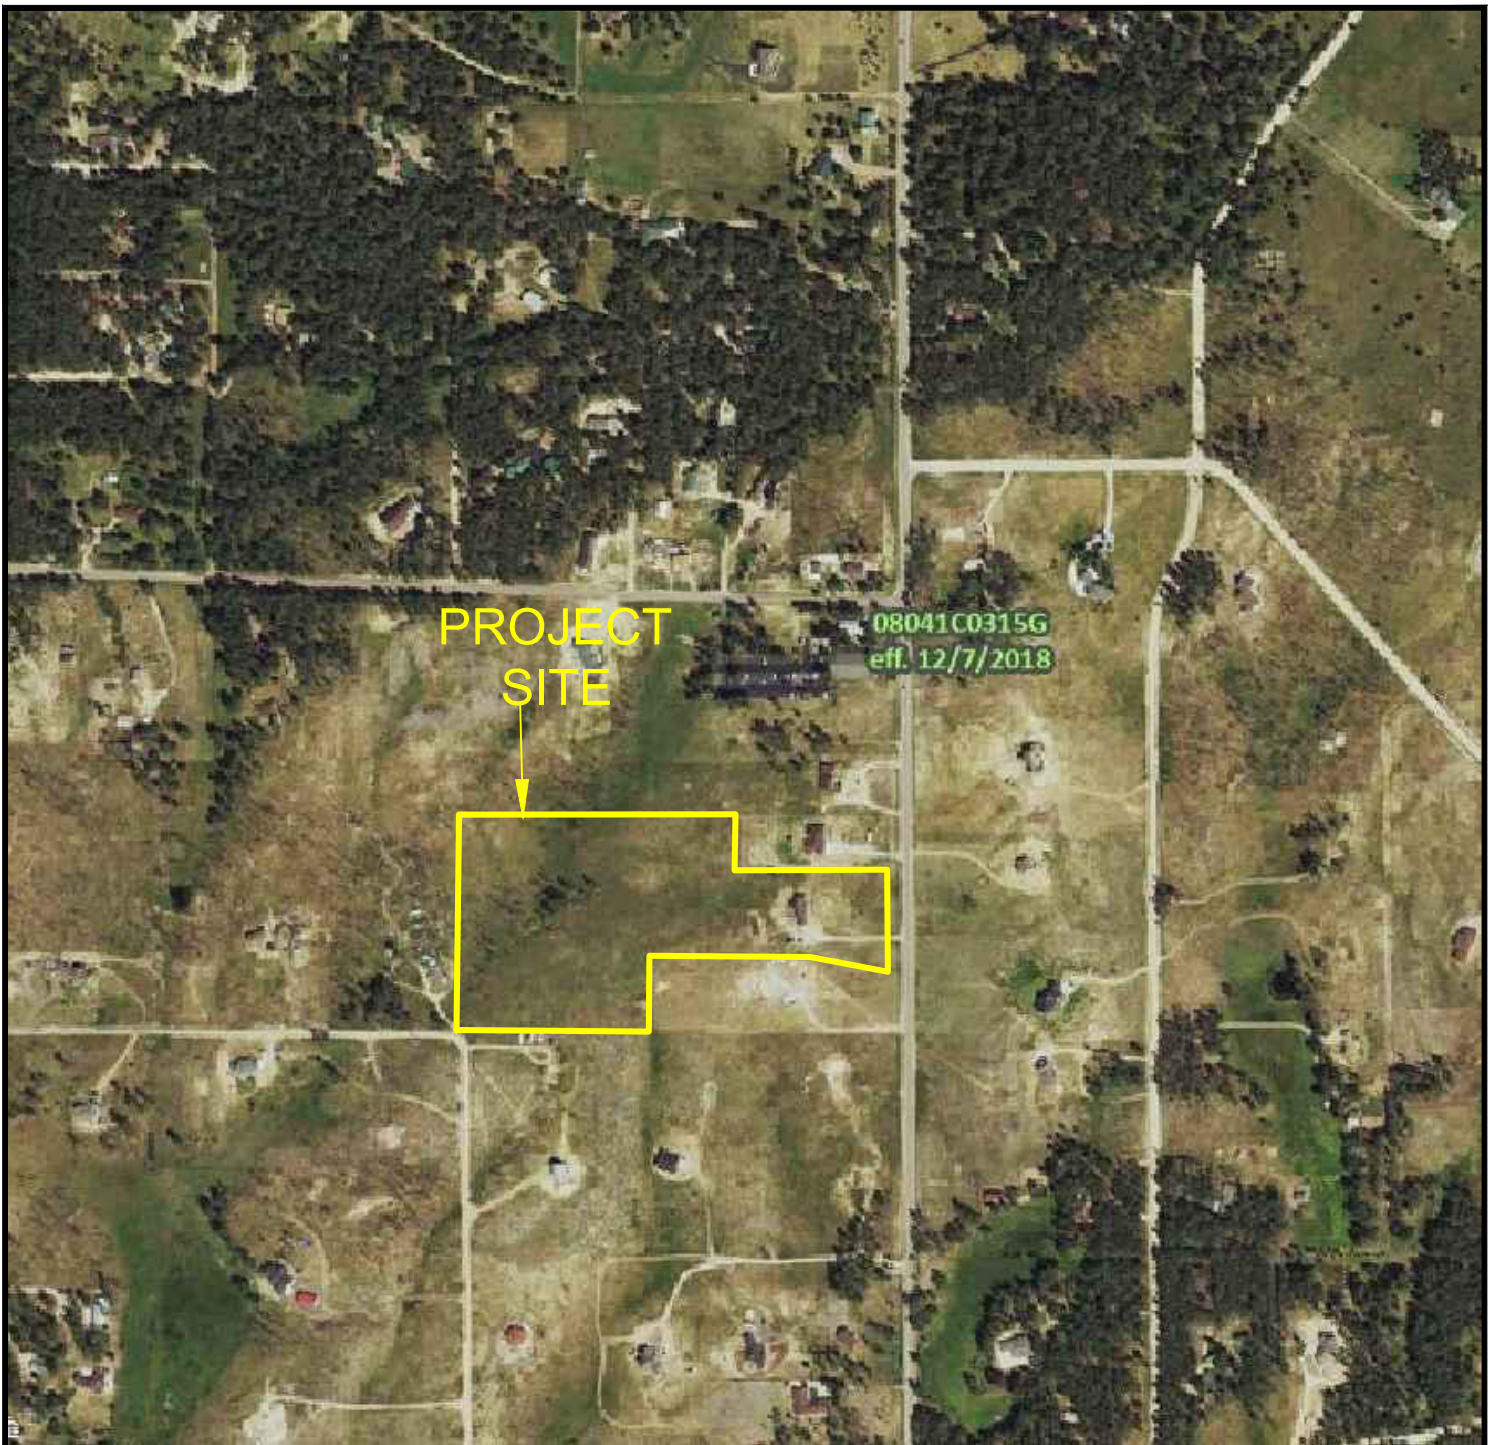
FEMA FLOODPLAIN MAP

The site is not mapped within any floodplains according to the FEMA Map No. 08041C0315G, dated December 7, 2018 (Figure 8, Reference 6). A minor drainage is located in the western portion of the site that has been identified as a seasonal shallow groundwater are, but was dry at the time of our initial site visit. This area is a no build/drainage easement and will be avoided. This area is discussed as follows

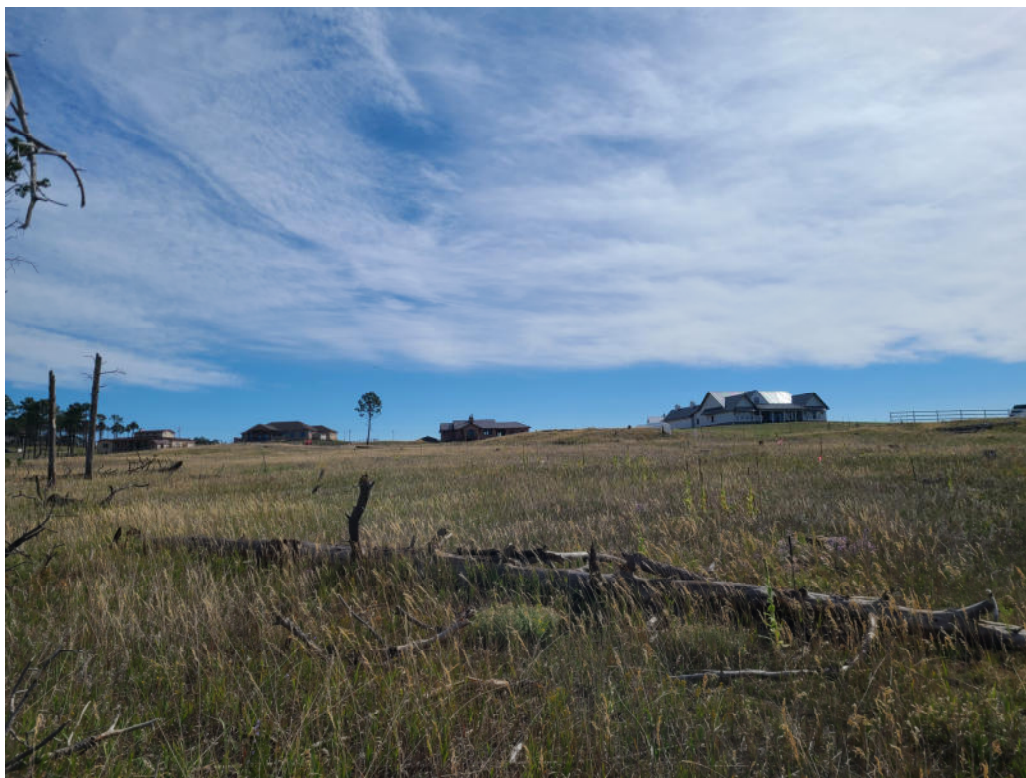
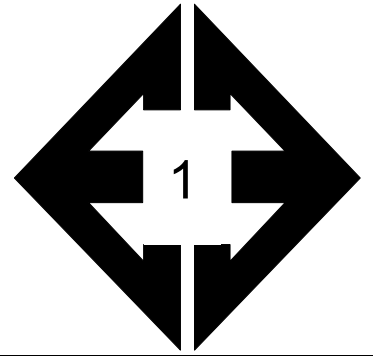
**Looking east from the
western portion of Lot
2.**

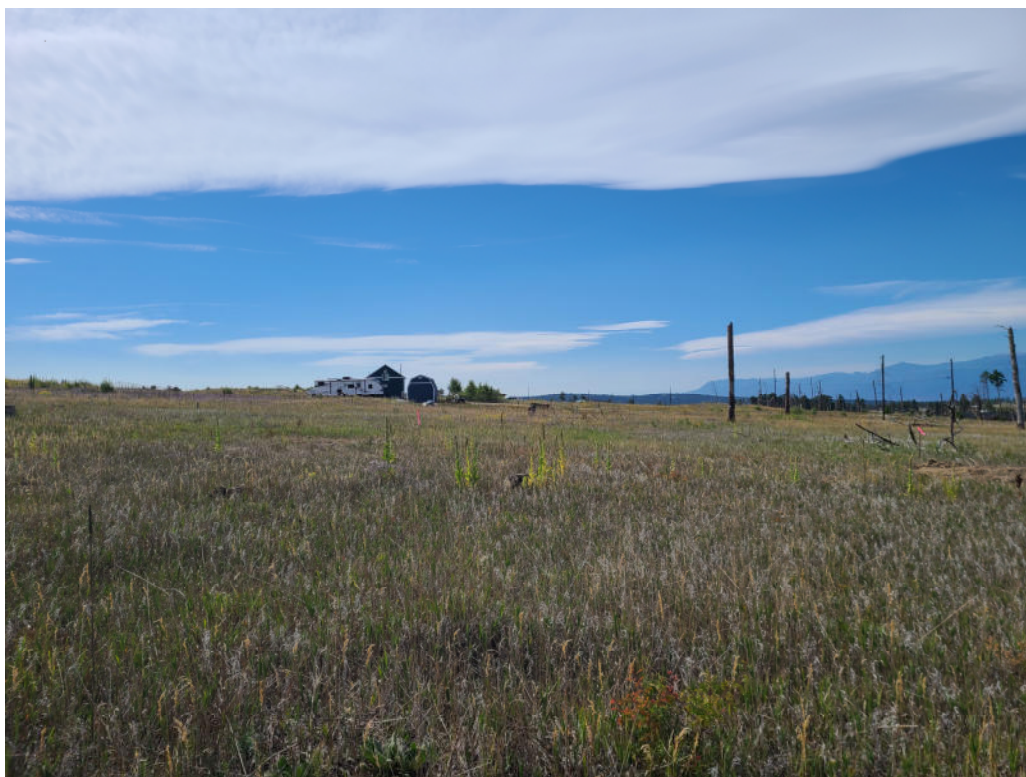
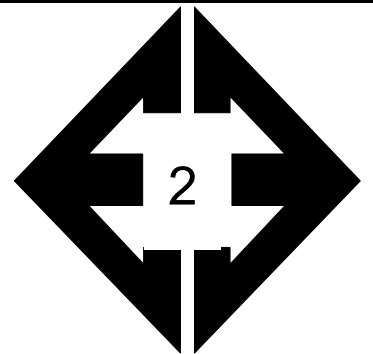
**Looking south the
central portion of Lot
No. 2.**

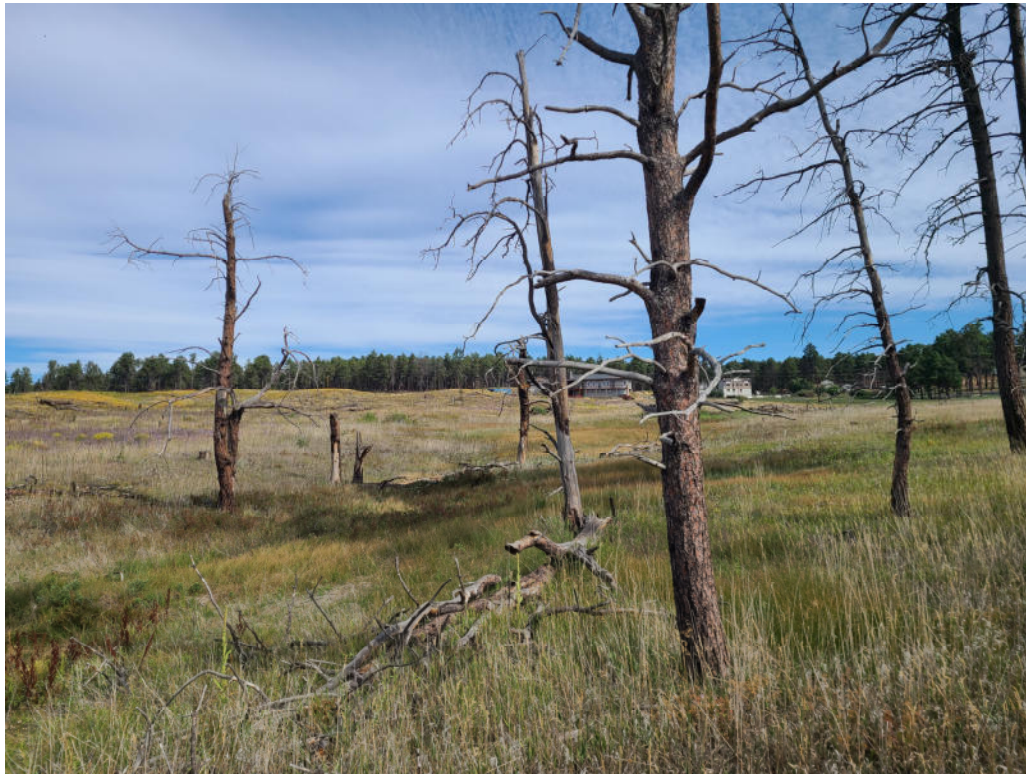
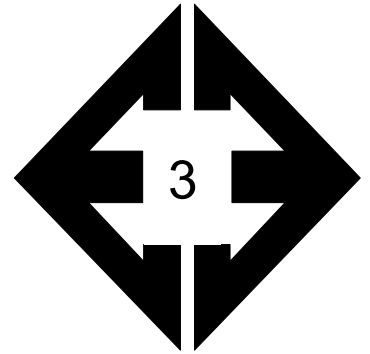
**Looking northeast
along drainage
easement in the
western portion of the
site.**

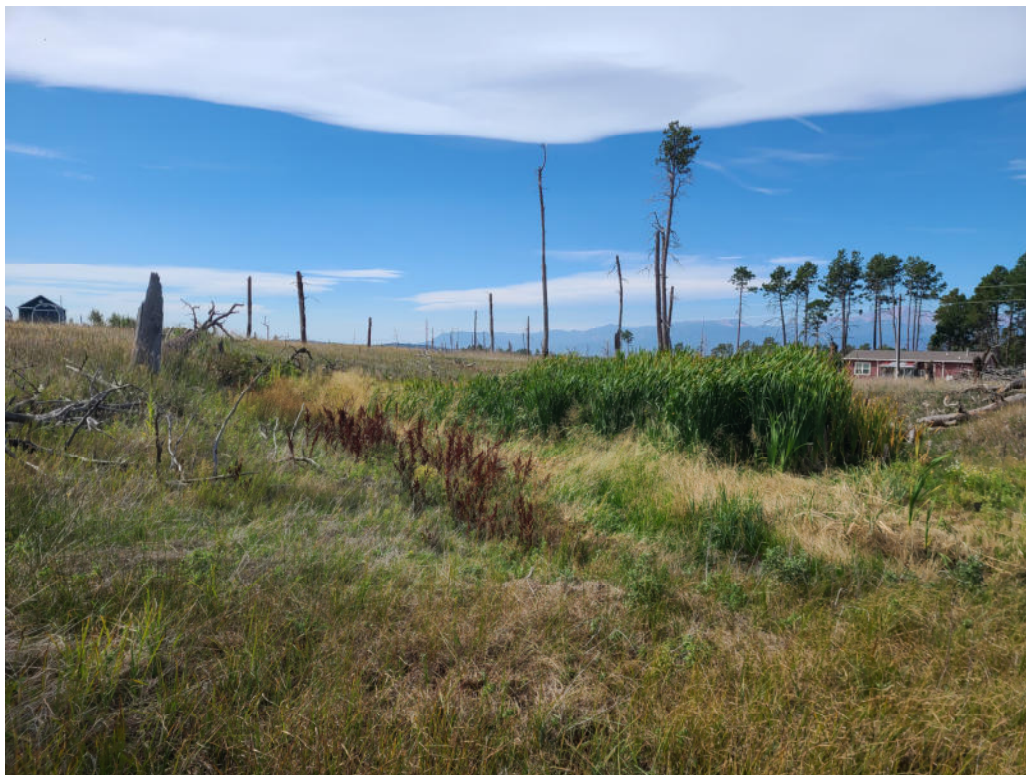
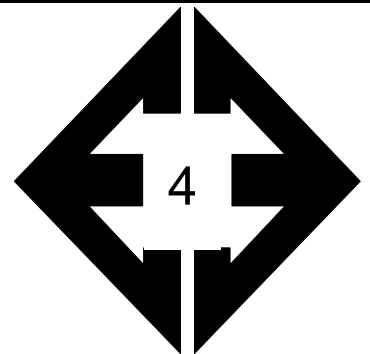
**Looking southwest
from the drainage
easement in the
western portion of the
site.**
