**ENTECH**  
ENGINEERING, INC.

**SOILS AND GEOLOGY STUDY  
THE COMMONS AT FALCON FIELD  
PARCEL NOS. 43070-00-001 AND 430720-00-015  
WOODMEN ROAD AND HIGHWAY 24  
EL PASO COUNTY, COLORADO**

January 20, 2021  
Revised July 21, 2023

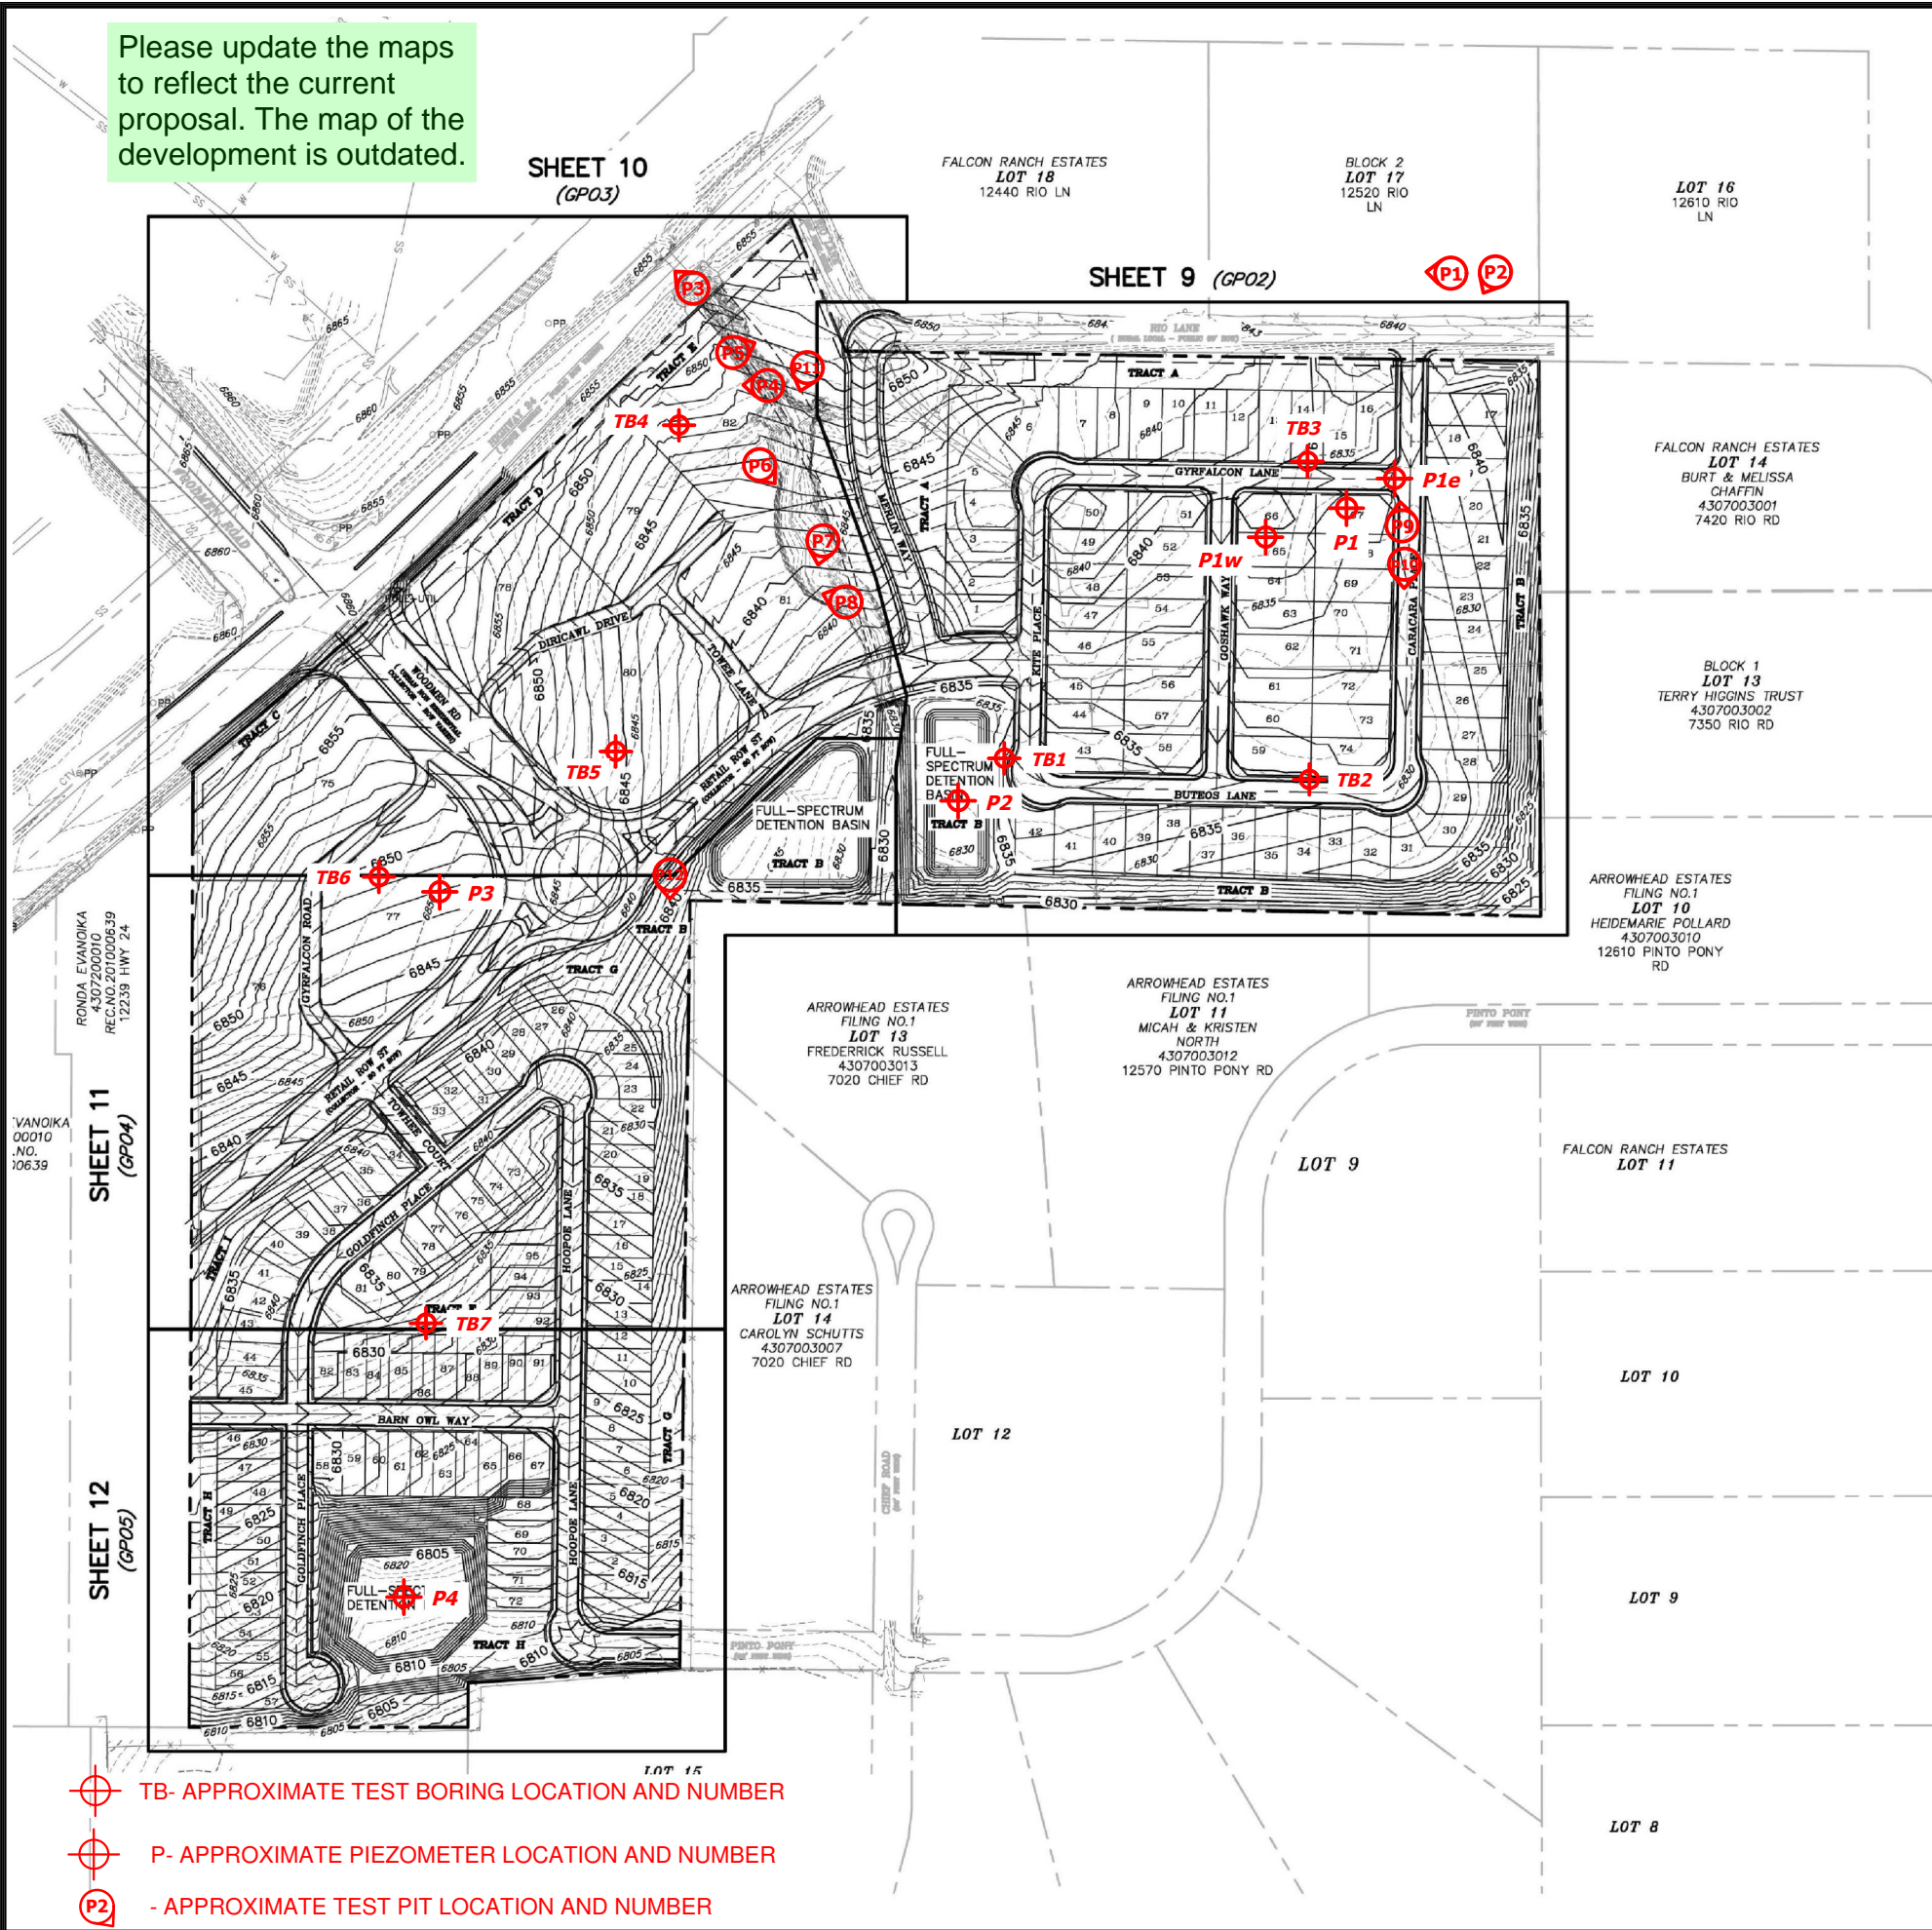
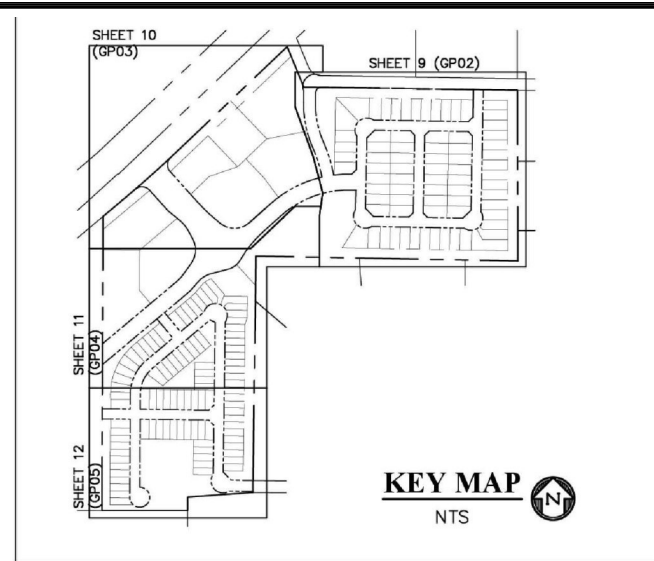
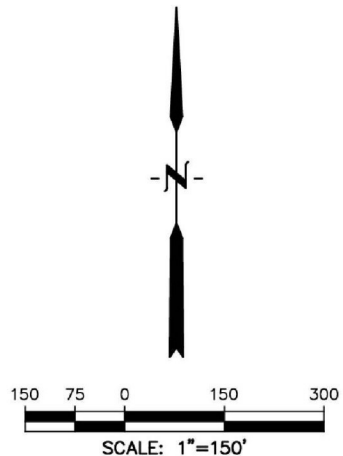
JOB NO.  
202649  
**FIG. 3**

Please update the maps to reflect the current proposal. The map of the development is outdated.

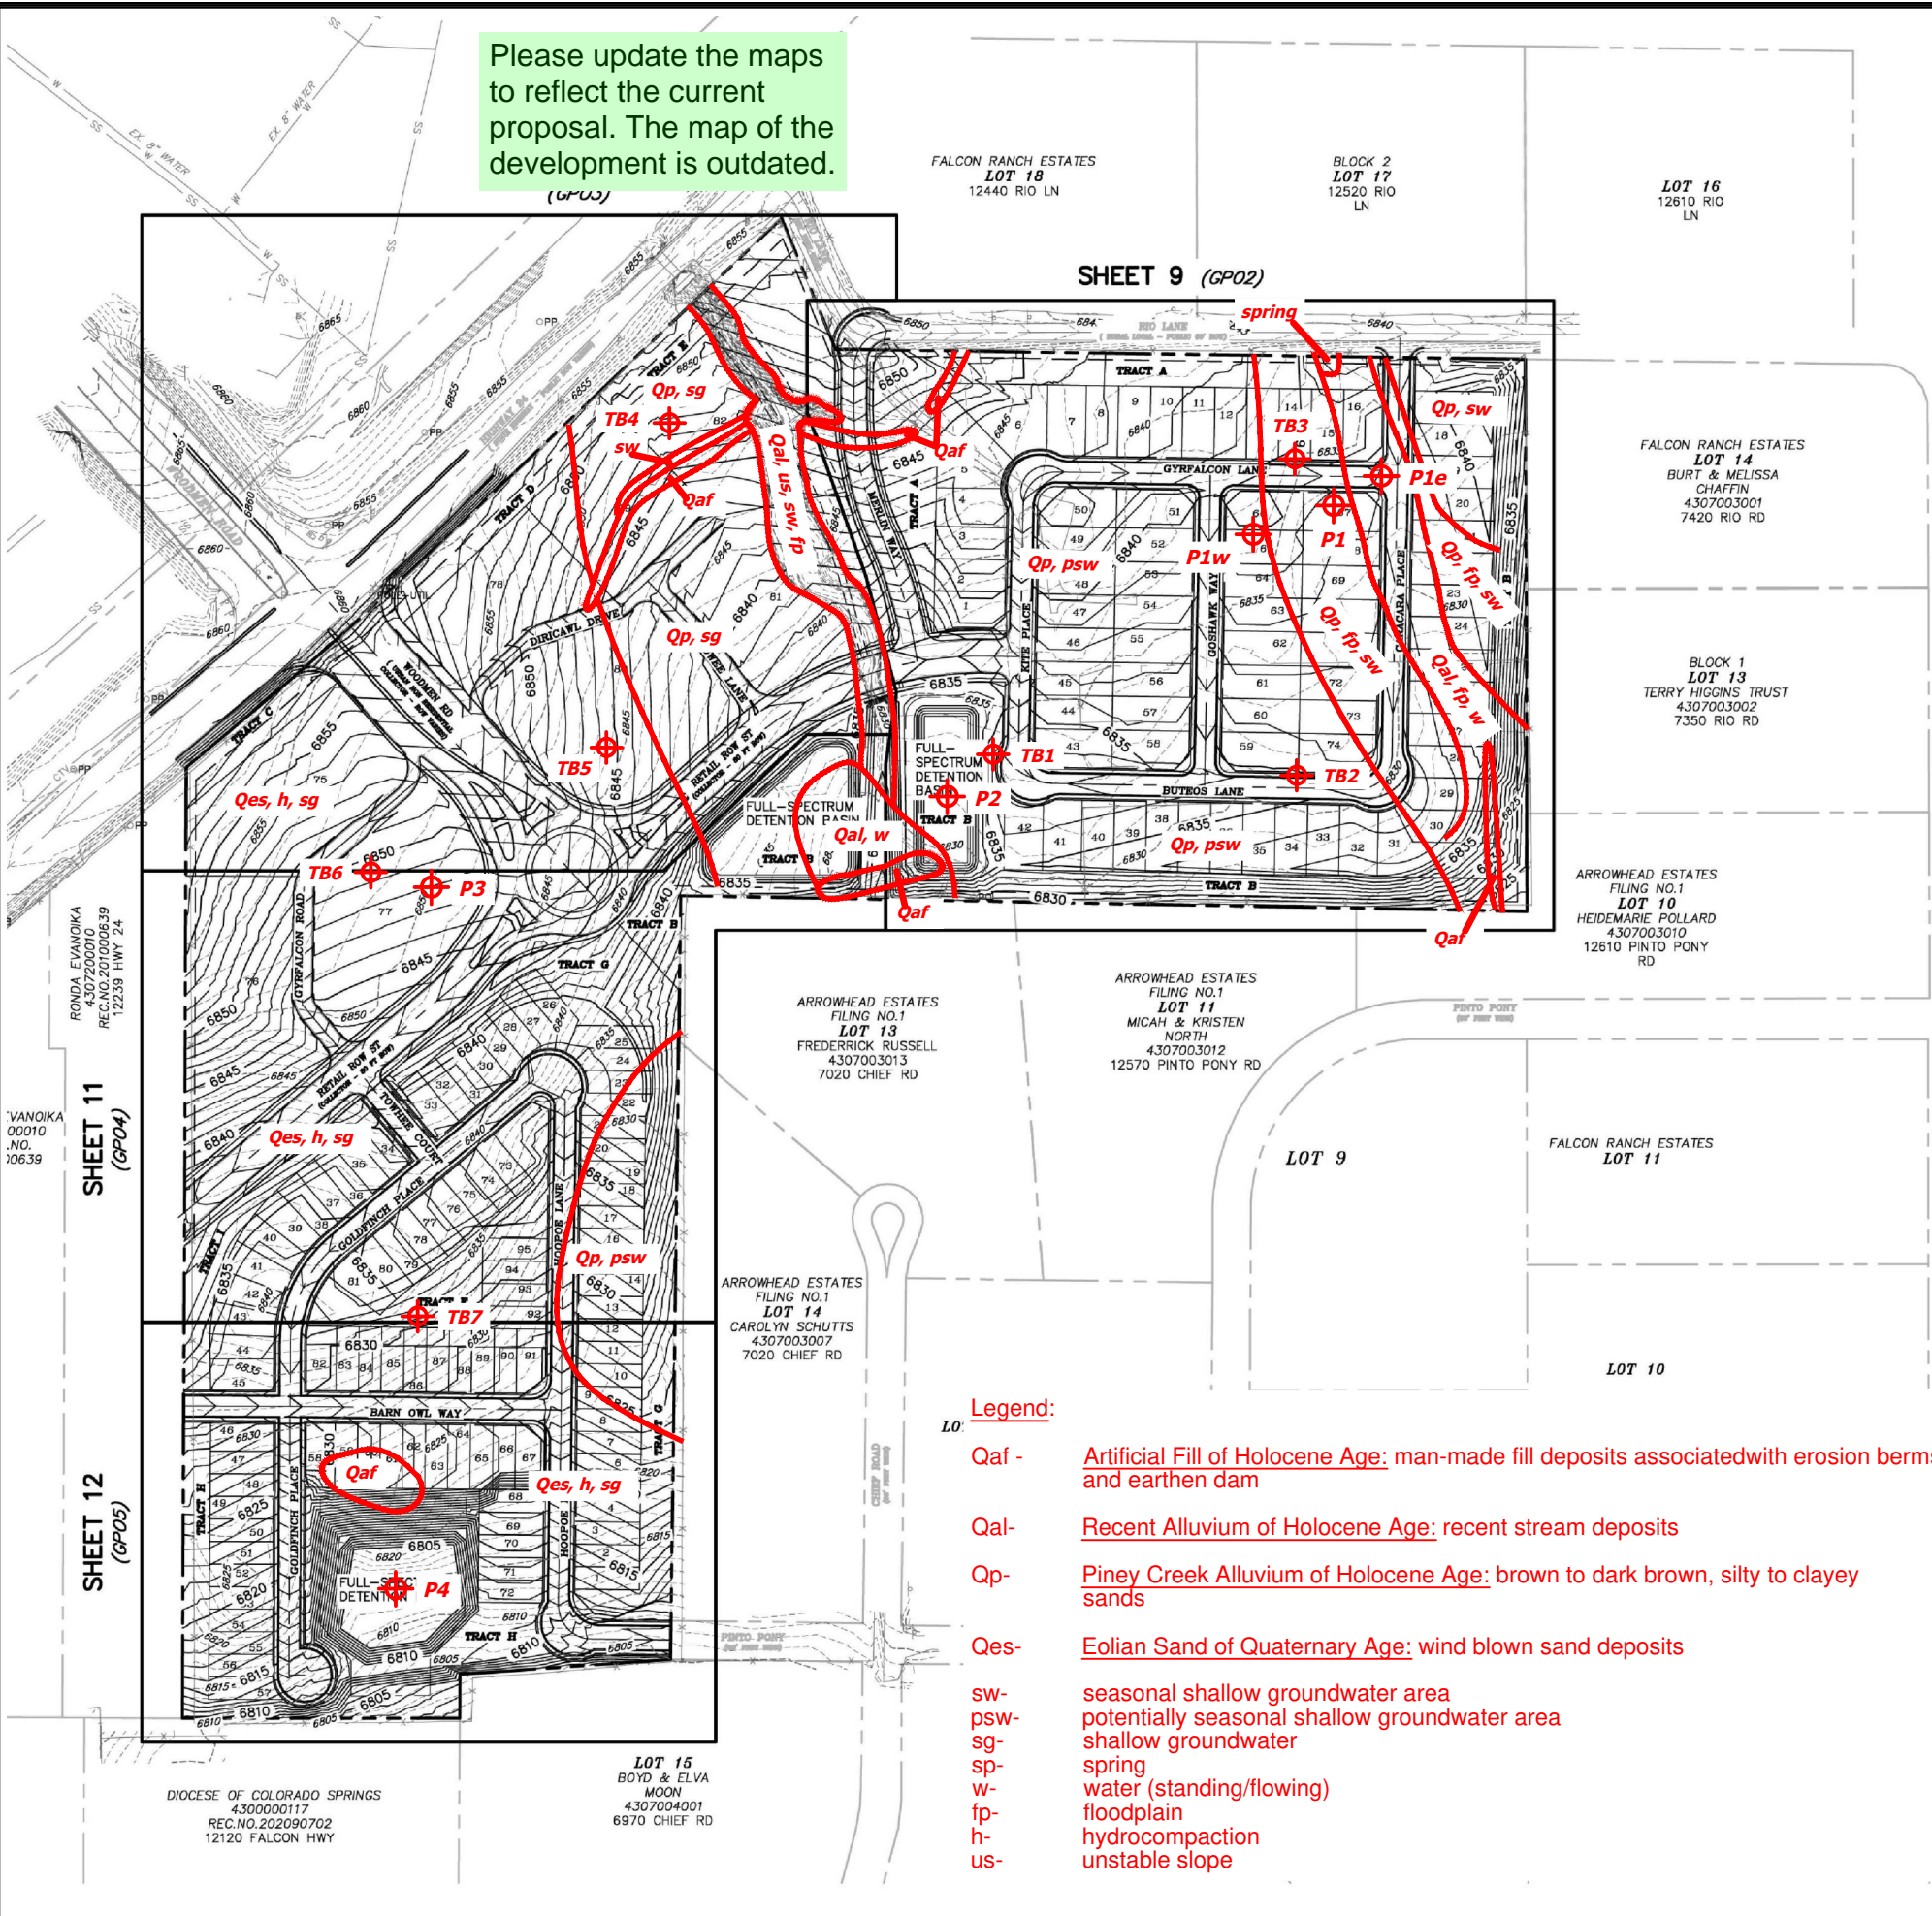
JOB NO. 202649  
FIG. 6

Detailed mapping has been performed on this site to produce an Engineering Geology Map (Figure 6). This map shows the location of various geologic conditions of which the developers and planners should be cognizant during the planning, design and construction stages of the project. The constraints/hazards identified on this site include artificial fill, hydrocompaction, potentially expansive soils, seasonal and potentially seasonal shallow groundwater areas, areas of ponded water, springs, unstable slopes, and floodplains. These geologic conditions and the recommended mitigation techniques are as follows.

Areas of the site have been identified as seasonal and potentially seasonal shallow groundwater areas. Additionally, shallow groundwater was encountered in some of the borings (less than 5 feet) and is identified as areas of shallow groundwater. A spring is located in the northeastern portion of the property along Rio Lane. Water was observed flowing in this area at the time of our recent site observations, and along the drainage. The drainage in the central portion of the site west of the existing house and has been mapped as a floodplain zone according to the FEMA Map Nos. 08041CO553G and 08041CO561G, (Figure 7, Reference 8). The minor drainage in to the east of the house is not a mapped FEMA floodplain, however, it is a physiographic floodplain. These areas are indicated on the Geology/Engineering Geology Map Figure 6. The existing drainages will be routed through a pipe or box culvert. These areas are further discussed as follows:

Floodplain – Constraint: The drainage in the central portion of the site and has been mapped as a floodplain zone according to the FEMA Map Nos. 08041CO553G and 08041CO561G, (Figure 8, Reference 8). There is also an unmapped physiographic floodplain in the eastern portion of the site. Any construction considered in a floodplain area will require approval of the drainage plan. Lots immediately adjacent to the floodplain may experience higher groundwater levels during peak flows. Subsurface perimeter drains are recommended for structures adjacent to the floodplain to help prevent the intrusion of water into areas below grade. Typical drain details are presented in Figure 8. Finished floor levels must be a minimum of one floor above the floodplain level. Exact floodplain locations by drainage studies are beyond the scope of this report.

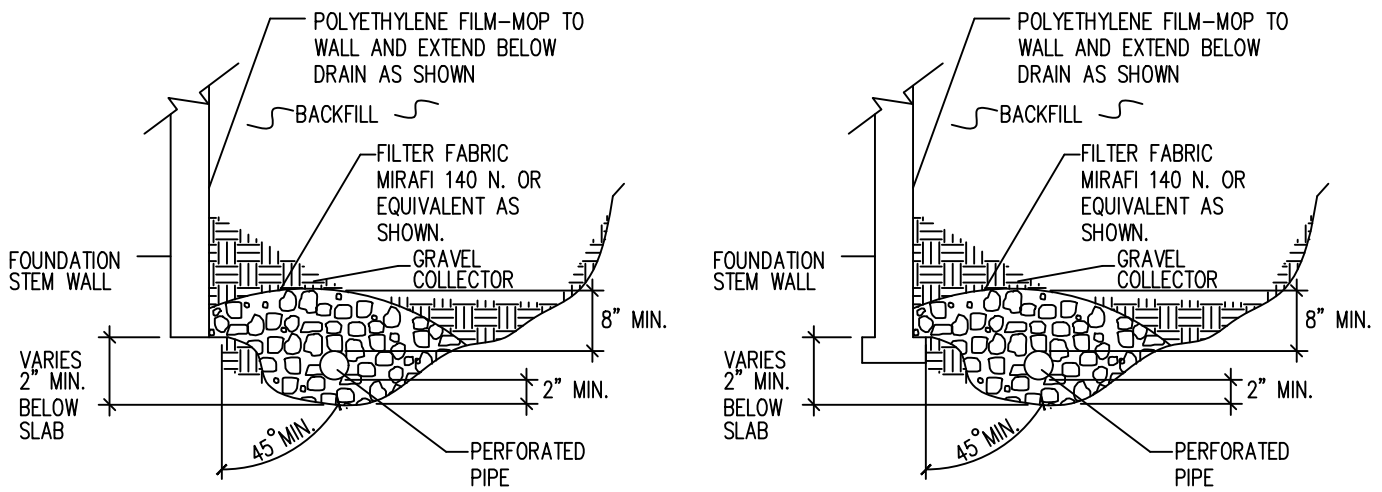
perimeter drain will be necessary to help prevent the intrusion of water into areas located below grade. A typical perimeter drain detail is presented in Figure 8. Unstable conditions should be expected where excavations approach the groundwater level. Stabilization using shot rock or geo-grids may be necessary. Underslab drains or capillary breaks or interceptor drains may be necessary to dewater the excavation. Drain details are presented in Figures 9 and 10. Basements or useable areas located below grade are not recommended in these areas. It may be desirable on some lots to build up the building area to raise the foundation further above the groundwater level. Any grading in these areas should be done to direct surface flow around construction to avoid areas of ponded water. All soft or organic soils should be removed prior to any construction or filling. Further investigation will be necessary to determine the groundwater depth at each individual building site. Some areas of the site appear to be caused from springs and perched water. **Dewatering will likely be necessary in some portions of the site.**

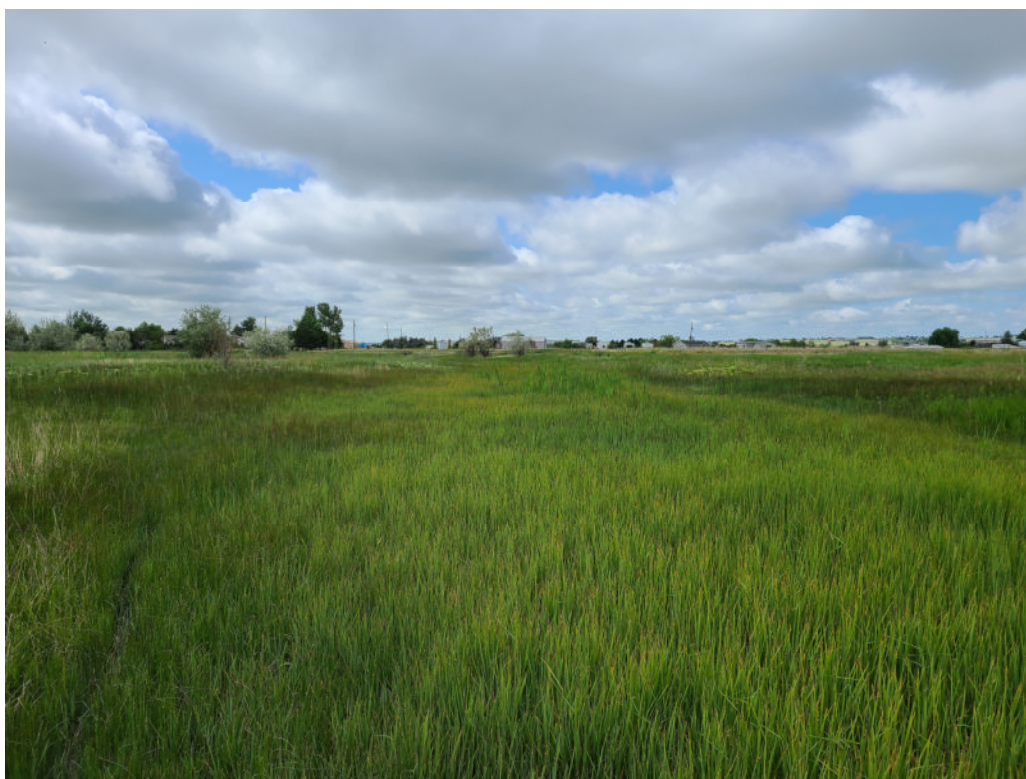
**Looking south from  
the physiographic  
floodplain in the  
eastern portion of the  
site.**
