**SOILS AND GEOLOGY STUDY  
THE COMMONS AT FALCON FIELD, FILING NOS. 1 – 3  
DEVELOPMENT PLAN AND FINAL PLAT  
EL PASO COUNTY, COLORADO**

Prepared for:  
**PT Falcon Field, LLC**  
1864 Woodmoor Drive, Suite 100  
Monument, Colorado 80132

May 1, 2025  
Revised July 22, 2026

Entech Job No. 240260

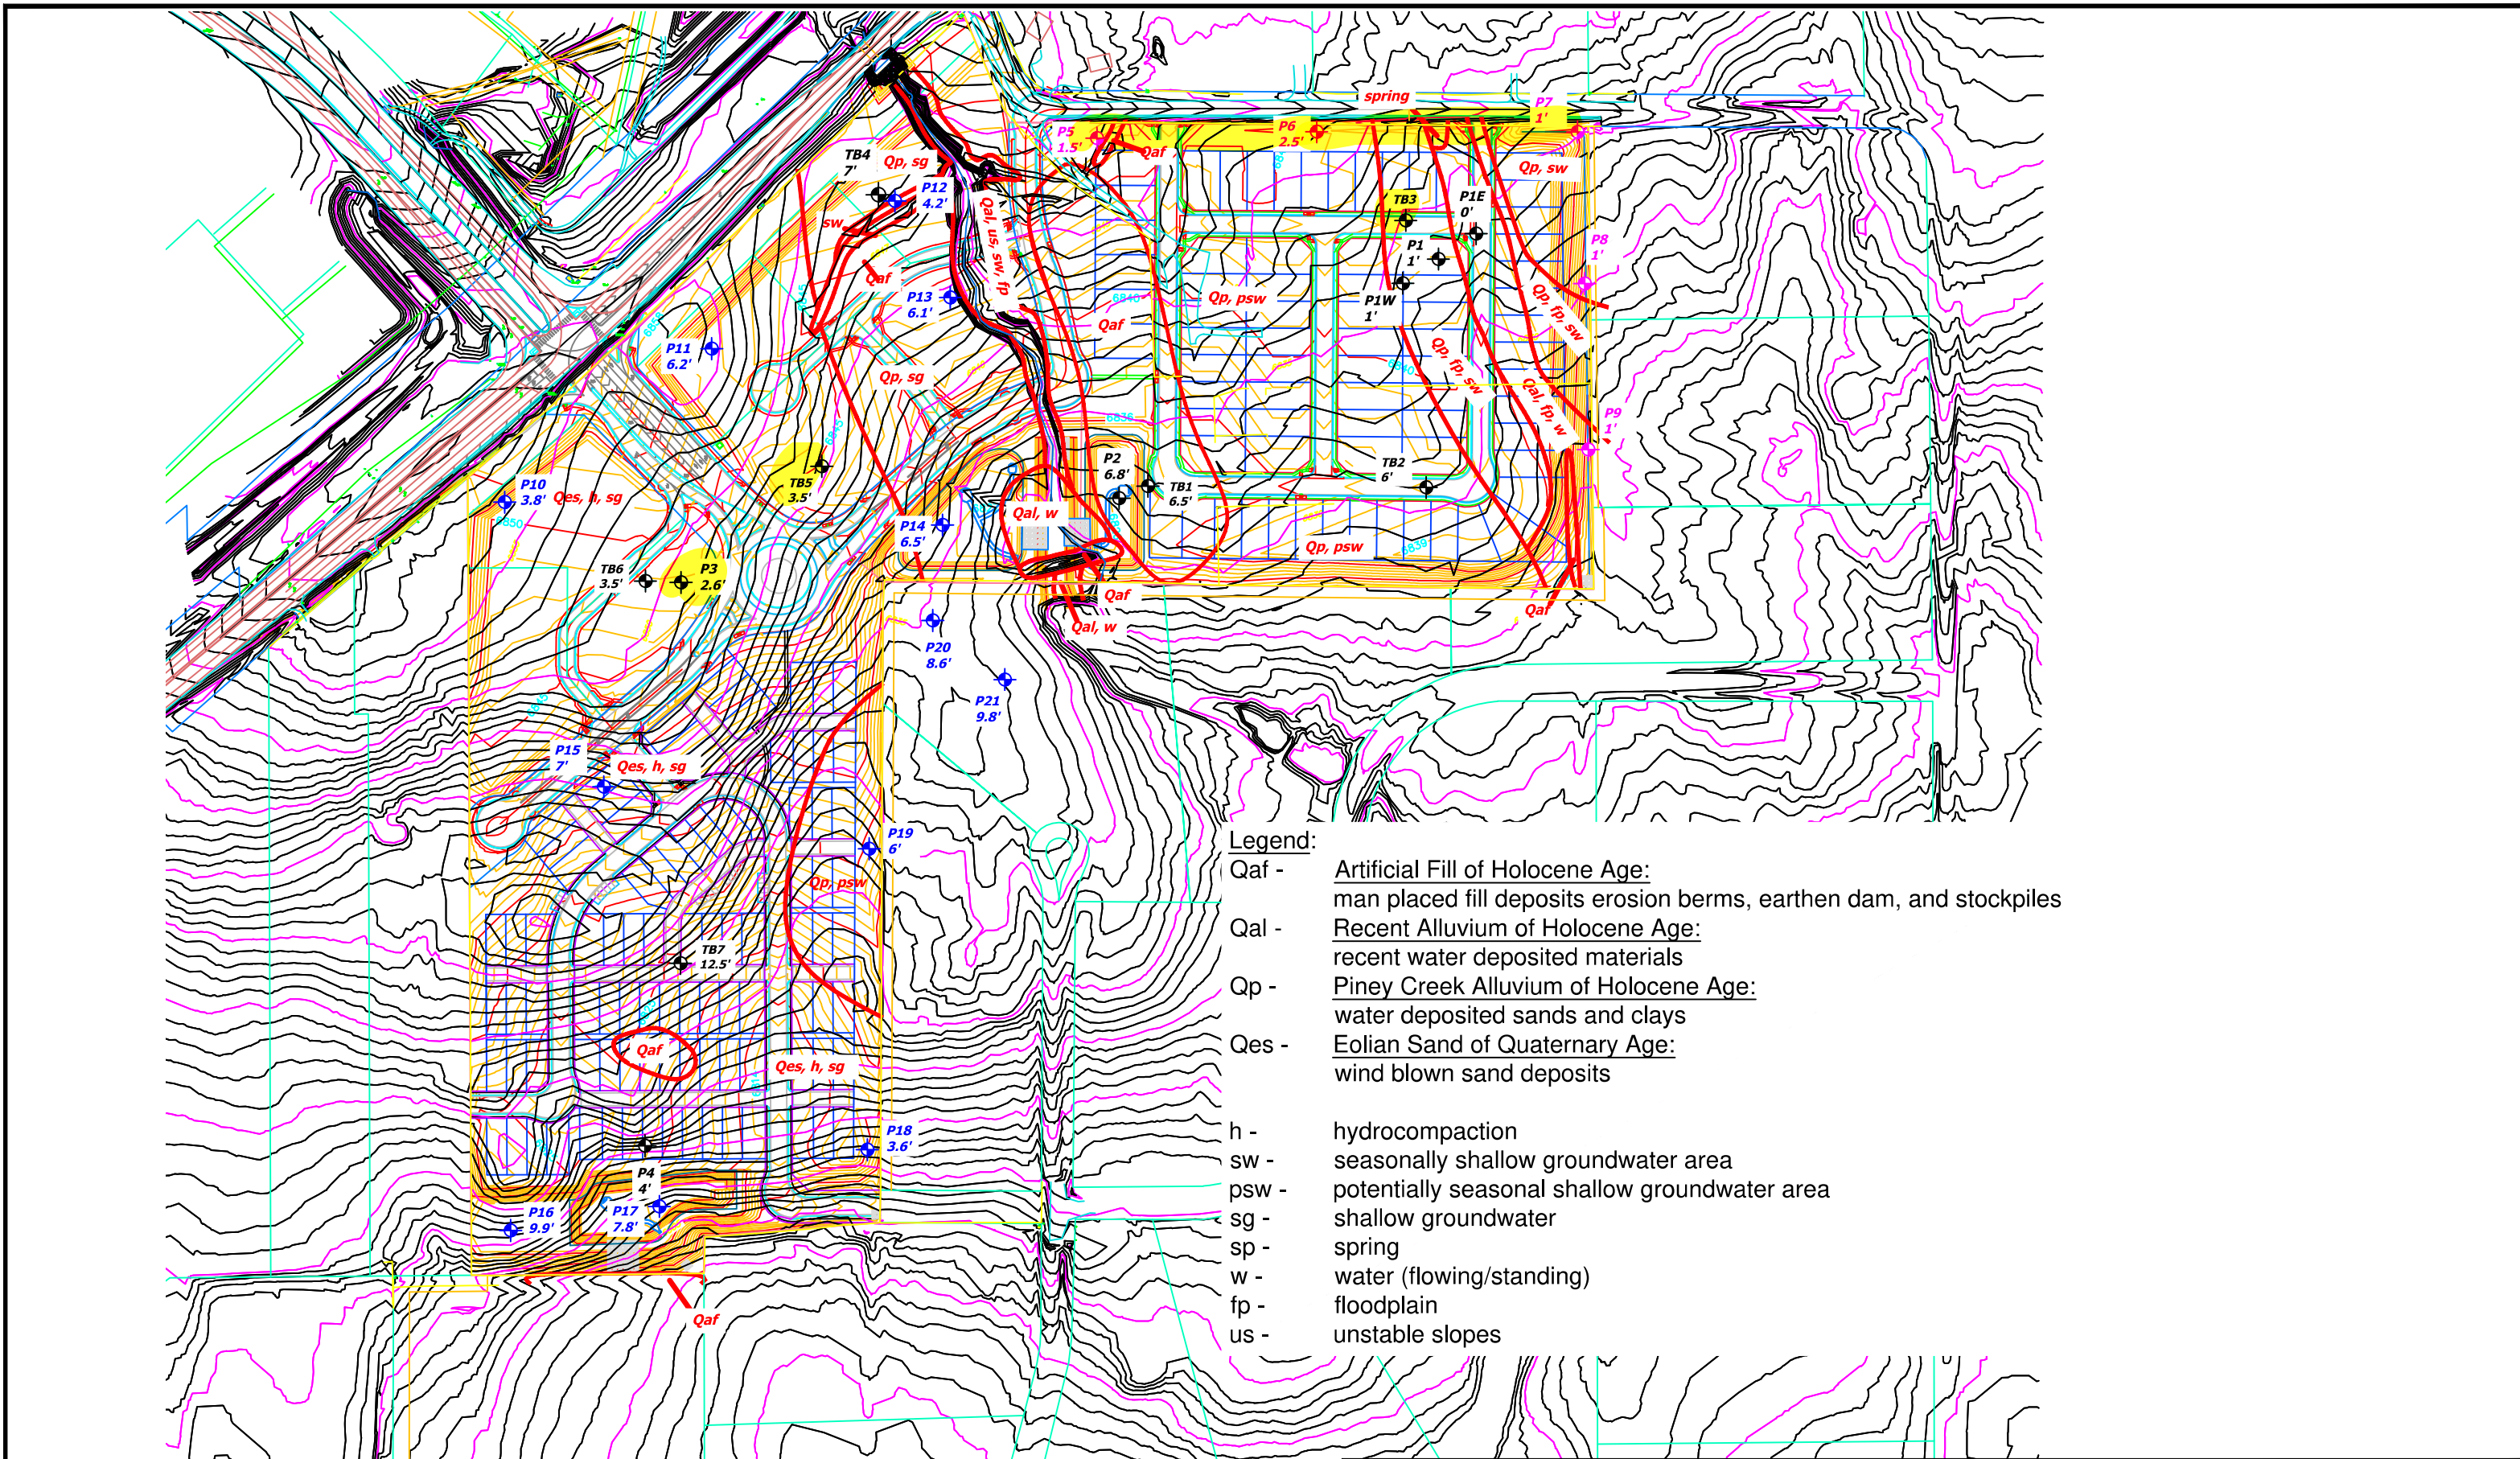
JOB NO.  
240260  
**FIG. 7**

Detailed mapping has been performed on this site to produce an Engineering Geology Map (Figure 7). This map shows the location of various geologic conditions that the developers should monitor during the planning, design, and construction stages of the project. The constraints/hazards identified on this site include artificial fill, hydrocompaction, potentially expansive soils, seasonal and potentially seasonal shallow groundwater areas, areas of ponded water, springs, unstable slopes, and floodplains. These constraints/hazards and the recommended mitigation techniques include:

The majority of the slopes on-site are gently sloping and do not exhibit any past or potential unstable slopes or landslides. Some of the steeper slopes along the drainage in the central portion of the site have been identified as unstable slopes. The mitigation recommendation for these areas is as follows:

Areas of the site have been identified as seasonal and potentially seasonal shallow groundwater areas. Additionally, shallow groundwater was encountered in some of the borings (less than 5 feet) and is identified as areas of shallow groundwater. A spring is located in the northeastern portion of the property along Rio Lane. Water was observed flowing in this area and along the drainage at the time of our recent site observations. The drainage in the central portion of the site west of the existing house has been mapped as a floodplain zone according to the FEMA Map Nos. 08041CO553G and 08041CO561G (Figure 8, Reference 8). The minor drainage to the east of the house is not mapped as a FEMA floodplain; however, it is a physiographic floodplain. These areas are indicated on the Geology/Engineering Geology Map (Figure 6). The existing drainages will be routed through a pipe or box culvert. These areas are further discussed as follows:

Mitigation: According to the grading plan prepared by Drexel Barrell & Company, the drainage area with the unstable slopes in the central portion of the site will be regraded and filled, mitigating the unstable slopes hazard. Fill should be placed on native soils or bedrock and properly benched

Mitigation: In these locations, foundations subject to severe frost-heave potential should penetrate sufficient depth to discourage the formation of ice lenses beneath foundations. At this location and elevation, a foundation depth for frost protection of 30 inches is recommended. In areas where high subsurface moisture conditions are anticipated periodically, a subsurface perimeter drain will be necessary to help prevent the intrusion of water into areas located below grade. A typical perimeter drain detail is presented in Figure 8. Unstable conditions should be expected where excavations approach the groundwater level. Stabilization using shot rock or geogrids may be necessary. Interceptor, underslab drains, capillary breaks, or overexcavation drains may be necessary to dewater the excavations. Drain details are presented in Figures 9 through 13. Underdrains along the utilities will be utilized to control groundwater. The underdrains will be connected to exfiltration areas.

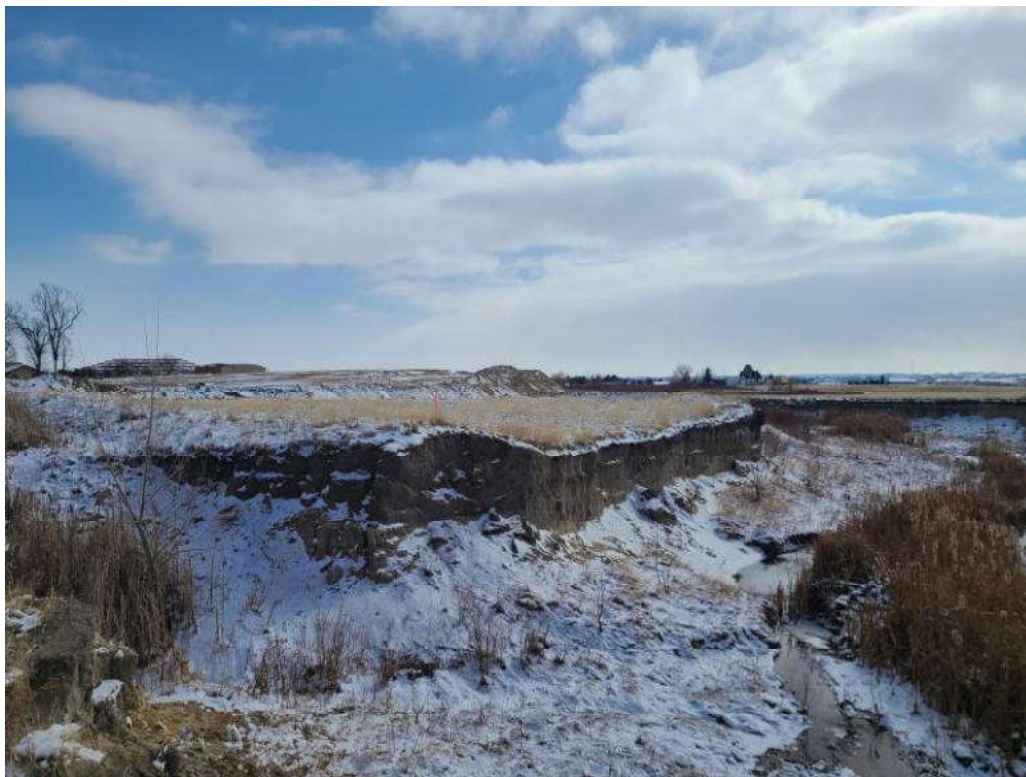
**Looking south along  
drainage from the  
northern portion of the  
site.**

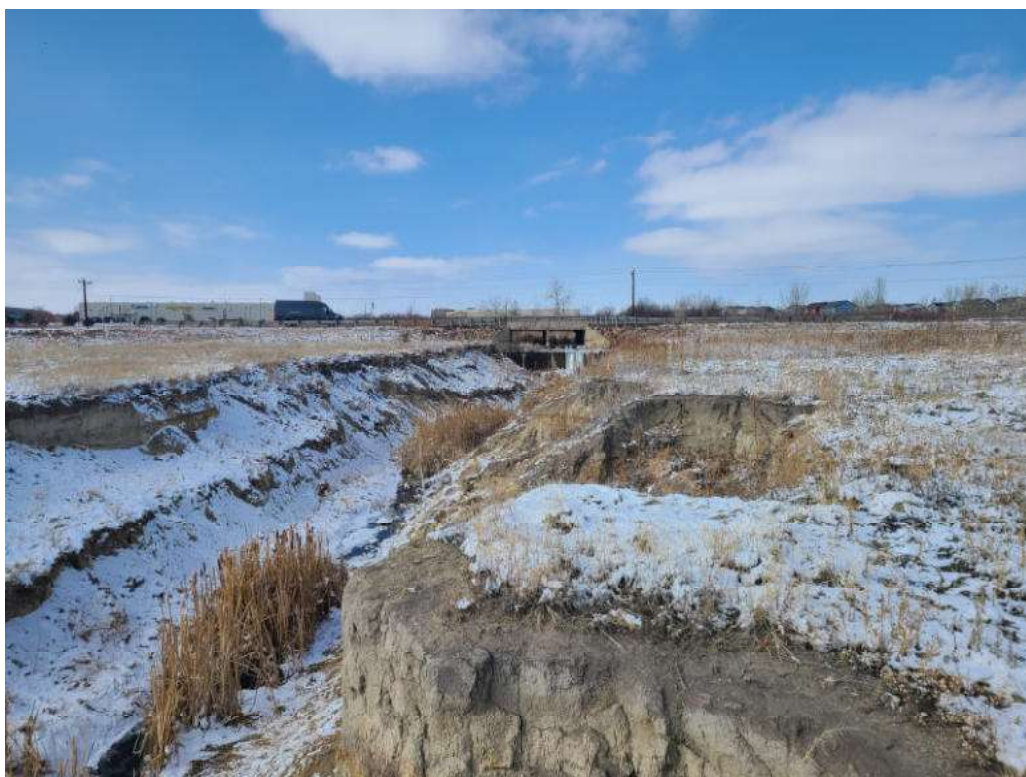
**Looking northwest  
along drainage  
towards Highway 24  
northern portion of the  
site.**

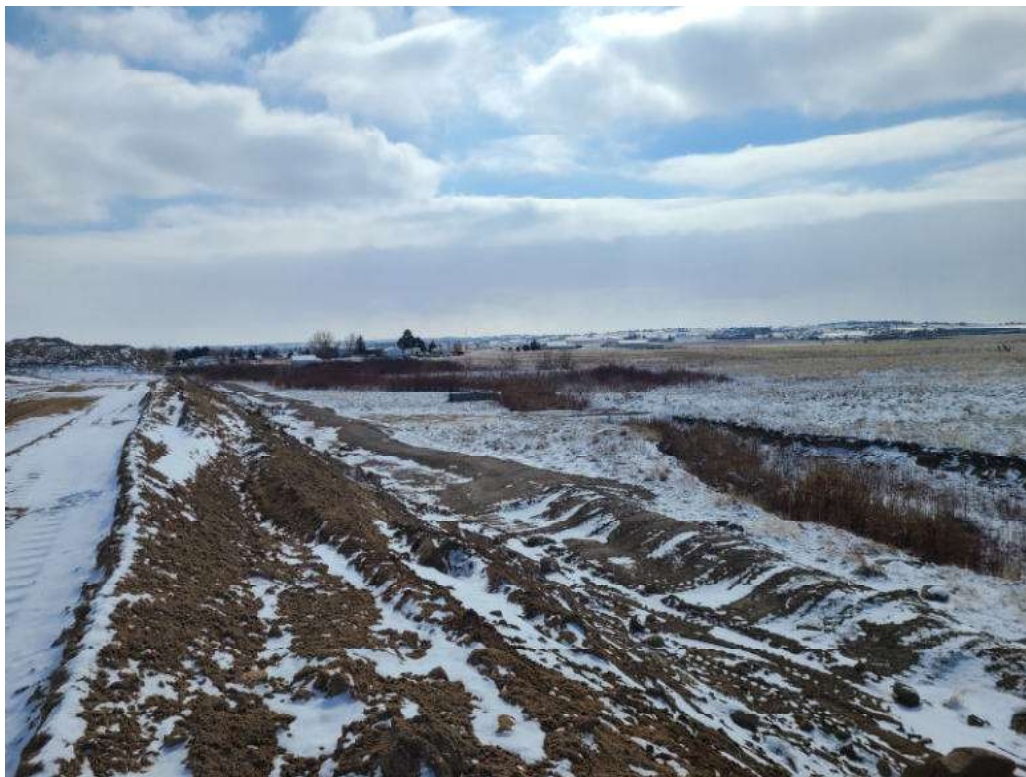
**Looking south from  
the central portion of  
the site.**

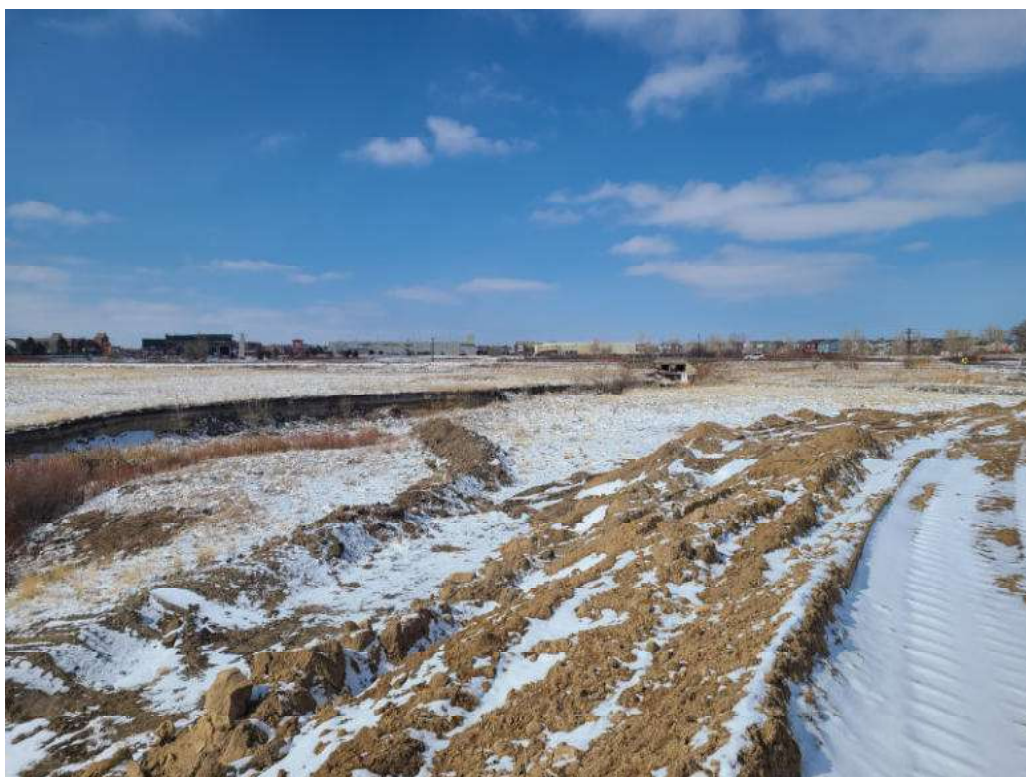
**Looking northwest  
from the central  
portion of the site.**

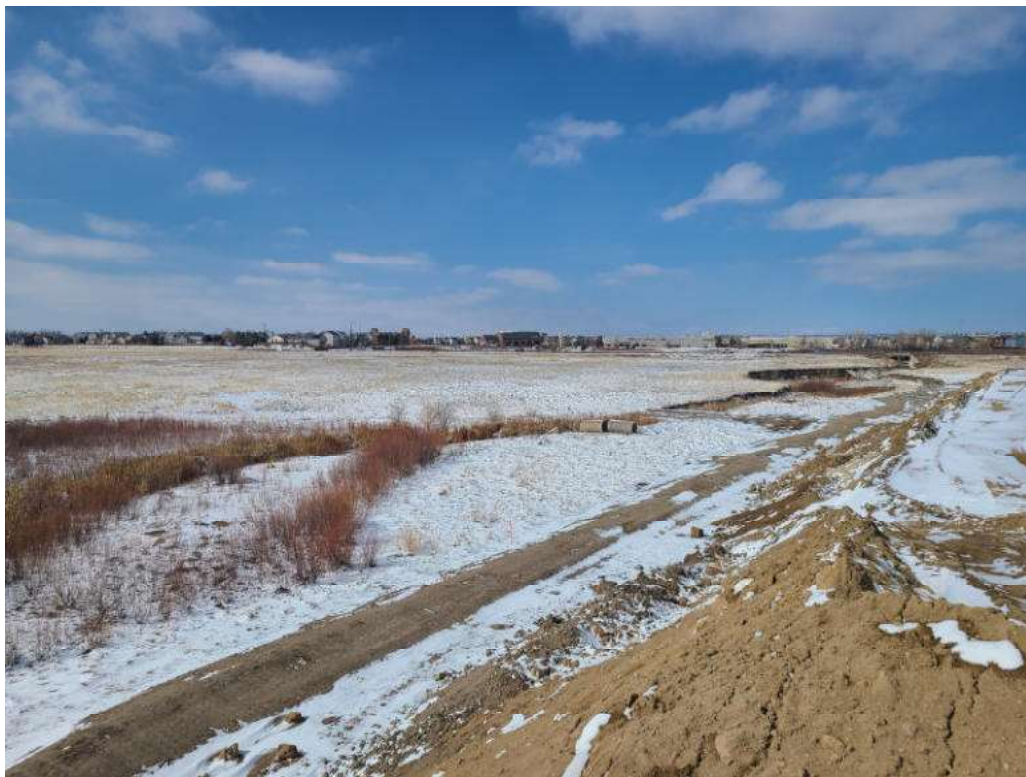
**Looking north from the  
southern side of the  
site.**

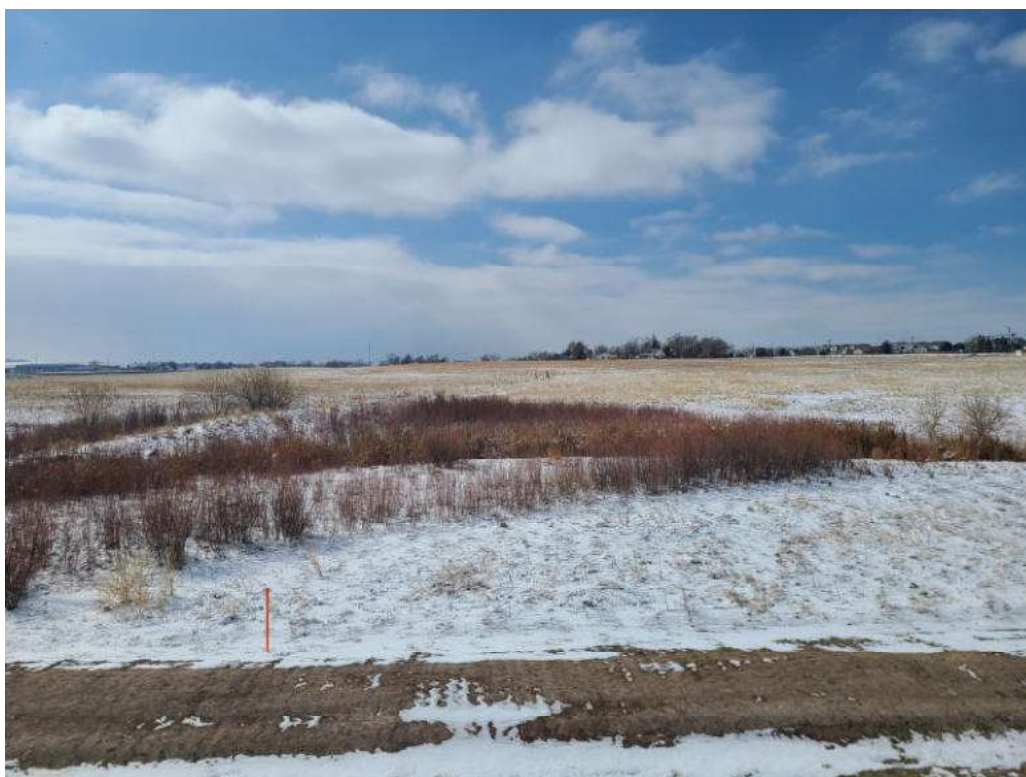
**Looking west from the  
southern side of the  
site.**
