**SOILS AND GEOLOGY STUDY
FLYING HORSE NORTH FILING NO. 3
EL PASO COUNTY, COLORADO**

August 23, 2023
Revised February 29, 2024

PCD No. SF2326

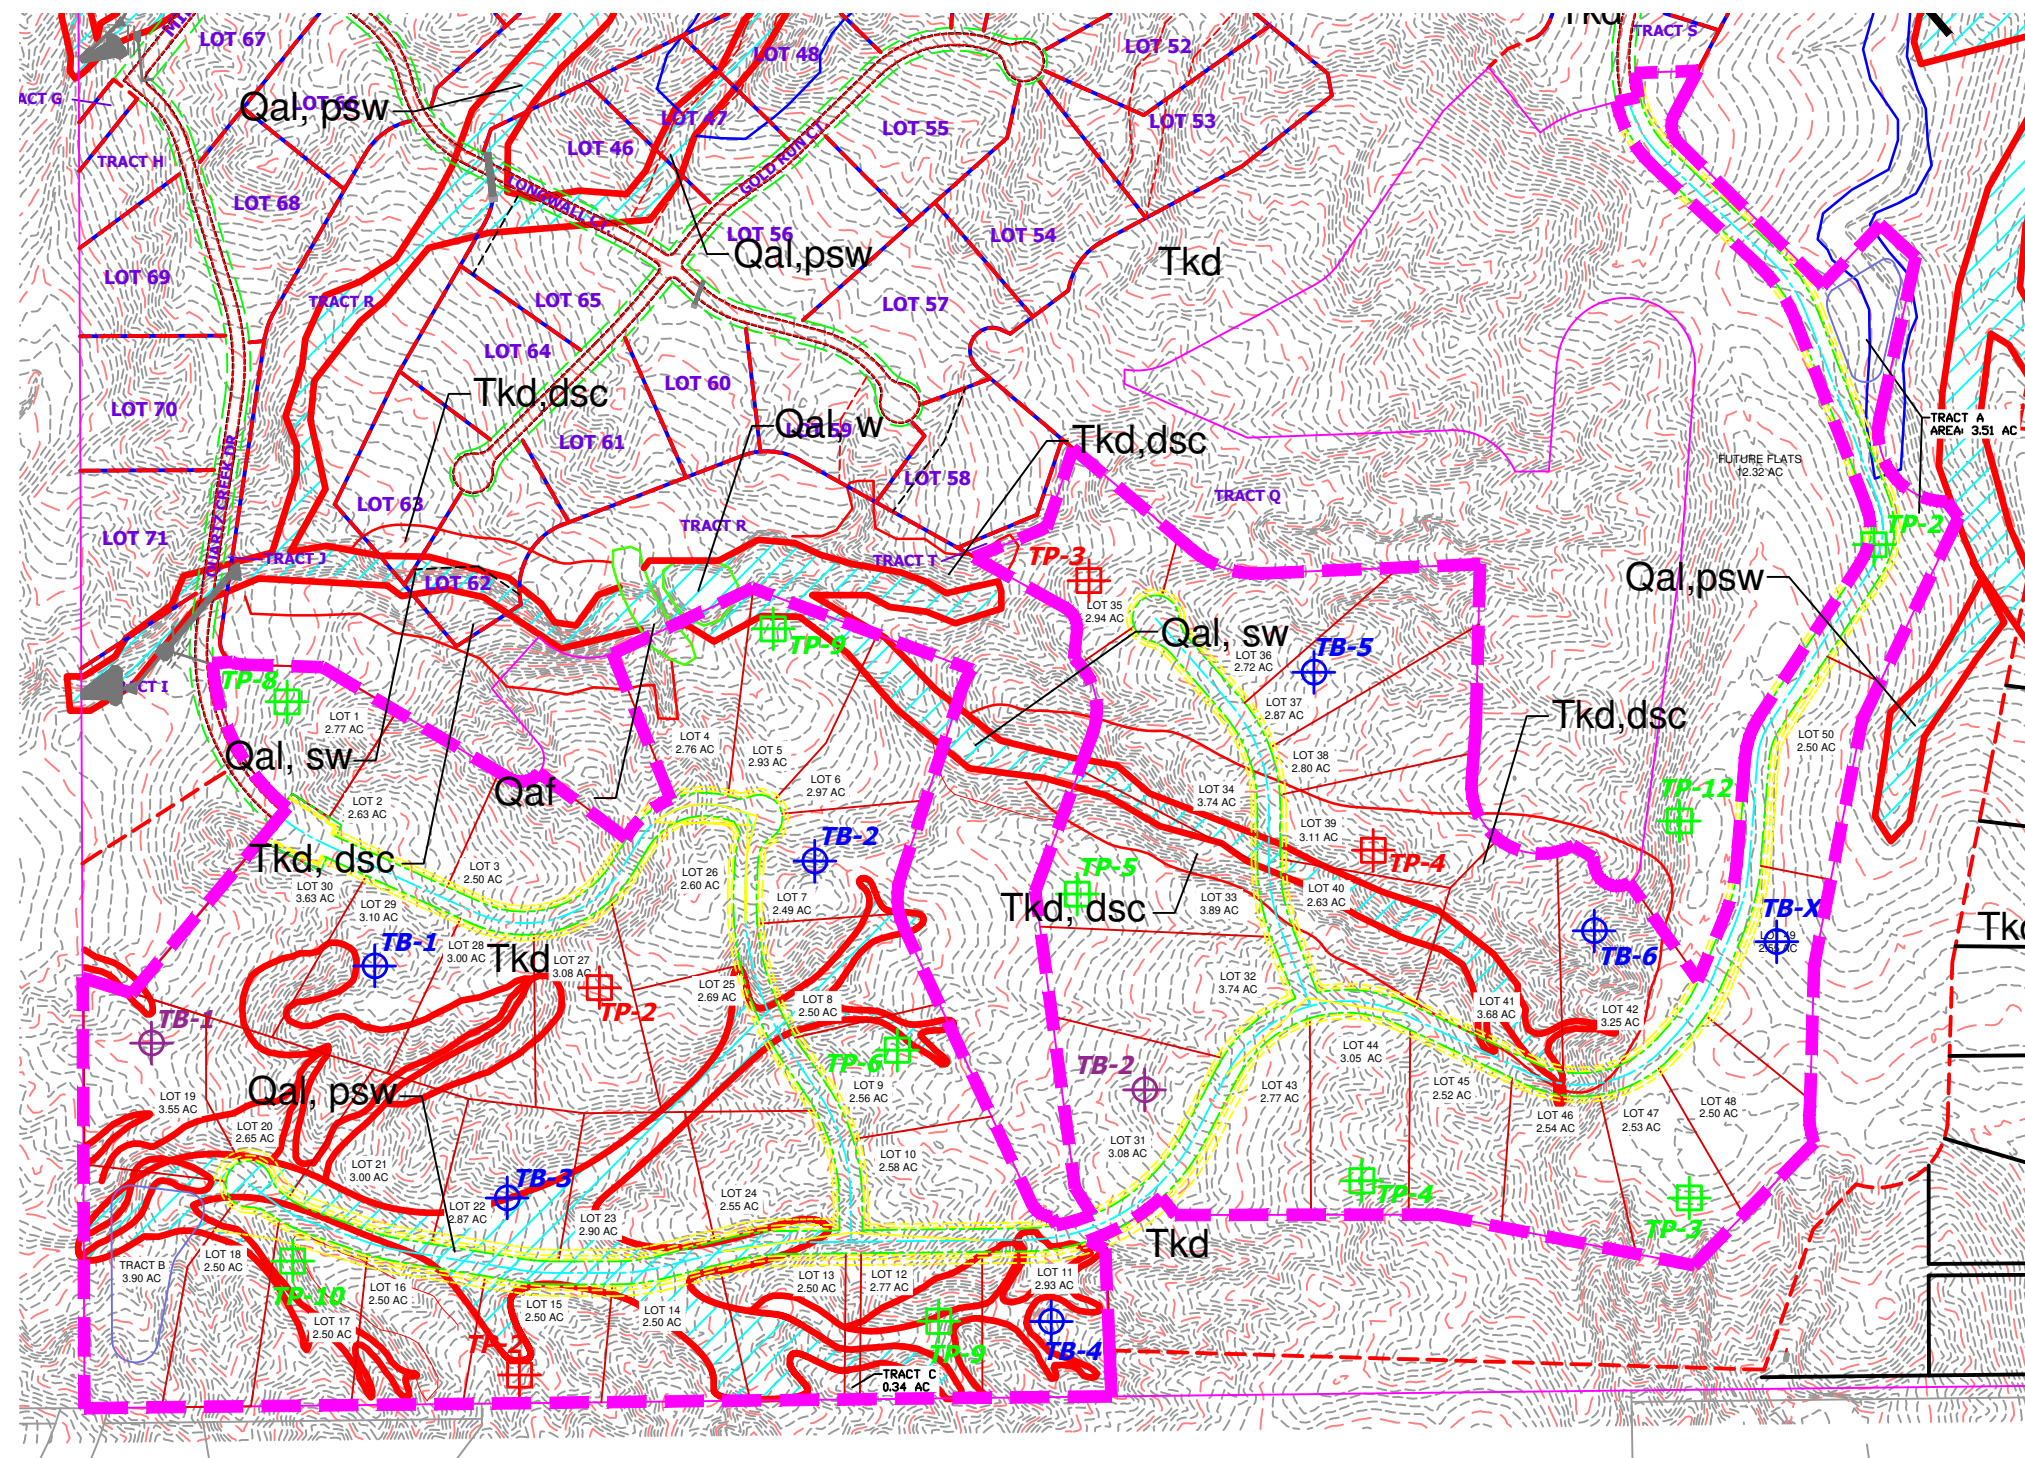
FIG. 6

Detailed mapping has been performed on this site to produce an Engineering Geology Map Figure 6. This map shows the location of various geologic conditions of which the developers should be cognizant during the planning, design and construction stages of the project. These hazards and the recommended mitigation techniques are as follows:
