**SOIL, GEOLOGY, GEOLOGIC HAZARD STUDY  
FLYING HORSE NORTH  
FILING NO. 2  
EL PASO COUNTY, COLORADO**

**Flying Horse Development, LLC**  
2138 Flying Horse Club Drive  
Colorado Springs, Colorado 80921

March 8, 2022

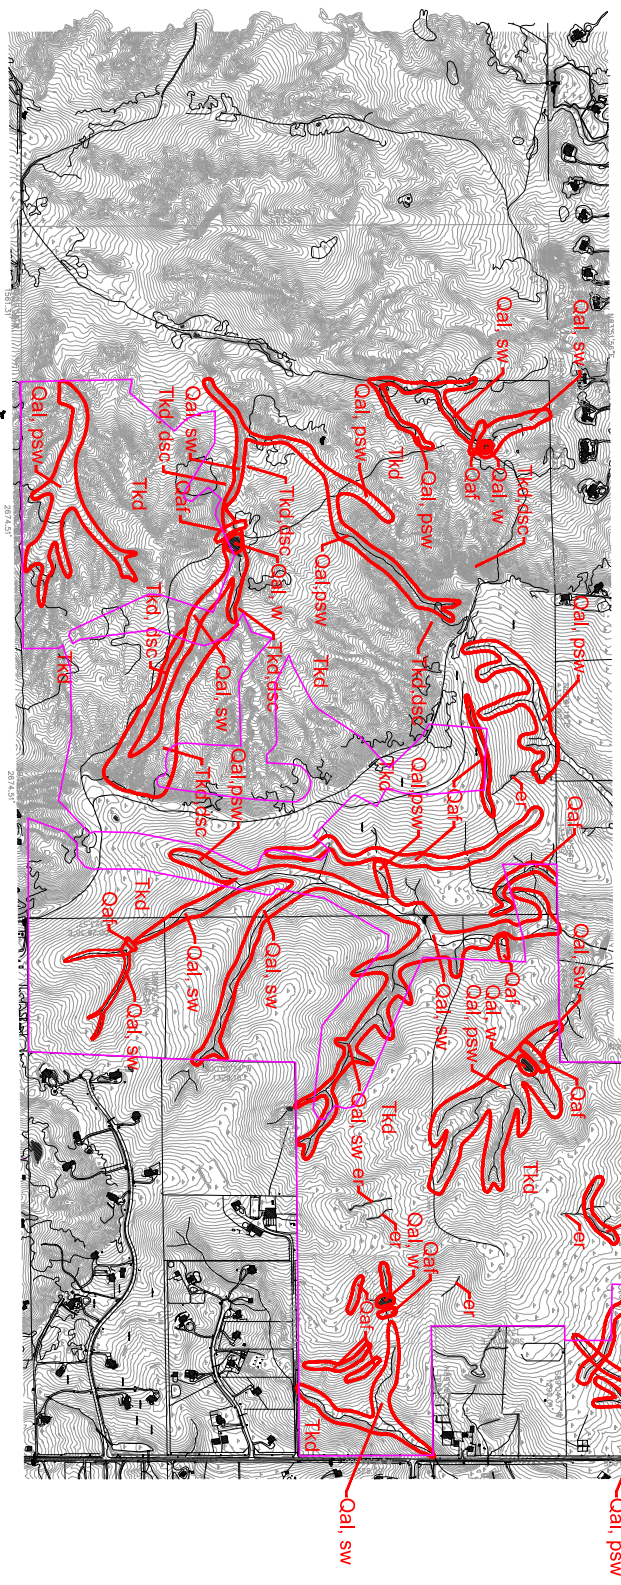
It is challenging to see how these correlate to the actual proposed lot layout without them overlaid over each other. The geologic hazards and constraints have with the proposed lot layout.

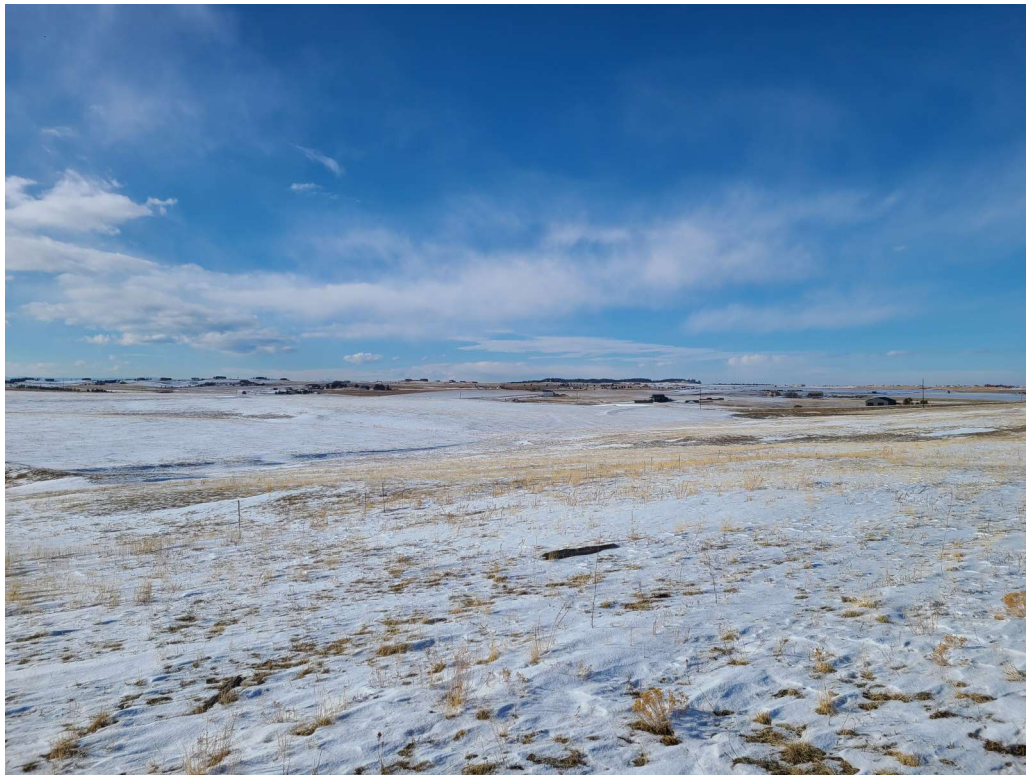
**Looking northwest  
from the northeastern  
side of the site along  
Black Forest Road.**

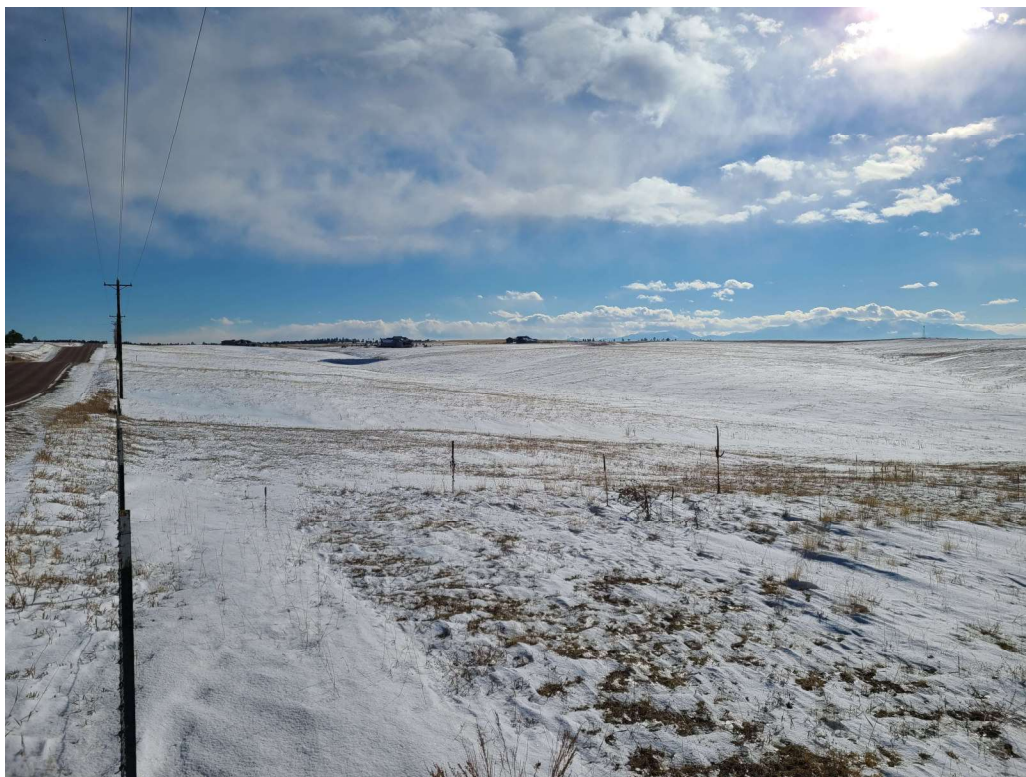
**Looking south from  
the northeastern side  
of the site along Black  
Forest Road.**

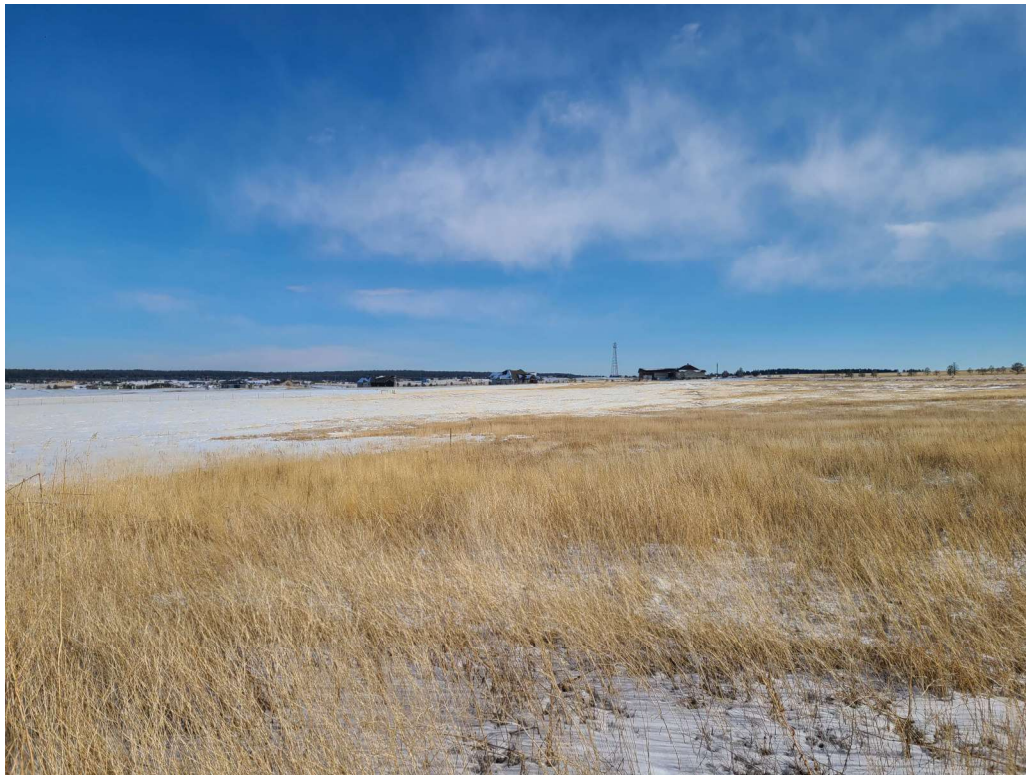
**Looking southeast  
from the north-central  
portion of the site.**

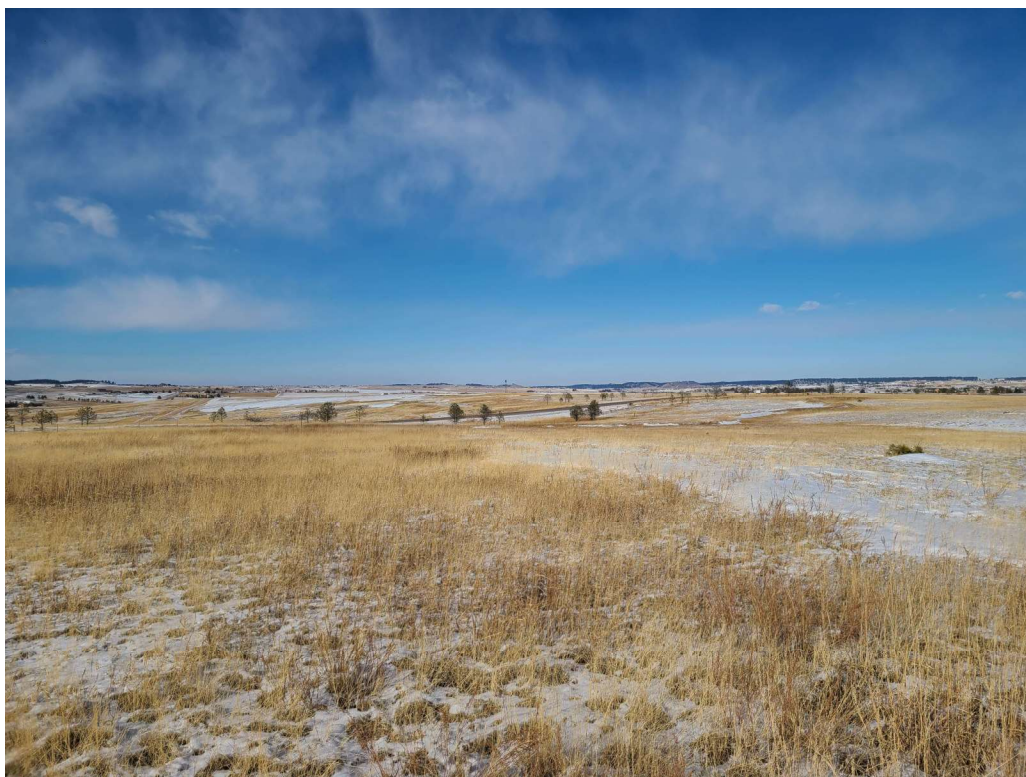
**Looking northeast  
from the central  
portion of the site.**

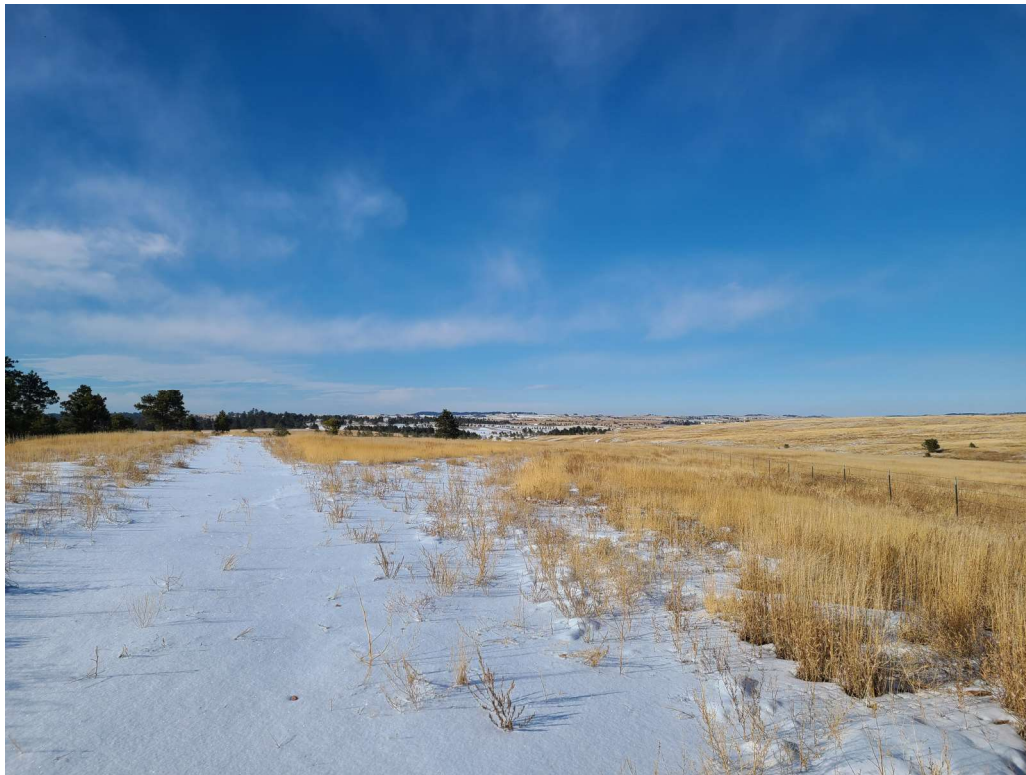
**Looking north from the southern portion of the site.**

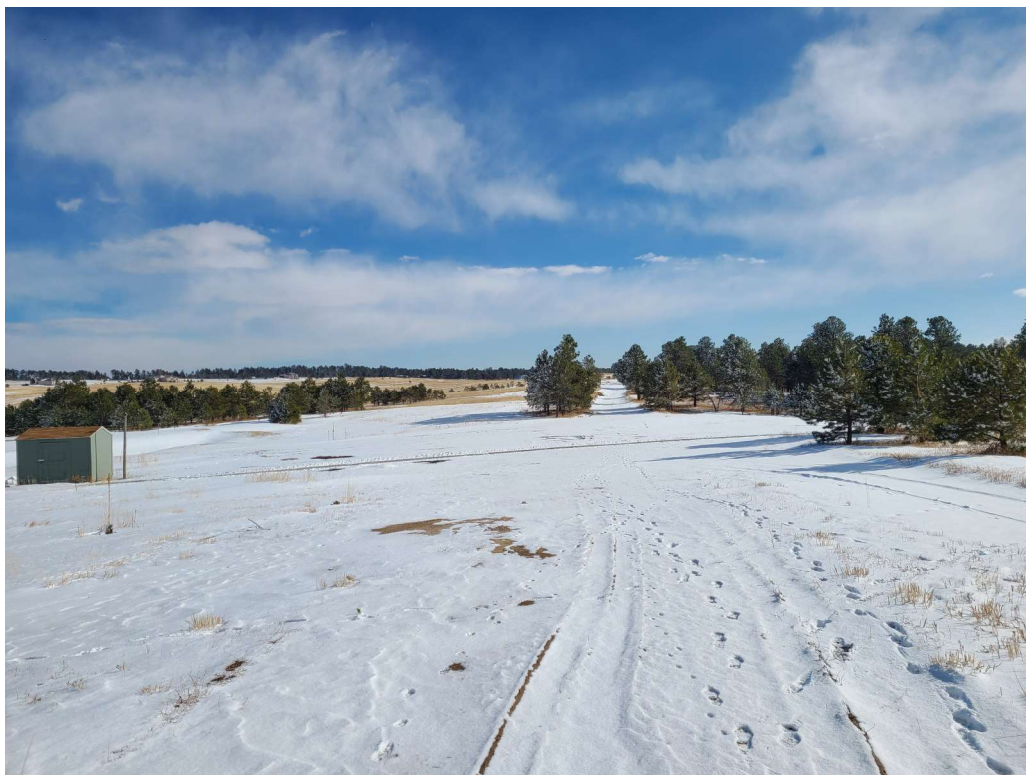
**Looking south from the central portion of the site.**

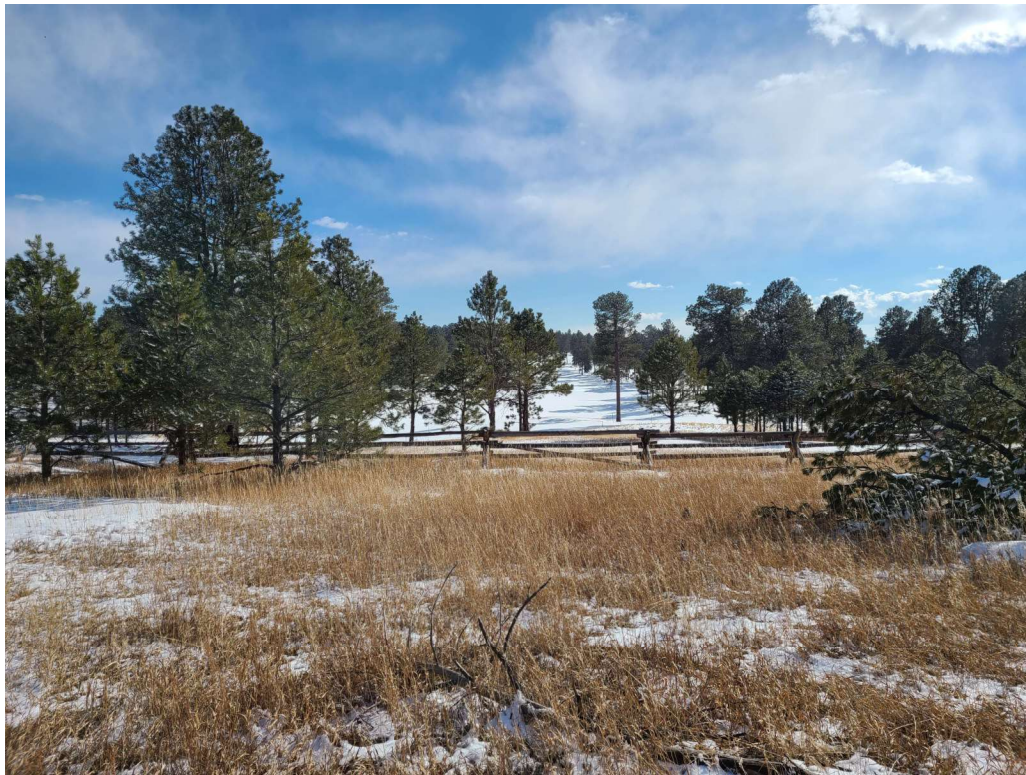
**Looking west from the west-central portion of the site.**

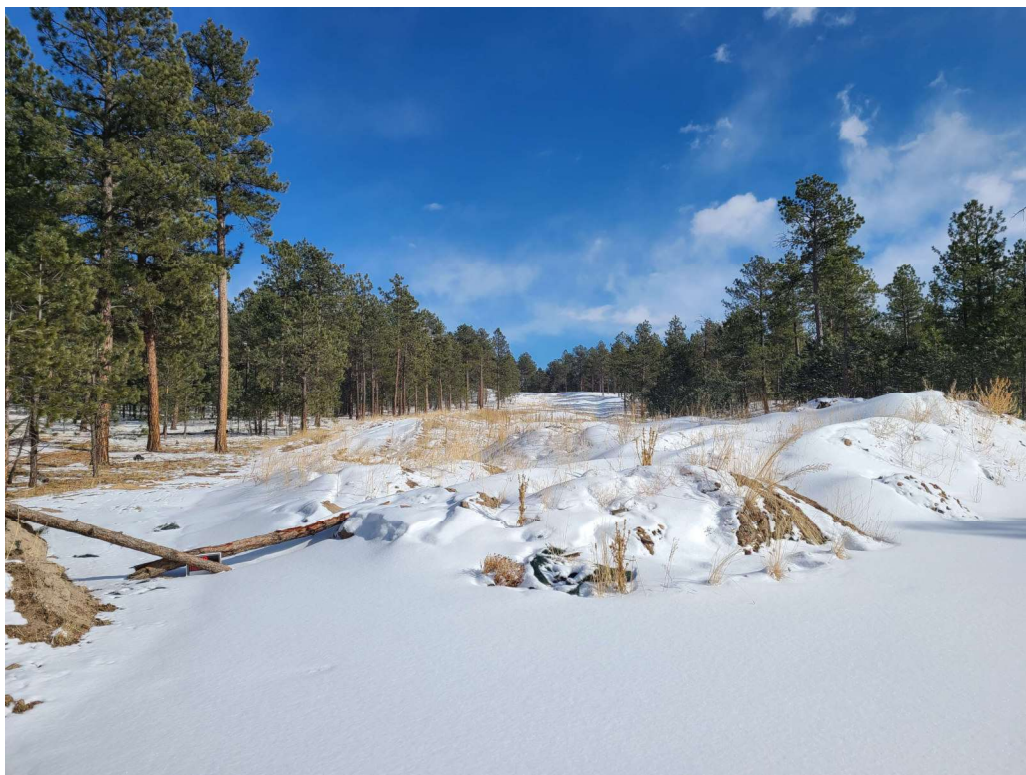
**Looking east from the southwestern side of the site.**
