**PRELIMINARY SOIL, GEOLOGY, GEOLOGIC  
HAZARD, AND WASTEWATER STUDY  
MEADOWLAKE RANCH  
13202 JUDGE ORR ROAD  
EL PASO COUNTY, COLORADO**

July 30, 2018

Entech Job No. 180517  
AAprojects/2018/180517countysoil/geo

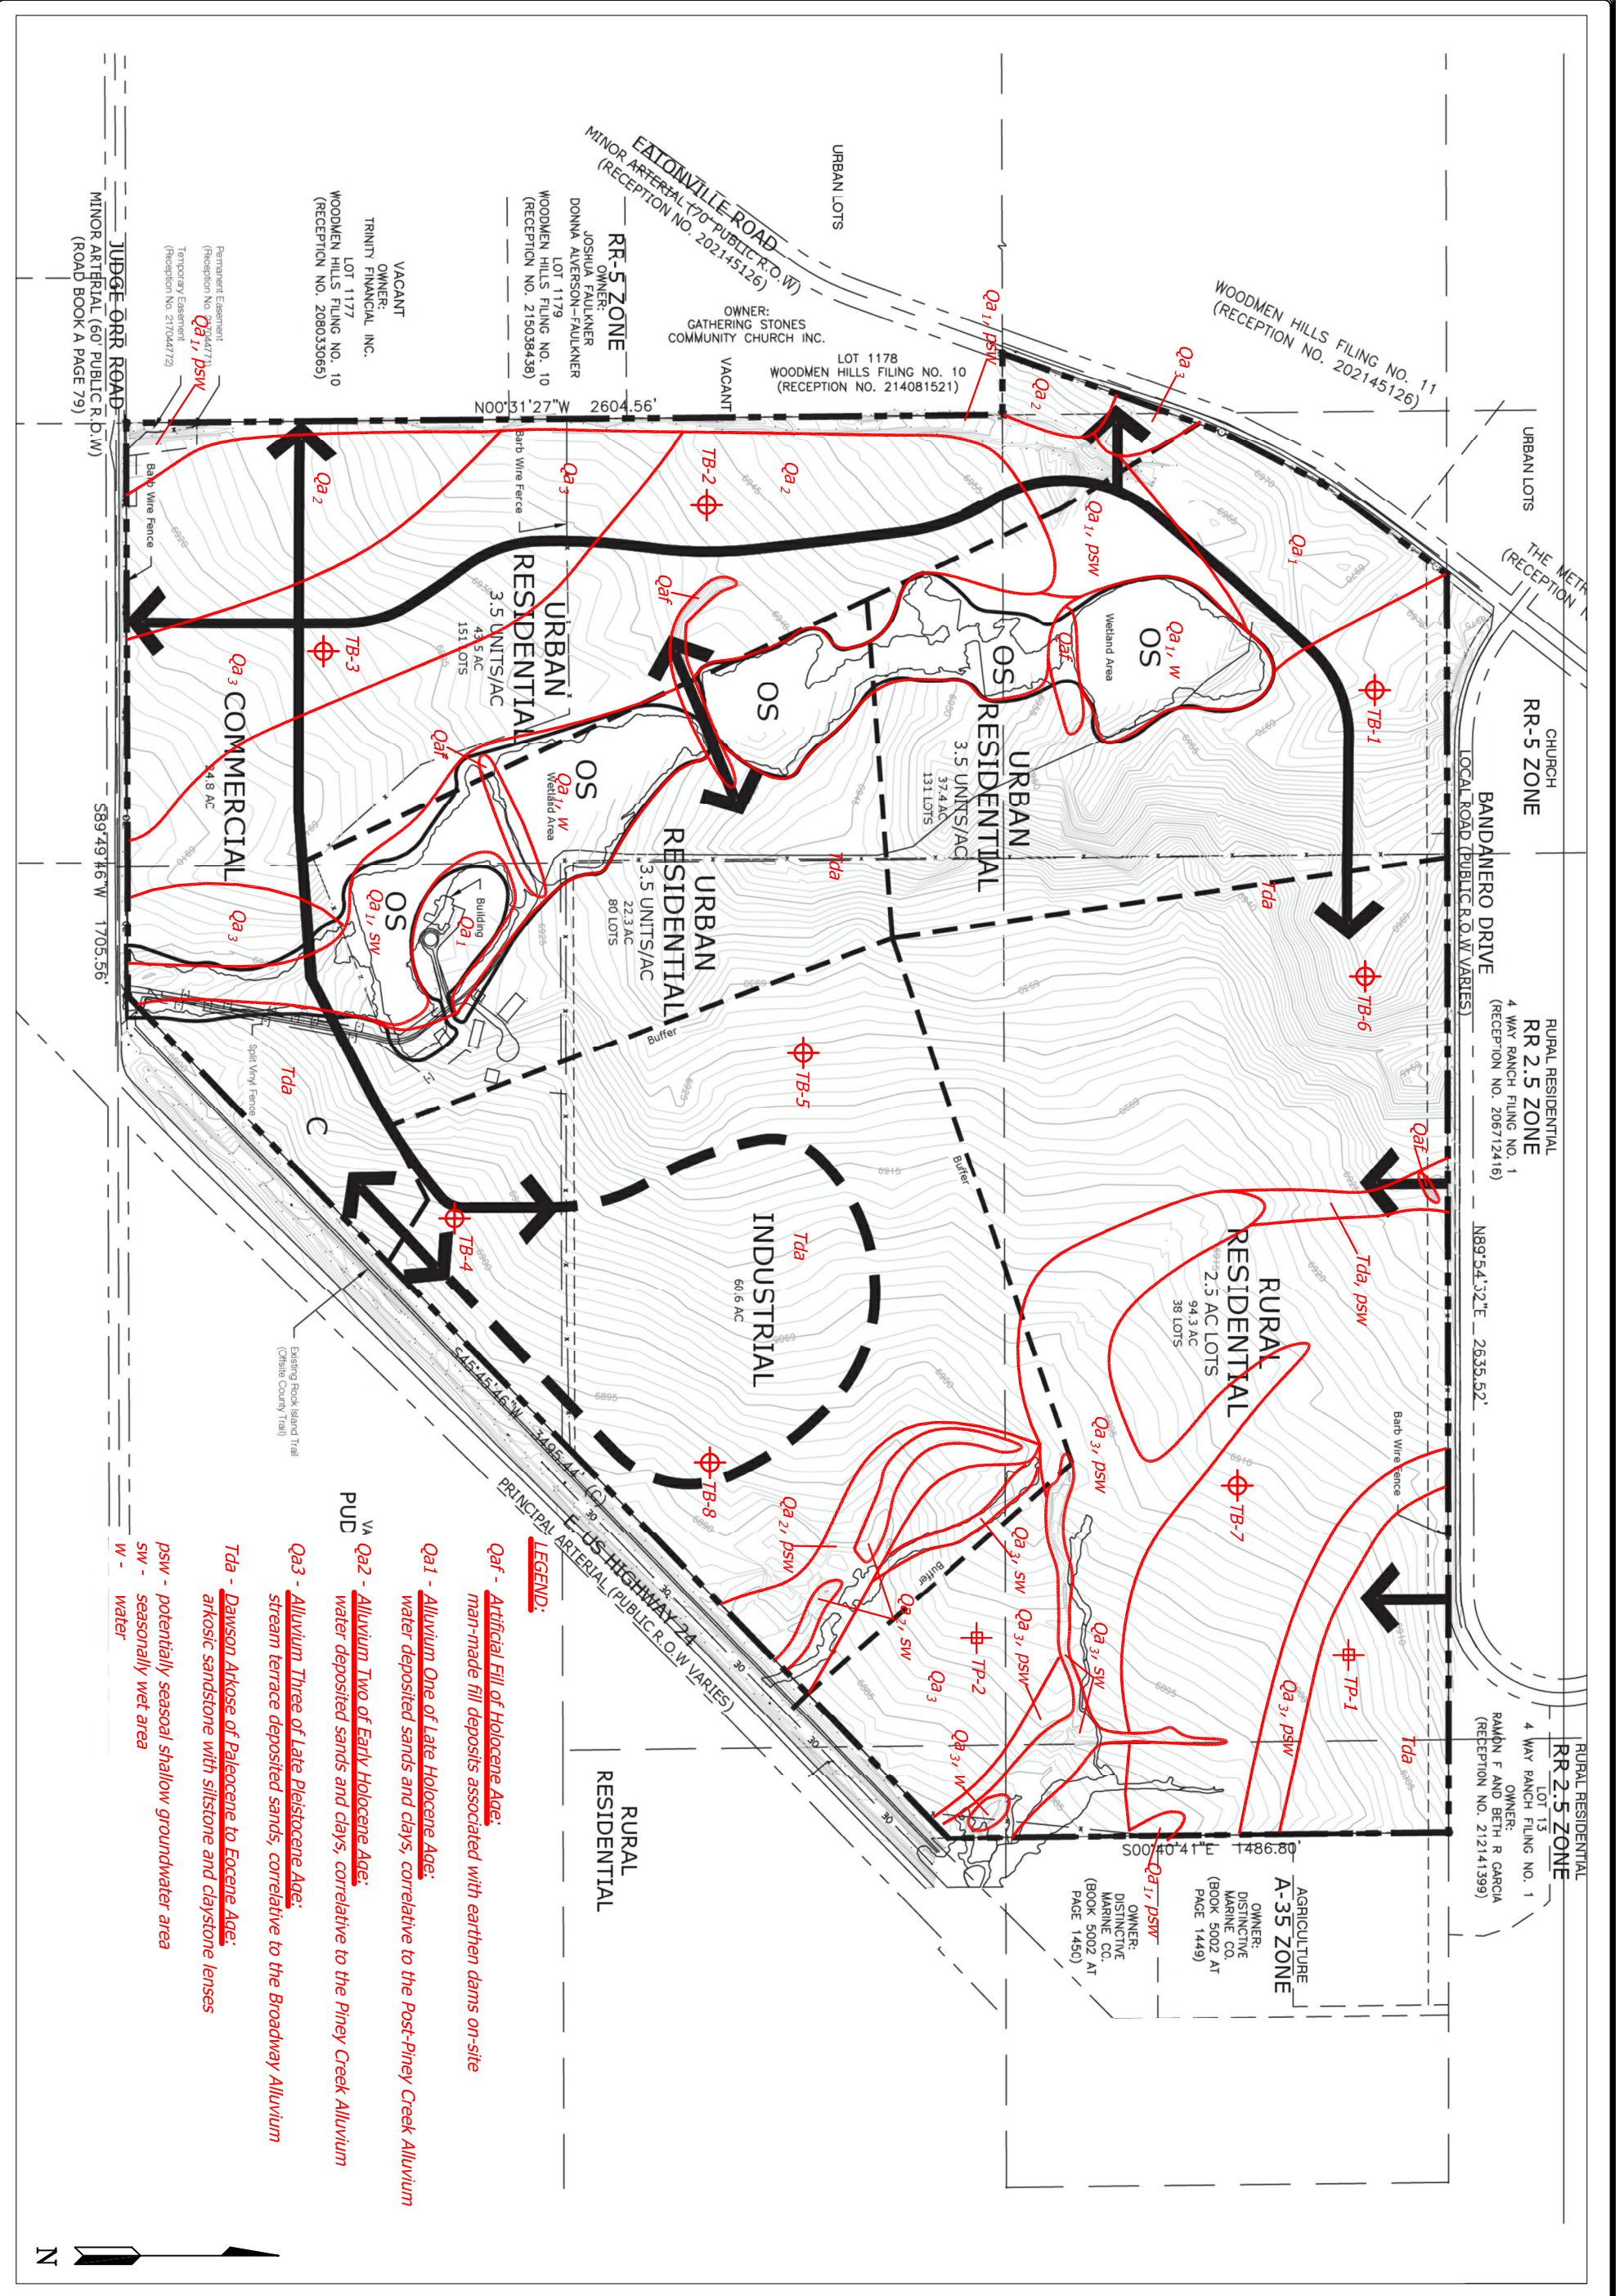
DATE	6/26/18
SCALE	AS SHOWN
JOB NO.	180517
FIGURE NO.	6

These are located within a proposed open space area and will be avoided by future development. Additionally, erosion berms were observed in places on the property that have not been mapped on Figure 6.

As mentioned previously, detailed mapping has been performed on this site to produce an Engineering Geology Map Figure 6. This map shows the location of various geologic conditions of which the developers should be cognizant during the planning, design and construction

These are recent man-made fill deposits associated with the dams located in the western portion of the site. This area is located in a proposed open space area and will be avoided by the development. One dam is in the area of a proposed roadway. It is anticipated that this dam will be removed and replaced with controlled fill during the site grading process. Areas of fill other than these mapped may be encountered, particularly associated with erosion berms.

Mitigation: The earthen dams lie within defined drainages and should be avoided as building sites. The fill on this site is considered uncontrolled for construction purposes. It is anticipated the erosion berms would be mitigated during site grading or could be penetrated by foundations. Any uncontrolled fill encountered beneath foundations will require removal and recompaction at a minimum of 95% of its maximum Modified Proctor Dry Density, ASTM D-1557.

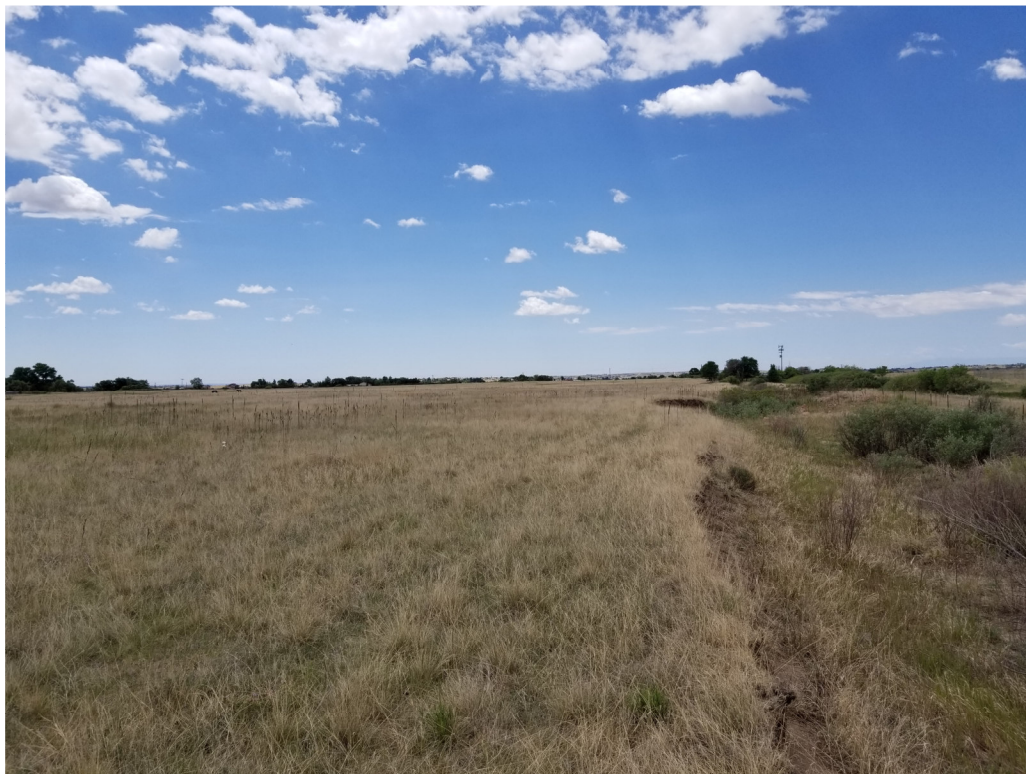
**Looking south along  
drainage along the  
western edge of the  
property.**

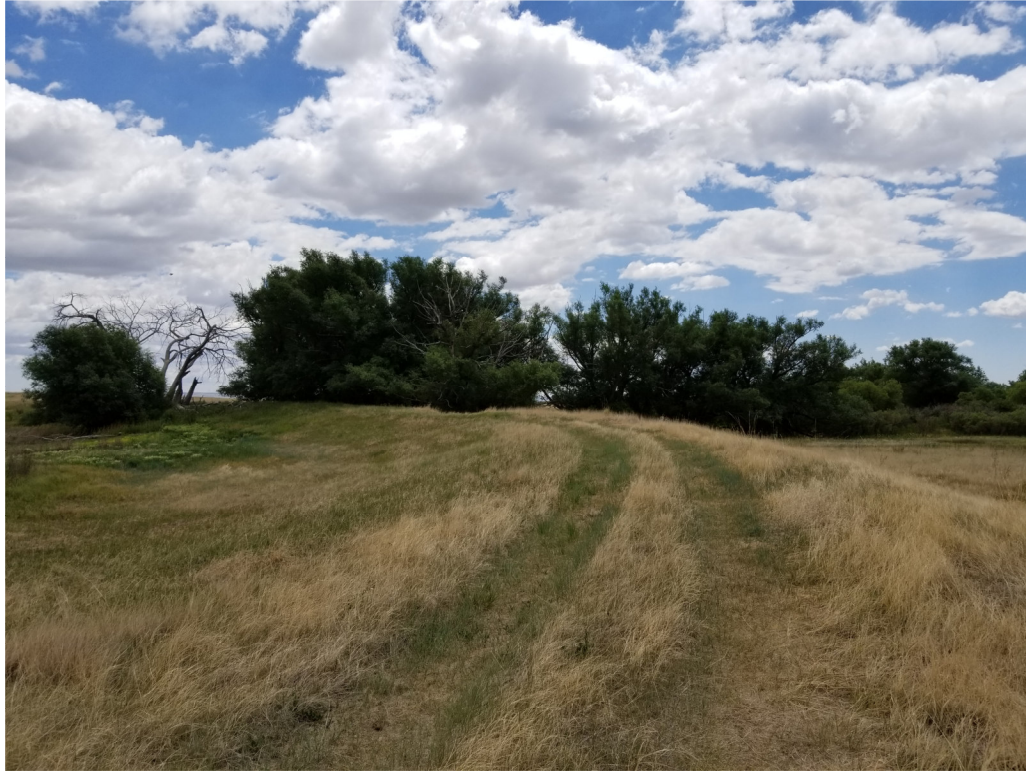
**Looking southeast  
towards an existing  
earthen dam in the  
western portion of the  
property.**
