**SOILS AND GEOLOGY STUDY
PREAMBLE AT HANNAH RIDGE FILING NO. 3
AKERS DRIVE AND CONSTITUTION AVENUE
EL PASO COUNTY, COLORADO**

Prepared for:
Elite Properties of America, Inc.
2138 Flying Horse Club Drive
Colorado Springs, Colorado 80921

December 23, 2024

Entech Job No. 242070

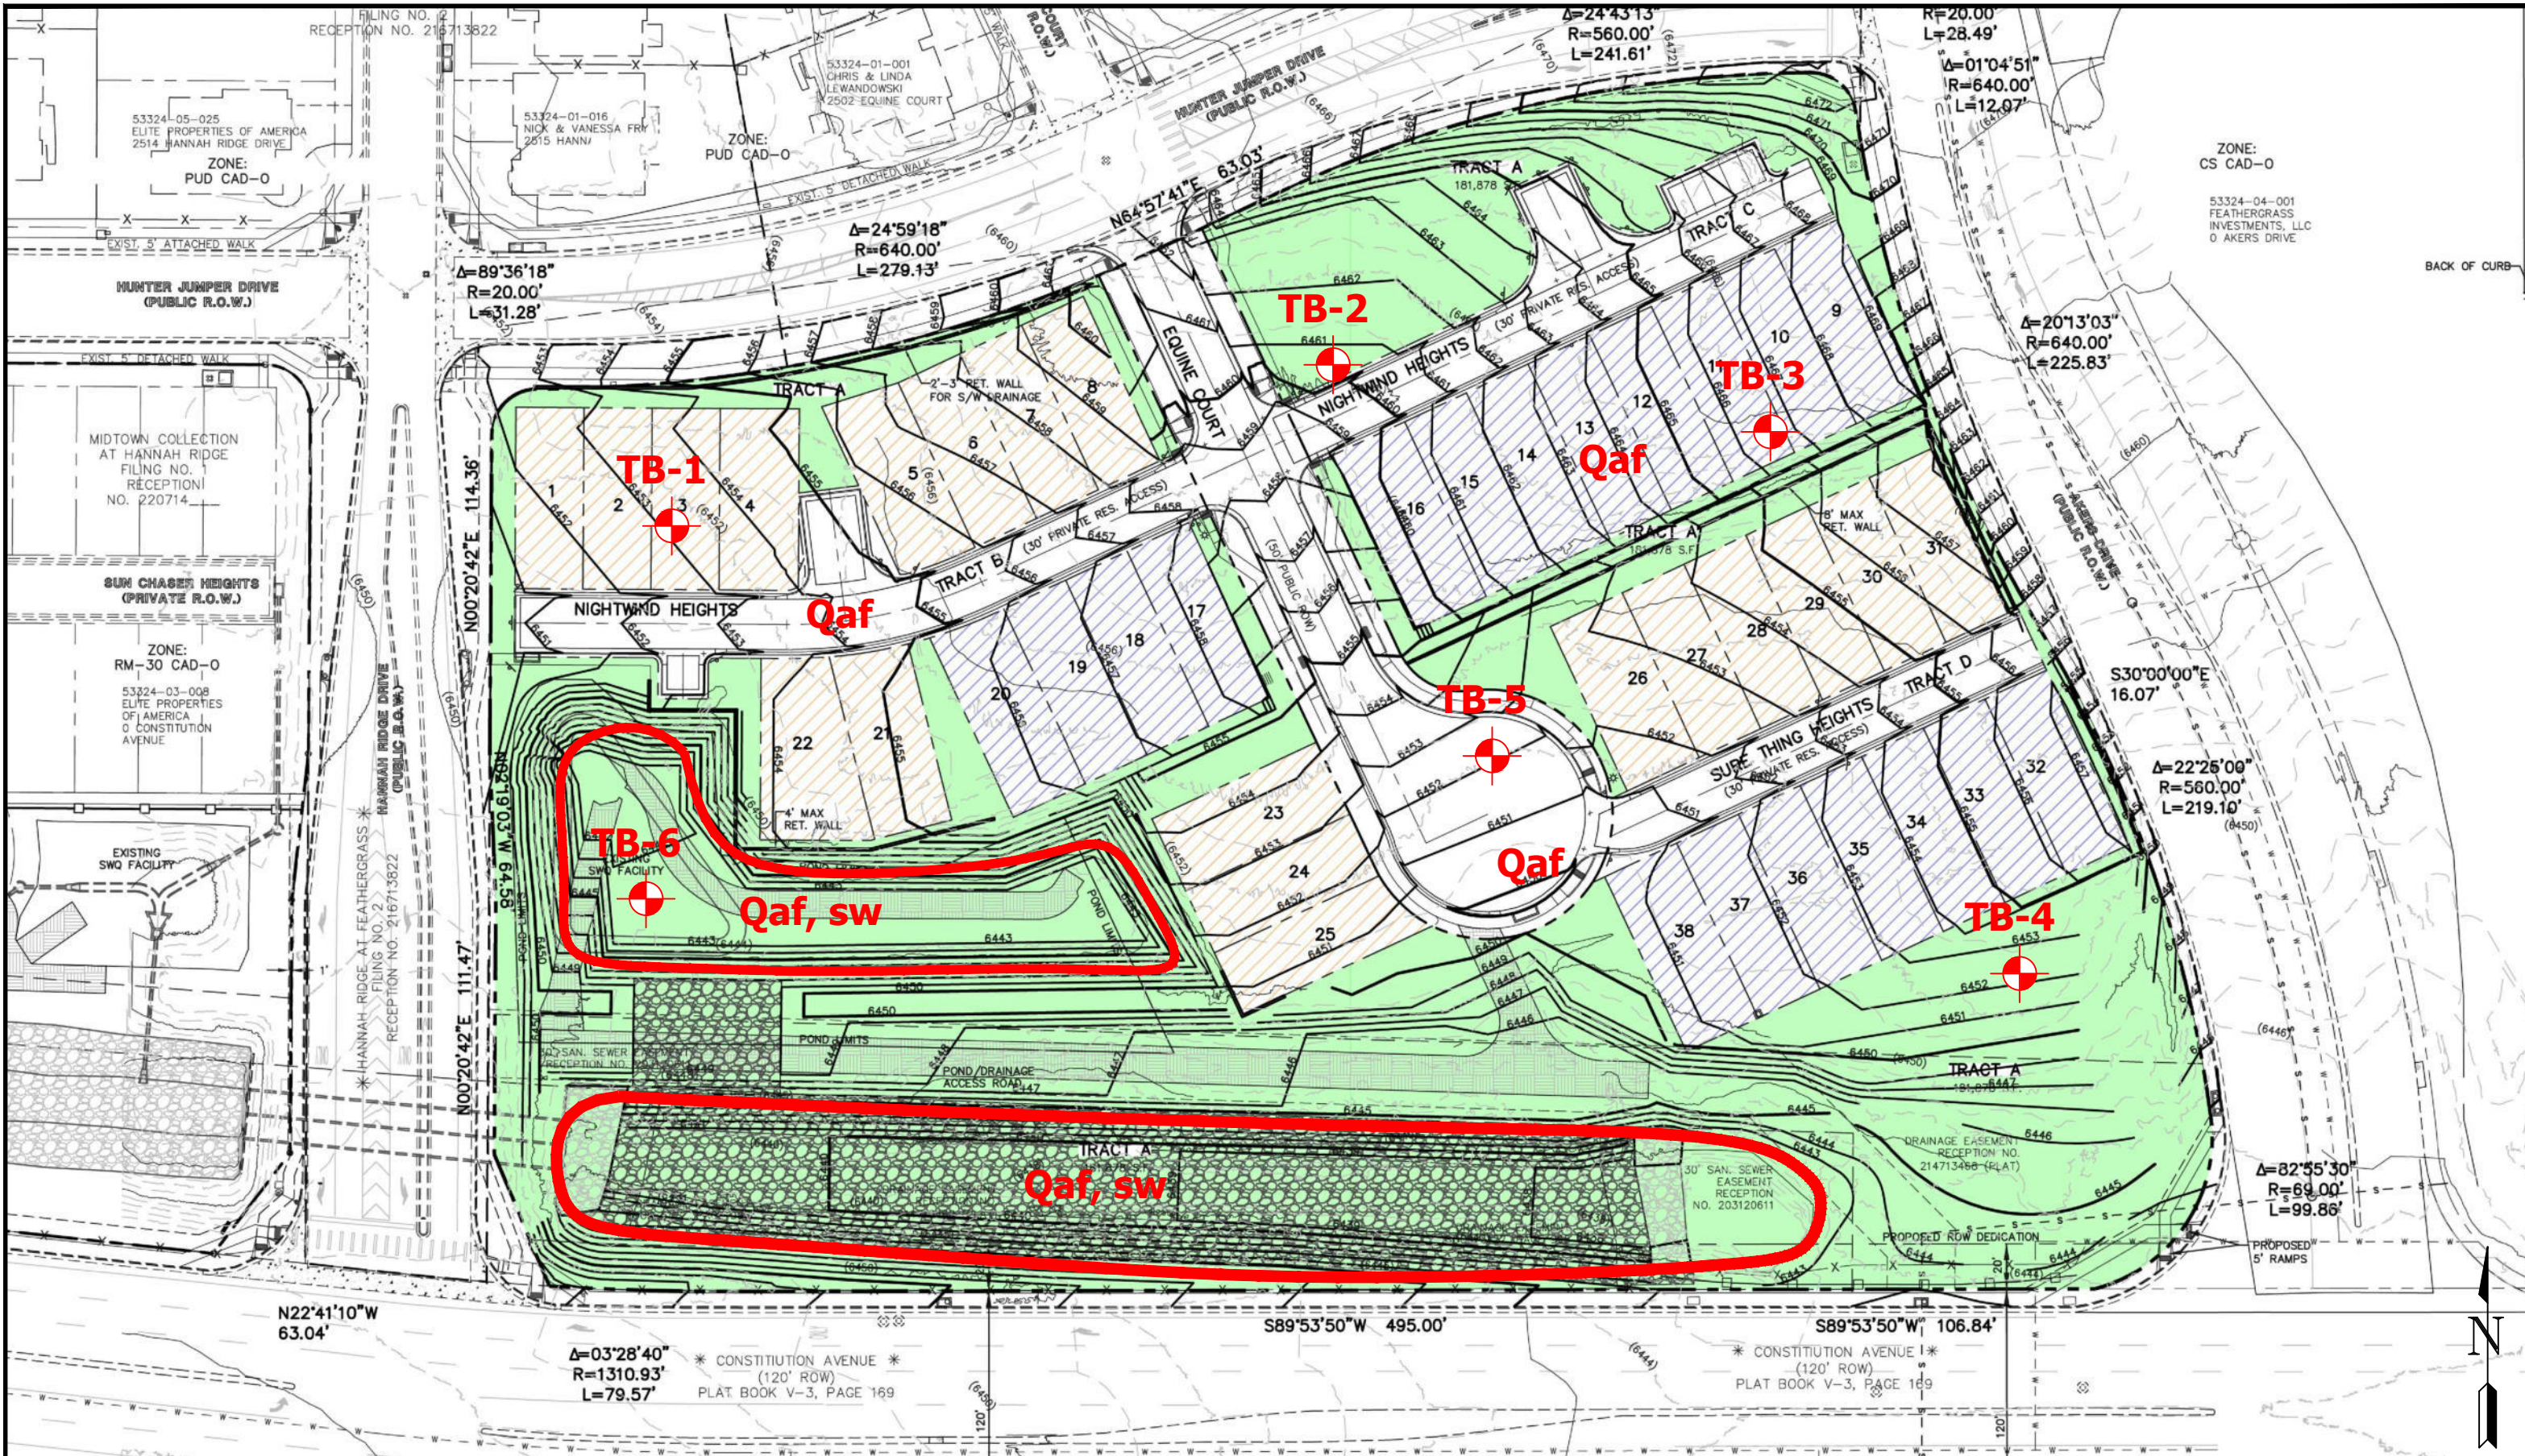
JOB NO. 242070
 FIG. 6

As mentioned previously, detailed mapping has been performed on this site to produce an Engineering Geology Map (Figure 7). This map shows the location of various geologic conditions the developers should monitor during the planning, design, and construction stages of the project. Hazards include areas of artificial fill, loose collapsible soils, expansive soils, seasonally shallow groundwater areas, and areas of erosion. These hazards and the recommended mitigation techniques are as follows:

Legend:
 Qaf - Artificial Fill of Holocene Age: man placed fill deposits associated with previously completed grading operations
 sw - seasonally shallow groundwater area

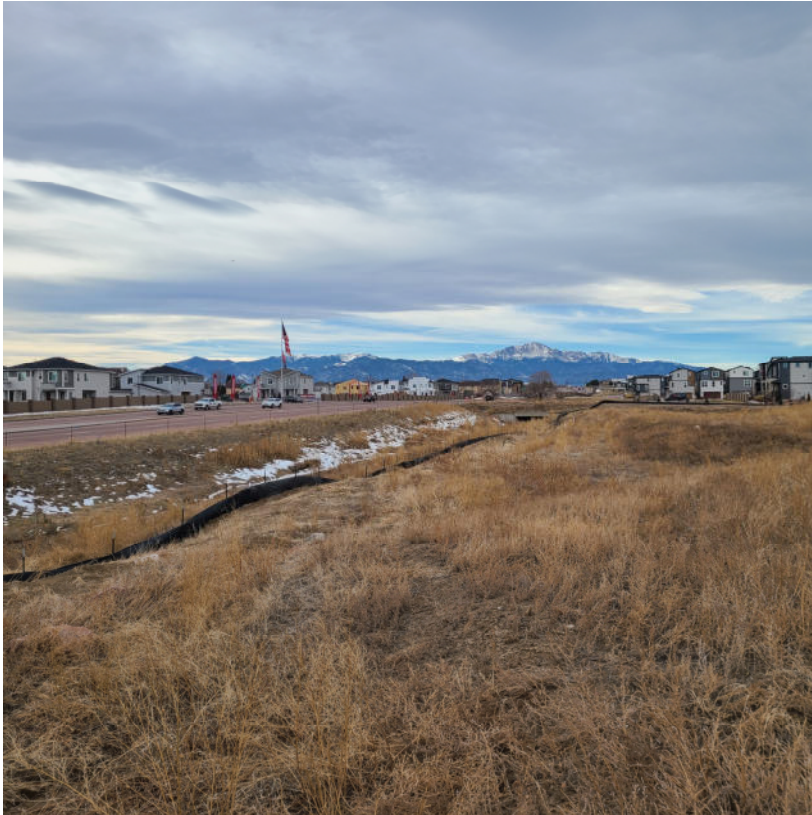
In these areas, we would anticipate the potential for periodically high subsurface moisture conditions and possible frost heave potential, depending on the soil conditions. Water was observed in portions of the drainage along the southern side of the site at the time of our field mapping. The areas mapped with this hazard are located in the drainage easement and will be avoided by the proposed residential structures. Shallow water is not expected in the building areas.

**Looking west along
drainage from the
southeastern side of
the site.**

Mitigation In these locations, foundations in areas subject to severe frost heave potential should penetrate sufficient depth so as to discourage the formation of ice lenses beneath foundations. At this location and elevation, a foundation depth for frost protection of 2.5 feet is recommended. In areas where high subsurface moisture conditions are anticipated periodically, a subsurface perimeter drain will be necessary to help prevent the intrusion of water into areas located below grade. Additionally, swales should be created to intercept surface runoff and carry it safely around and away from structures. The site grading completed for the development mitigate the majority of the drainage issues.
