**ENTECH**  
ENGINEERING, INC.

December 7, 2021

Re: Wastewater Study  
Trinity Subdivision  
20040 Highway 94  
Tax Schedule No. 34000-00-455  
El Paso County, Colorado

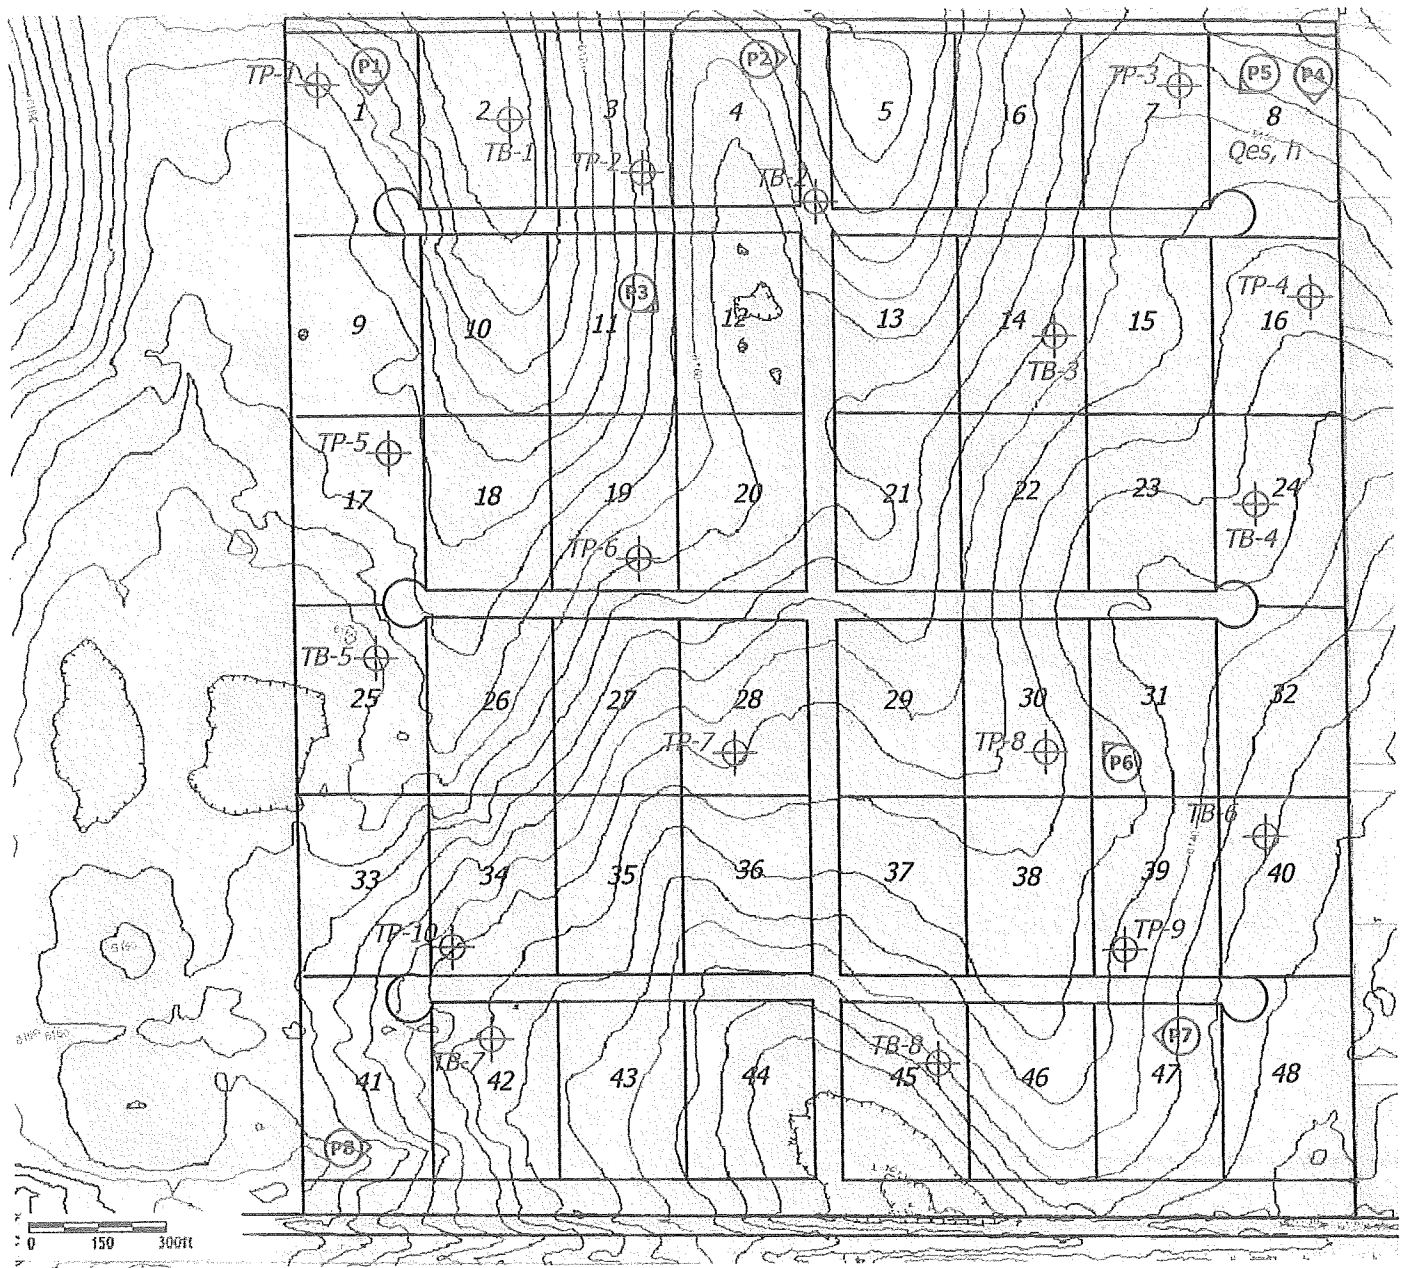
FIG NO.:  
**3**

Ten (10) test pits were excavated on the site to determine general suitability of the soil characteristics for residential construction and on-site wastewater treatment systems. The locations of the test pits are indicated on the Site Plan/Test Boring Location Map, Figure 3. The Test Pit Logs are presented in Appendix B, and Laboratory Testing results are included in Appendix C.

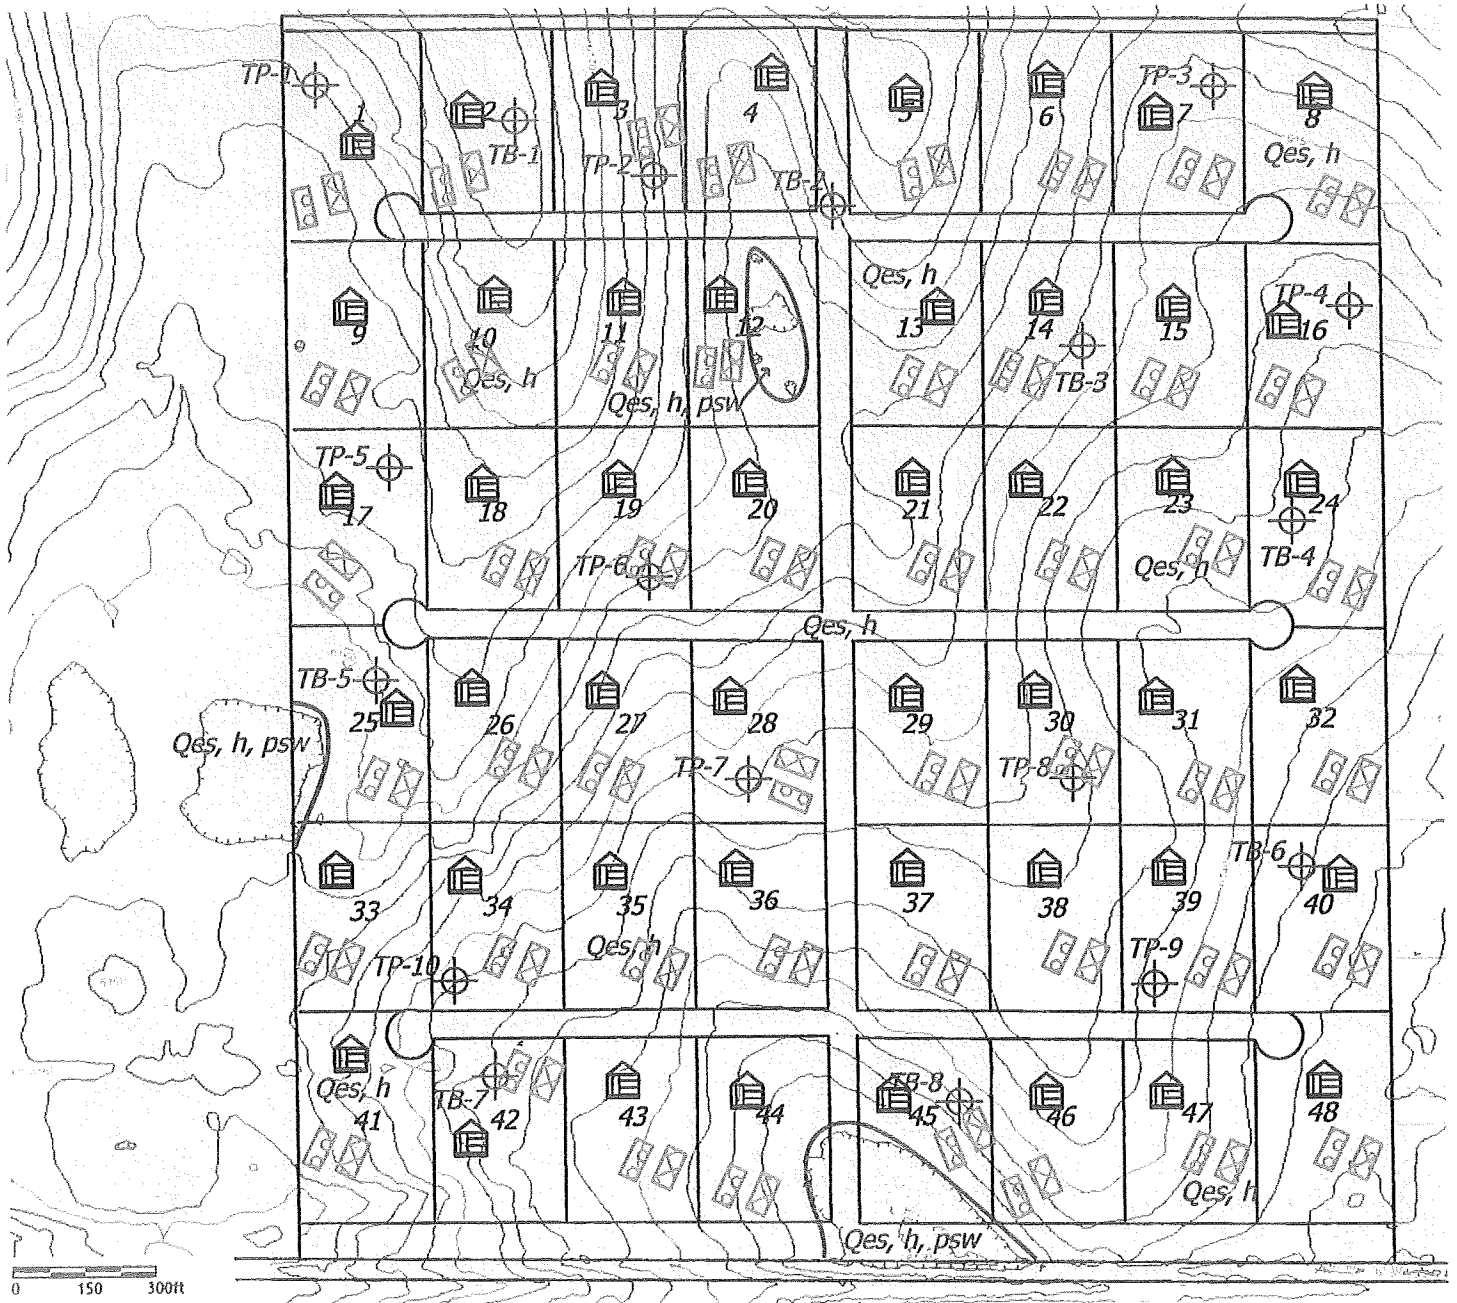
FIG NO.:  
8

In summary, it is our opinion the site is suitable for individual on-site wastewater treatment systems (OWTS) and that contamination of surface and subsurface water resources should not occur provided the OWTS sites are evaluated and installed according to El Paso County and State Guidelines and properly maintained. Based on the testing performed, conventional systems would likely be appropriate for the majority of the lots, some lots may require designed systems. The Septic Suitability Map is presented in Figure 8. Possible house locations and two septic sites for the lots are indicated on Figure 8. The subdivision is anticipated to be supplied by central water. Areas that should be avoided by septic systems are indicated on the septic suitability map.

- OWTS ARE NOT RECOMMENDED IN AREAS OF  
POTENTIALLY SEASONAL SHALLOW GROUNDWATER (PSW)

**Individual soil testing is required for proposed construction on each lot prior to construction.** Absorption fields must be located a minimum of 100 feet from any well, including those on adjacent properties. Absorption fields must also be located a minimum of 50 feet from any drainages, floodplains or ponded areas and 25 feet from dry gulches.
