**SOILS AND GEOLOGY STUDY  
ASPEN WILLOW SUBDIVISION  
PARCEL NO. 61000-00-298  
1480 E. HIGBY ROAD  
EL PASO COUNTY, COLORADO**

Prepared for:  
**Charles Woodall**  
1480 E. Higby Road  
Monument, Colorado 80132

August 21, 2026

Entech Job No. 261137

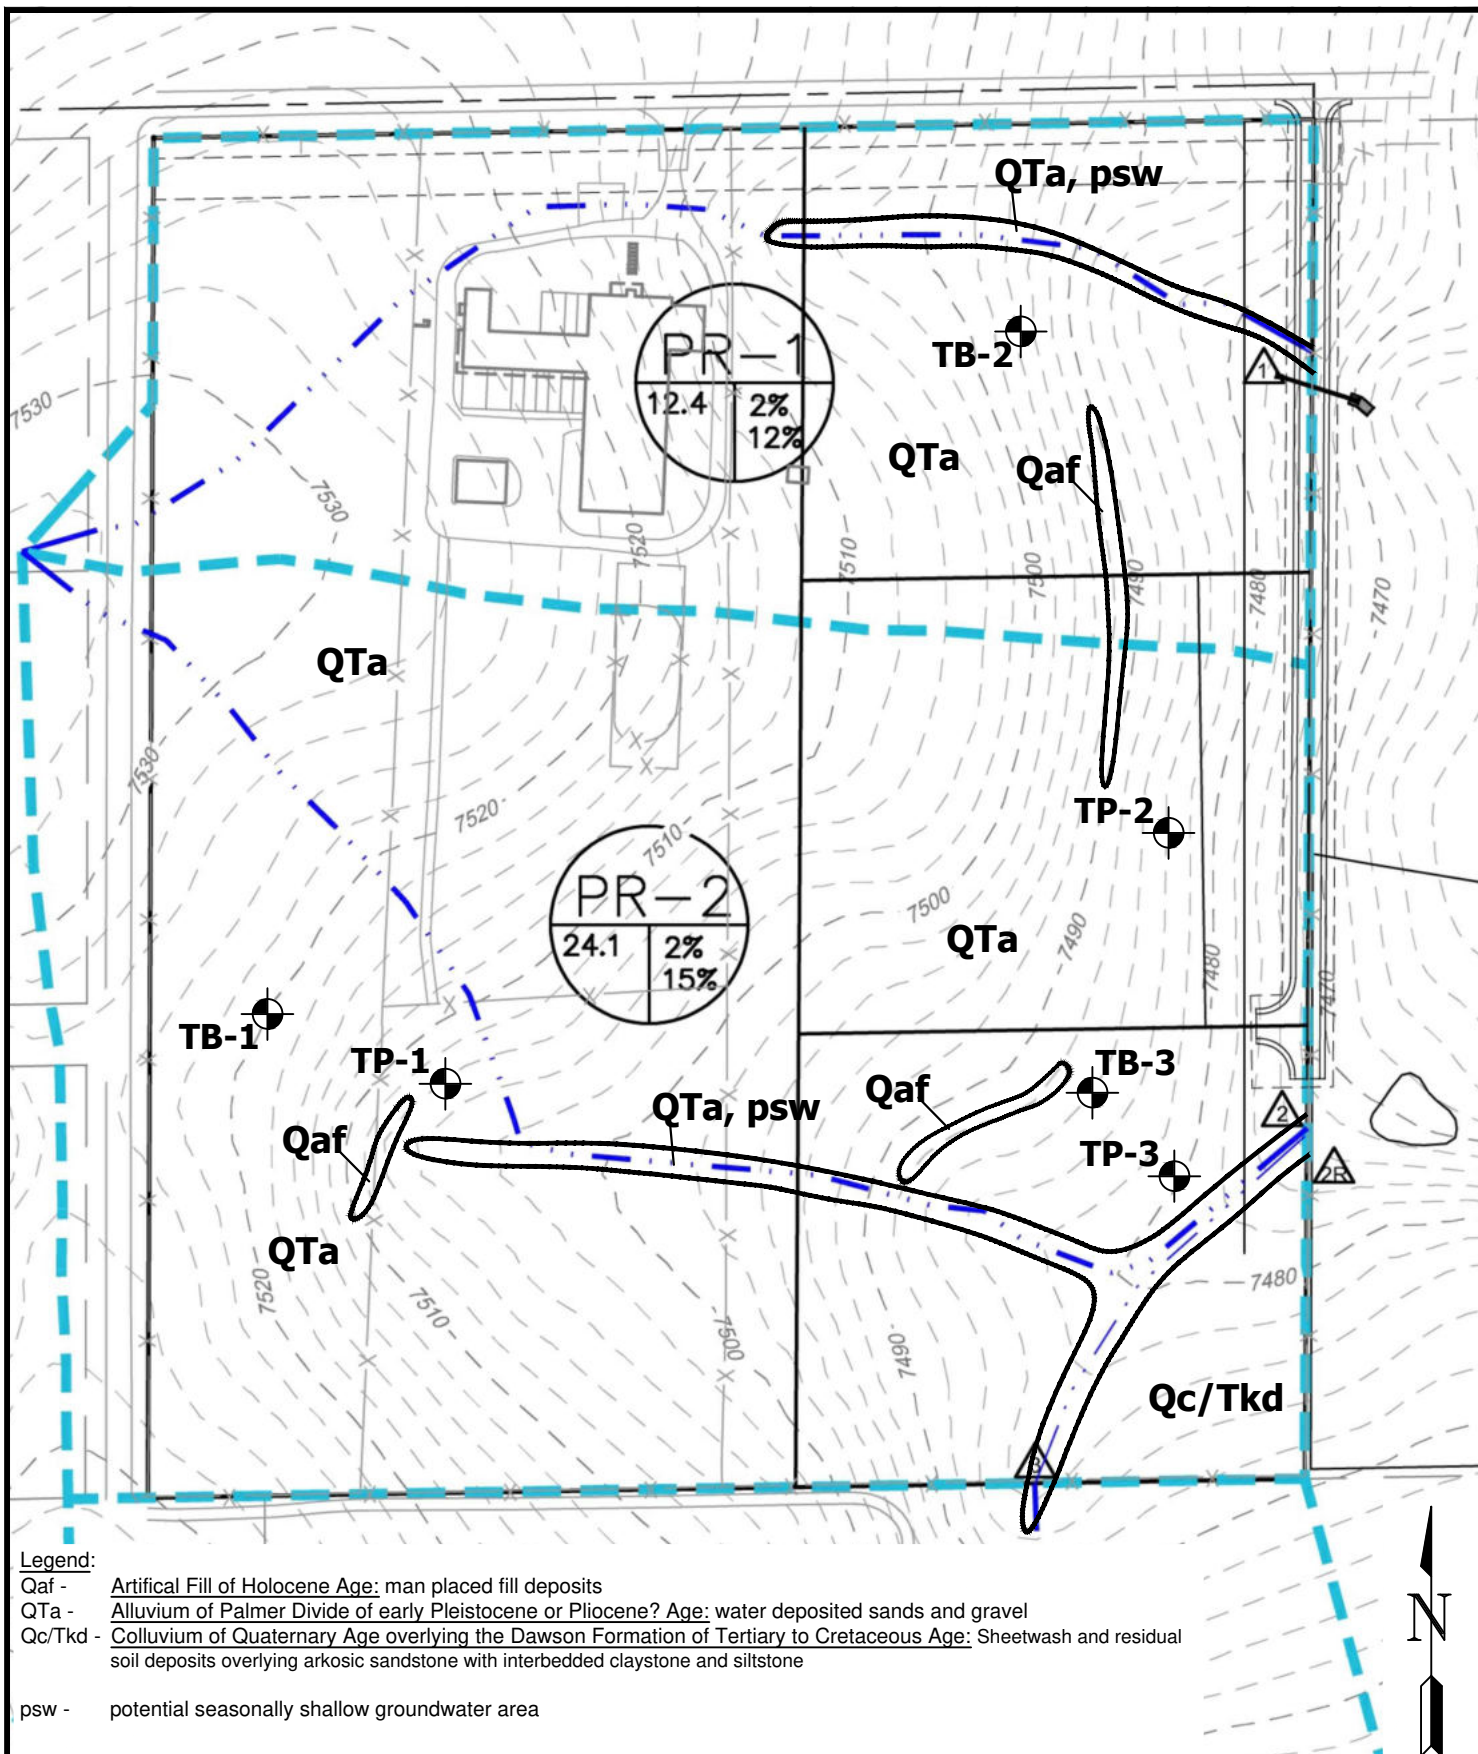
**GEOLOGY/ENGINEERING  
GEOLOGY MAP**  
ASPEN WILLOW SUBDIVISION  
CHARLES WOODALL

Detailed mapping has been performed on this site to produce a Geology/Engineering Geology Map (Figure 3). This map shows the location of various geologic conditions the developers should monitor during the planning, design, and construction stages of the project. No significant geologic hazards were identified on the site; however, the following constraints have been identified on the site: artificial fill, potentially collapsible soils, potentially expansive soils, potential seasonally shallow groundwater areas, and the potential for elevated radon levels. These constraints and the recommended mitigation techniques are discussed below.

#### Potentially Seasonal Shallow Groundwater Areas – Constraint

The areas identified with this constraint are the minor drainage swales in the northern and southern portion of the site. In these areas, we would anticipate periodic high subsurface moisture conditions and frost heave potential on a seasonal basis. Groundwater was not encountered in the test borings during or subsequent to drilling. Redoximorphic features were encountered in TP-6 at a depth of 6 feet during excavation, but were not encountered in the remaining test pits. Due to the size of the lots these areas can be avoided by future residences or OWTS's. Any structures in or adjacent to potentially shallow groundwater areas should follow the mitigation discussed below.

Mitigation: The erosion berms if located within proposed building areas can be removed or regraded with future development on the lots. Any uncontrolled fill encountered beneath foundations will require removal and recompaction at a minimum of 95% of the Modified Procter (ASTM D1557) maximum dry density.

Mitigation: Should loose or collapsible soils be encountered beneath foundations, recompaction of the loose soils to a minimum of 95% of the Modified Procter (ASTM D1557) maximum dry density may be necessary. Depths of recompaction should be determined for each lot after additional investigation of the building site. Exterior flatwork and driveway areas may also experience movement. Proofrolling and recompaction of soft areas should be performed during site work.

Mitigation: Foundations on this site must have a minimum 30-inch depth for frost protection. Buildings should typically be set a minimum of 3 feet above groundwater levels if possible. Subsurface perimeter drains are recommended for any usable below-grade. If groundwater is encountered within 3 feet of foundation
