ENTECH
ENGINEERING, INC.

Re: Soil, Geology and Geologic Hazards Report and Site Review
Midtown at Hannah Ridge – Tracts AA & BB
El Paso County, Colorado

**SOIL, GEOLOGY AND
GEOLOGIC HAZARD STUDY
HANNAH RIDGE FILING NO. 1
CONSTITUTION AVENUE AND
SHAWNEE DRIVE
EL PASO COUNTY, COLORADO**

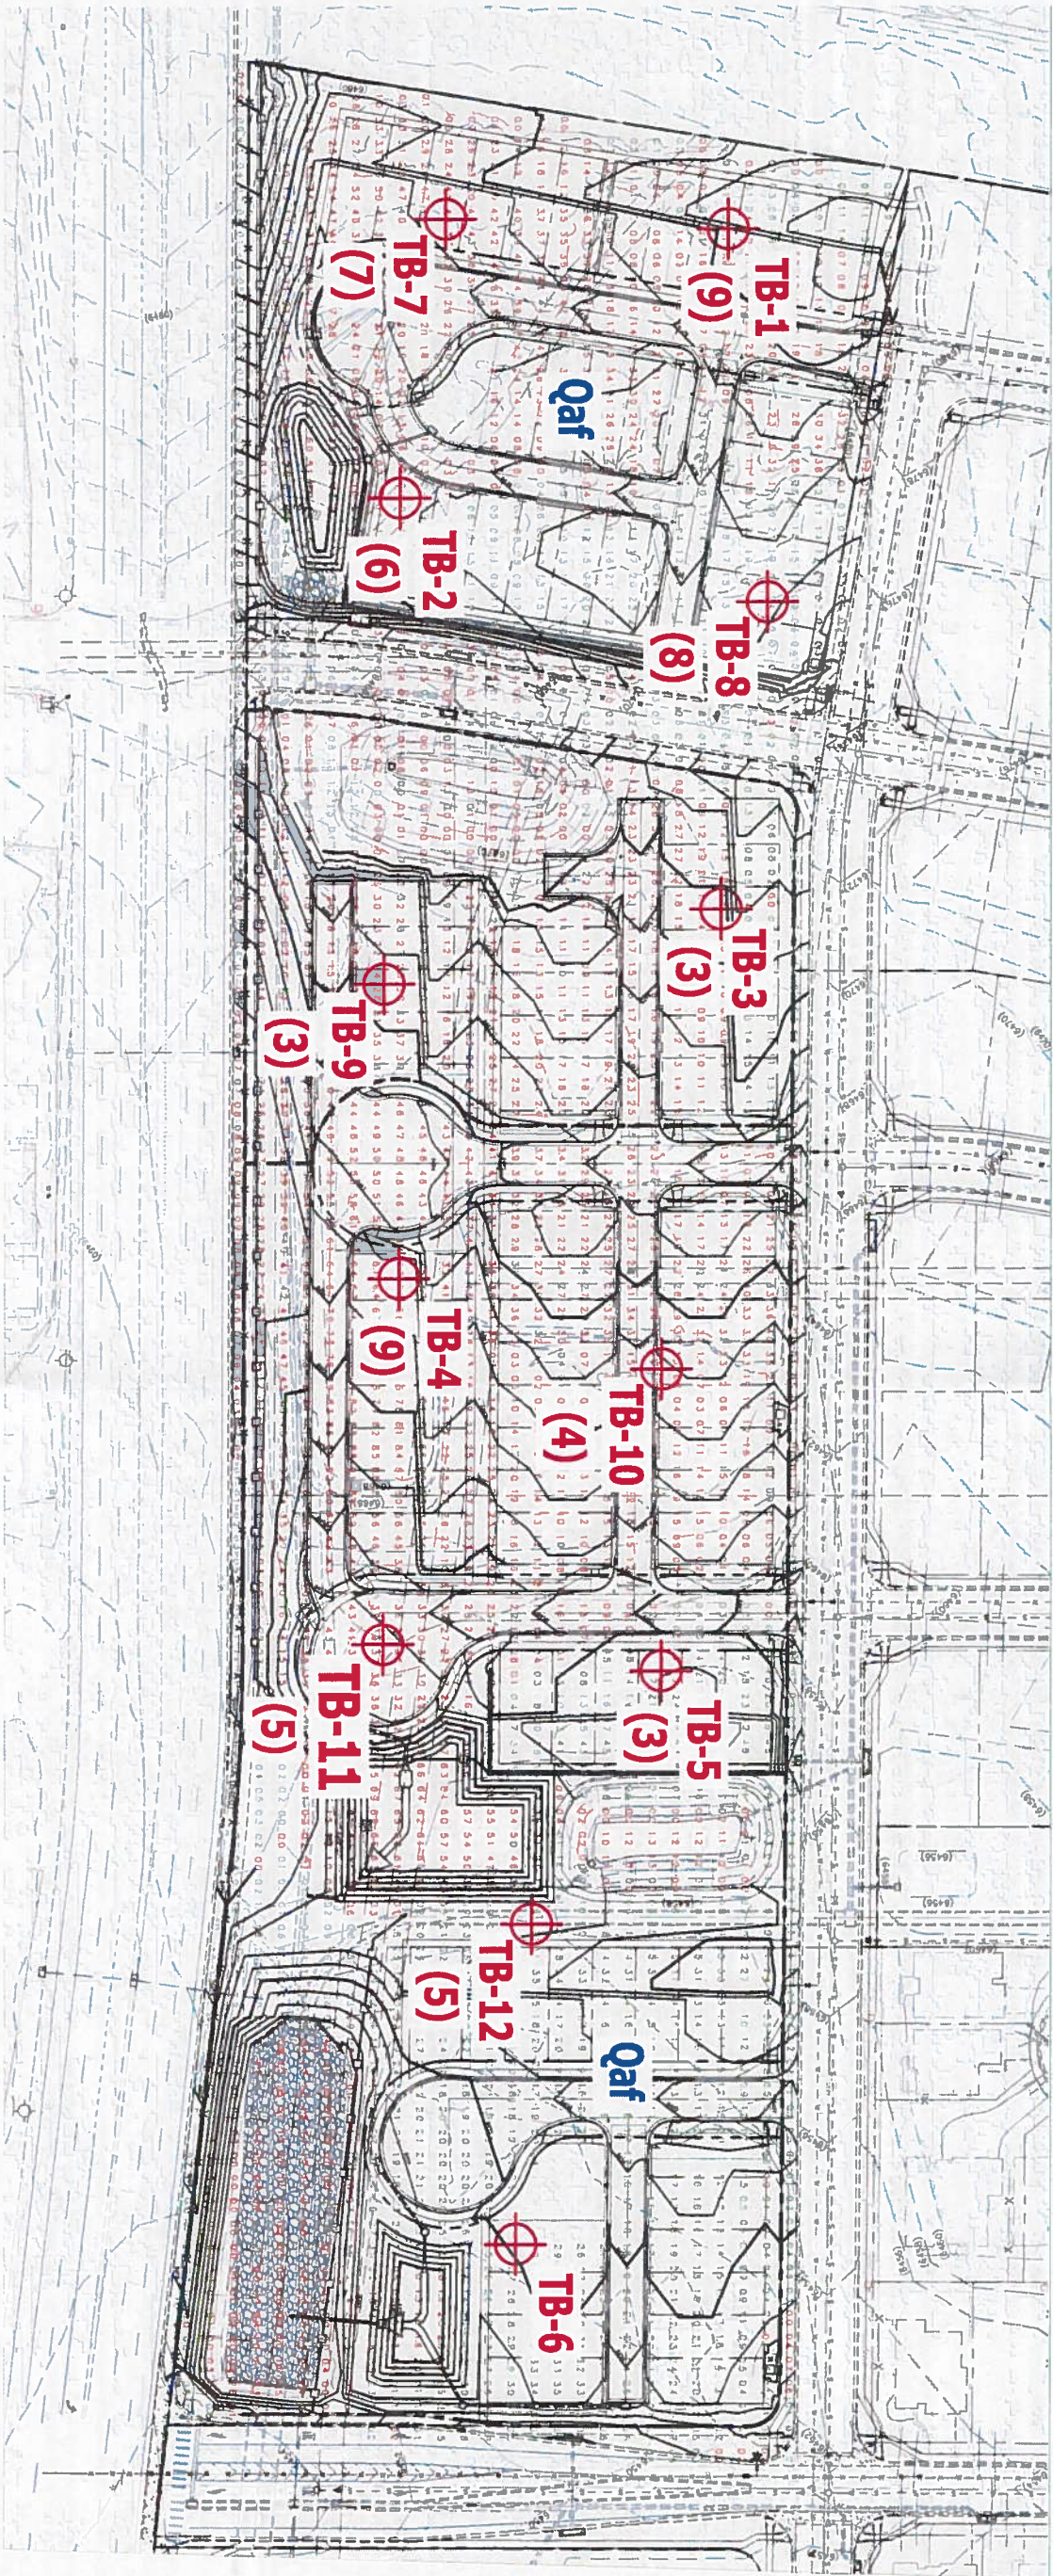
GEOLOGY MAP
 MIDTOWN AT HANNAH RIDGE
 EL PASO COUNTY, COLORADO
 FOR: ELITE PROPERTIES OF AMERICA

This area was previously mapped in an area of “Qaf: Artificial fill of Quaternary Age”. Soils encountered in the Subsurface Soil Investigation by Entech, referenced above, consisted of 3 to 9 feet of clayey sand fill and sandy clay fill overlying native sands and clays. Bedrock was not encountered in the test borings, which were drilled to depths ranging from 5 to 20 feet. The Bedrock underlying the site consists of the Dawson Formation of Tertiary to Cretaceous Age. The Dawson typically consists of sandstone with interbedded lenses of claystone or siltstone. The geology of the site is shown on the Geology Map, Figure 1. Test Boring Logs from the above referenced Subsurface Soil Investigation are included in Appendix A. The Laboratory Test Results are summarized in Table 1.

Artificial fill has been mapped and encountered over the entire site in the above referenced reports. Fill was observed on the site during our recent site visit. The fill is considered uncontrolled for construction purposes and will require mitigation. Recommendations for the site have been included in the above referenced Subsurface Soil Investigation and in the Soil, Geology and Geologic Hazard Study. It is our opinion the conclusions and recommendations in the above referenced reports remain valid and the reports may be used for the proposed development. The Soil, Geology, and Geologic Hazard Study is included in Appendix B.

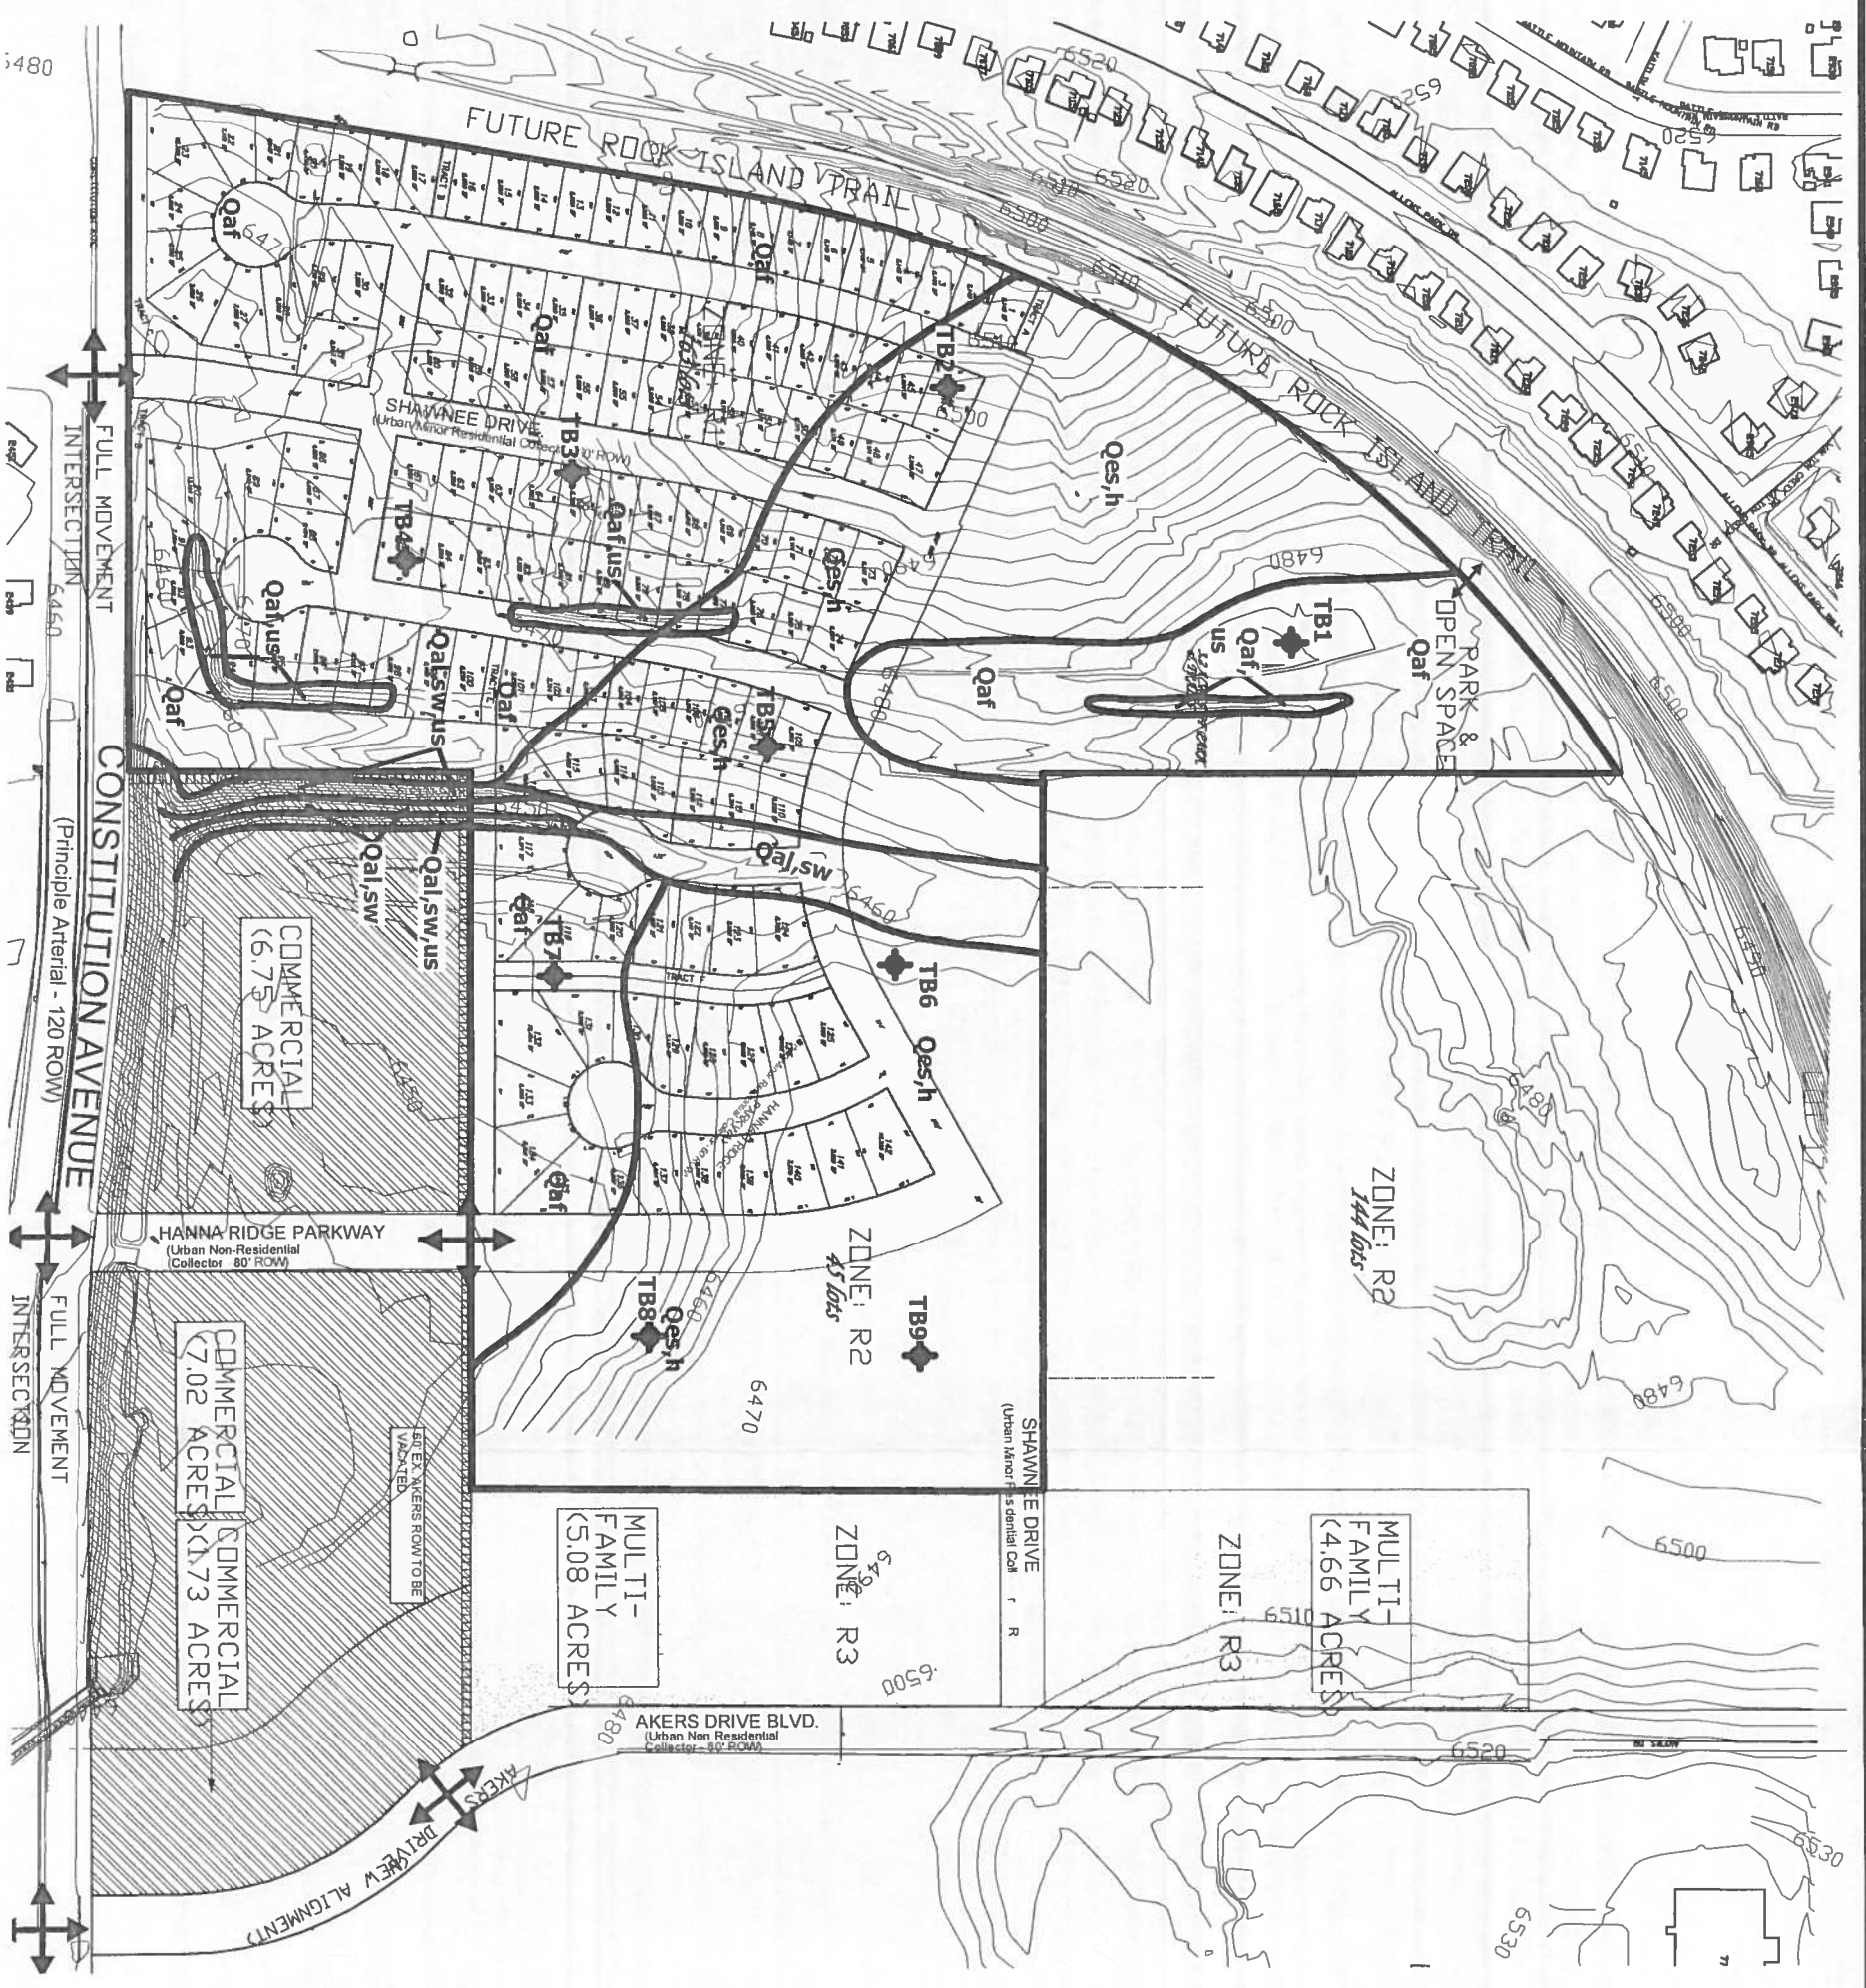
DRAWN BY: R.J. OLSON
 DESIGNED BY: KAE
 CHECKED BY:
 DATE: 12/21/05
 SCALE: 1" = 125'
 JOB NO.: 35044
 FIGURE NO.: 8

As mentioned previously, detailed mapping has been performed on this site to produce an Engineering Geology Map (Figure 8). This map shows the location of various geologic conditions of which the developers and planners should be cognizant during the planning,

Some areas of expansive soils were encountered in the upper soils in the test borings. These occurrences are too sporadic to be mapped, however, expansive clays may be encountered in the subsurface on the site. These clays can cause differential movement in the structure foundation. These occurrences should be identified and dealt with on an individual basis.

Areas mapped with this hazard may be subject to high groundwater conditions on a seasonal basis. In these areas, we would anticipate the potential for periodically high subsurface moisture conditions and possible frost heave potential, depending on the soil conditions.

Areas in which this hazard has been identified are acceptable as building sites. However, in areas identified for this hazard classification, we anticipate a potential for settlement movements upon saturation of these surficial soils. The low density, uniform grain sized, windblown sand deposits are particularly susceptible to this type of phenomenon.

Areas of loose soils may also be encountered on this site. Should loose soils be encountered beneath foundations, recompaction of the upper 2 feet of soil at 90% of its maximum Modified Proctor Dry Density, ASTM D-1557 may be required. Proofrolling may also be necessary where roadways cross loose soils.

Mitigation: Mitigation of expansive soils will require special foundation design. Overexcavation and replacement with non-expansive soils at 90% of Modified Proctor Dry Density, ASTM D-1557 is a suitable mitigation which is common in the area. Drilled piers are another option that is used in areas where highly expansive soils are encountered. Typical minimum pier depths are on the order of 20 feet or more and require penetration into the bedrock material a minimum of 4 to 6 feet, depending upon building loads. Floor slabs on expansive soils should be expected to experience movement. Overexcavation and replacement has been successful in minimizing slab movements. Final recommendations should be determined after additional investigation of each building site.

Mitigation: We would anticipate these areas to be filled, during site grading raising foundation levels further above the groundwater level. Foundations in areas close to the water table are subject to severe frost heave potential and should penetrate sufficient depth so as to discourage the formation of ice lenses beneath foundations. At this location and elevation, a foundation depth for frost protection of 2.5 feet is recommended. In areas where high subsurface moisture conditions are anticipated periodically, drains may be necessary to help prevent the intrusion of water into areas located below grade. Typical Perimeter Drain Details are presented in Figure 9. During periods of high moisture, the water table may be shallower. It is anticipated that the site grading may mitigate areas of seasonally shallow groundwater. No areas of the site are

Mitigation: The potential for settlement movement is directly related to saturation of the soils below the foundation areas. Therefore, good surface and subsurface drainage is extremely critical in these areas in order to minimize the potential for saturation of these soils. The ground surface around all permanent structures should be positively sloped away from the structure to all points, and water must not be allowed to stand or pond anywhere on the site. We recommend that the ground surface within 10 feet of the structures be sloped away with a minimum gradient of five percent. If this is not possible on the upslope side of the structures, then a well-defined swale should be created to intercept the surface water and carry it quickly and safely around and away from the structures. Roof drains should be made to discharge well away from the structures and into areas of positive drainage. Where several structures are involved, the overall drainage design should be such that water directed away from one structure is not directed against an adjacent building. Planting and watering in the immediate vicinity of the structures, as well as general lawn irrigation, should be minimized.

Mitigation: Unless records can be obtained, the fill is considered uncontrolled for construction purposes. Any uncontrolled fill encountered beneath foundations will

require removal and recompaction at 90% of its maximum Modified Proctor Dry Density, ASTM D-1557. Large areas of soil/ debris fill must be removed prior to development. An alternative mitigation in areas of deeper fill is the use of drilled pier foundation systems, as discussed under Expansive Soils.

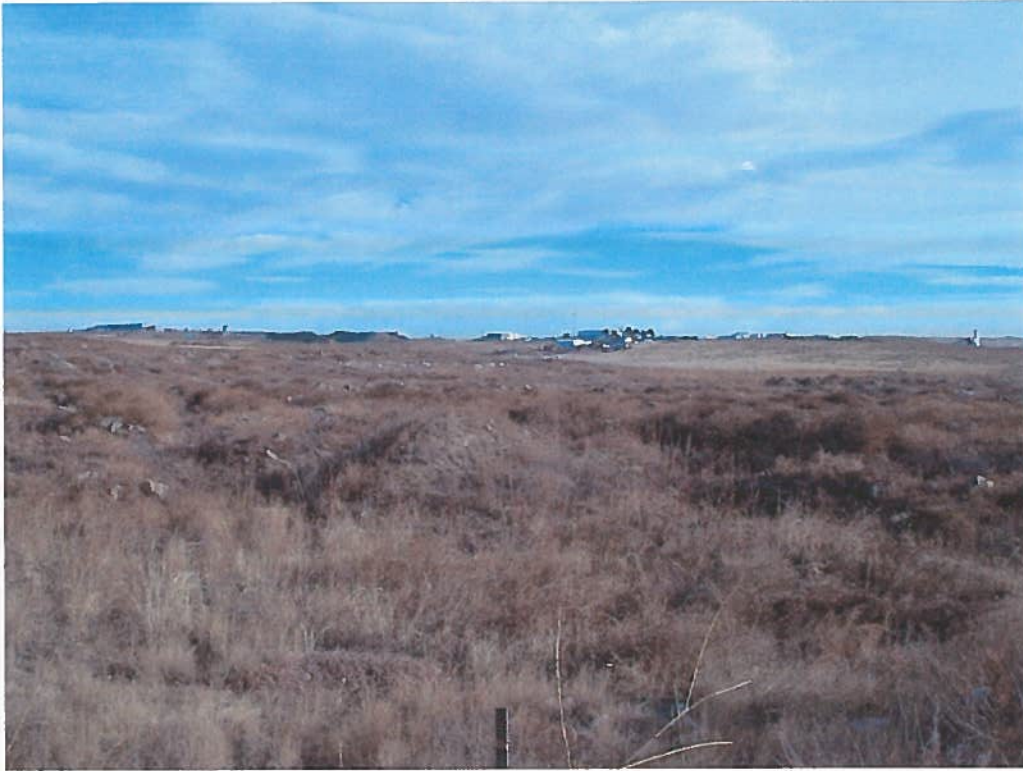
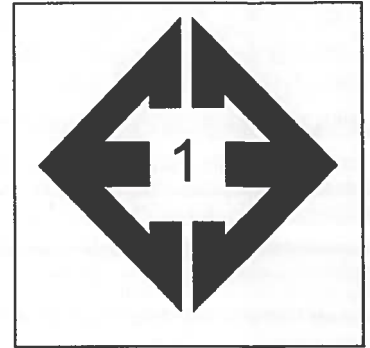
**Looking
northeast from
southeast corner
of site.**

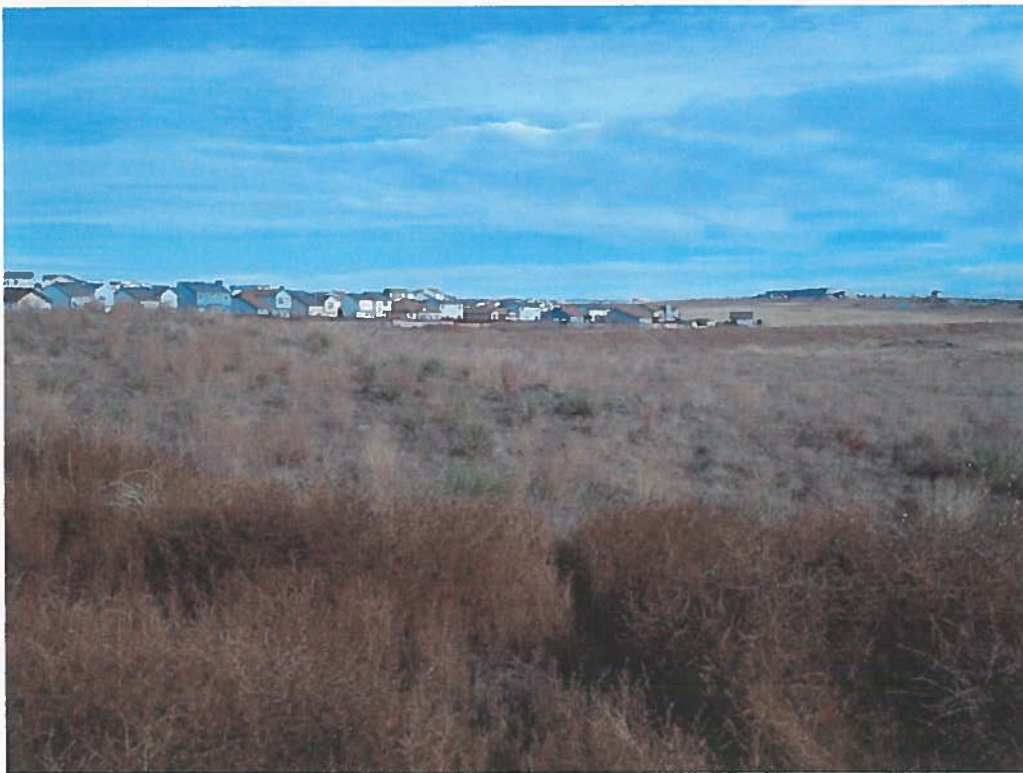
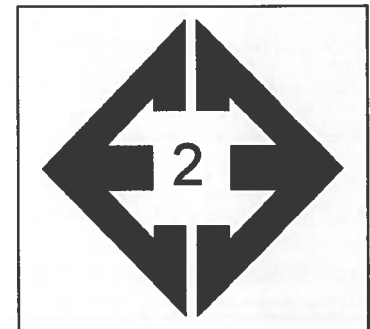
**Looking
northeast from
west-central
portion of site.**

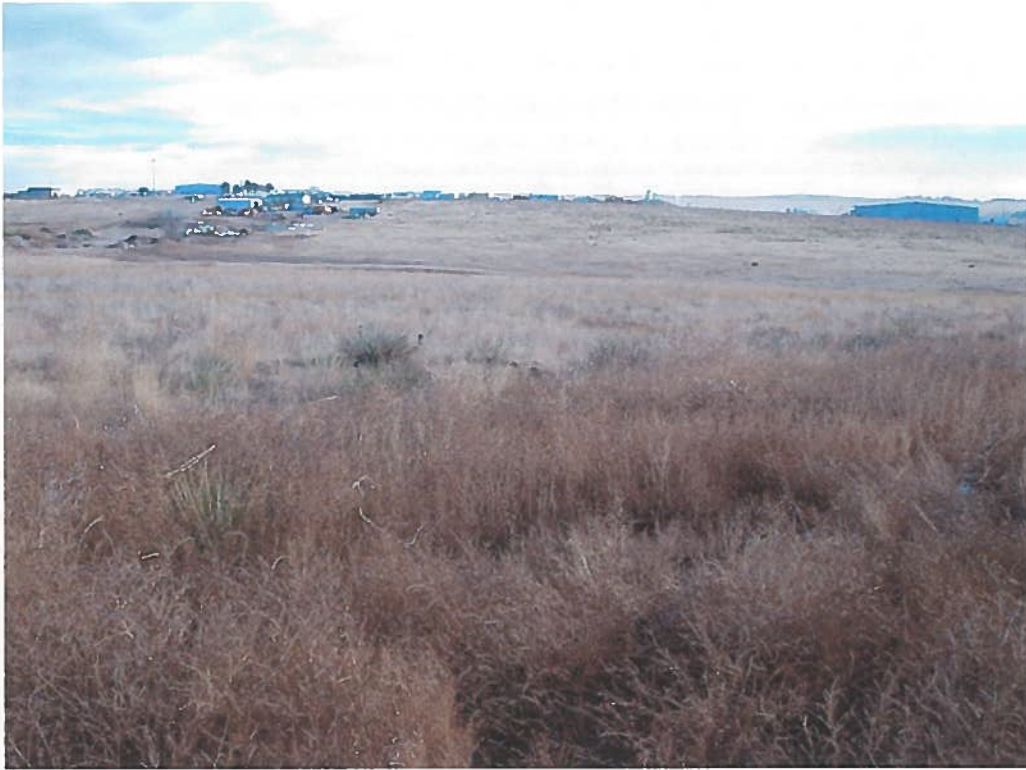
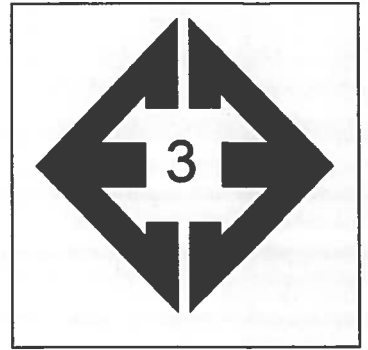
**Looking east
from west-
central portion
of site.**

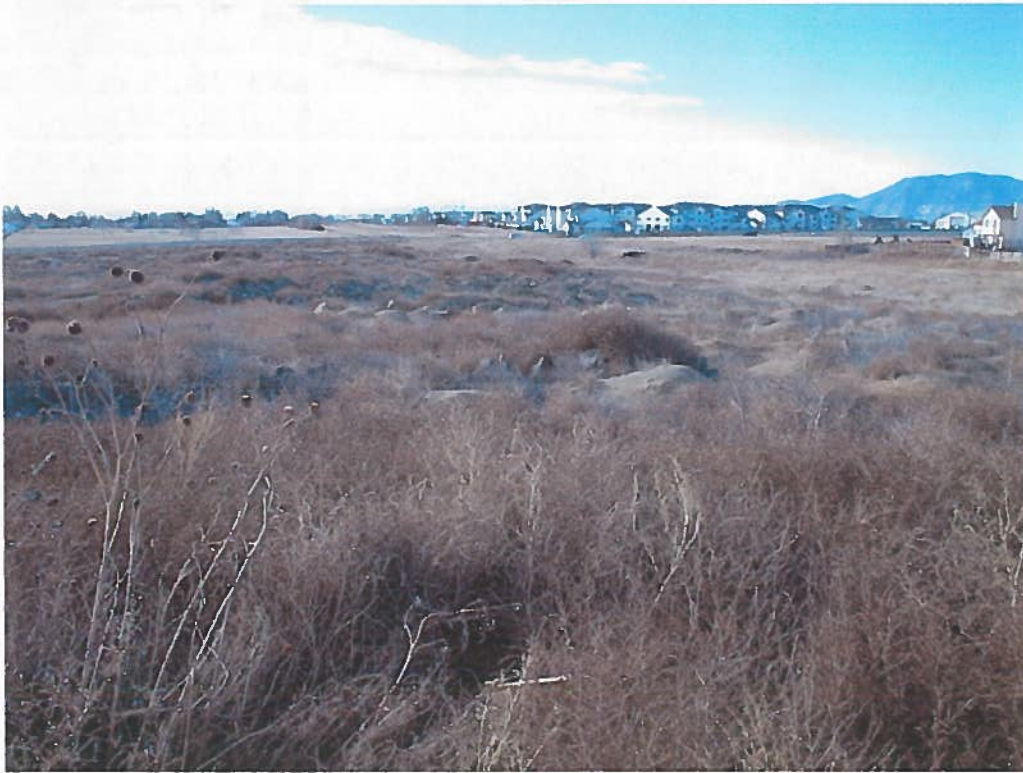
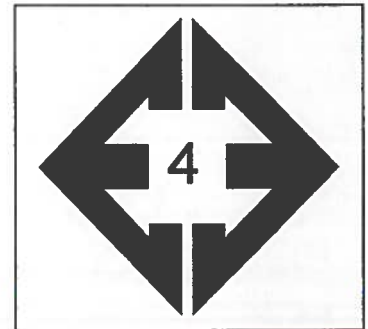
**Looking south
from west-
central portion
of site.**

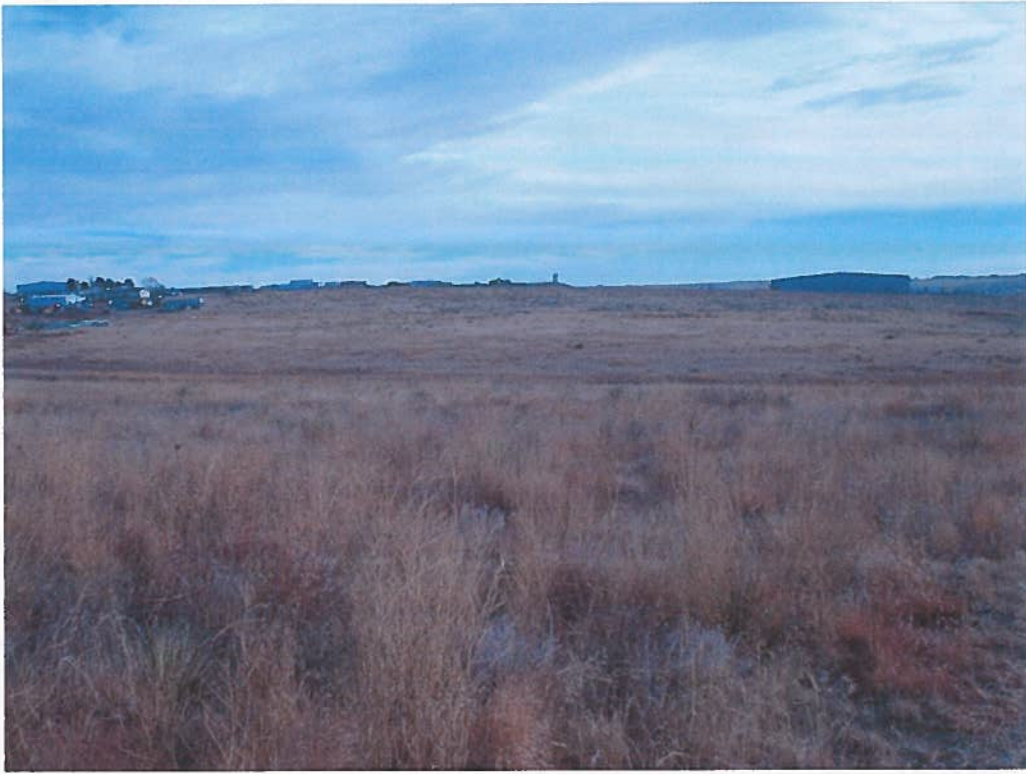
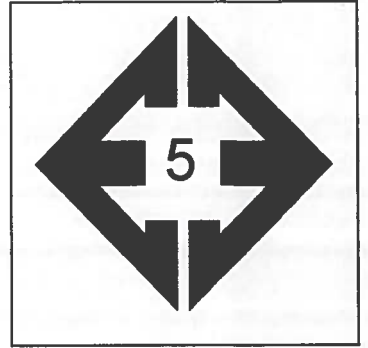
**Looking east
from central
portion of site.**

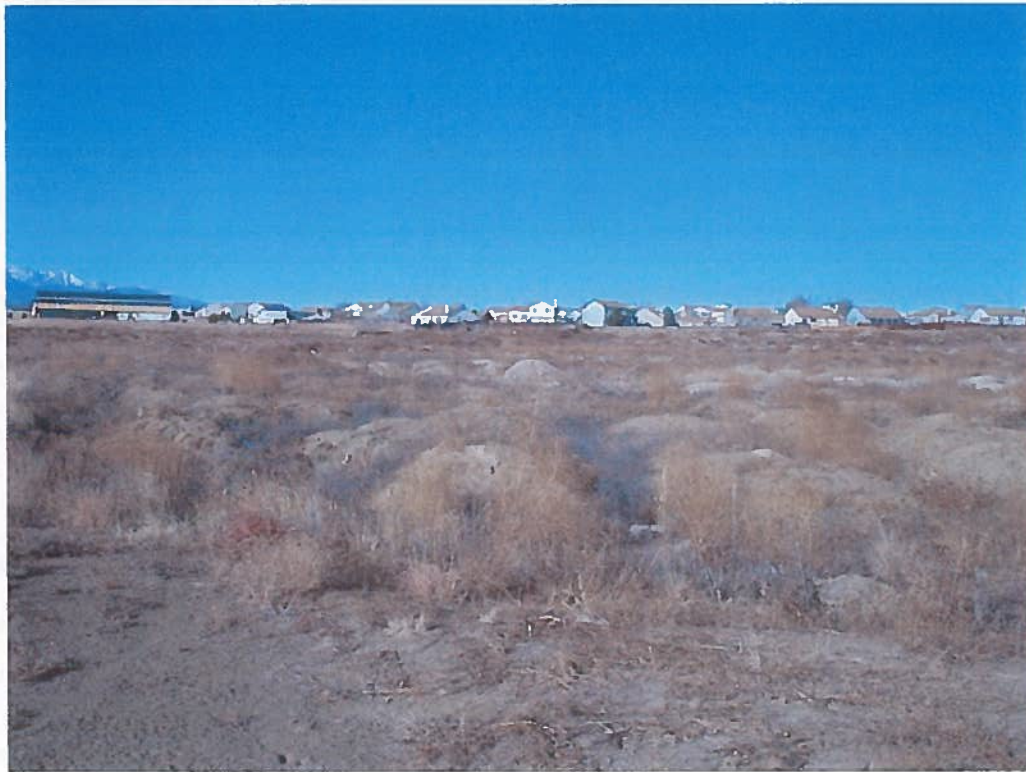
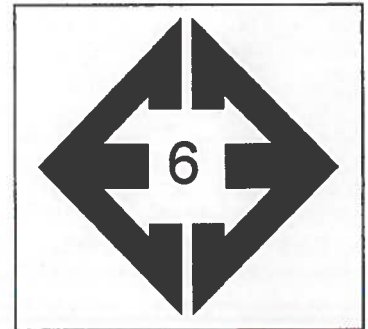
**Looking west
from southern
portion of site.**
