ENTECH
ENGINEERING, INC.

**SOILS AND GEOLOGY STUDY
RETREAT AT PRAIRIERIDGE FILING NO. 4
POCO ROAD AND VOLLMER ROAD
EL PASO COUNTY, COLORADO**

April 25, 2025
Revised July 1, 2025

Entech Job No. 250431
LLL/JCG

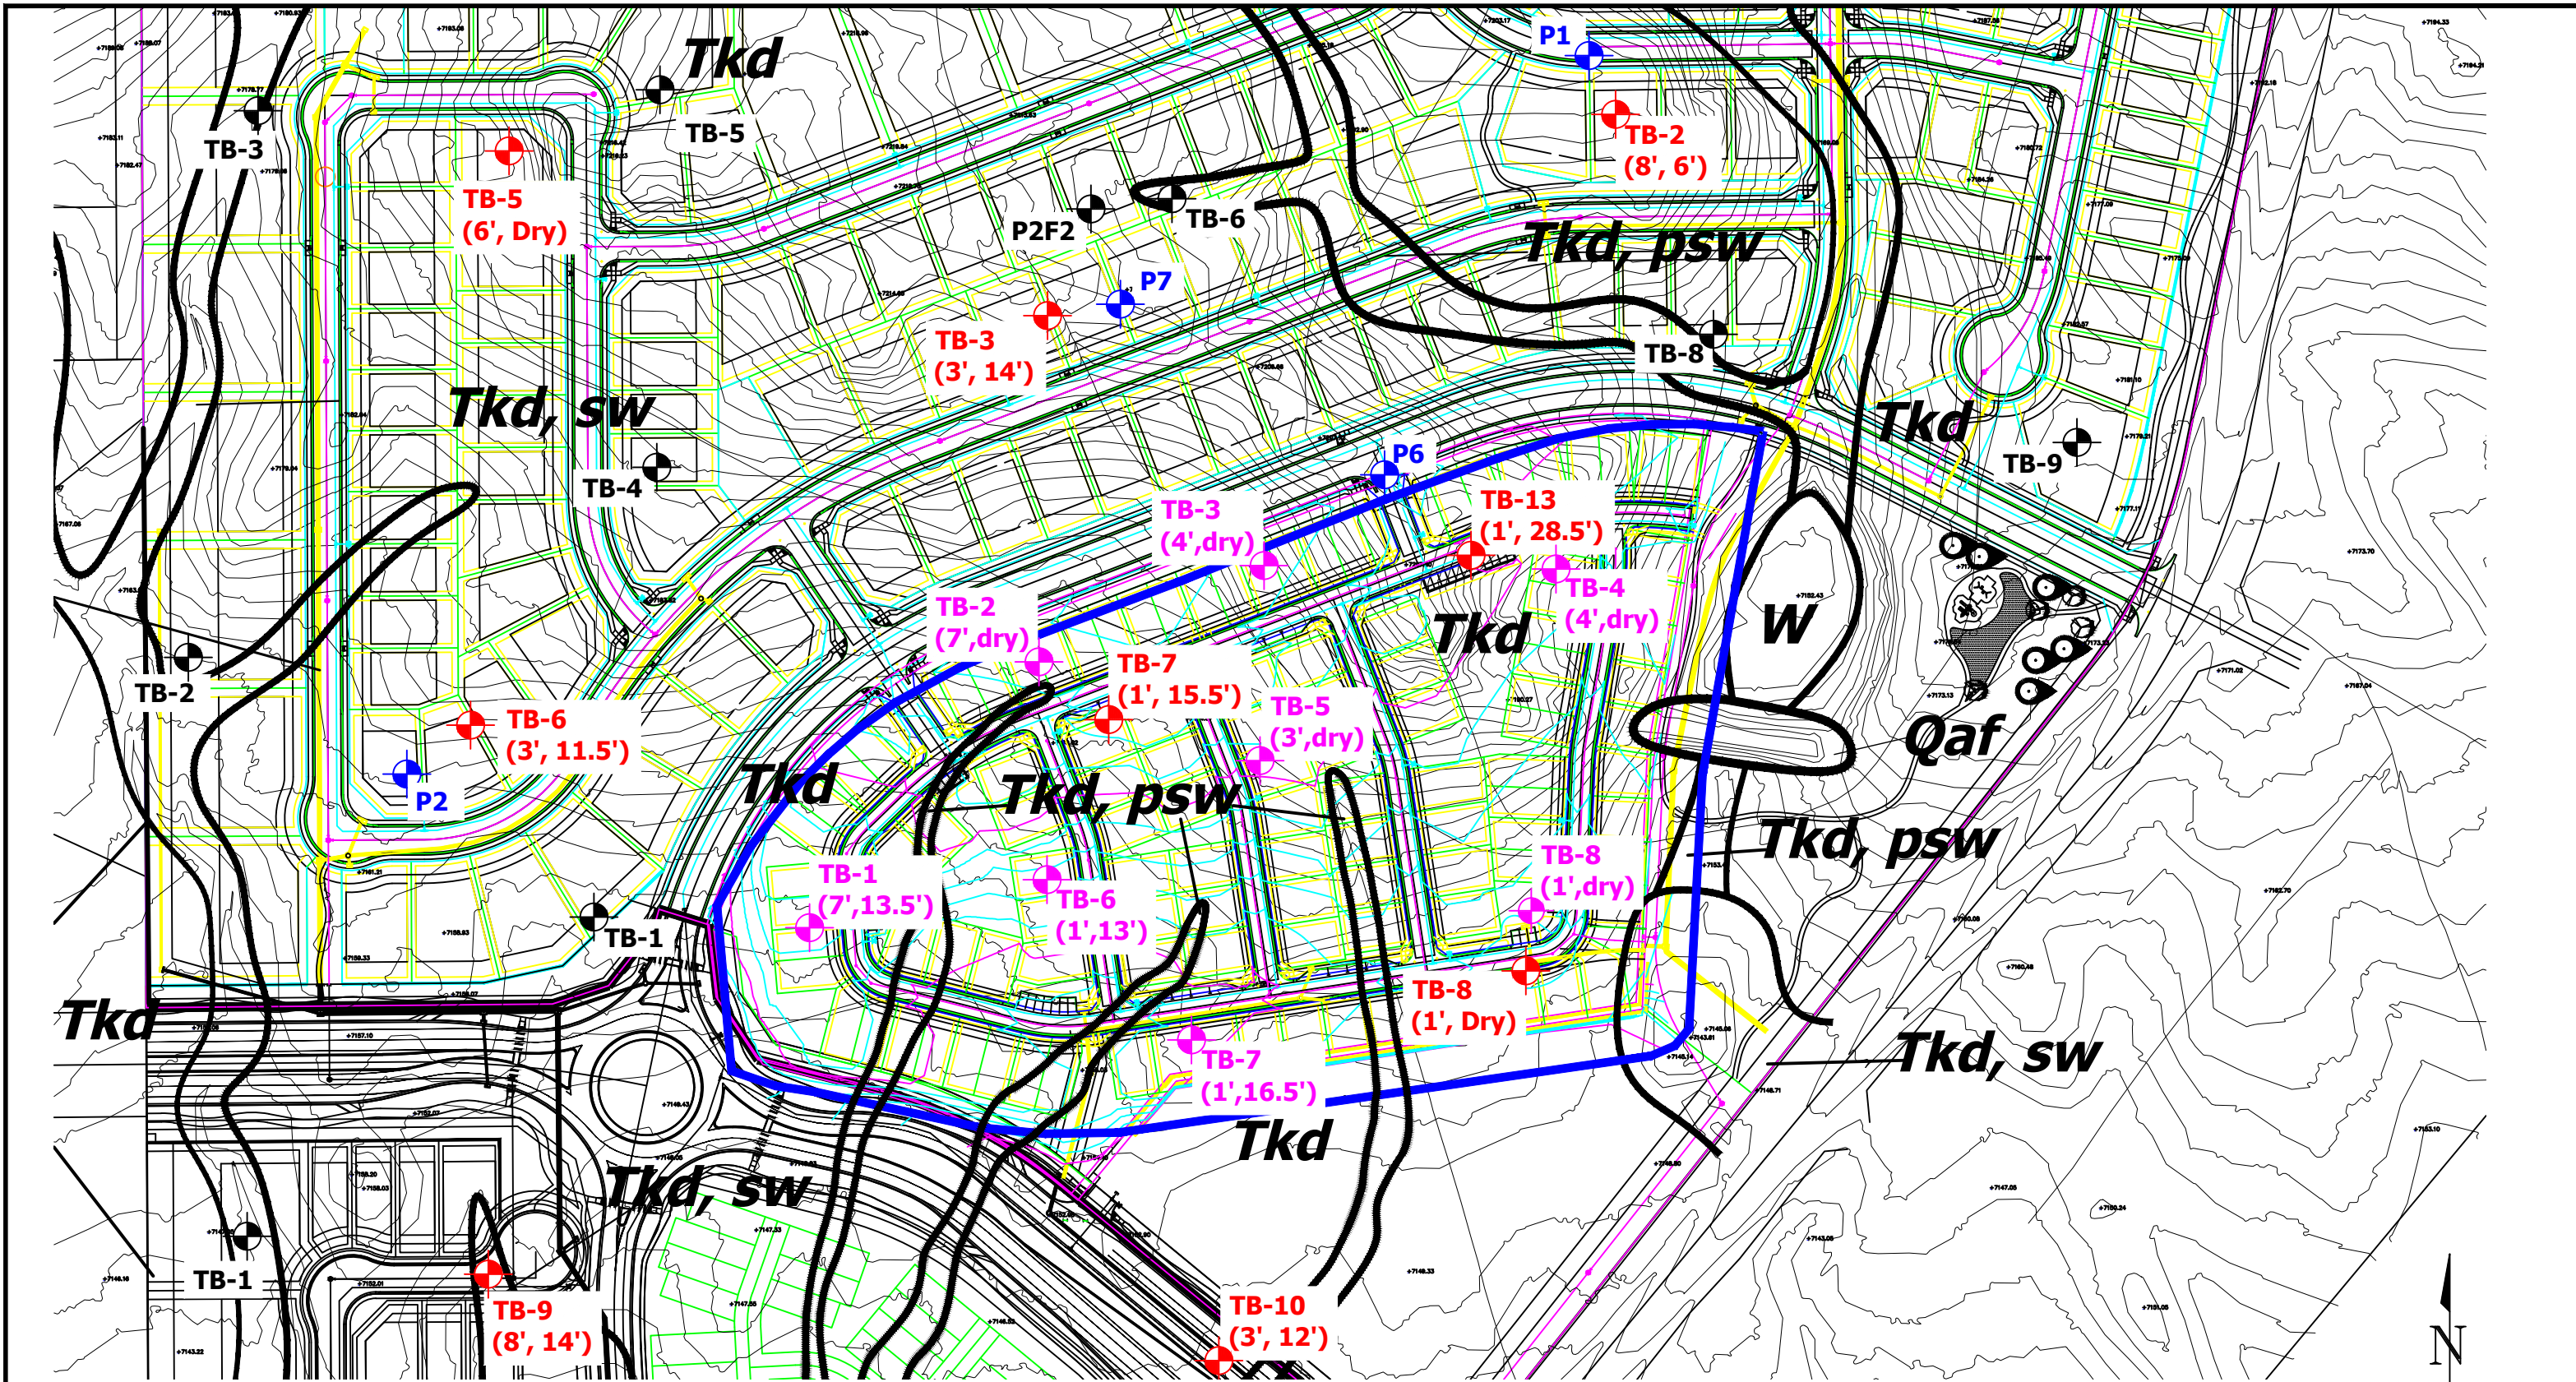
JOB NO.
250431
FIG. 7

Detailed mapping has been performed on this site to produce a Geology/Engineering Geology Map Figure 7. This map shows the location of various geologic conditions of which the developers should be cognizant during the planning, design and construction stages of the project. These hazards and the recommended mitigation techniques are as follows:

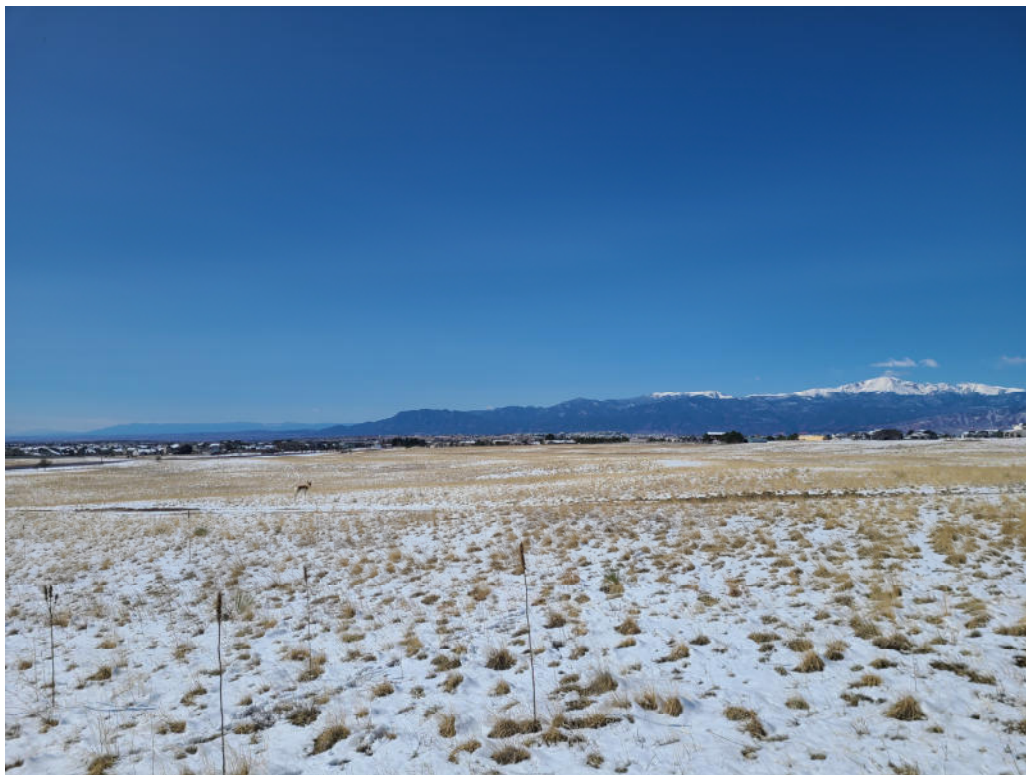
**Looking southwest
from the northeastern
portion of the site.**

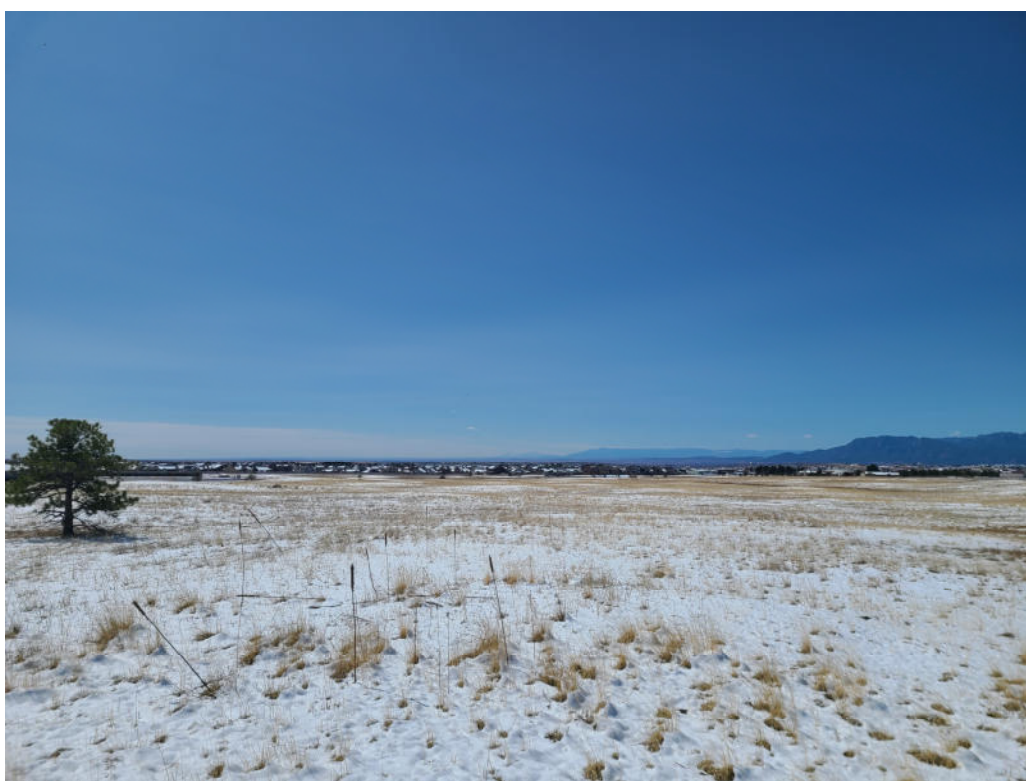
**Looking south from
the northern portion of
the site.**

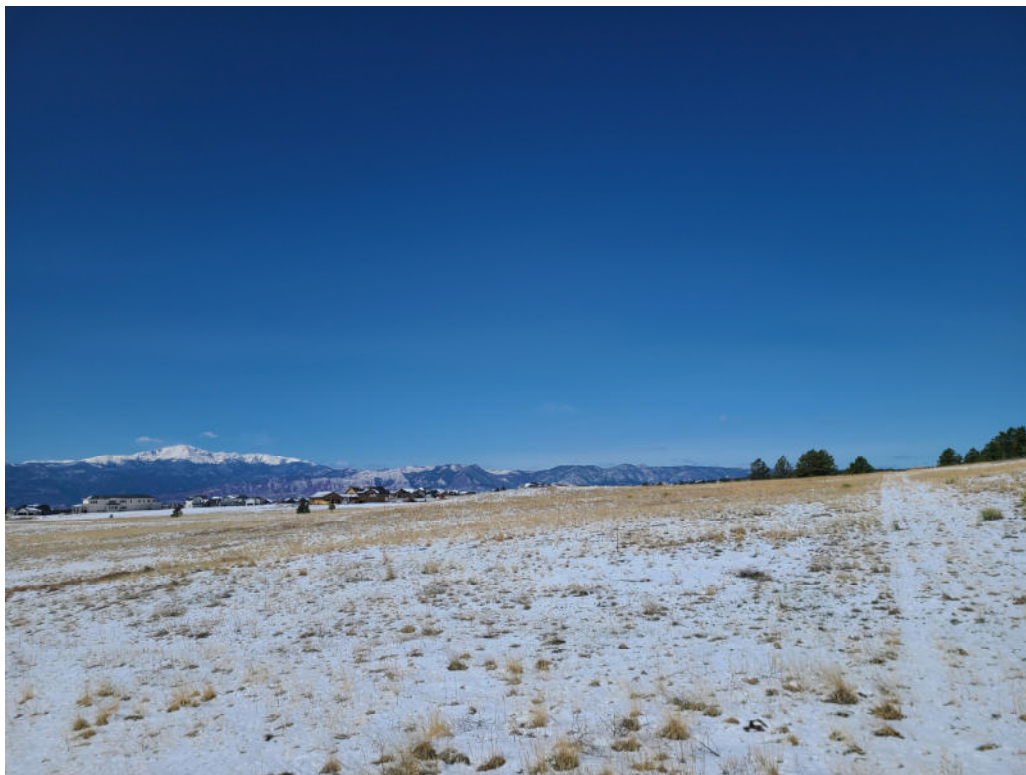
**Looking northwest
from the northern
portion of the site.**

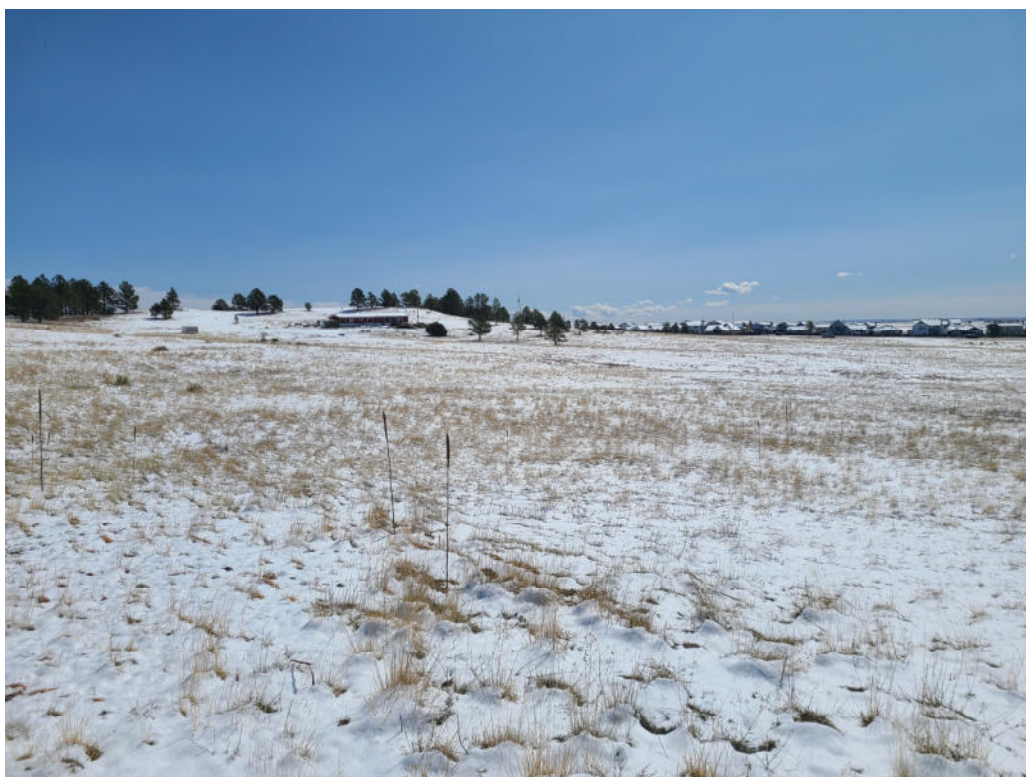
**Looking east from the
western portion of the
site.**

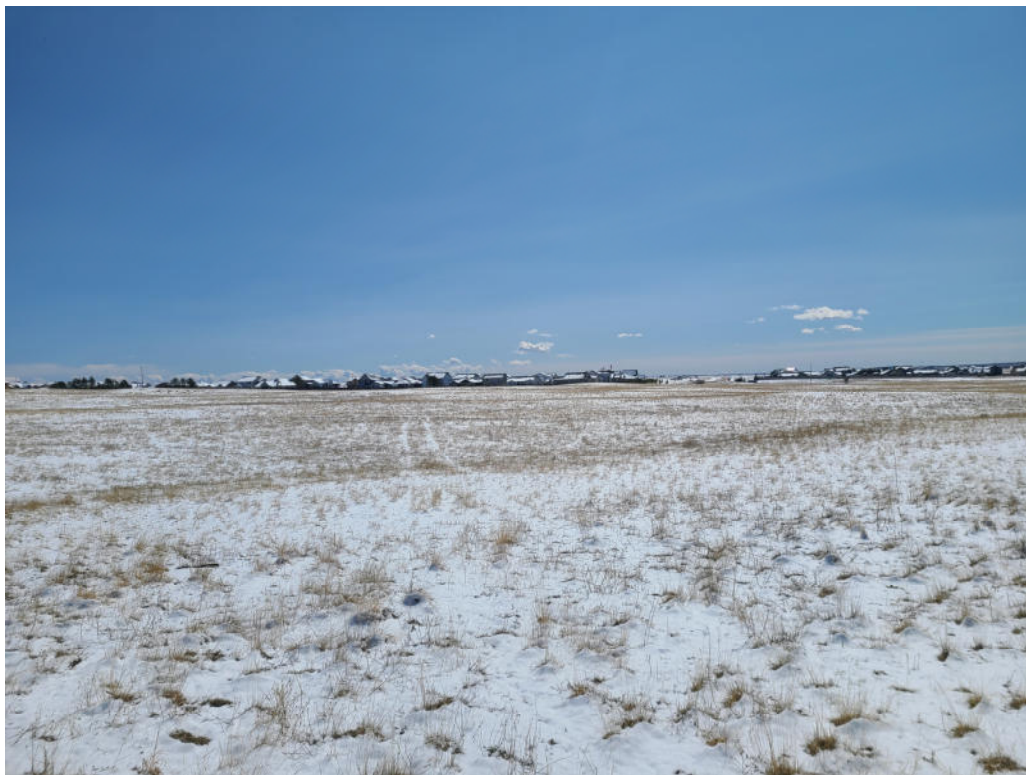
**Looking east from the
southwestern portion
of the site.**

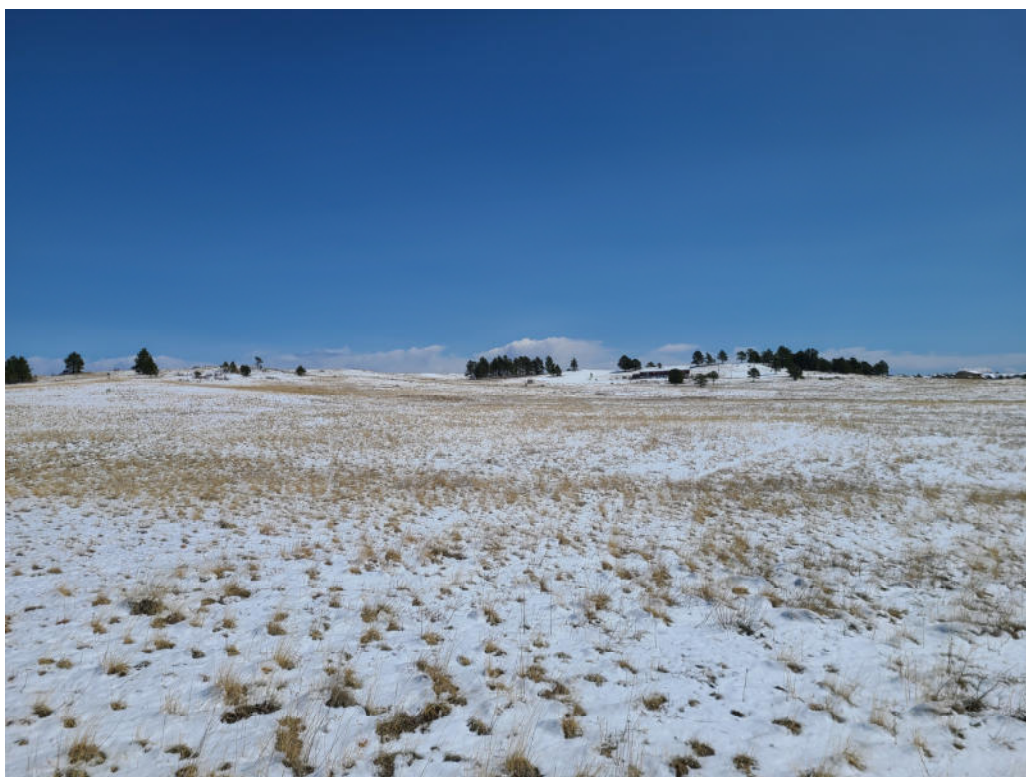
**Looking northeast
from the southwestern
portion of the site.**
