March 5, 2021

La Plata Communities
1755 Telstar Drive, Suite 211
Colorado Springs, Colorado

Subject: Preliminary Geologic Hazards Evaluation
The Ranch, Phase 2
Northeast of Link Road and Squirrel Creek Road
El Paso County, Colorado
Project No. CS19053.001-115 L2

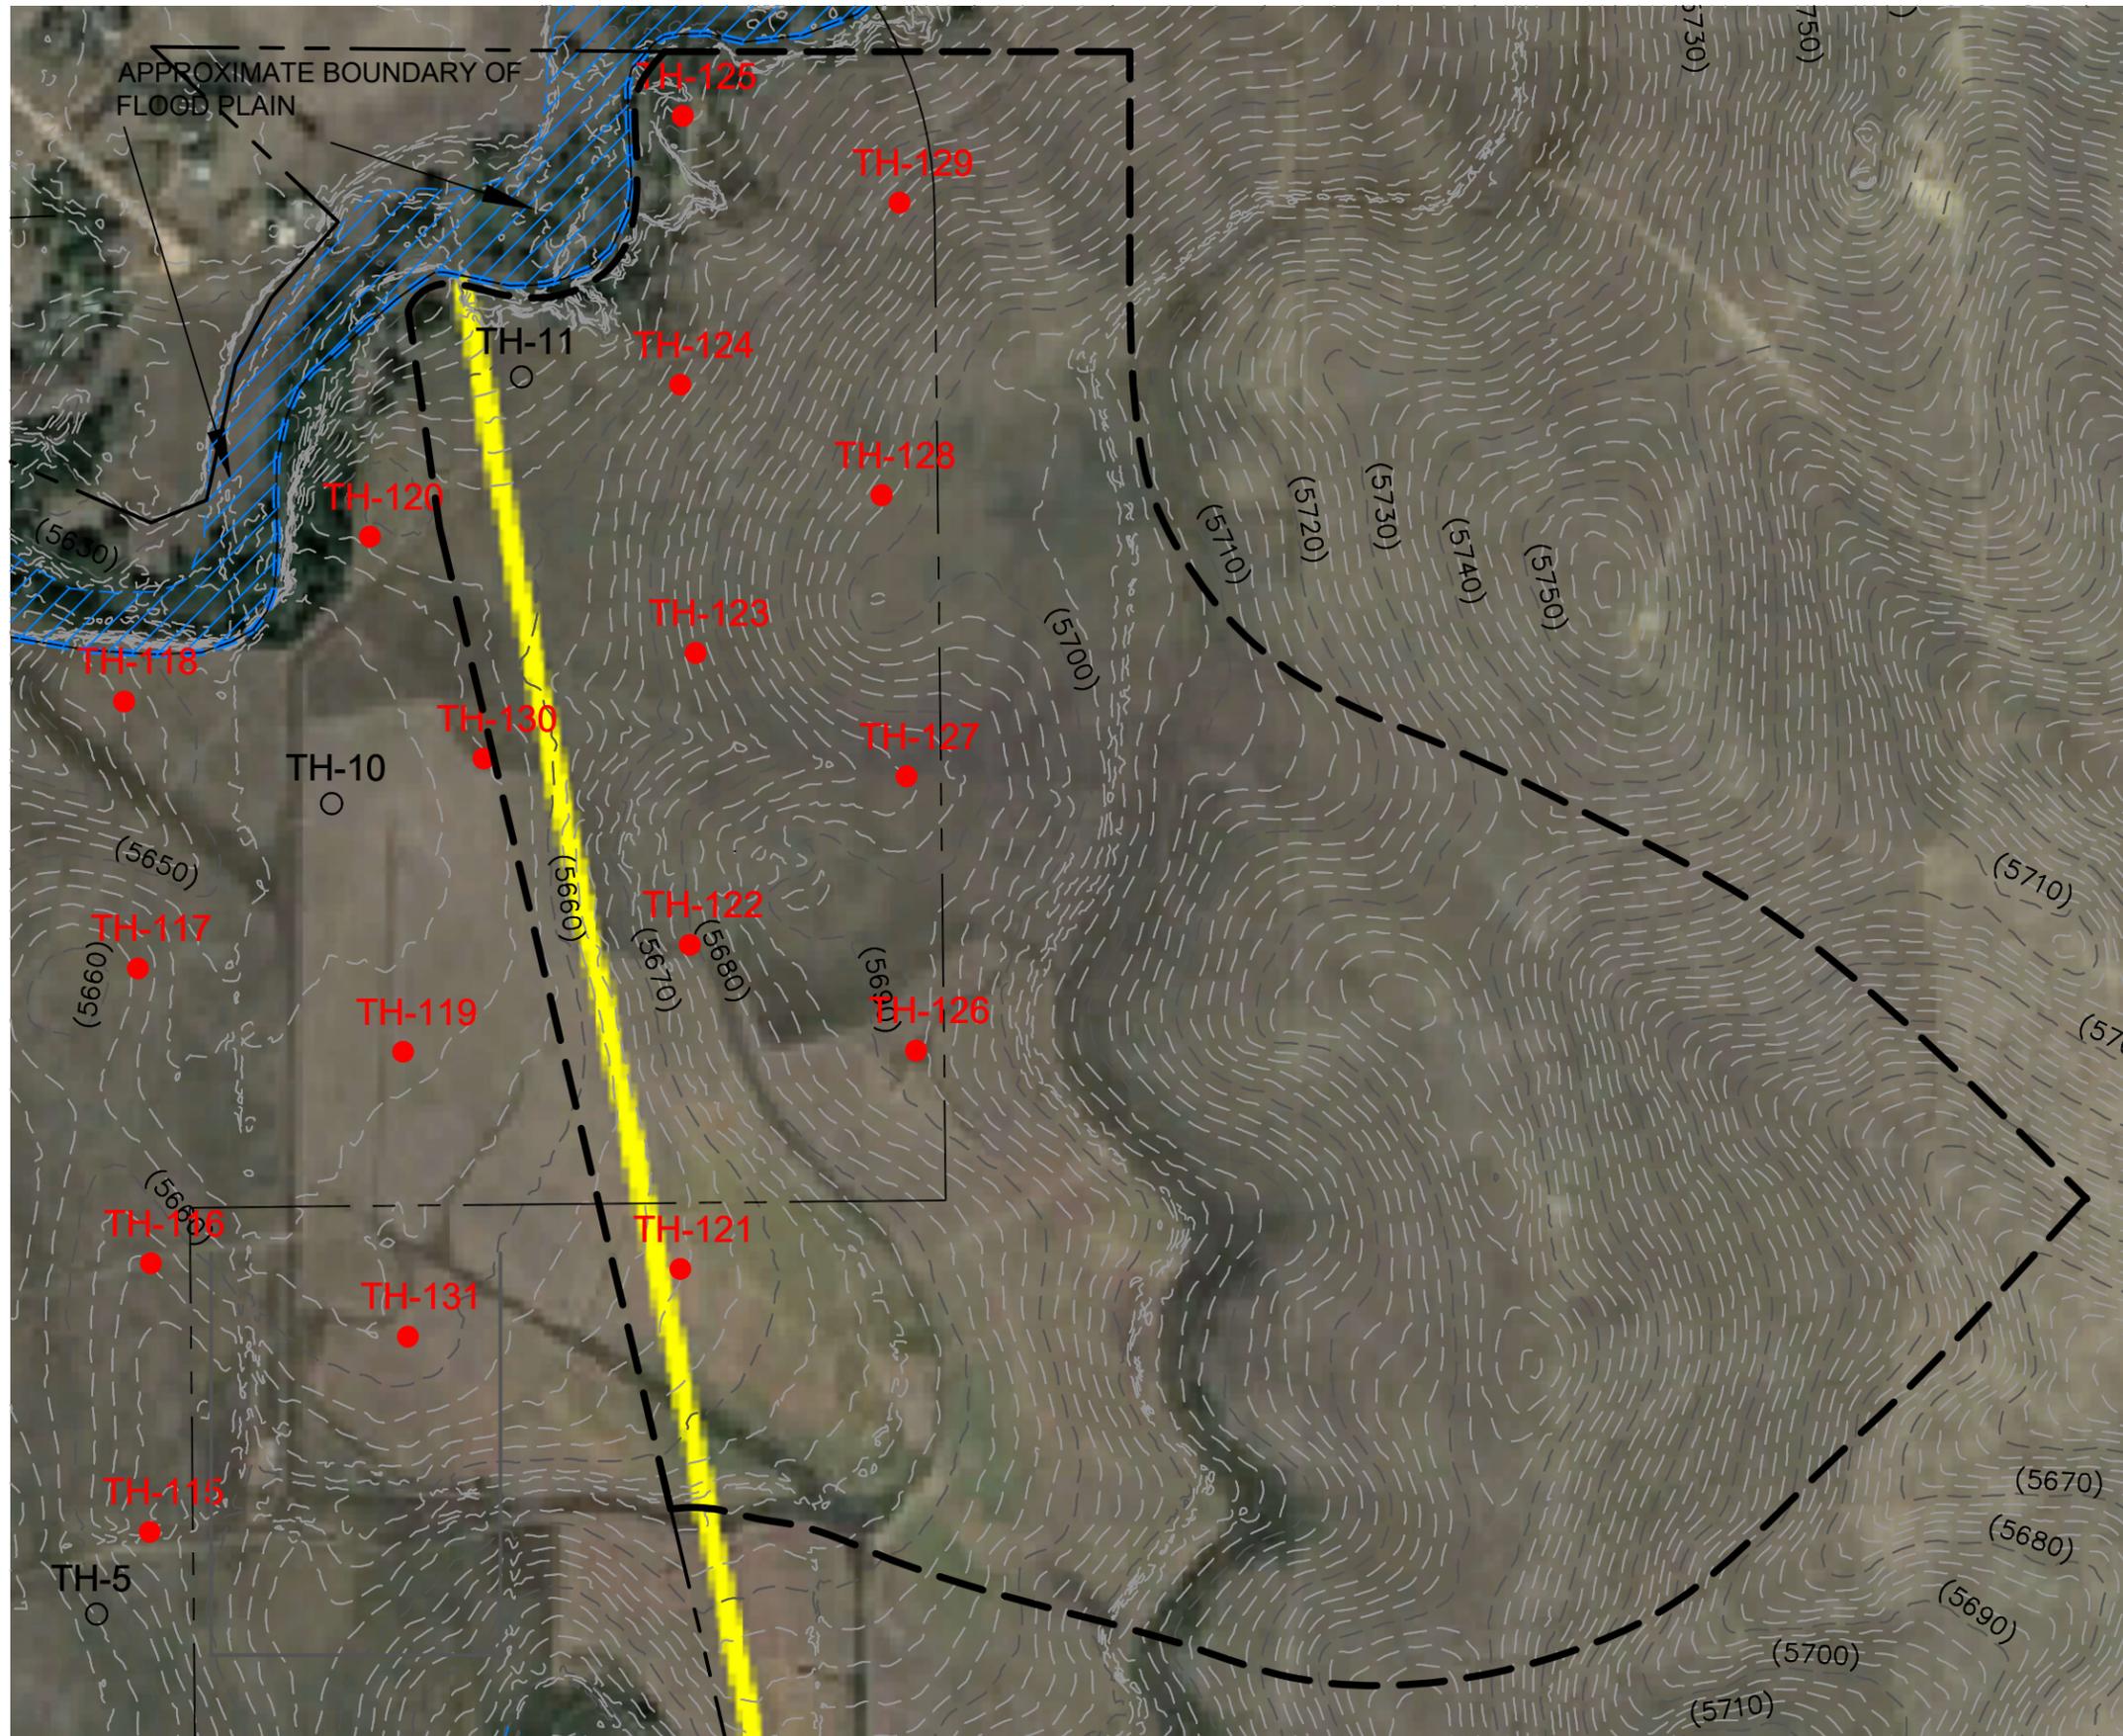
**Location of
Exploratory
Borings**

Subsurface conditions were previously investigated by drilling a total of forty-three (43) widely spaced borings across the overall Ranch site. A total of 10 borings are located in Phase 2 of the Ranch development, generally in the western half of the phase. Locations of the previous borings are presented in Fig. 1. Our interpretation of mapping of geological and engineering conditions by Charles S. Robinson and Associates, Inc are presented on Figs. 2 and 3, respectively. Exploratory boring logs from our previous investigations and laboratory test results can be found in Appendix A.

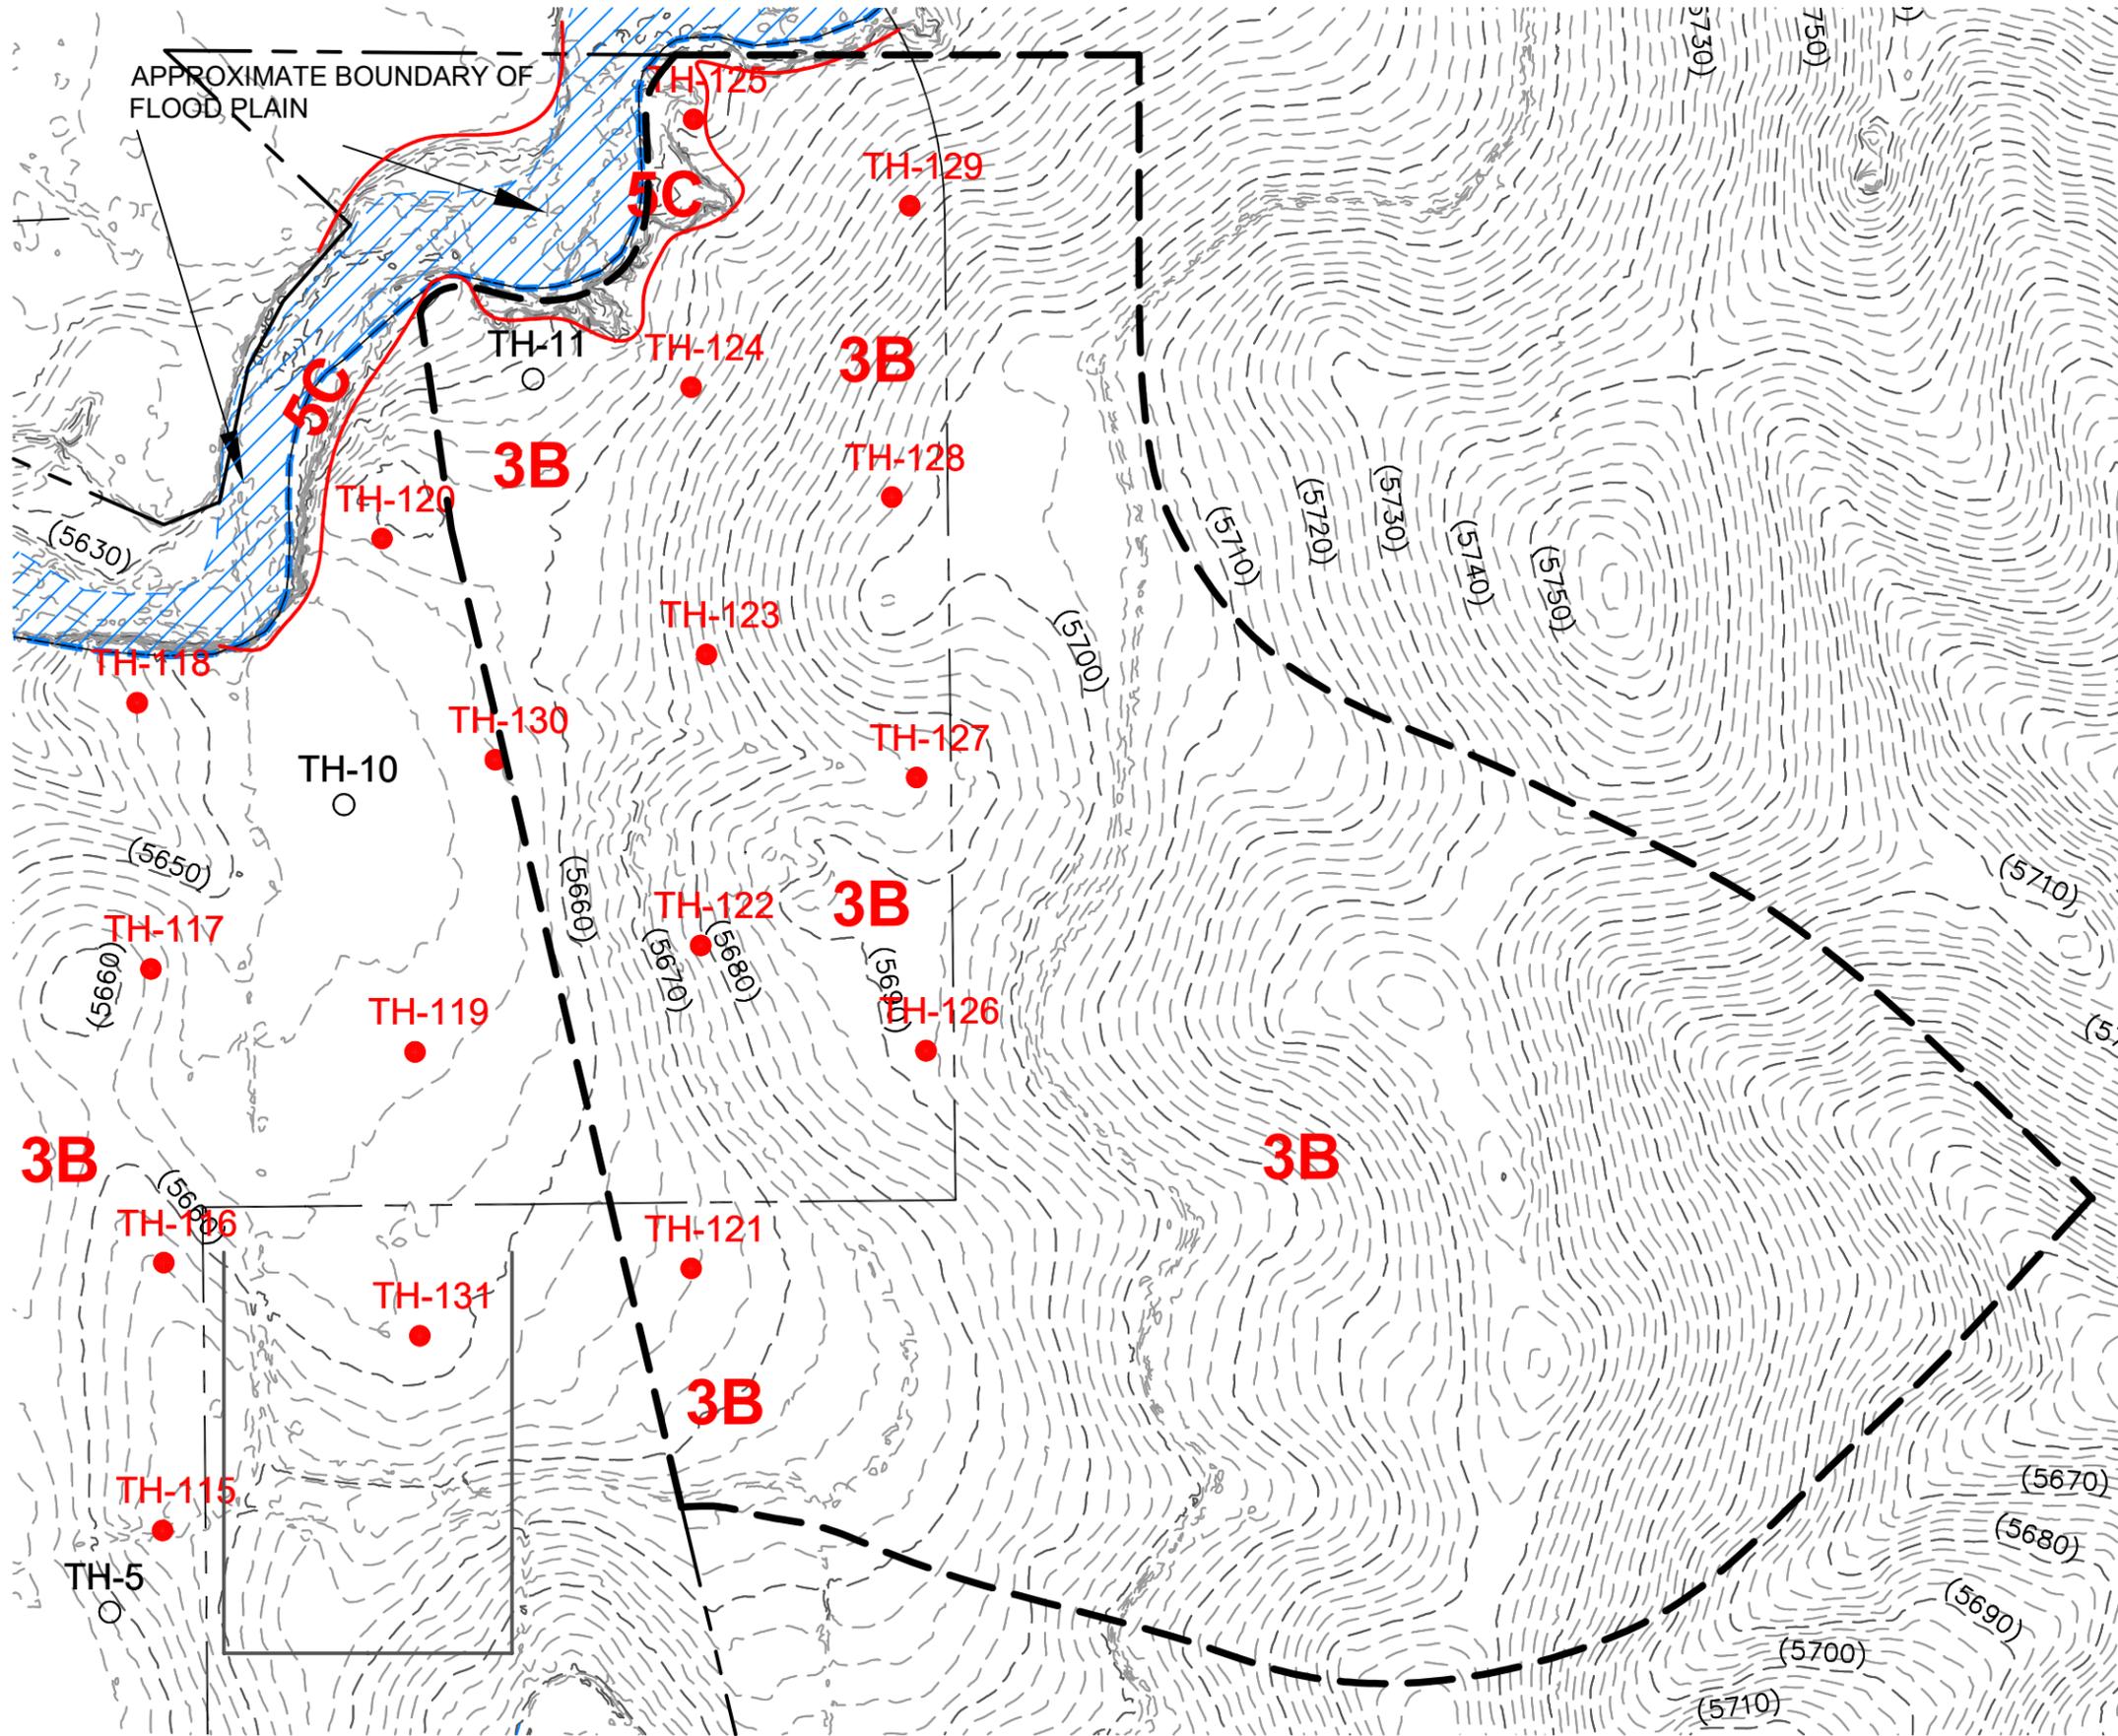
The Engineering Geology classification developed by Charles Robinson (1977) was considered for evaluation of the parcel of Silver Cross Ranch currently named The Ranch and is mapped as described below. Portions with steep, unstable and potentially unstable slopes are shown in Fig. 3, map unit 5C. These areas are typically adjacent to physiographic flood plains that are undergoing active bank

erosion. The civil engineer should determine the flood potential and inundation areas for site design. The other issues are site-wide concerns and are not depicted in Fig. 3.

Map Unit “3B” depicts expansive and potentially expansive alluvium, colluvium and bedrock on flat to moderate slopes (0-12%).

Map Unit “5C” depicts unstable or potentially unstable colluvium or bedrock on steep slopes (12-30%).

Areas with unstable or potentially unstable slopes were observed in and adjacent to Jimmy Camp Creek. Down-cutting erosion has over-steepened slopes. Over-steepened slopes are subject to creep and slump failure. A method to reduce risk is to avoid the slopes. A reasonable rule of thumb is to limit development to areas outside of a 3:1 (horizontal to vertical) line from the base of the steep slope. Grading to flatten slopes is an alternative, along with erosion protection.
