**PRELIMINARY SOIL, GEOLOGY, GEOLOGIC HAZARD,
AND WASTEWATER STUDY,
GRANDVIEW RESERVE
PARCEL NO. 42000-00-396
0 EASTONVILLE ROAD
EL PASO COUNTY, COLORADO**

Entech Job No. 181951

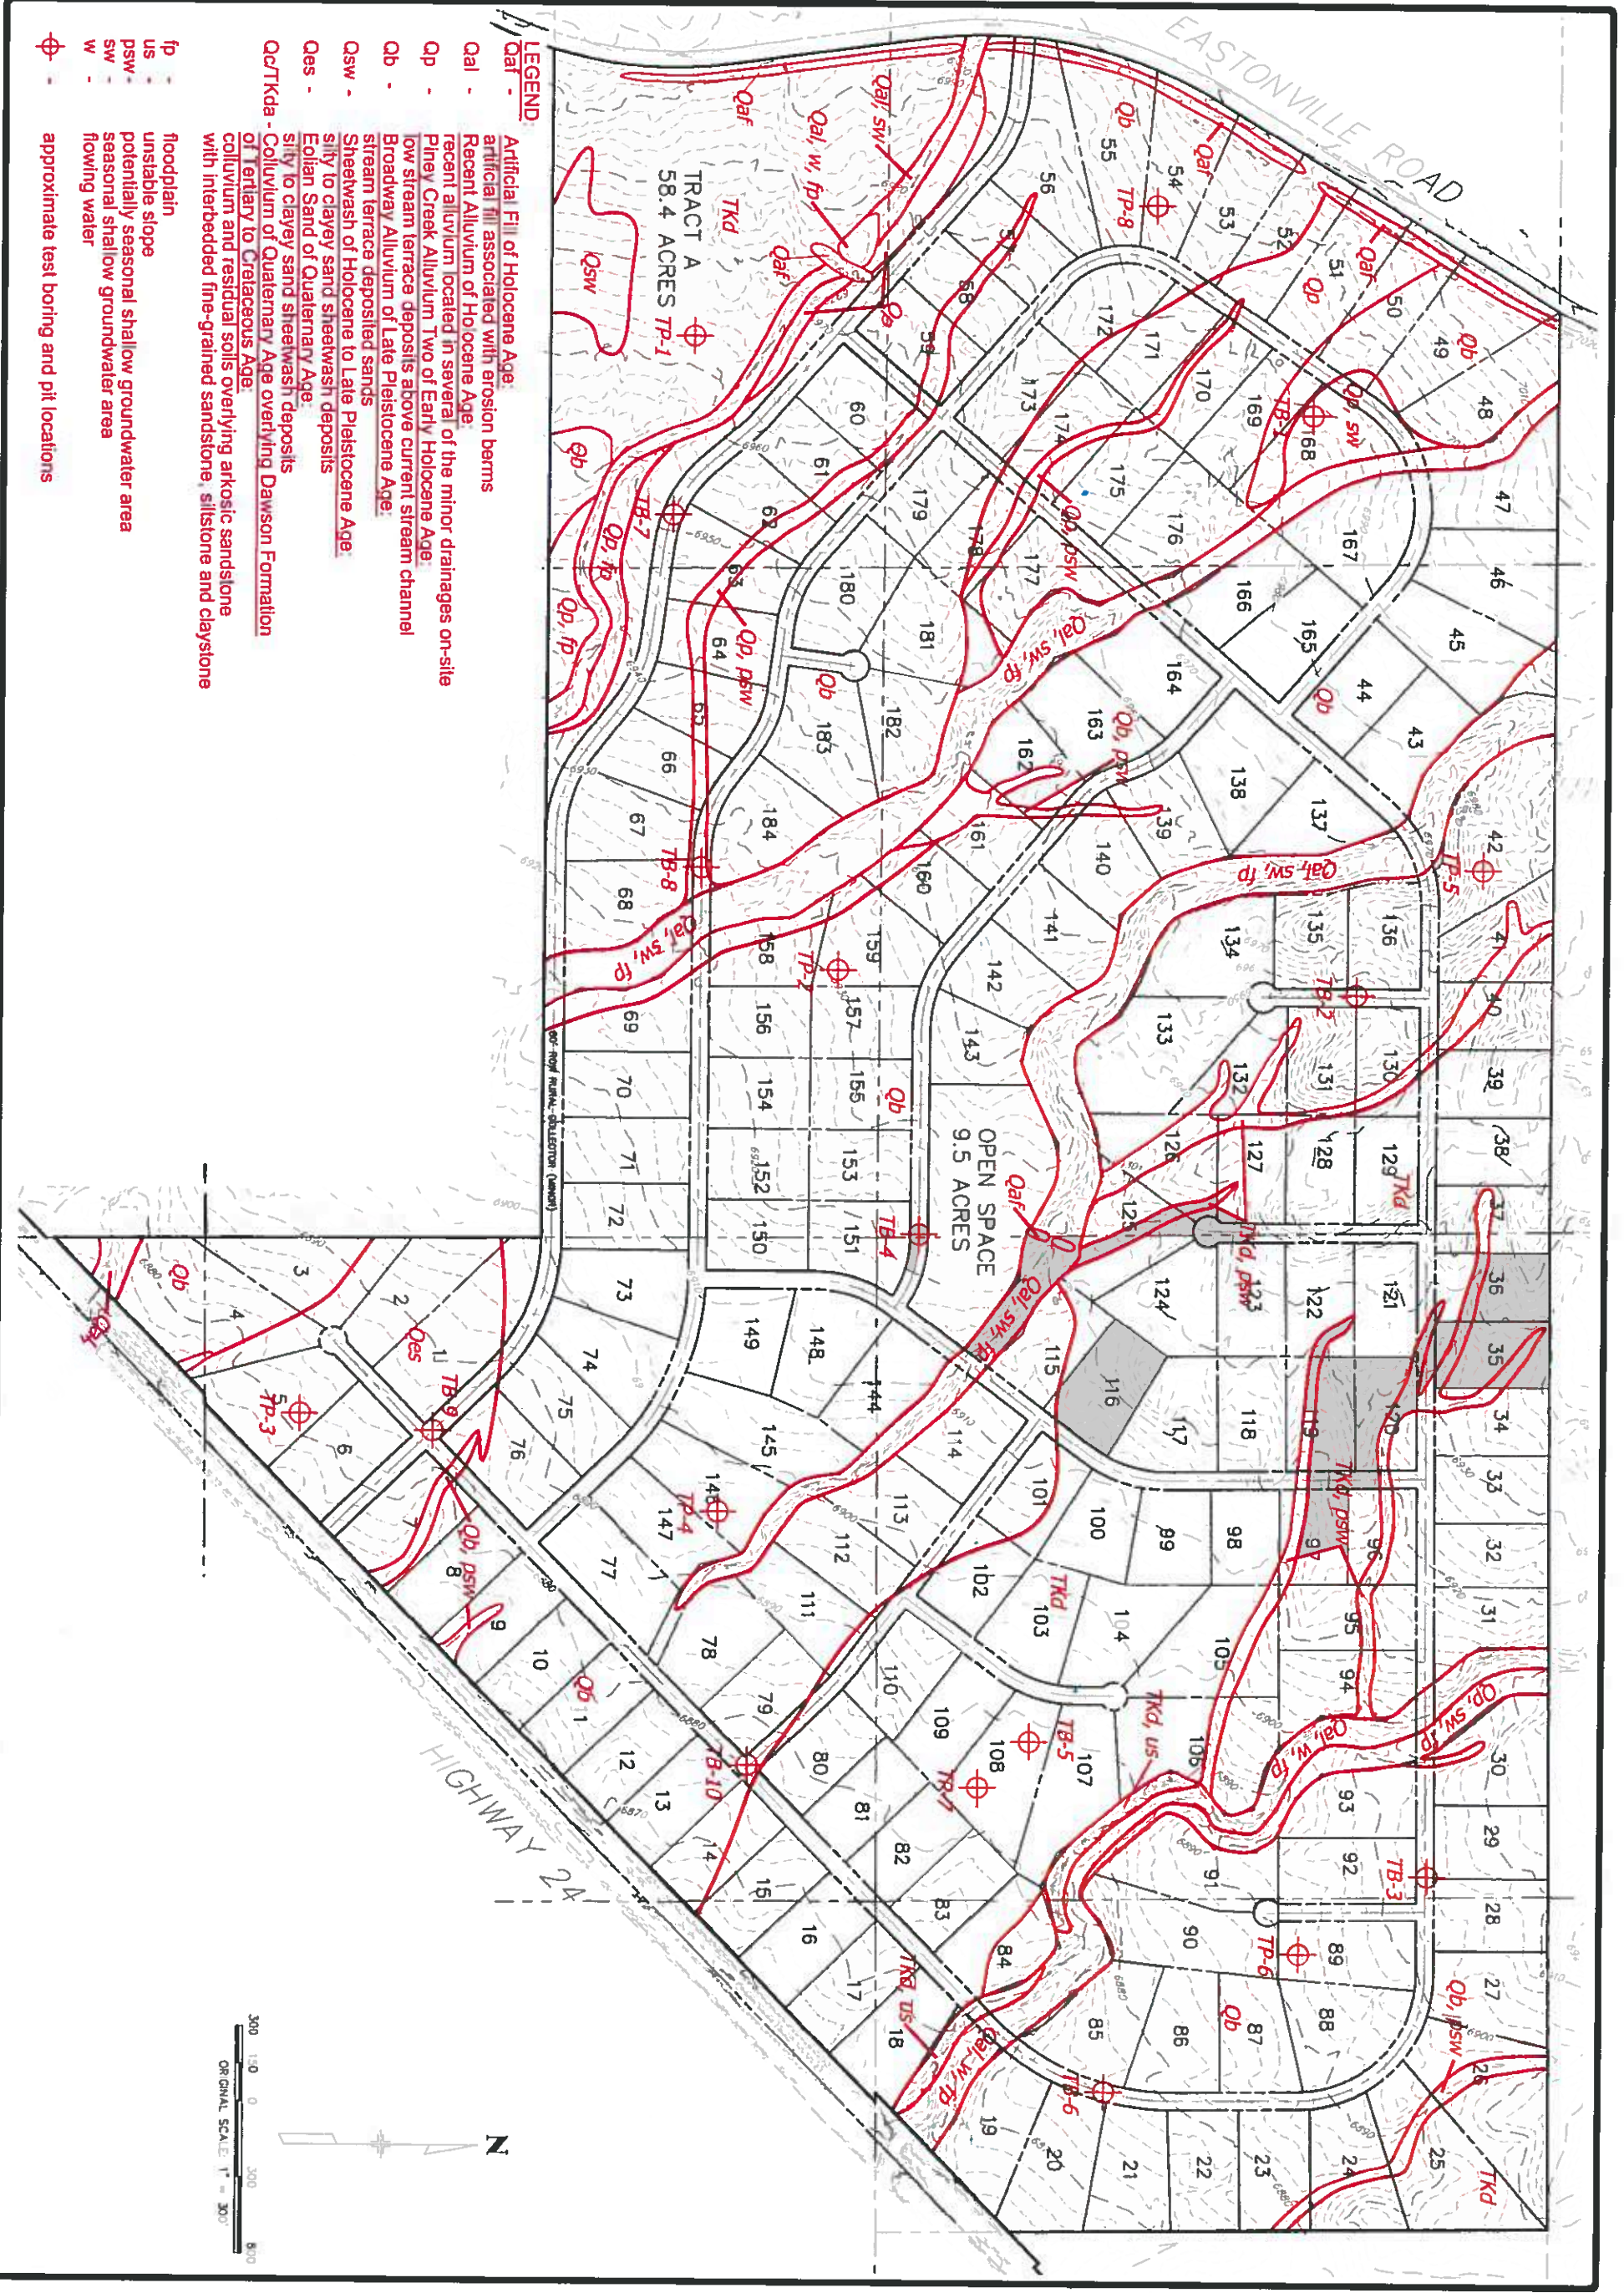
GEOLOGY/ENGINEERING GEOLOGY MAP
 GRANDVIEW RESERVE
 EASTONVILLE ROAD
 EL PASO COUNTY, CO.
 FOR: 4 SITE INVESTMETNS, LLC

The majority of the slopes in the building areas on site are gently to moderately sloping and do not exhibit any past or potential unstable slopes or landslides. However, the steeply sloping areas along the drainage in the eastern portion of the site have been identified as unstable slopes. These areas are identified on the Geology/Engineering Geology Map, Figure 6. The recommendations for these areas are as follows:

The area identified with this hazard is located along a portion of a minor drainage where cut banks have created unstable slopes. Considerable care must be exercised in these areas not to create a condition which would tend to activate instability.

Mitigation: Building should be avoided in these areas. The lots most significantly affected by unstable slopes are Lots 18, 84, 106 and 107. The structures on these lots should be set back a minimum of 30 feet from the crest of these slopes. It appears there is sufficient room on the lots to avoid this hazard. Proper control of drainage at both the surface above the slope and the subsurface is extremely important. Areas of ponded water at the surface should be avoided. Utility trenches, basement excavations and other subsurface features should not

Unstable slopes exist along portions of the drainage in the eastern portion of the site where the drainage has eroded cut banks. A 30-foot building setback is recommended from the crest of the unstable slopes. Septic fields should not be located within the building setback as well. The slopes primarily affect Lots 18, 84, 106 and 107. It appears there is sufficient room on the lots to avoid the unstable slopes. Additional reinforcement may be necessary in the foundation to account for additional pressures due to sloping conditions. Tie-beams and/or buttresses may be necessary, depending on site conditions and grading plans.

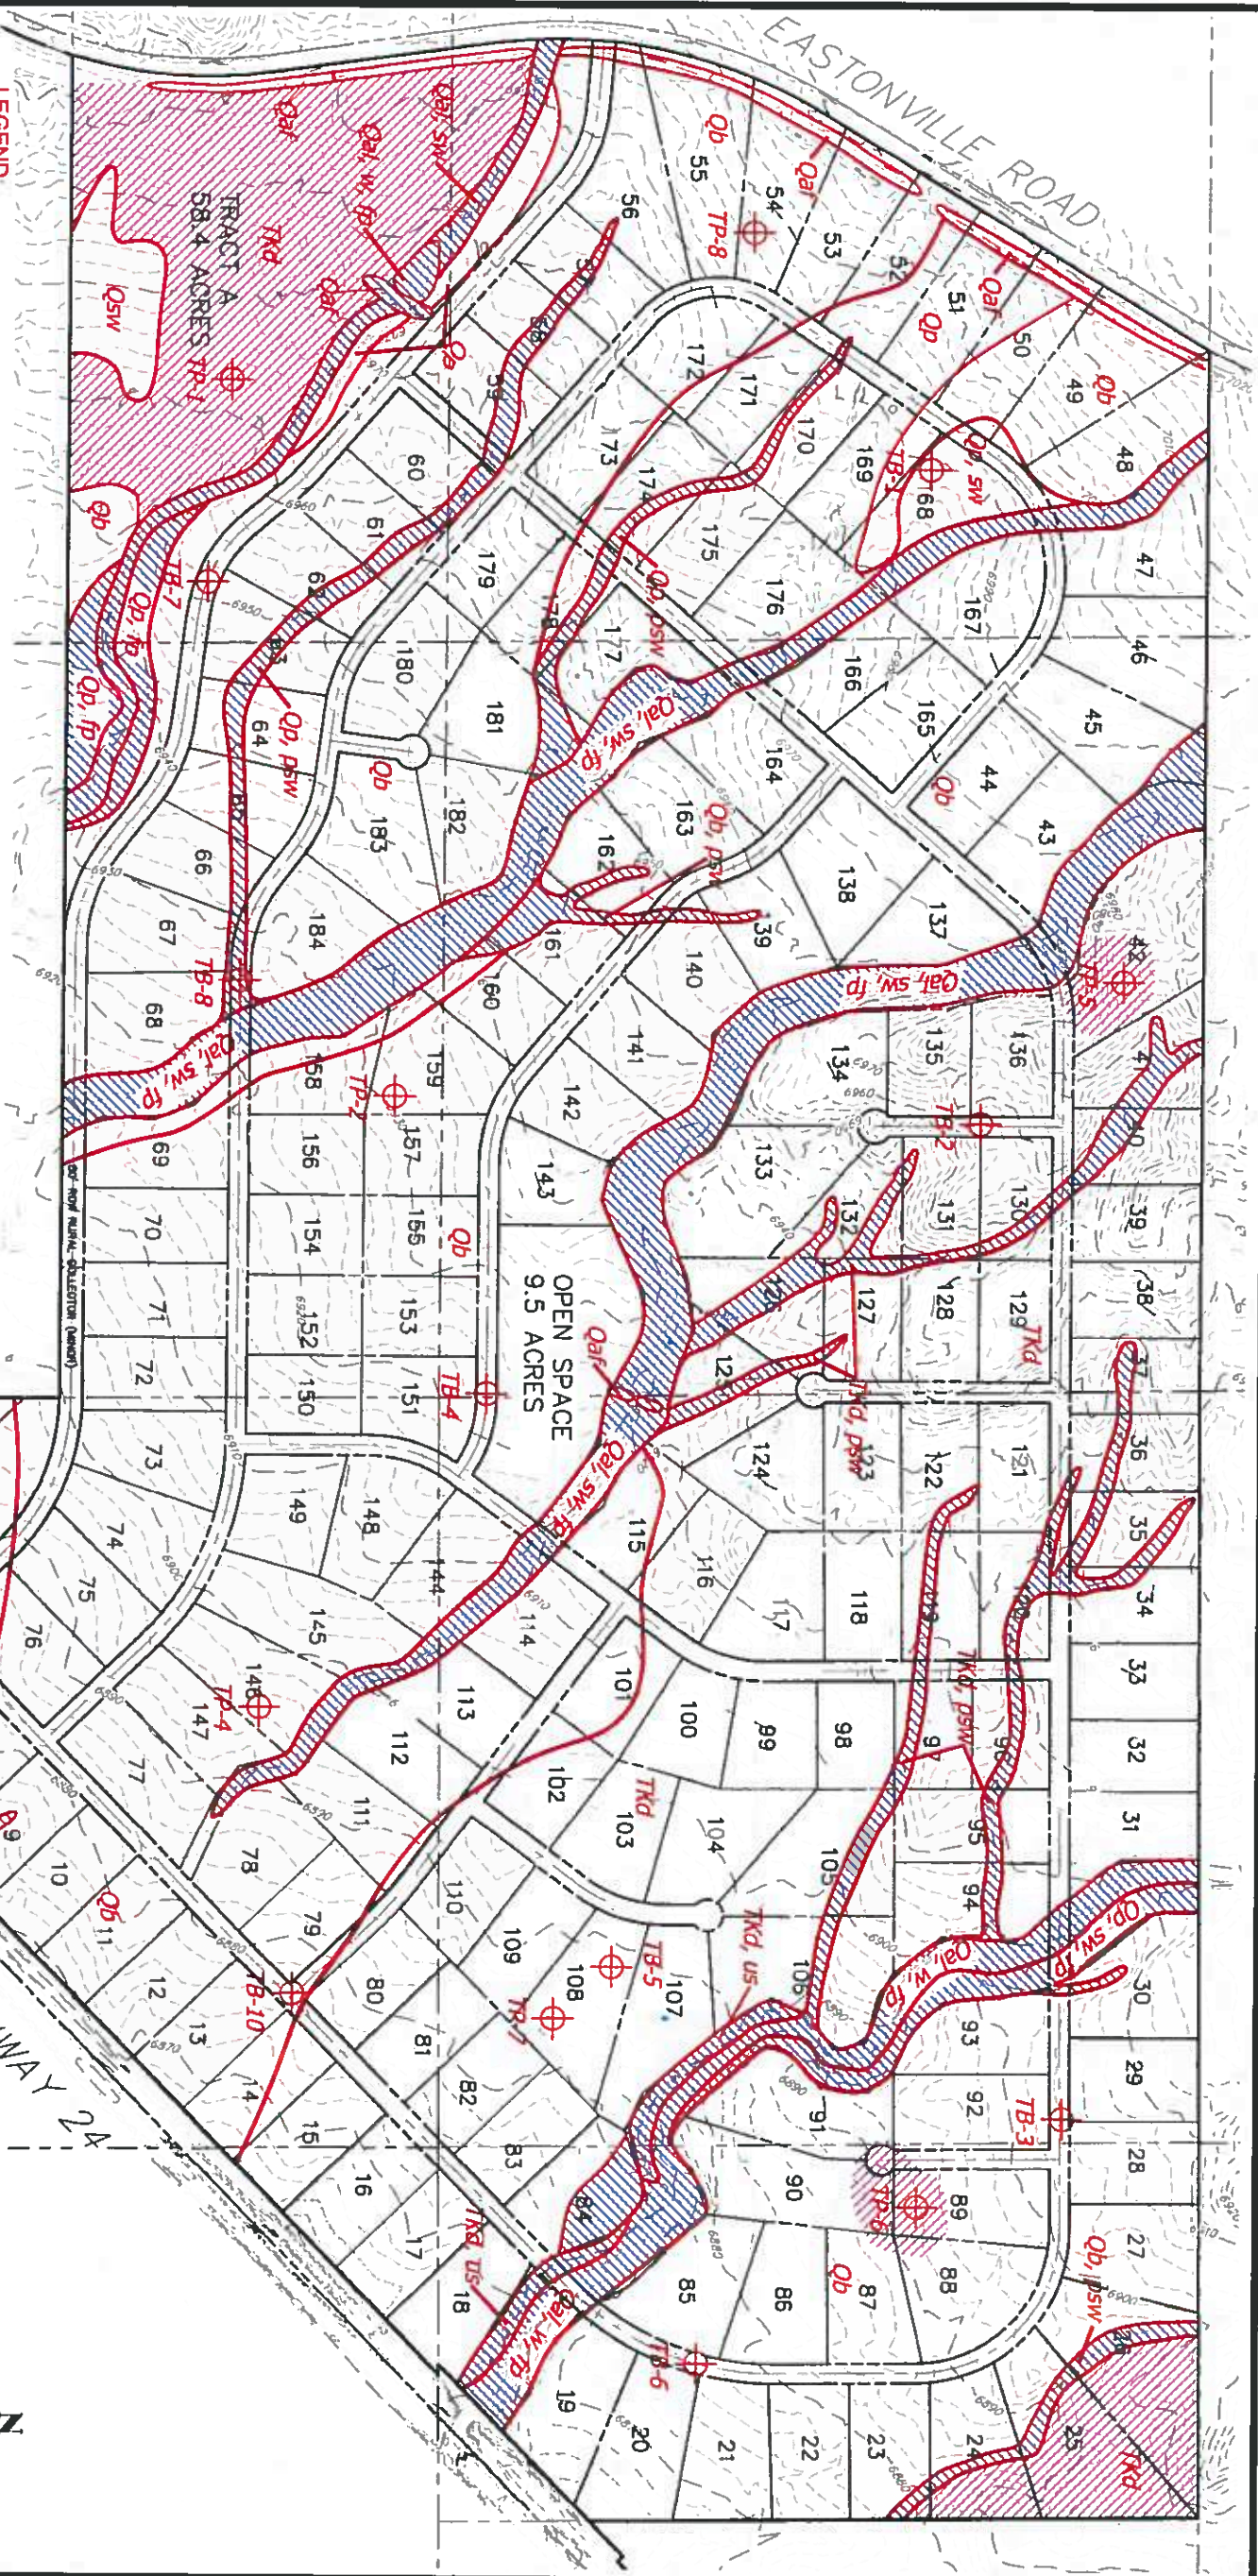
SEPTIC SUITABILITY MAP
GRANDVIEW RESERVE
EASTONVILLE ROAD
EL PASO COUNTY, CO.
FOR: 4 SITE INVESTMETNS, LLC

Soils encountered in the tactile test pits consisted of loamy sand to gravelly loamy sand, gravelly sand, sandy clay loam, very sandy clay, silty to very clayey sandstone and sandy claystone. Bedrock was encountered in three of the test pits at depths ranging from 2 to 4 feet. The limiting layers encountered in the test pits are the sandy loam (Soil Type 2), sandy clay loam (Soil Type 3A), sandy clay, silty to clayey sandstone and sandy claystone (Soil Type 4A) which corresponds to LTAR values of 0.80 to 0.15 gallons per day per square foot. The conditions encountered in the Test Pit Nos. 1 and 5 through 8 will require a designed system. Groundwater was encountered in Test Pit Nos. 2, 3 and 7 at depths ranging from 6.5 to 8.5 feet. Areas where shallow bedrock or groundwater are encountered may require designed systems. Additional investigation may identify areas where suitable for conventional systems could be used.

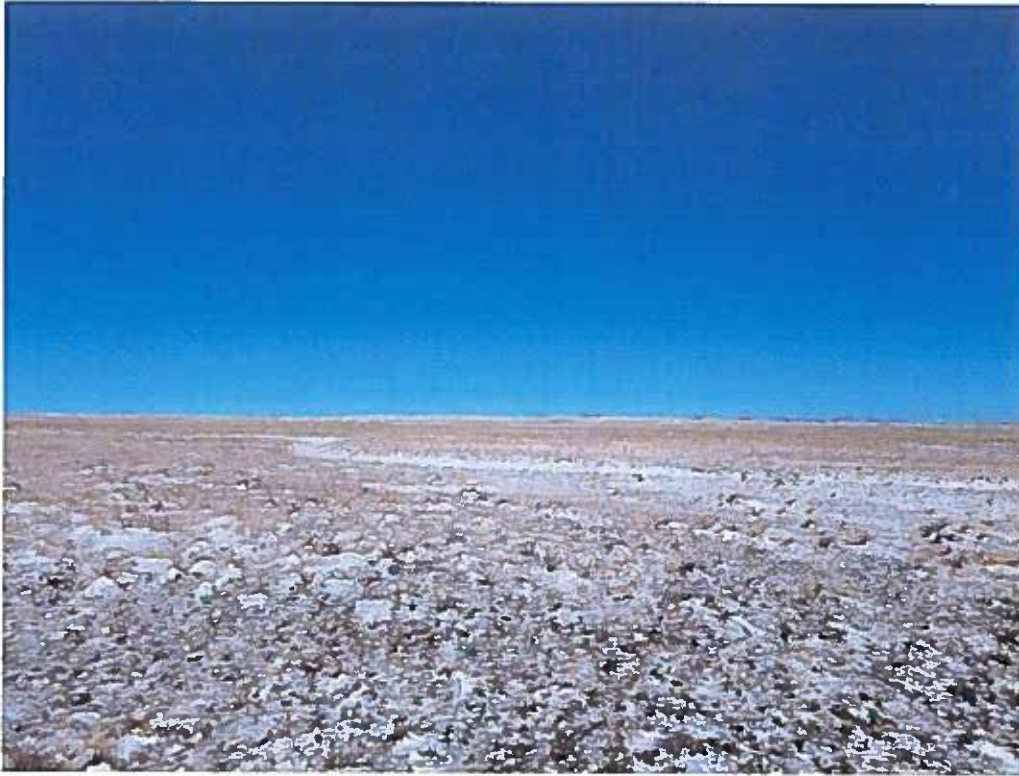
**Looking northwest
along drainage in
eastern portion of the
site.**

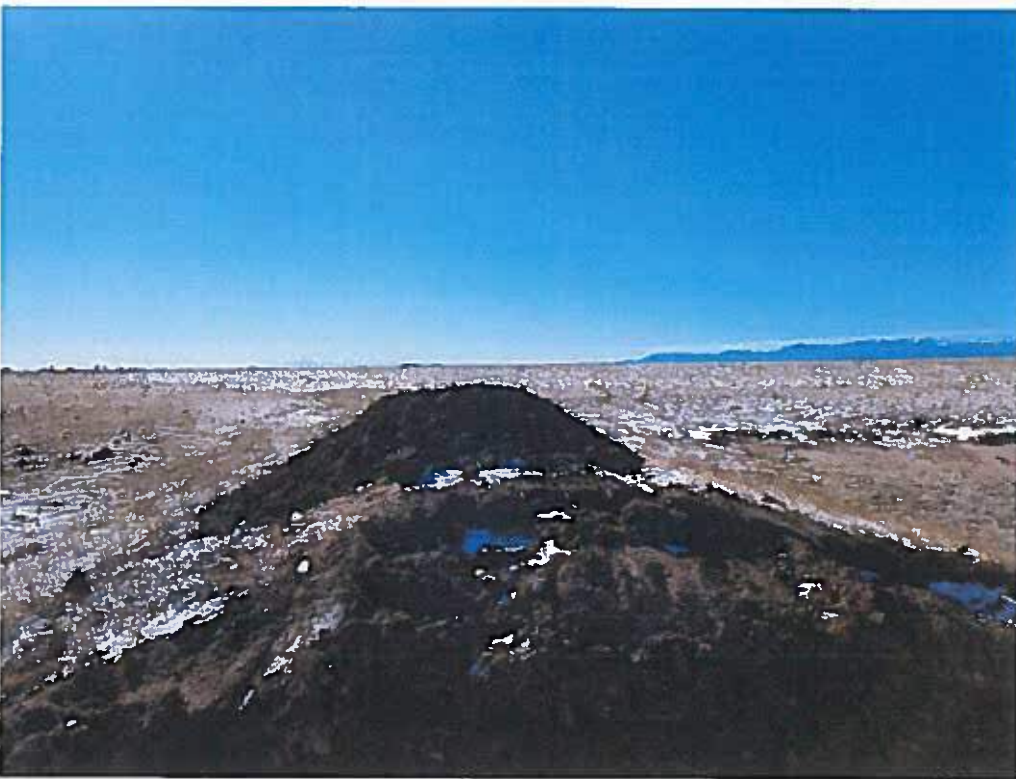
**Looking southwest
along man-made dam
in the central portion
of the site.**

Mitigation: Berms were observed along Eastonville Road that can be avoided or easily removed or penetrated by foundations. The earthen dams lie within areas designated as open space and will be avoided by development. Should any uncontrolled fill be encountered beneath foundations, removal and recompaction at 95 percent of its maximum Modified Proctor Dry Density, ASTM D-1557 will be required.
