**SOILS AND GEOLOGY STUDY
JAYNES PROPERTY – PRELIMINARY PLAN
POCO ROAD AND VOLLMER ROAD
EL PASO COUNTY, COLORADO**

Prepared for:
Elite Properties of America, LLC
2138 Flying Horse Club Drive
Colorado Springs, CO 80921

November 21, 2023

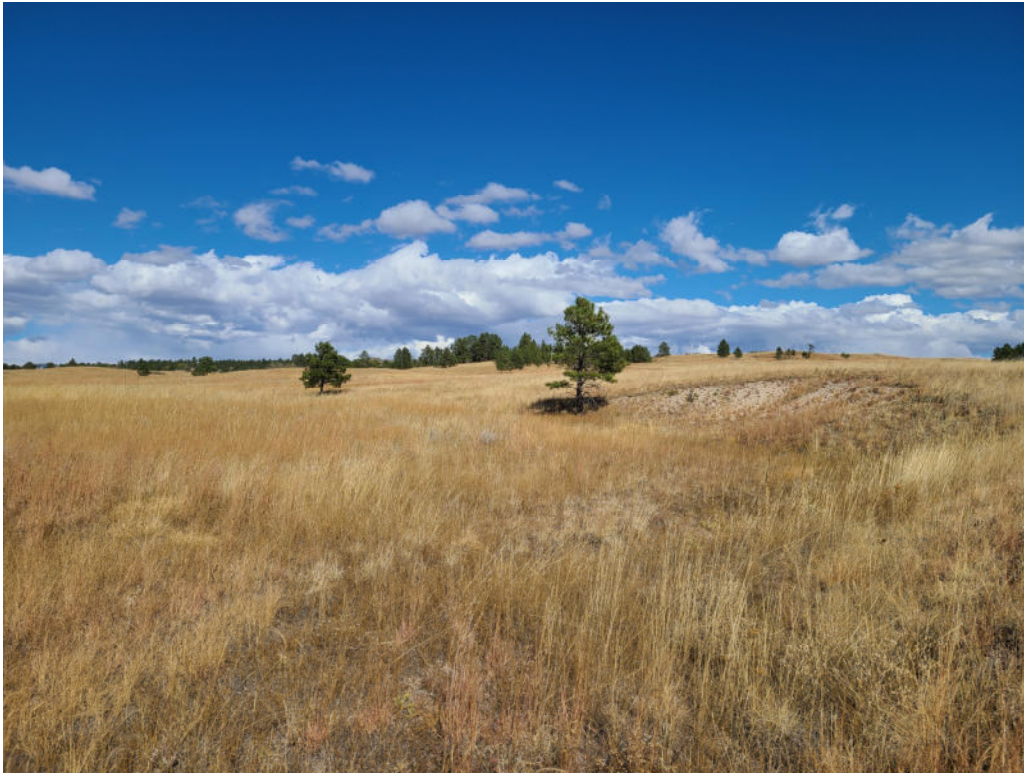
**Looking north along
drainage in the
southwestern portion
of the site.**

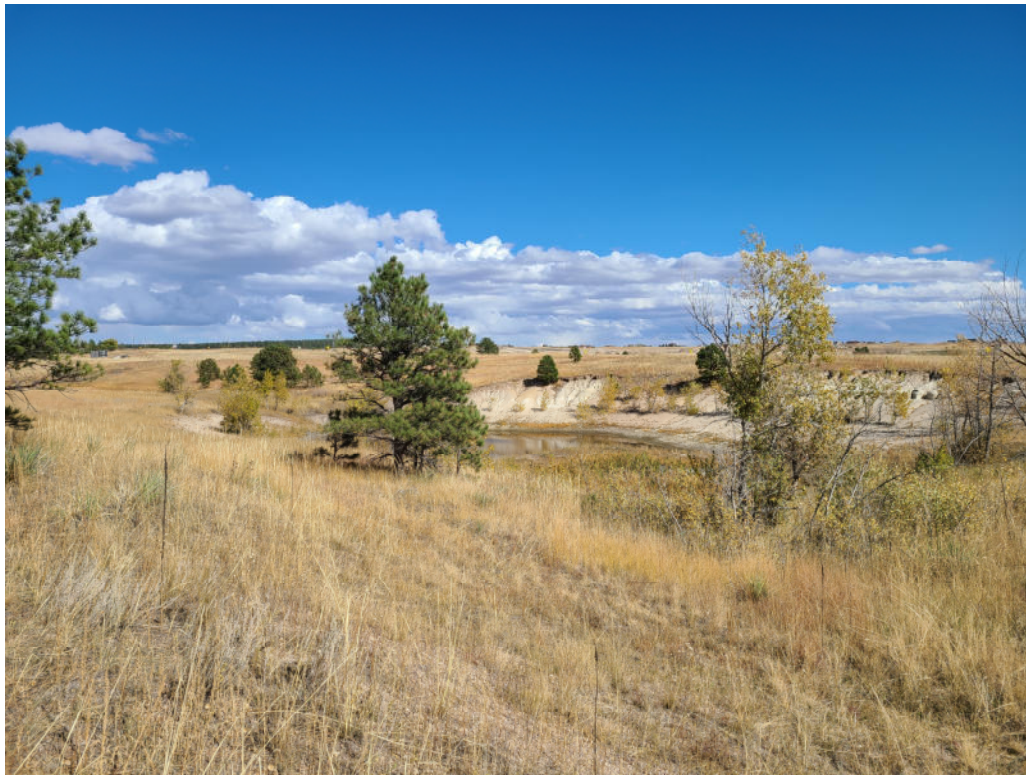
Two drainages exist in the eastern and western portions of the site that have been identified as areas of seasonally wet and/or seasonally high groundwater areas. Water was observed in the pond located in the eastern portion of the site. Water was not observed in the drainage areas on the site. The site is not mapped within floodplain zones according to the FEMA Map Nos. 08041CO533G and 08041CO535G, Figure 8 (Reference 8). These areas are discussed as follows:

**Looking northeast
towards pond in the
northeastern portion of
the site.**

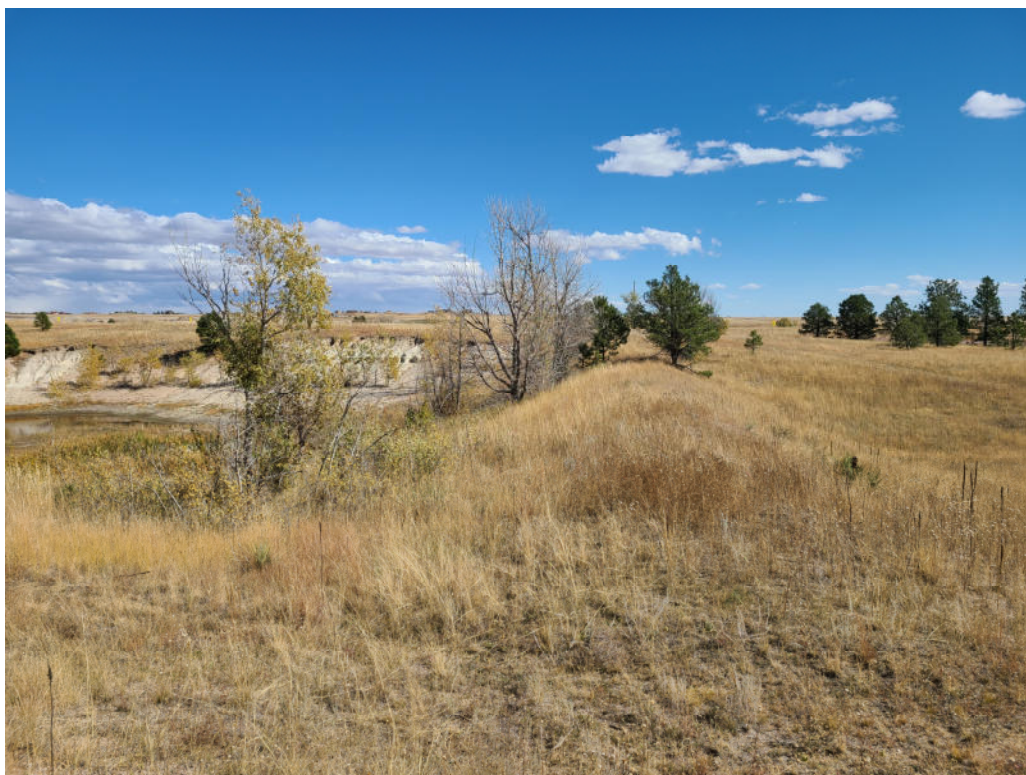
These are recent man-made fill deposits associated with the earthen dam located in the eastern portion of the site. It is anticipated that this dam will be removed and filled during the site grading process. At the time of the investigation, the condition of the dam was observed, and appeared to be in good condition.

**Looking east along
earthen dam in the
eastern portion of the
site.**

Mitigation: The earthen dam lies within a defined drainage and should be avoided as building sites. The fill on this site is considered uncontrolled for construction purposes. Any uncontrolled fill encountered beneath foundations will require removal and recompaction at a minimum of 95% of its maximum Modified Proctor Dry Density, ASTM D-1557.
