**SOILS AND GEOLOGY STUDY
JAYNES PROPERTY – PRELIMINARY PLAN
POCO ROAD AND VOLLMER ROAD
EL PASO COUNTY, COLORADO**

Prepared for:
**Elite Properties of America, LLC
2138 Flying Horse Club Drive
Colorado Springs, CO 80921**

November 21, 2023

PCD No SP-23-009

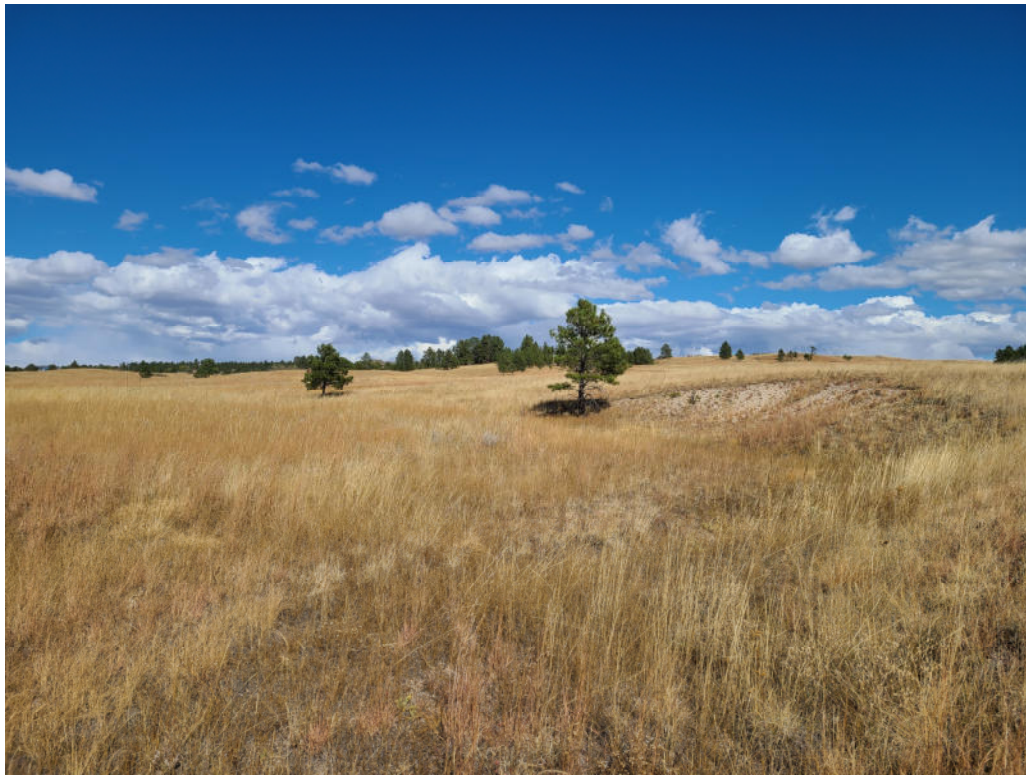
**Looking north along
drainage in the
southwestern portion
of the site.**

Mitigation: Foundations must have a minimum 30-inch depth for frost protection. In areas where high subsurface moisture conditions are anticipated periodically, subsurface perimeter drains are recommended to help prevent the intrusion of water into areas below grade. Typical drain details are presented in Figures 9 through 11. Any grading in these areas should be done to direct surface flow around construction to avoid areas of ponded water. Structures should not block drainages. All organic material should be completely removed prior to any fill placement. Finished floor levels must be located a minimum of one foot above floodplain levels.

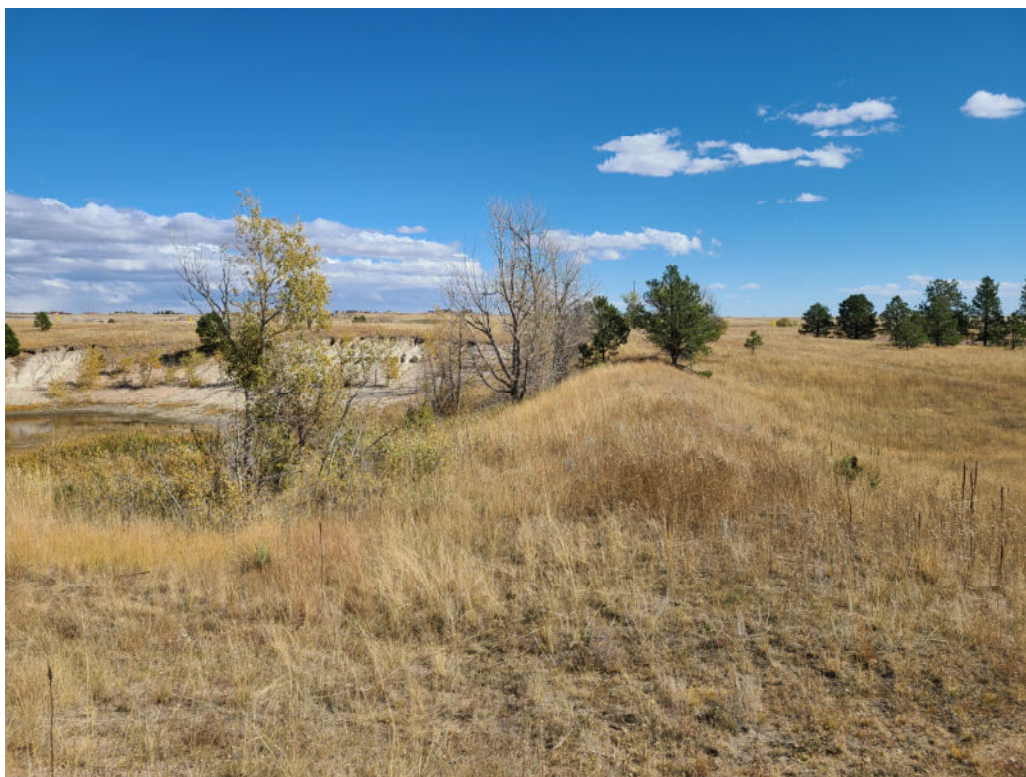
These are recent man-made fill deposits associated with the earthen dam located in the eastern portion of the site. It is anticipated that this dam will be removed and filled during the site grading process. At the time of the investigation, the condition of the dam was observed, and appeared to be in good condition.

**Looking east along
earthen dam in the
eastern portion of the
site.**

Mitigation: The earthen dam lies within a defined drainage and should be avoided as building sites. The fill on this site is considered uncontrolled for construction purposes. Any uncontrolled fill encountered beneath foundations will require removal and recompaction at a minimum of 95% of its maximum Modified Proctor Dry Density, ASTM D-1557.

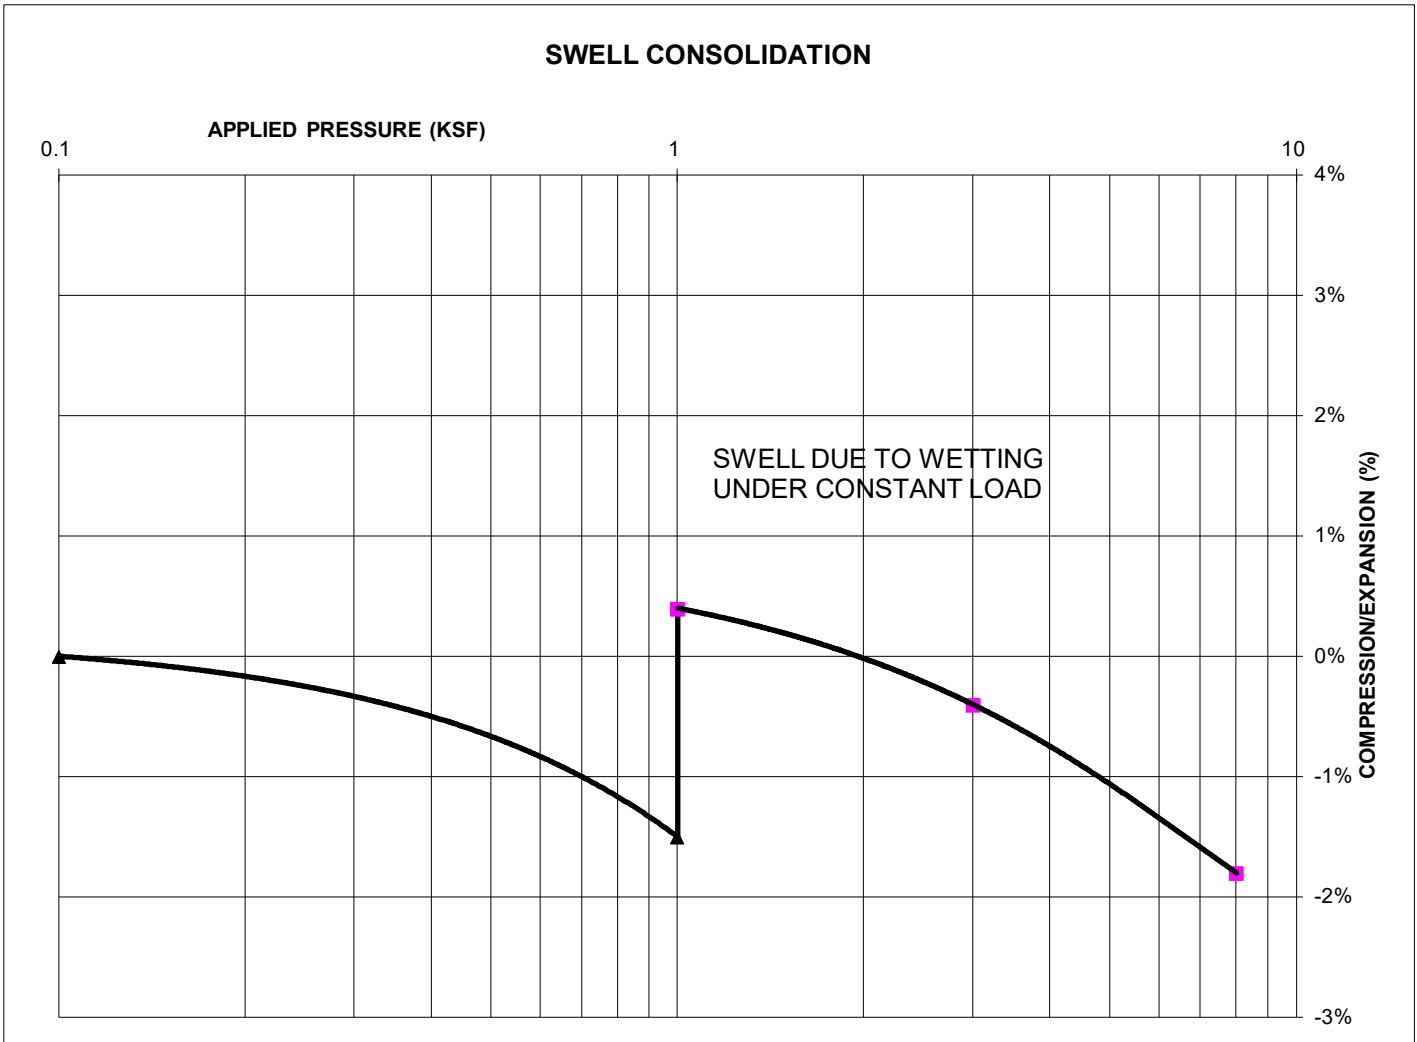
TEST BORING 12
DEPTH (FT) 5

Expansive soils were encountered in the test borings drilled on site. These occurrences are typically sporadic; therefore, none have been indicated on the maps. The clays and claystone, if encountered at foundation grade, can cause differential movement in structures. These occurrences should be identified and dealt with on an individual basis.

NATURAL UNIT DRY WEIGHT (PCF): 112
NATURAL MOISTURE CONTENT: 16.9%
SWELL/CONSOLIDATION (%): 1.9%

Mitigation Should expansive soils be encountered beneath foundations, mitigation will be necessary. Mitigation of expansive soils will require special foundation design. Overexcavation and replacement with non-expansive soils at a minimum of 95% of its maximum Modified Proctor Dry Density, ASTM D-1557 is a suitable mitigation, which is common in the area. Floor slabs on

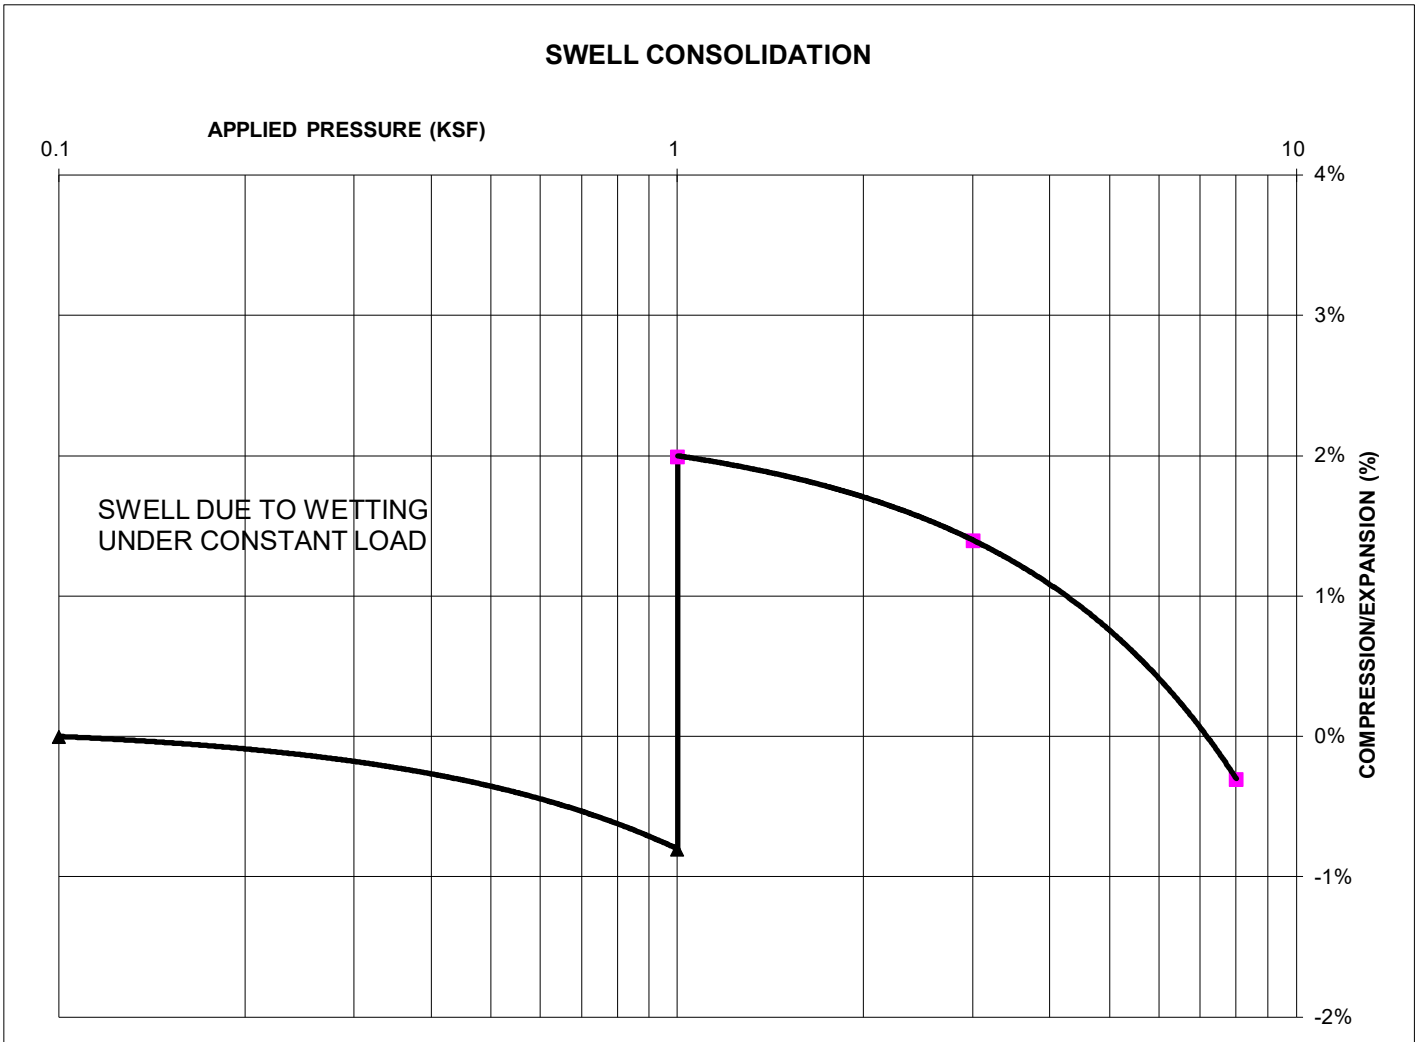
TEST BORING 3
DEPTH (FT) 20

NATURAL UNIT DRY WEIGHT (PCF): 115
NATURAL MOISTURE CONTENT: 16.0%
SWELL/CONSOLIDATION (%): 2.8%

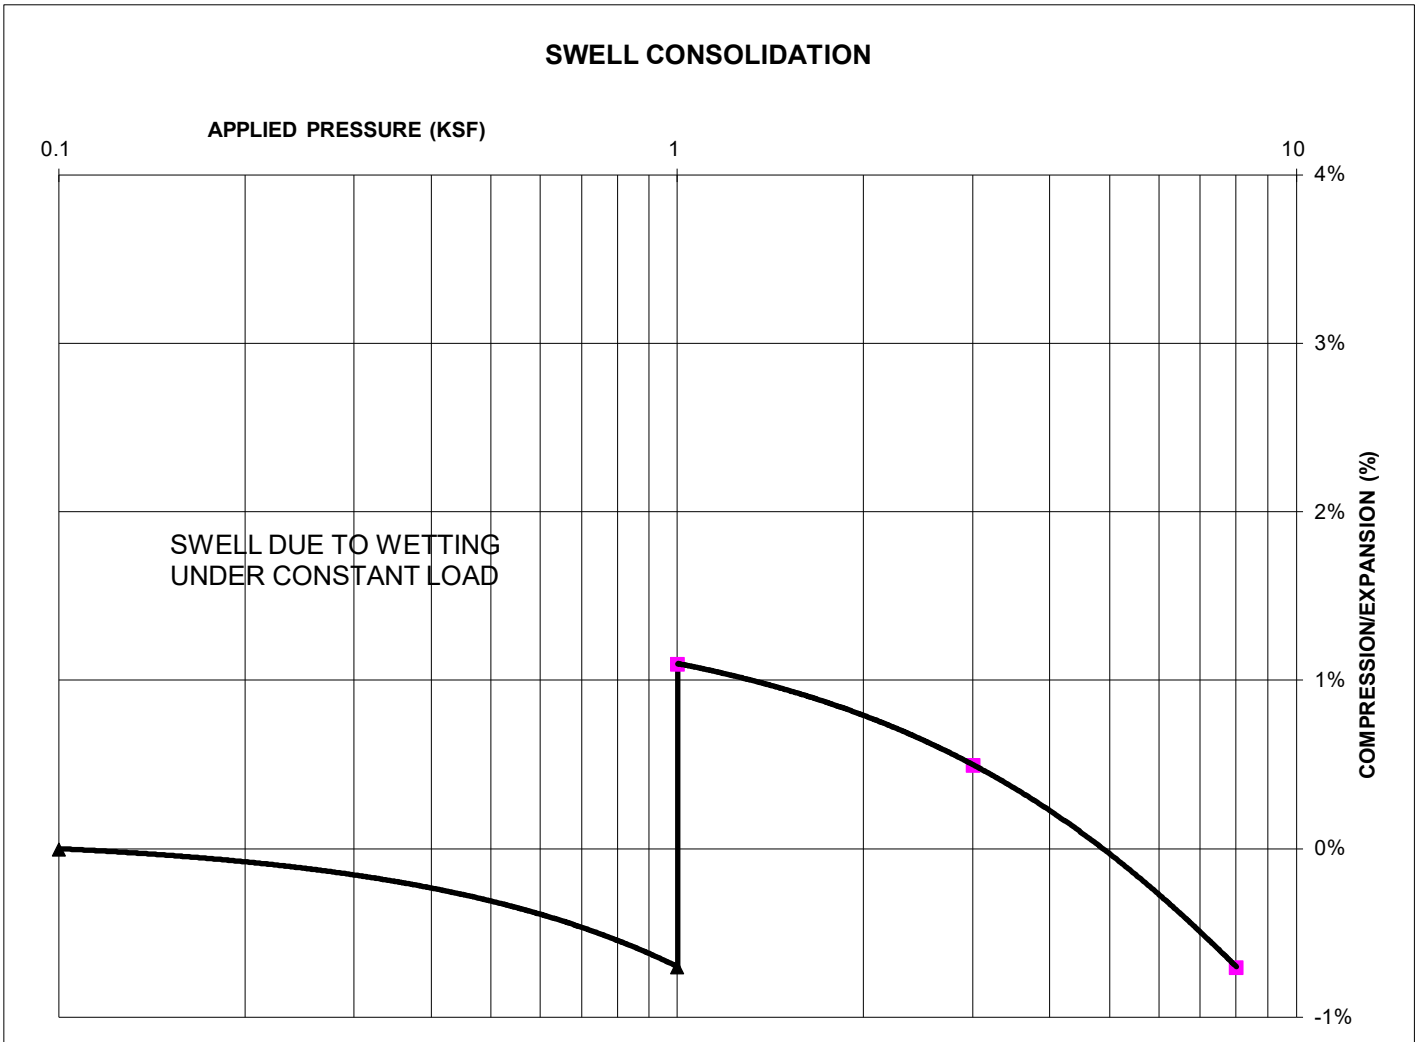
TEST BORING 6
DEPTH (FT) 20

NATURAL UNIT DRY WEIGHT (PCF): 119
NATURAL MOISTURE CONTENT: 14.7%
SWELL/CONSOLIDATION (%): 1.8%
