ENTECH
ENGINEERING, INC.

**SOILS AND GEOLOGY STUDY
RETREAT AT PRAIRIERIDGE
FILINGS 1, 2, AND 3 – PRELIMINARY PLAN
POCO ROAD AND VOLLMER ROAD
EL PASO COUNTY, COLORADO**

November 21, 2023
Revised February 29, 2024
Revised April 2, 2024
Revised June 5, 2024
Revised July 18, 2024

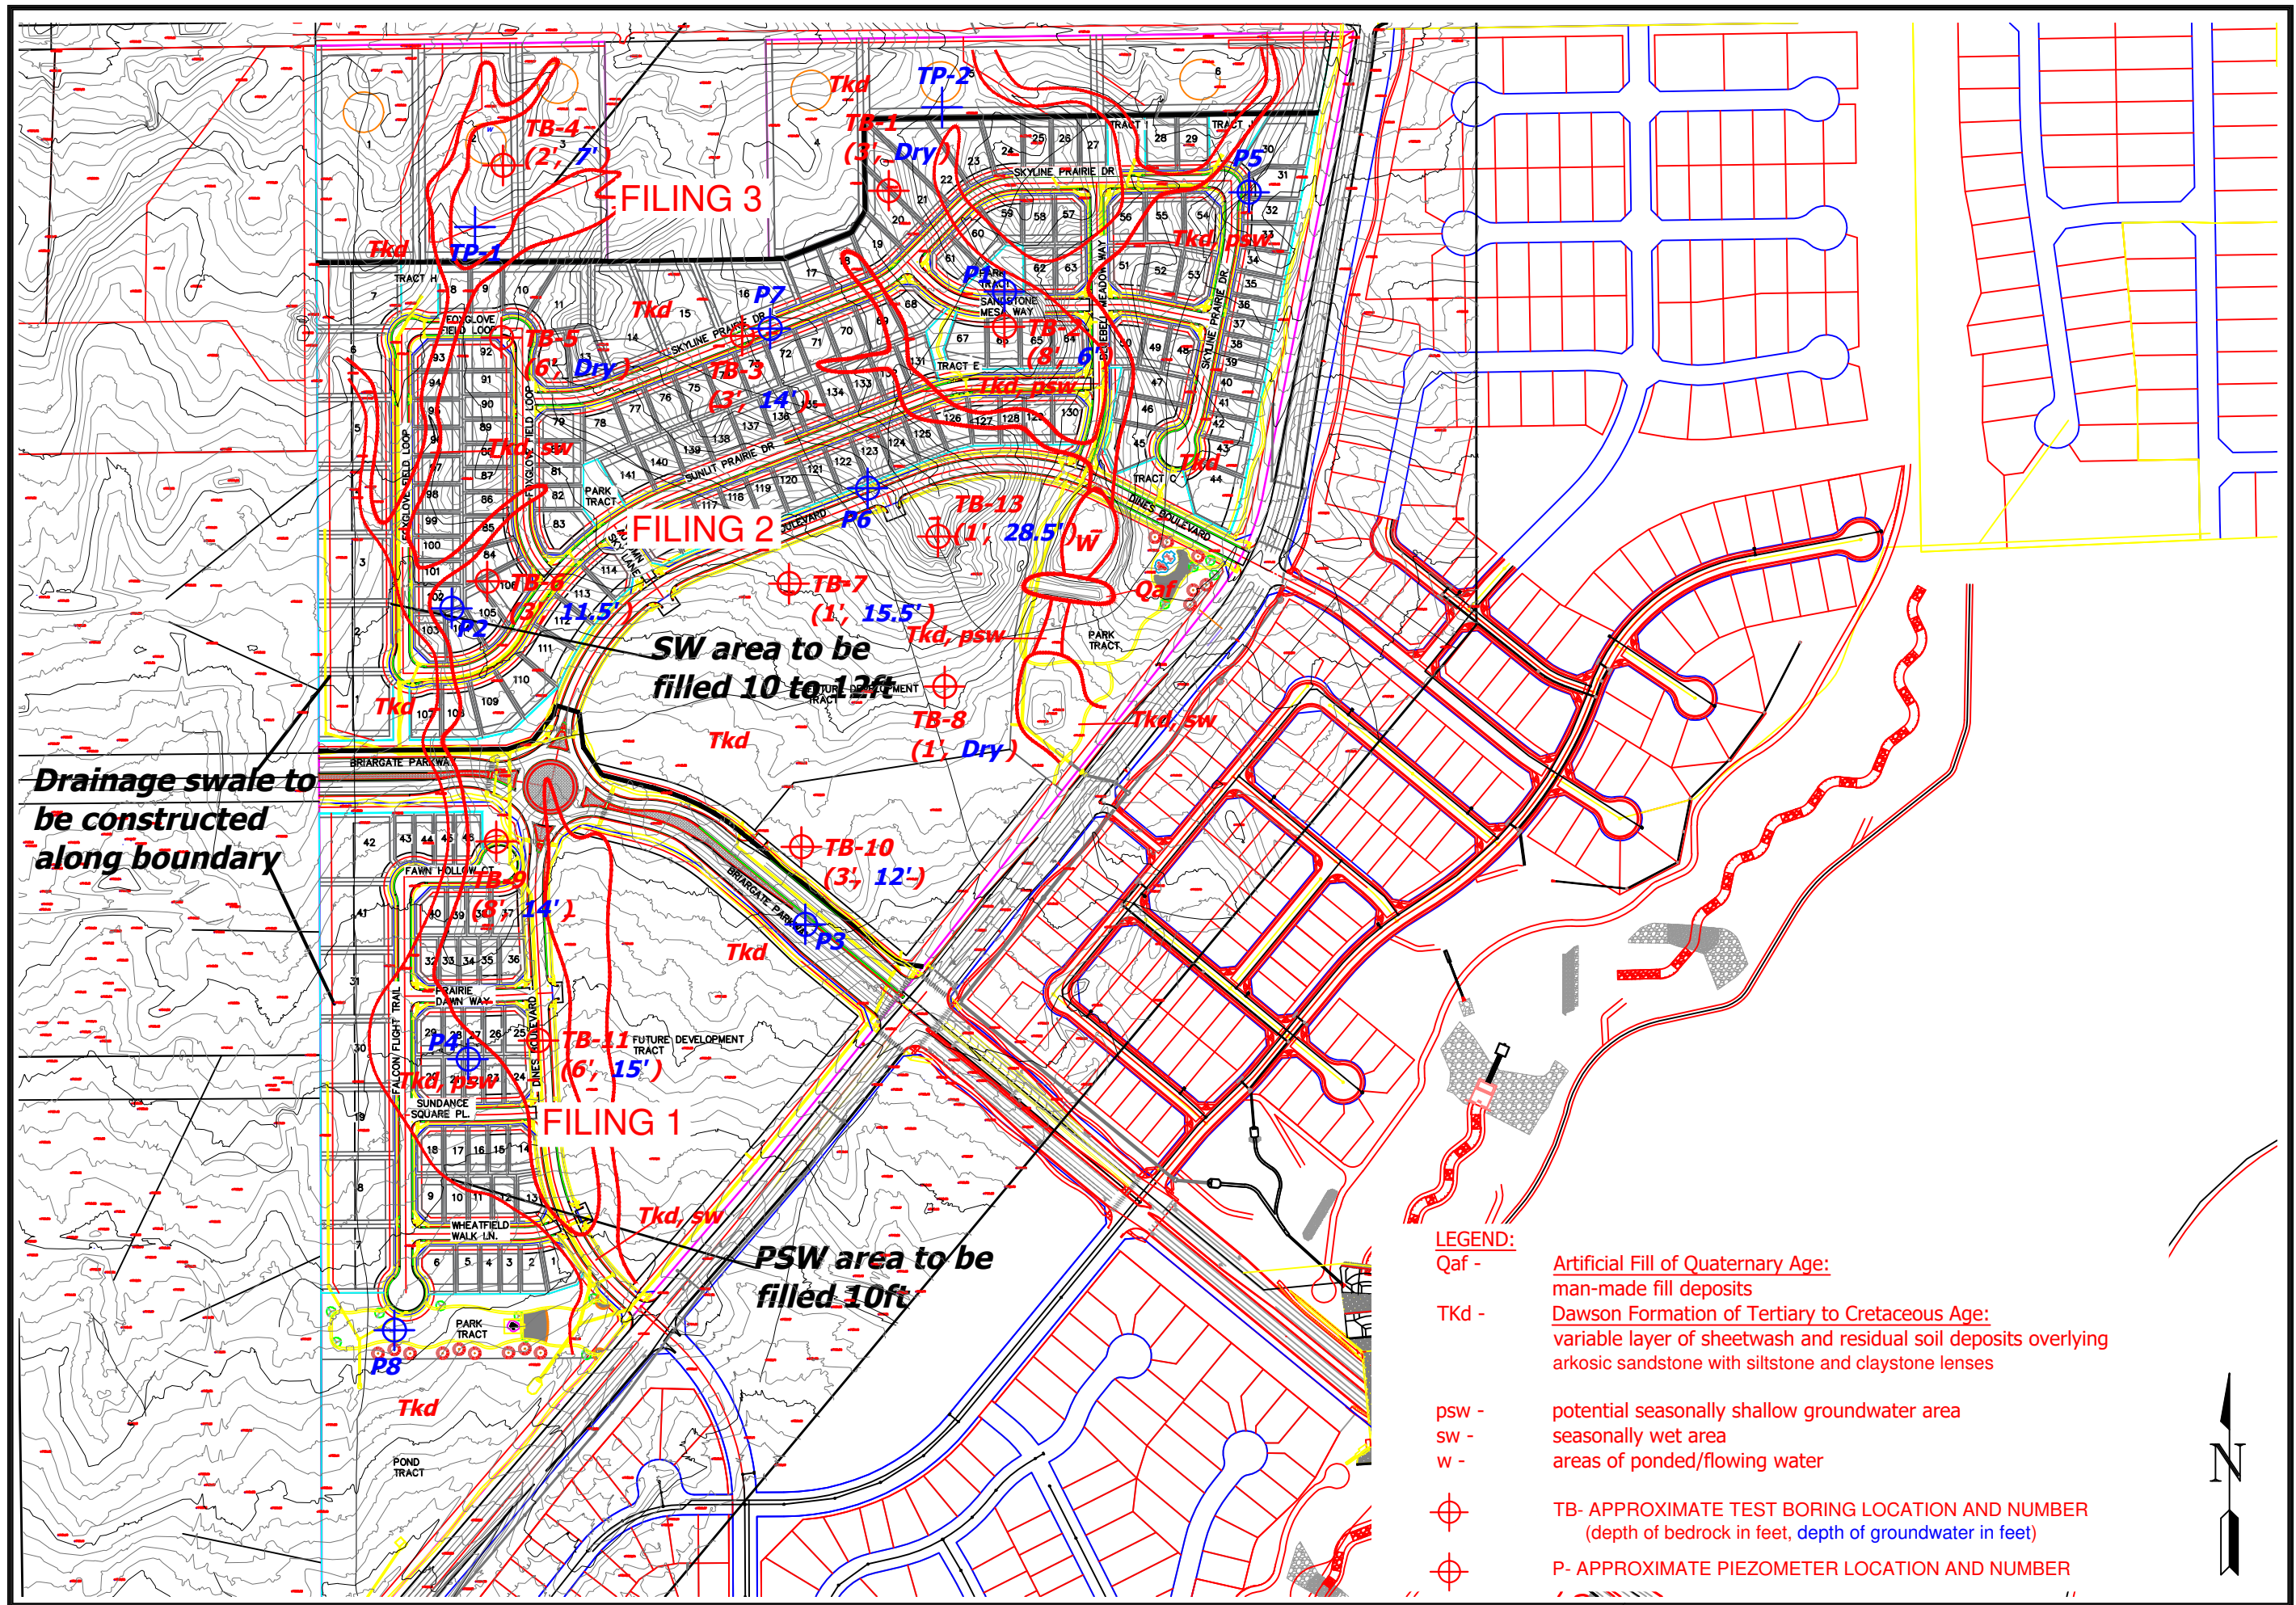
GEOLOGY ENGINEERING MAP
 RETREAT AT PRAIRIERIDGE
 POCO ROAD & VOLLMER ROAD
 EL PASO COUNTY, CO
 ELITE PROPERTIES OF AMERICA, INC.

Drainage swale to be constructed along boundary

SW area to be filled 10 to 12ft

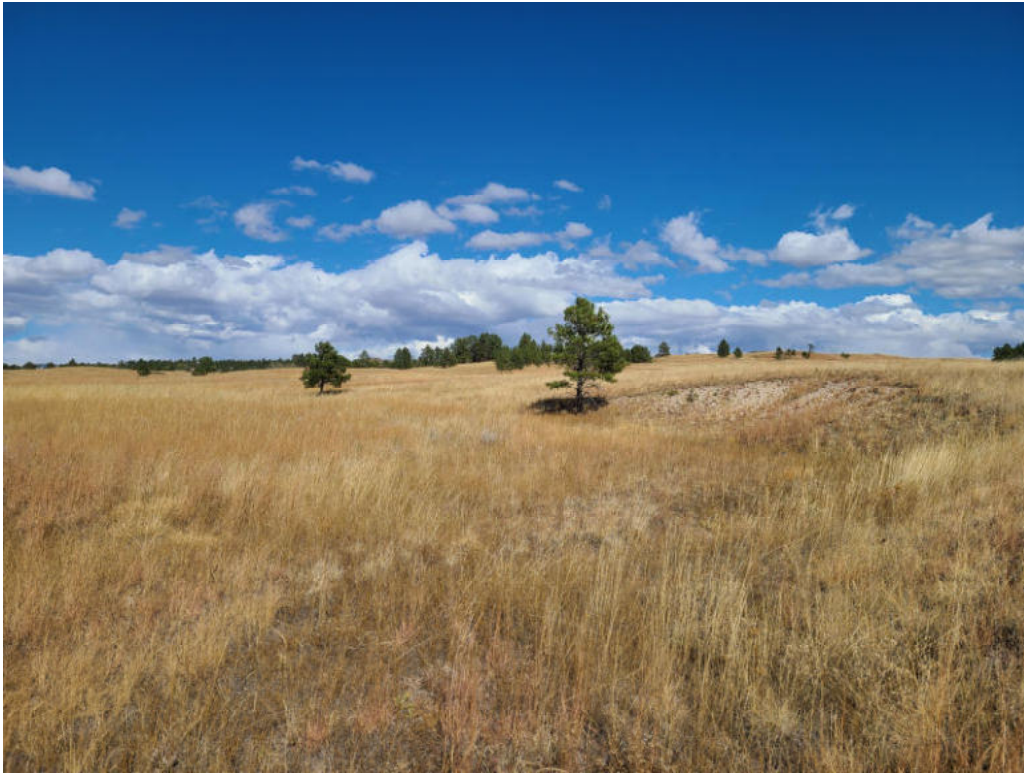
**Looking north along
drainage in the
southwestern portion
of the site.**

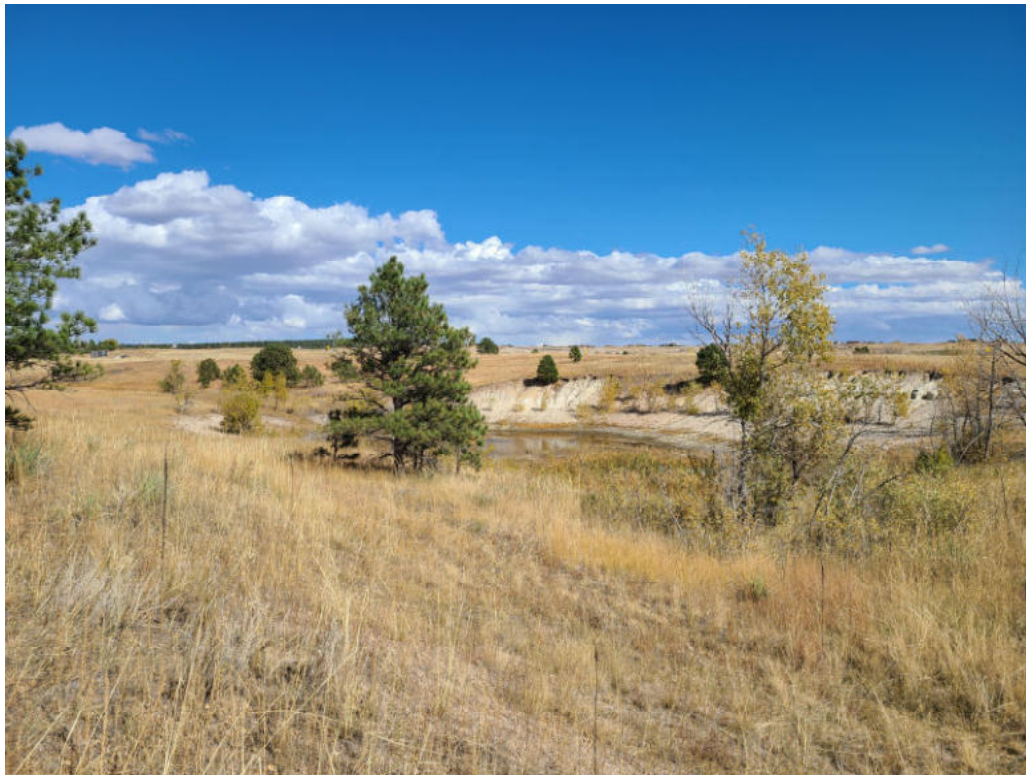
**Looking northeast
towards pond in the
northeastern portion of
the site.**

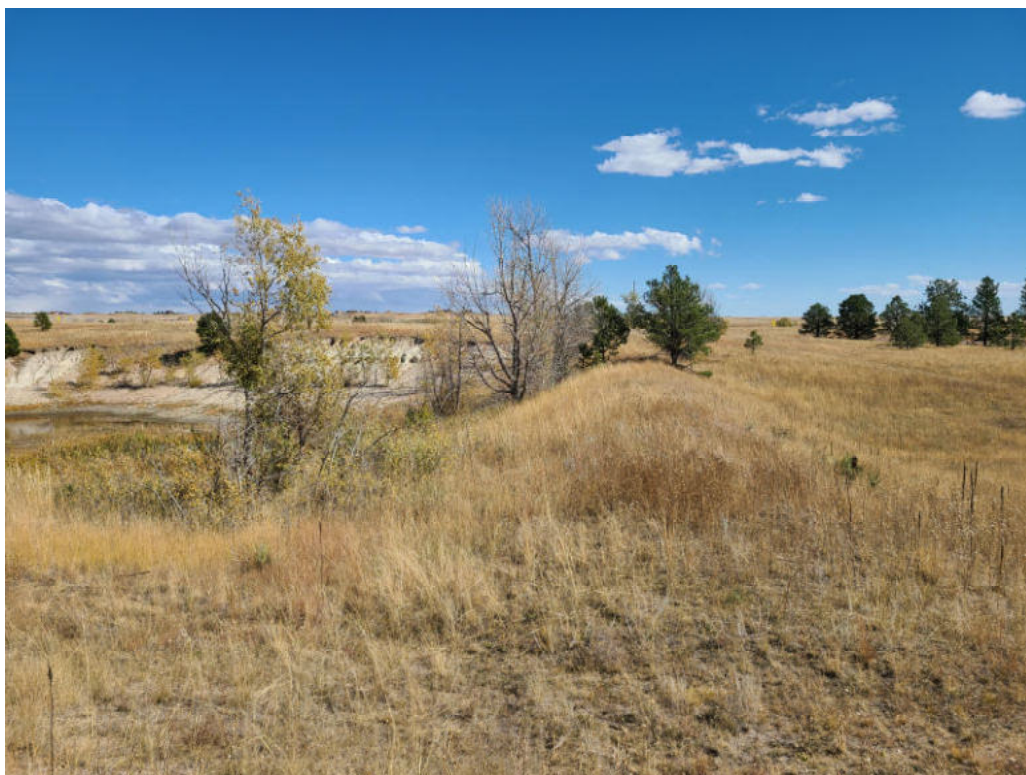
These are recent man-made fill deposits associated with the earthen dam located in the eastern portion of the site. It is anticipated that this dam will be removed and filled during the site grading process. At the time of the investigation, the condition of the dam was observed, and appeared to be in good condition.

**Looking east along
earthen dam in the
eastern portion of the
site.**

Mitigation: The earthen dam lies within a defined drainage and should be avoided as building sites. The fill on this site is considered uncontrolled for construction purposes. Any uncontrolled fill encountered beneath foundations will require removal and recompaction at a minimum of 95% of its maximum Modified Proctor Dry Density, ASTM D-1557.
