**SOILS AND GEOLOGY STUDY  
MERIDIAN RANCH – ROLLING HILLS RANCH NORTH  
FILING NOS. 1 AND 2  
EL PASO COUNTY, COLORADO**

Prepared for:  
**Tech Contractors**  
**3575 Kenyon Street, Suite 200**  
**San Diego, California 92110**

February 12, 2024

**EPC: PUD SP-235**

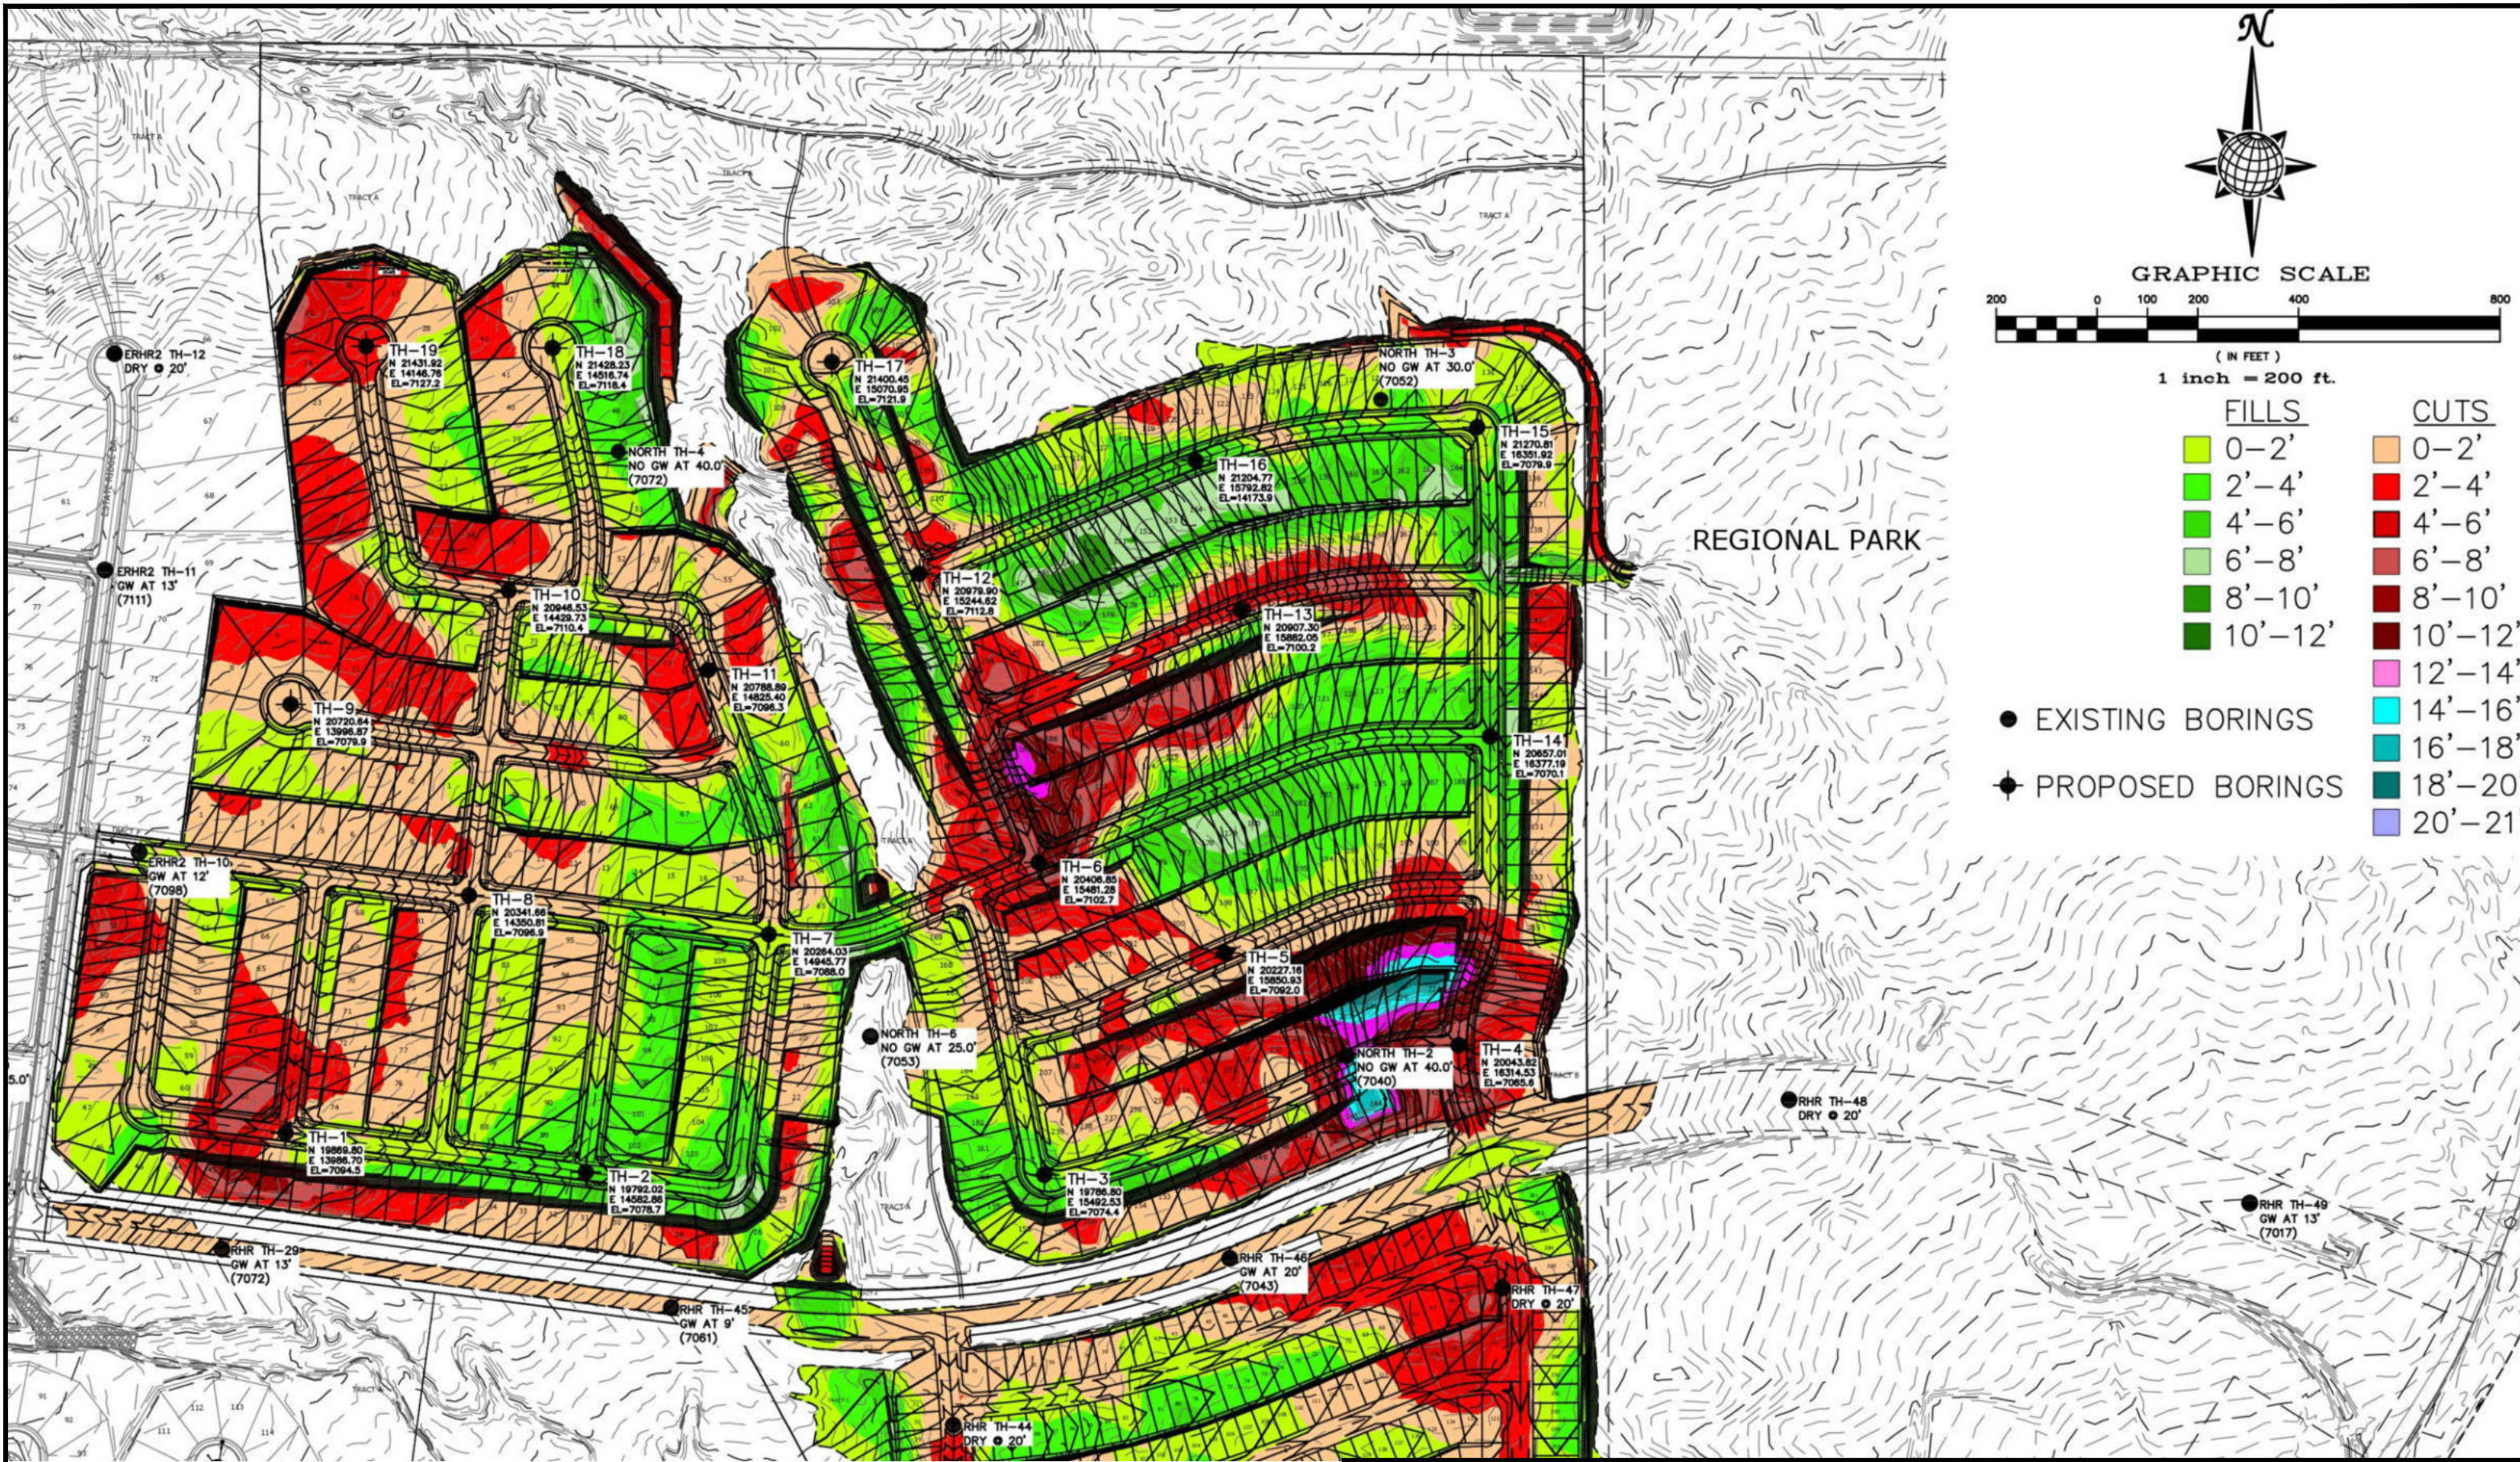
**CUT/FILL MAP**  
 MERIDIAN RANCH  
 ROLLING HILLS RANCH NORTH  
 TECH CONTRACTORS

- Qda Disturbed Area of Holocene Age:** These are the recent cut/fill operations for the development that have been completed. The fill placement was observed and tested by representatives of Entech, and the Cut/Fill Map is presented in Figure 4. The overlot fill density records are included in Appendix D.

This area is associated with the grading for the development has been completed. The fill placement was observed and tested by representatives of Entech, and the Cut/Fill Map is presented in Figure 4. The overlot fill density records are included in Appendix D. The fill is considered controlled for construction purposes, however, where clay or claystone are encountered mitigation for expansive soils will be required.

The overlot grading was performed prior to the completion of this report. Overlot fill placement was observed and tested by representatives of Entech. The Cut/Fill Map is presented in Figure 4. The overlot fill density records are included in Appendix D. The fill is considered controlled for construction purposes, however, where clay or claystone are encountered mitigation for expansive soils will be required.

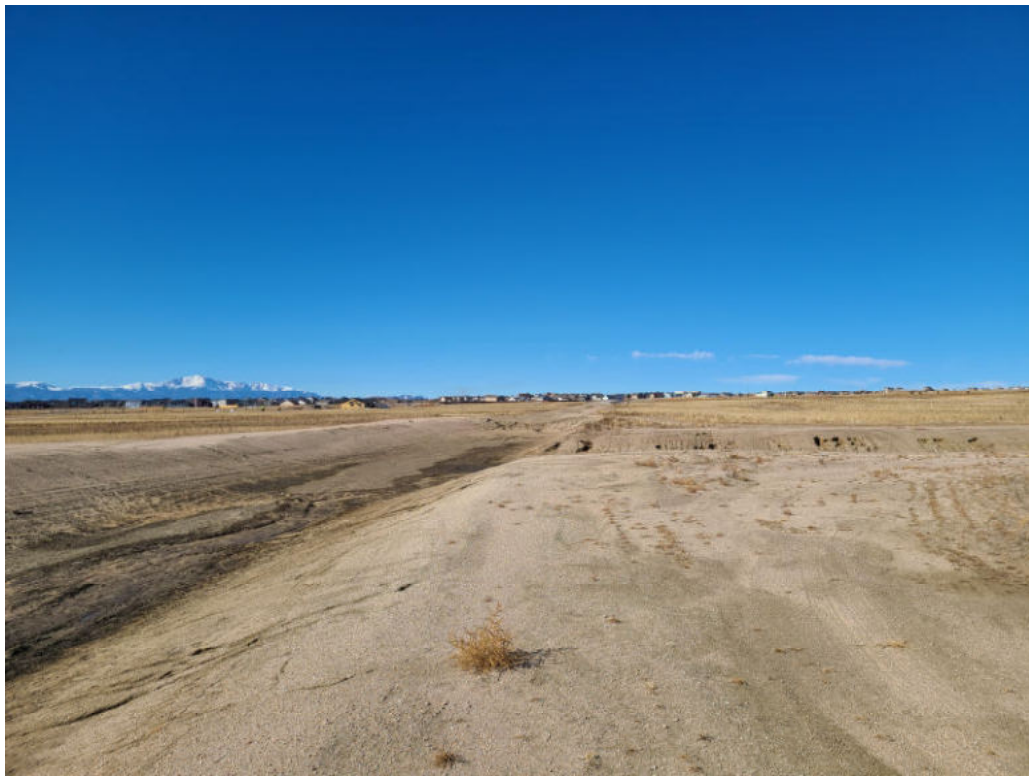
**Looking west along the future drainage crossing.**
