ENTECH
ENGINEERING, INC.

**SOILS AND GEOLOGY STUDY
CALM BREEZE SUBDIVISION FILING NO. 1
PARCEL NO. 52110-00-013
EL PASO COUNTY, COLORADO**

May 29, 2026

Entech Job No. 260651
PBK/LLL/JCG

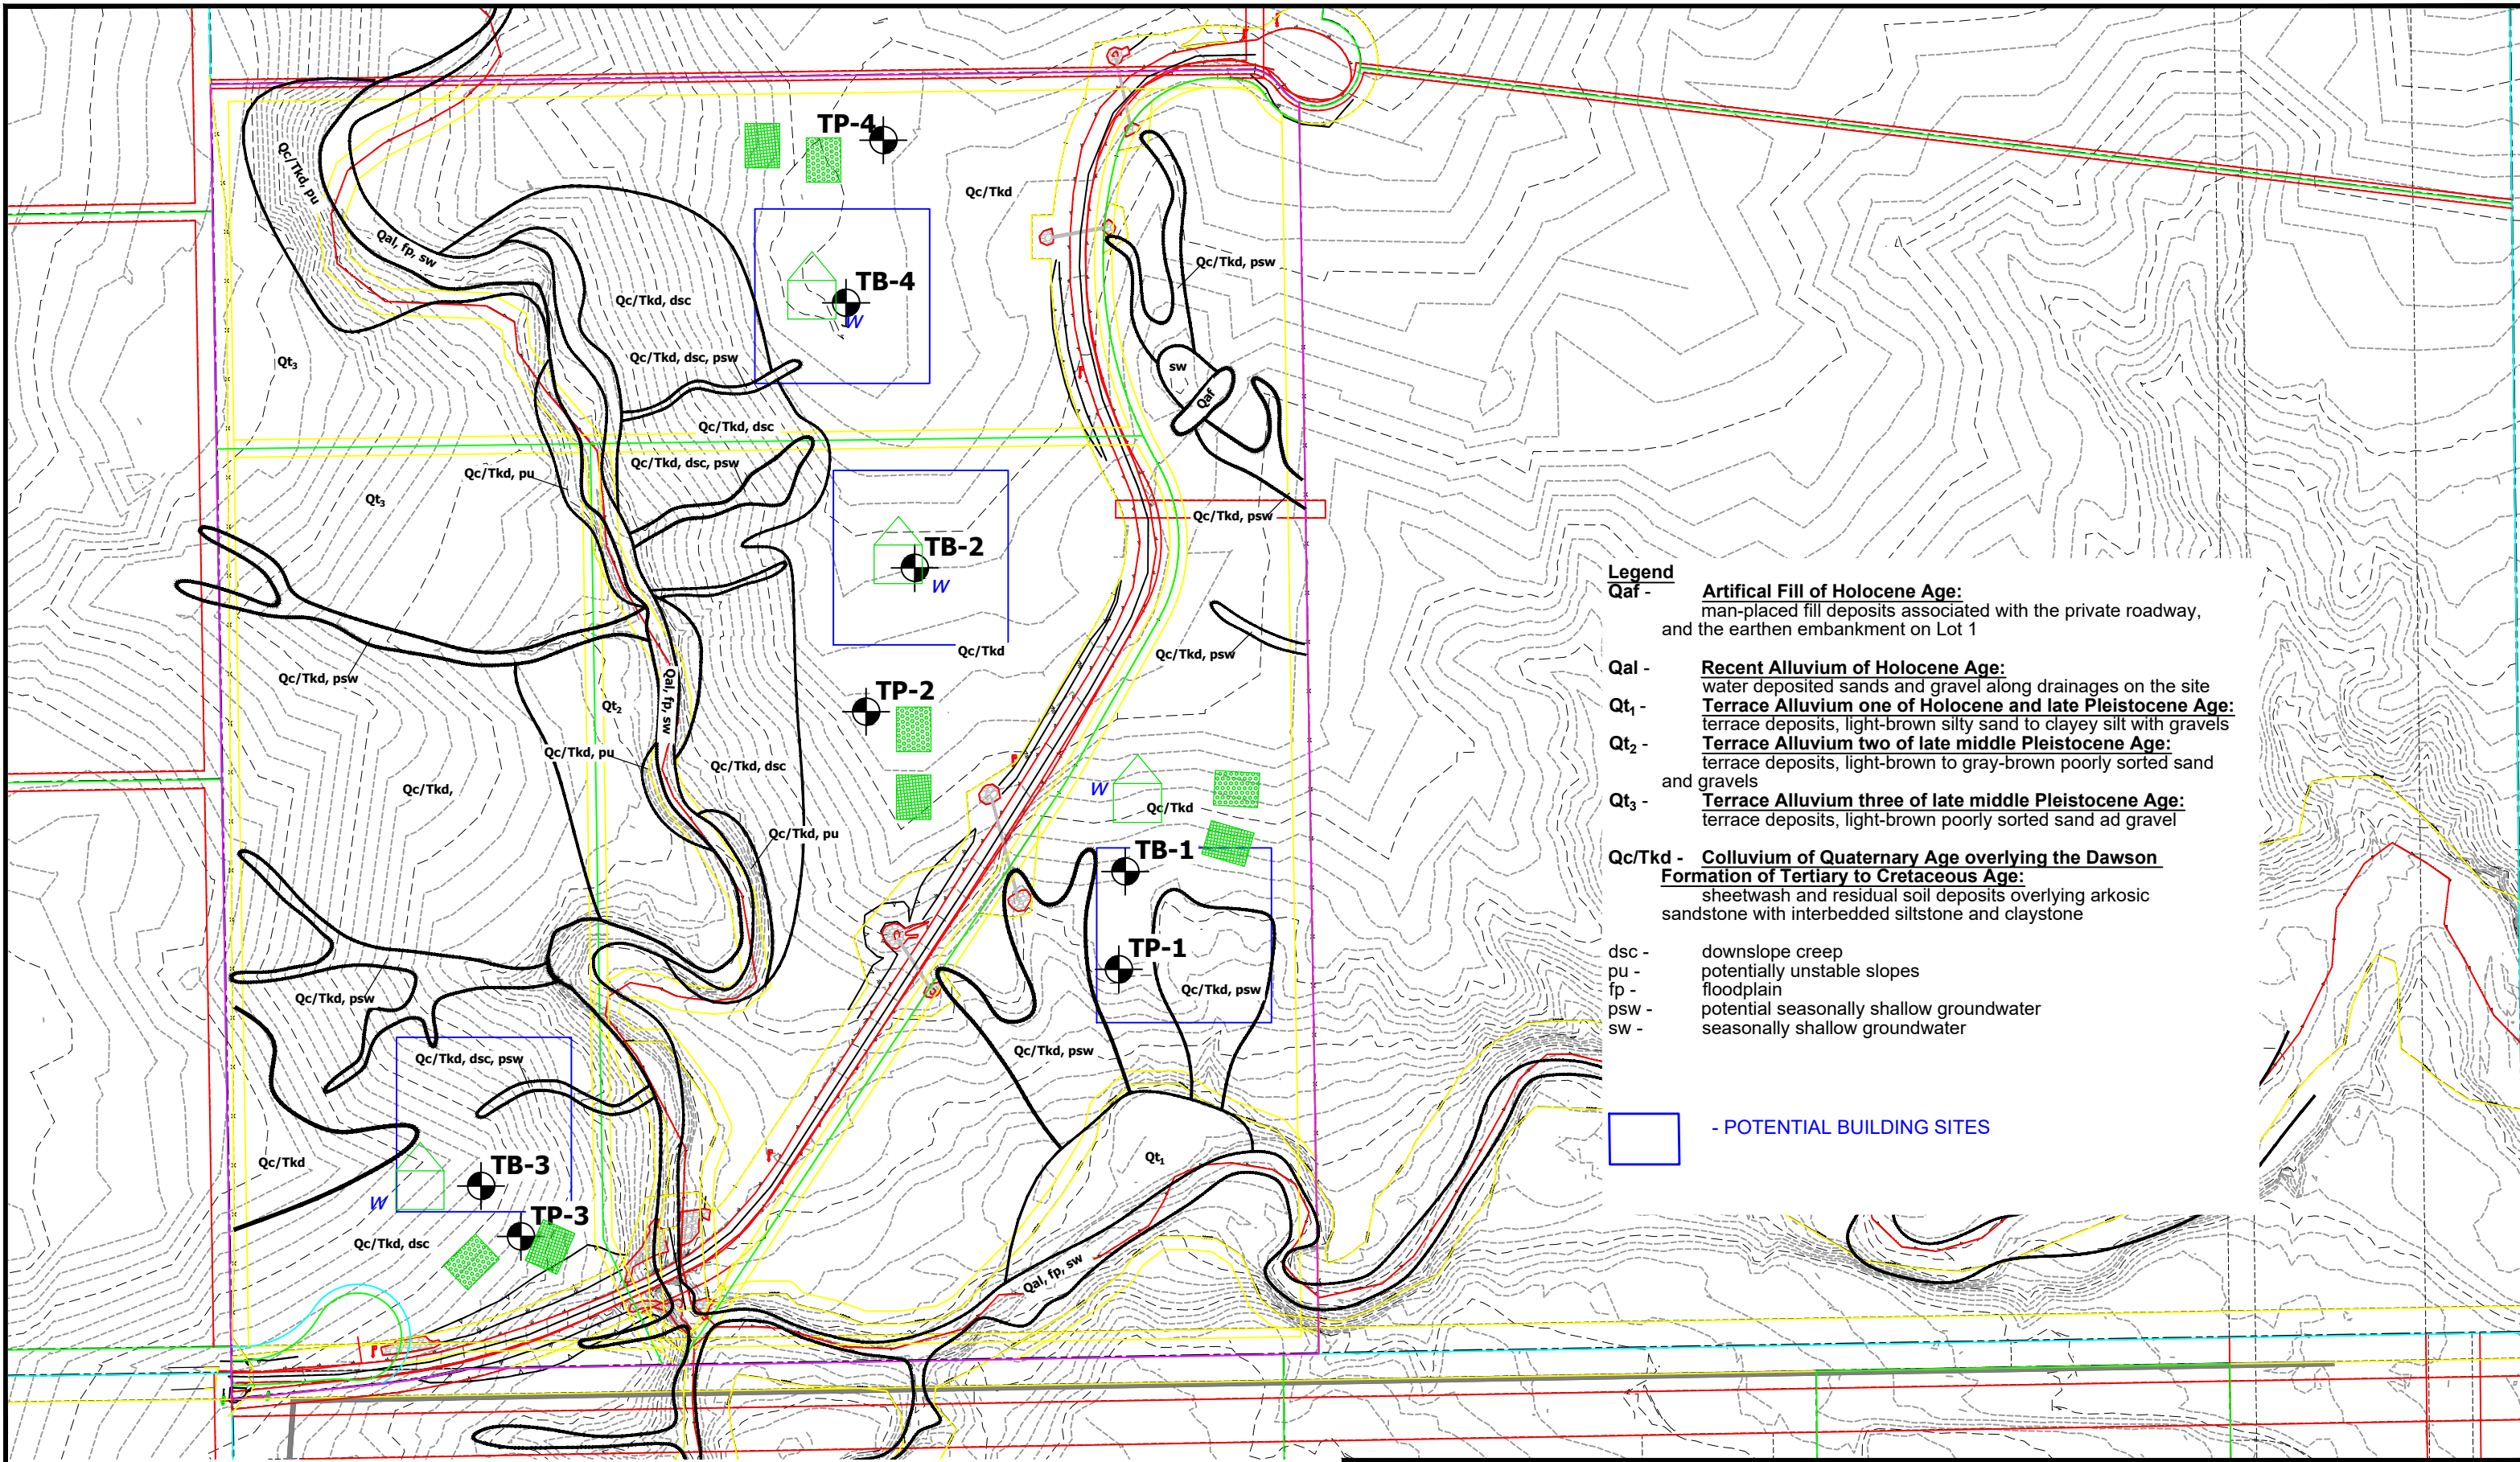
Detailed mapping has been performed on this site to produce a Geology/Engineering Geology Map (Figure 6). This map shows the location of various geologic conditions the developers should monitor during the planning, design, and construction stages of the project. No significant geologic hazards were identified on the site; however, the following constraints have been identified on the site: artificial fill, potentially expansive soils, potentially shallow and seasonally shallow groundwater areas, drainage areas, downslope creep, potentially unstable slopes, and the potential for elevated radon levels. These constraints and the recommended mitigation techniques are discussed below.

Areas of downslope creep associated with the moderate to steep slopes on the site have been identified. In these areas we would anticipate lateral and vertical movement of the near surface soils in the downslope direction. These areas are suitable as building sites with the following constraints on construction. If construction in these areas is considered, the following mitigation recommendations should be considered.

The steep slopes along portions of the drainages on the site have been identified as potentially unstable. These slopes are considered stable in their present condition; however, considerable care must be exercised in these areas not to create a condition which would tend to activate instability. These areas are primarily located along the banks of Black Squirrel Creek and should be avoided by construction. A minimum setback of 30 feet from the crest of the potentially unstable slope is recommended. Depending on final development plans and building locations site specific slope stability analysis may be needed.

Mitigation: Building is possible in these areas if the following engineering and construction mitigation steps are taken: Downslope creep will increase lateral pressures against foundation components on the uphill side of structures. The design of foundations in these areas should account for this additional pressure. A lateral pressure detail is shown in Figure 8. Where possible in areas of downslope creep, structures should be designed to be as compact and rigid as possible. This will help them better tolerate the vertical and lateral movements to which the foundation system may be subjected. Long, rambling, irregular structures should be avoided in these areas as they are associated with a much greater potential for damaging differential movement. Tie walls and buttresses are often used to stiffen the foundation system.

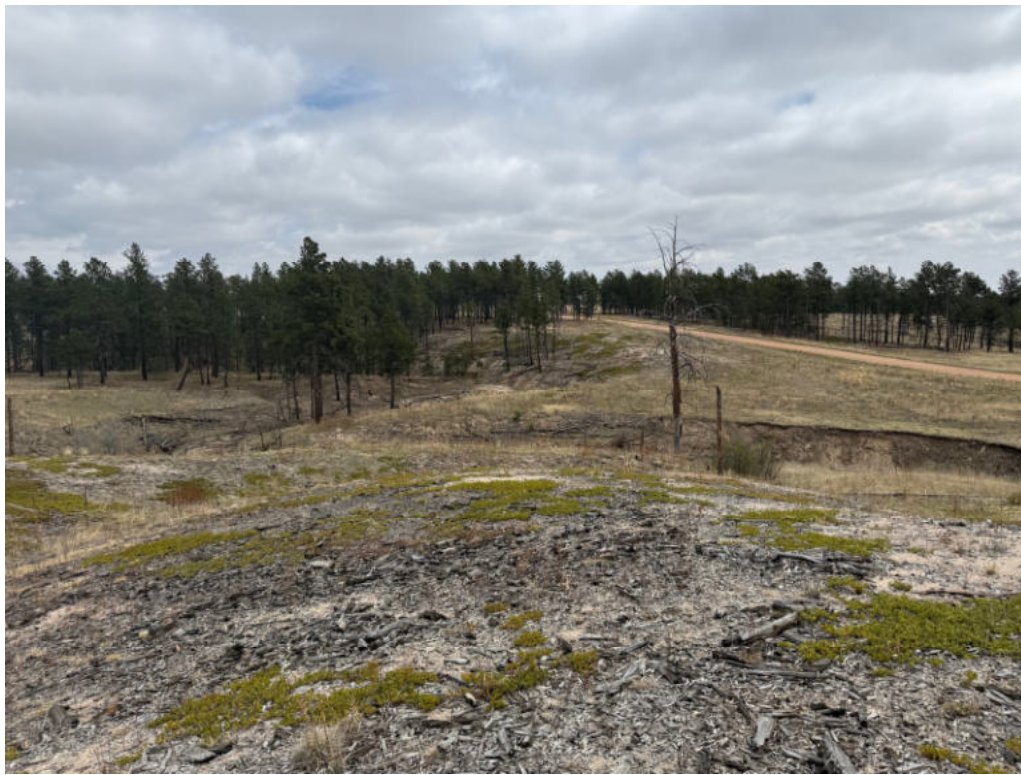
Looking north from the southern portion of proposed Lot 3.

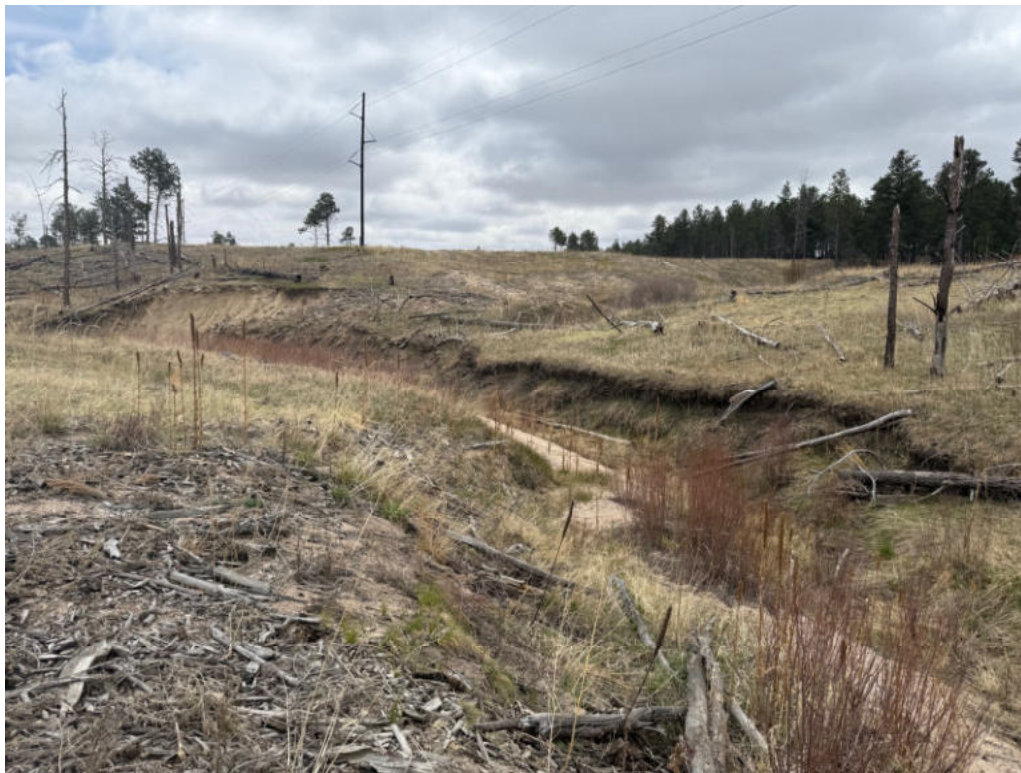
Looking east along Black Squirrel Creek from the southeastern portion of proposed lot 1.

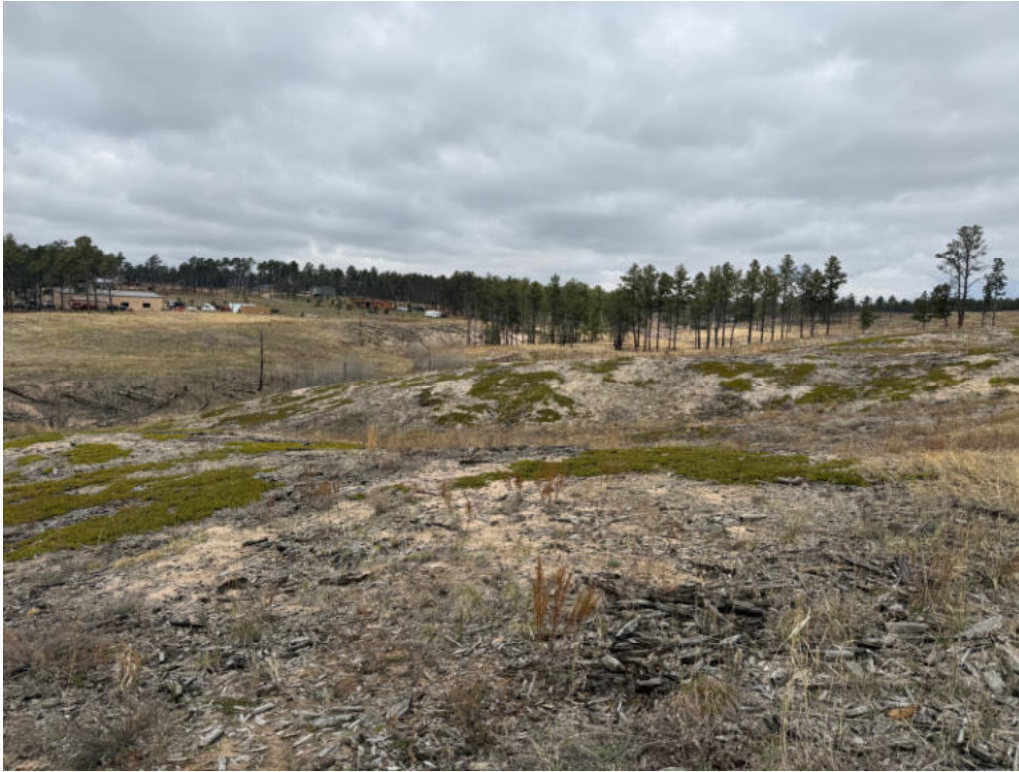
**Looking northeast
from the northern
portion of proposed
Lot 3.**

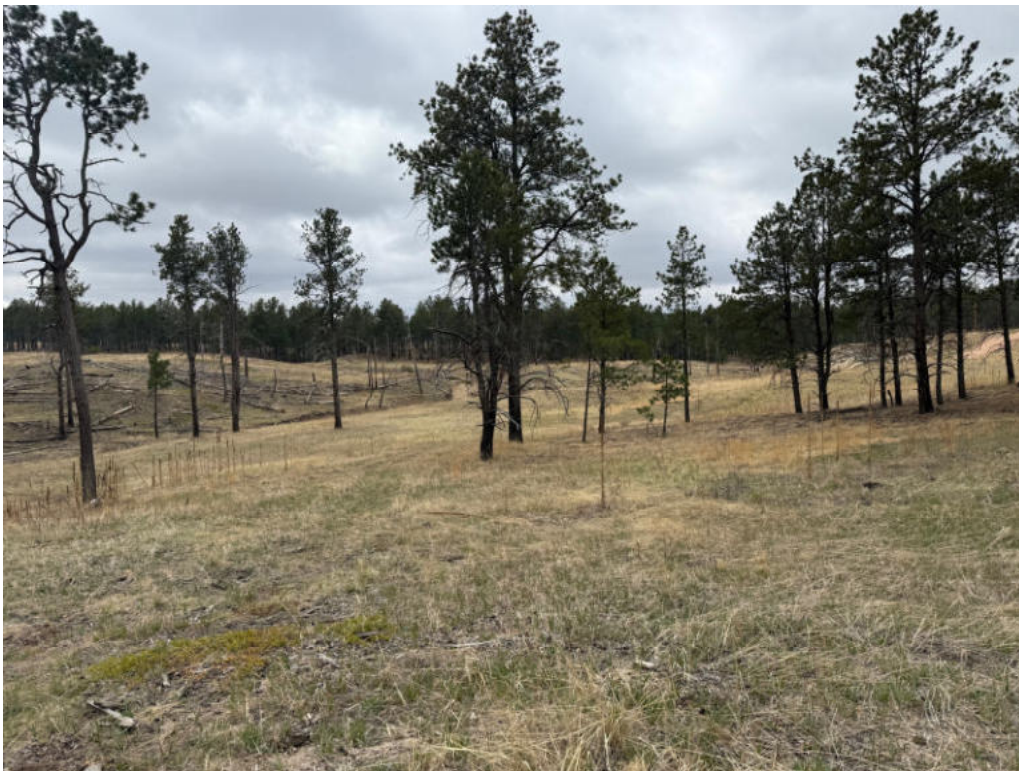
**Looking east from the
central portion of
proposed Lot 1.**
