**SOIL, GEOLOGY, & GEOLOGIC HAZARD STUDY
FOURSQUARE AT STERLING RANCH EAST
PRELIMINARY PLAN NO. 2 – PARCEL NO. 19
EL PASO COUNTY, COLORADO**

April 14, 2022
Revised September 15, 2022

Entech Job No. 220572
AAprojects/2022/220572 countysoil/geo

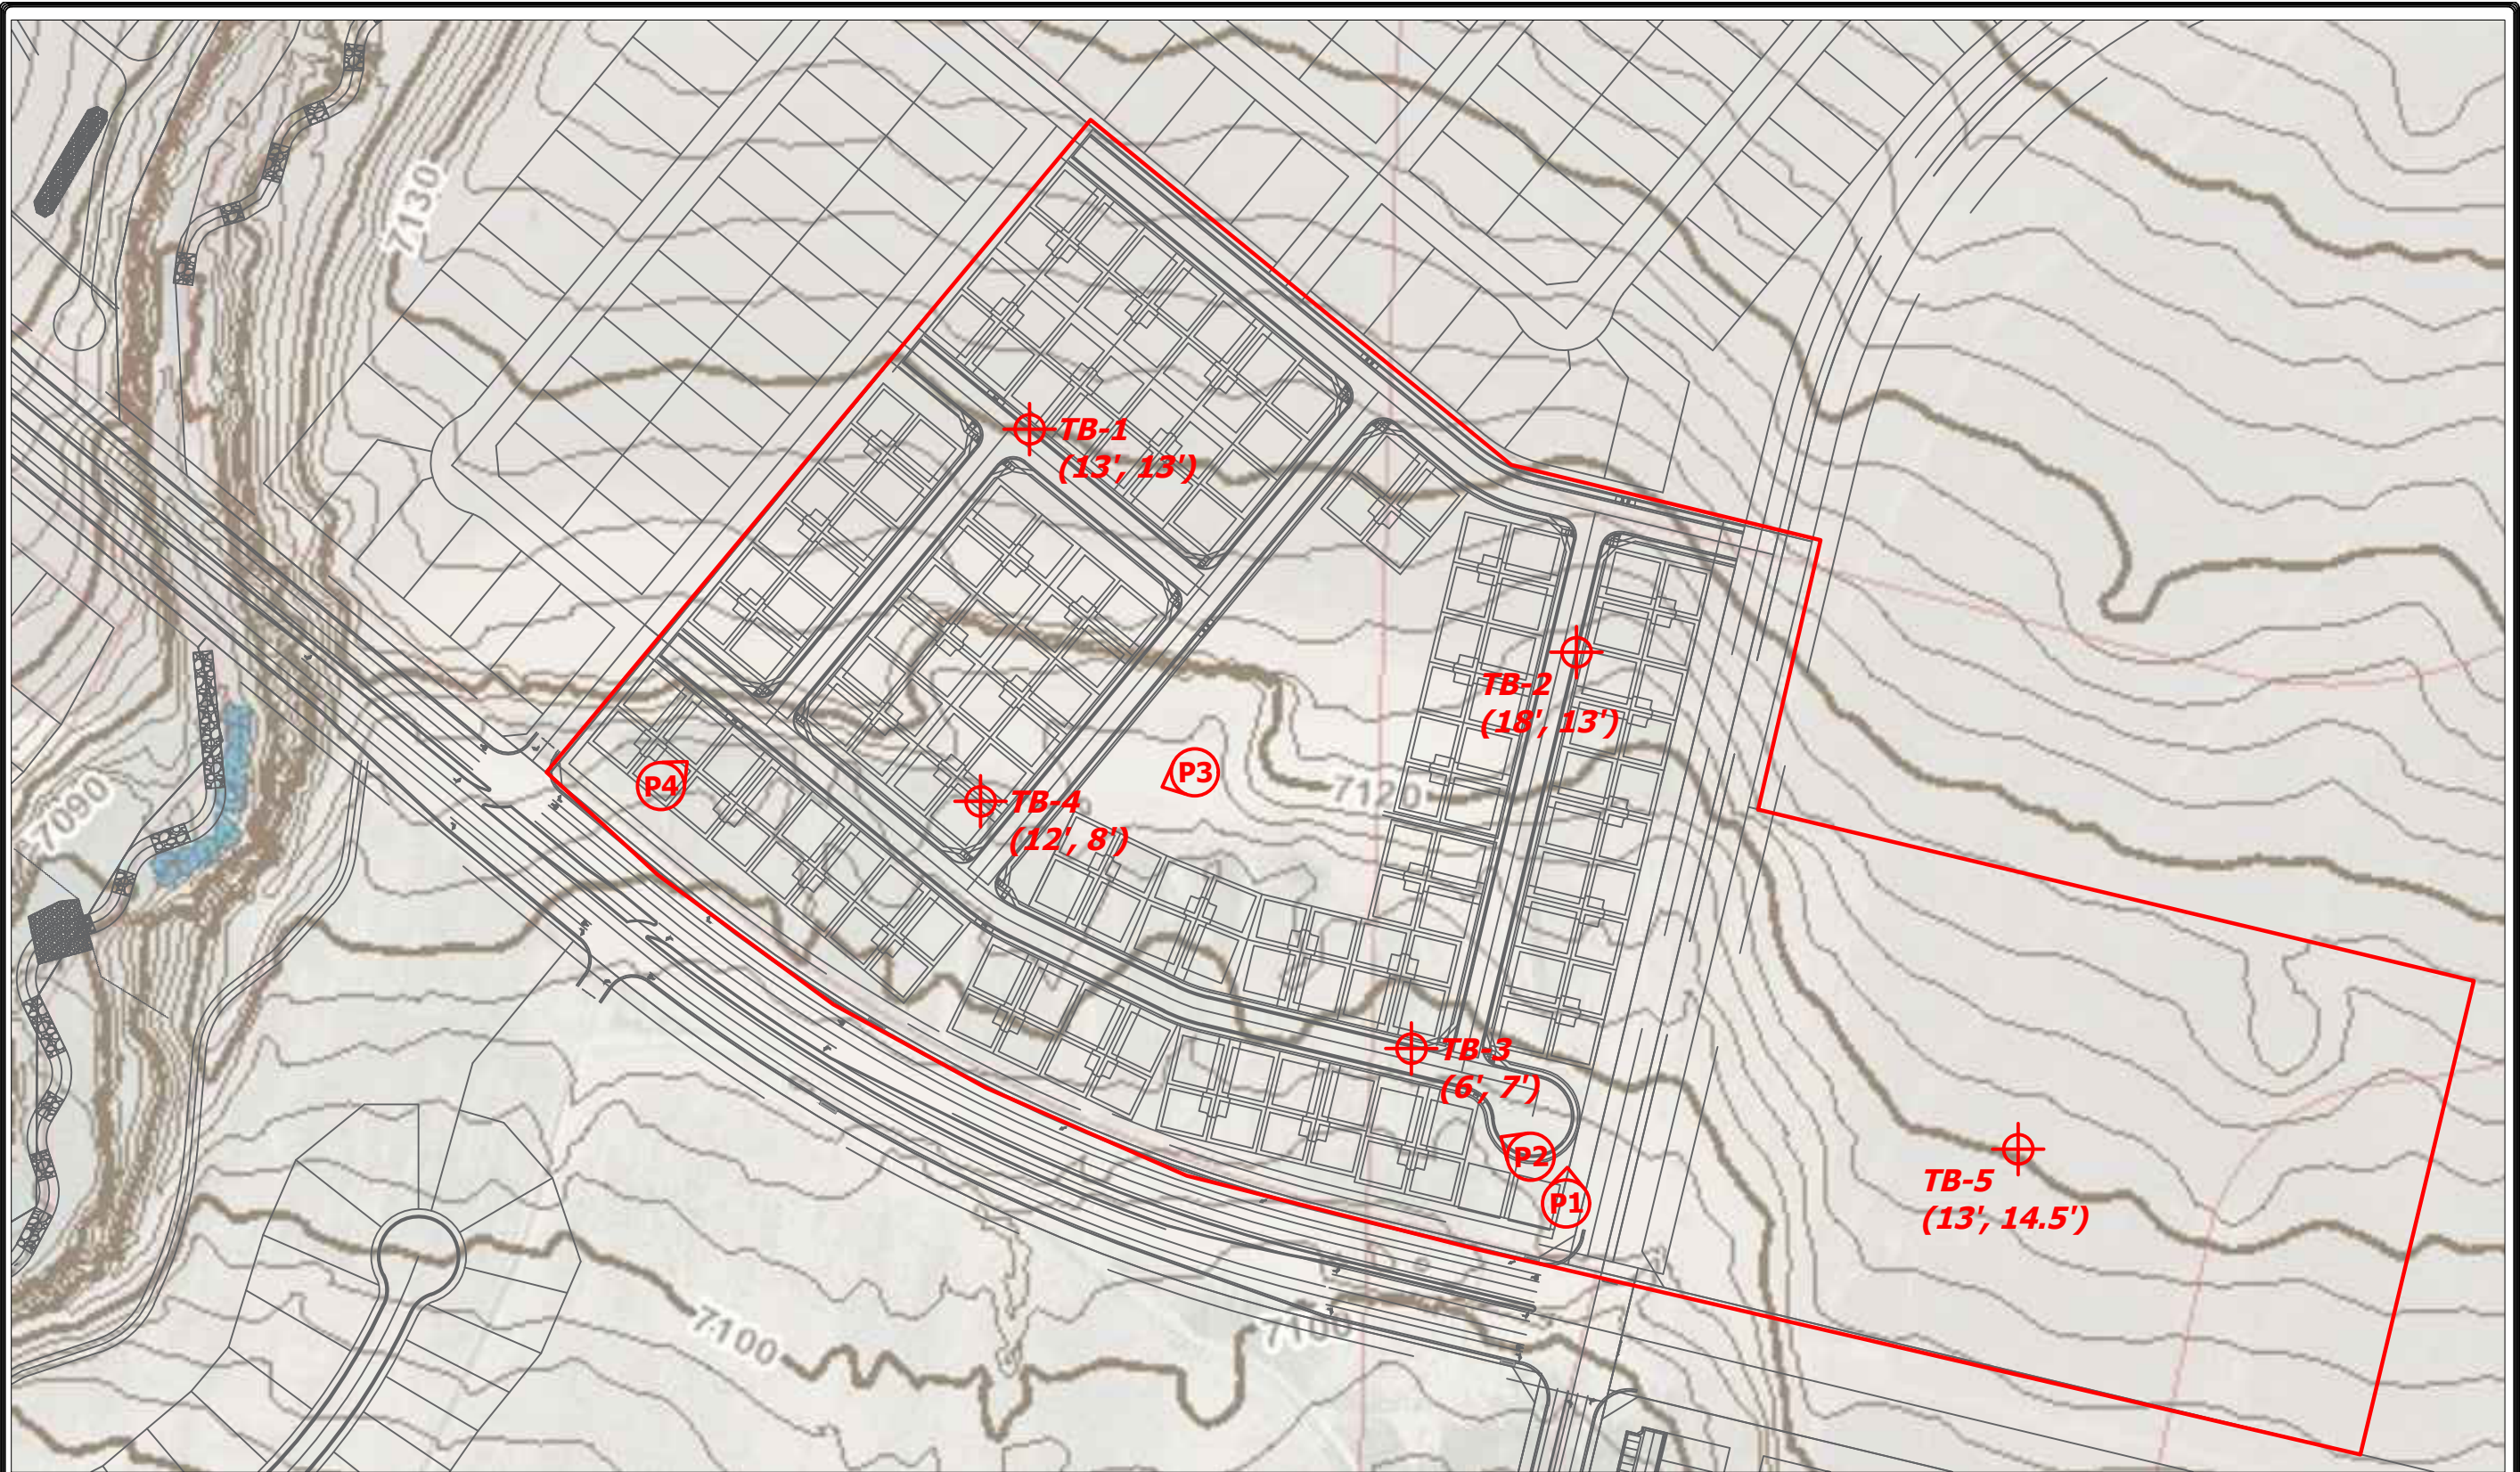
DRAWN L.L.L. CHECKED
DATE 9/15/22
SCALE AS SHOWN
JOB NO. 220572
FIGURE No. 4

Test Boring No.	Depth of Bedrock (ft.)	Depth of Groundwater (ft.)
1	13	13
2	18	13
3	6	7
4	12	8
5	13	14.5

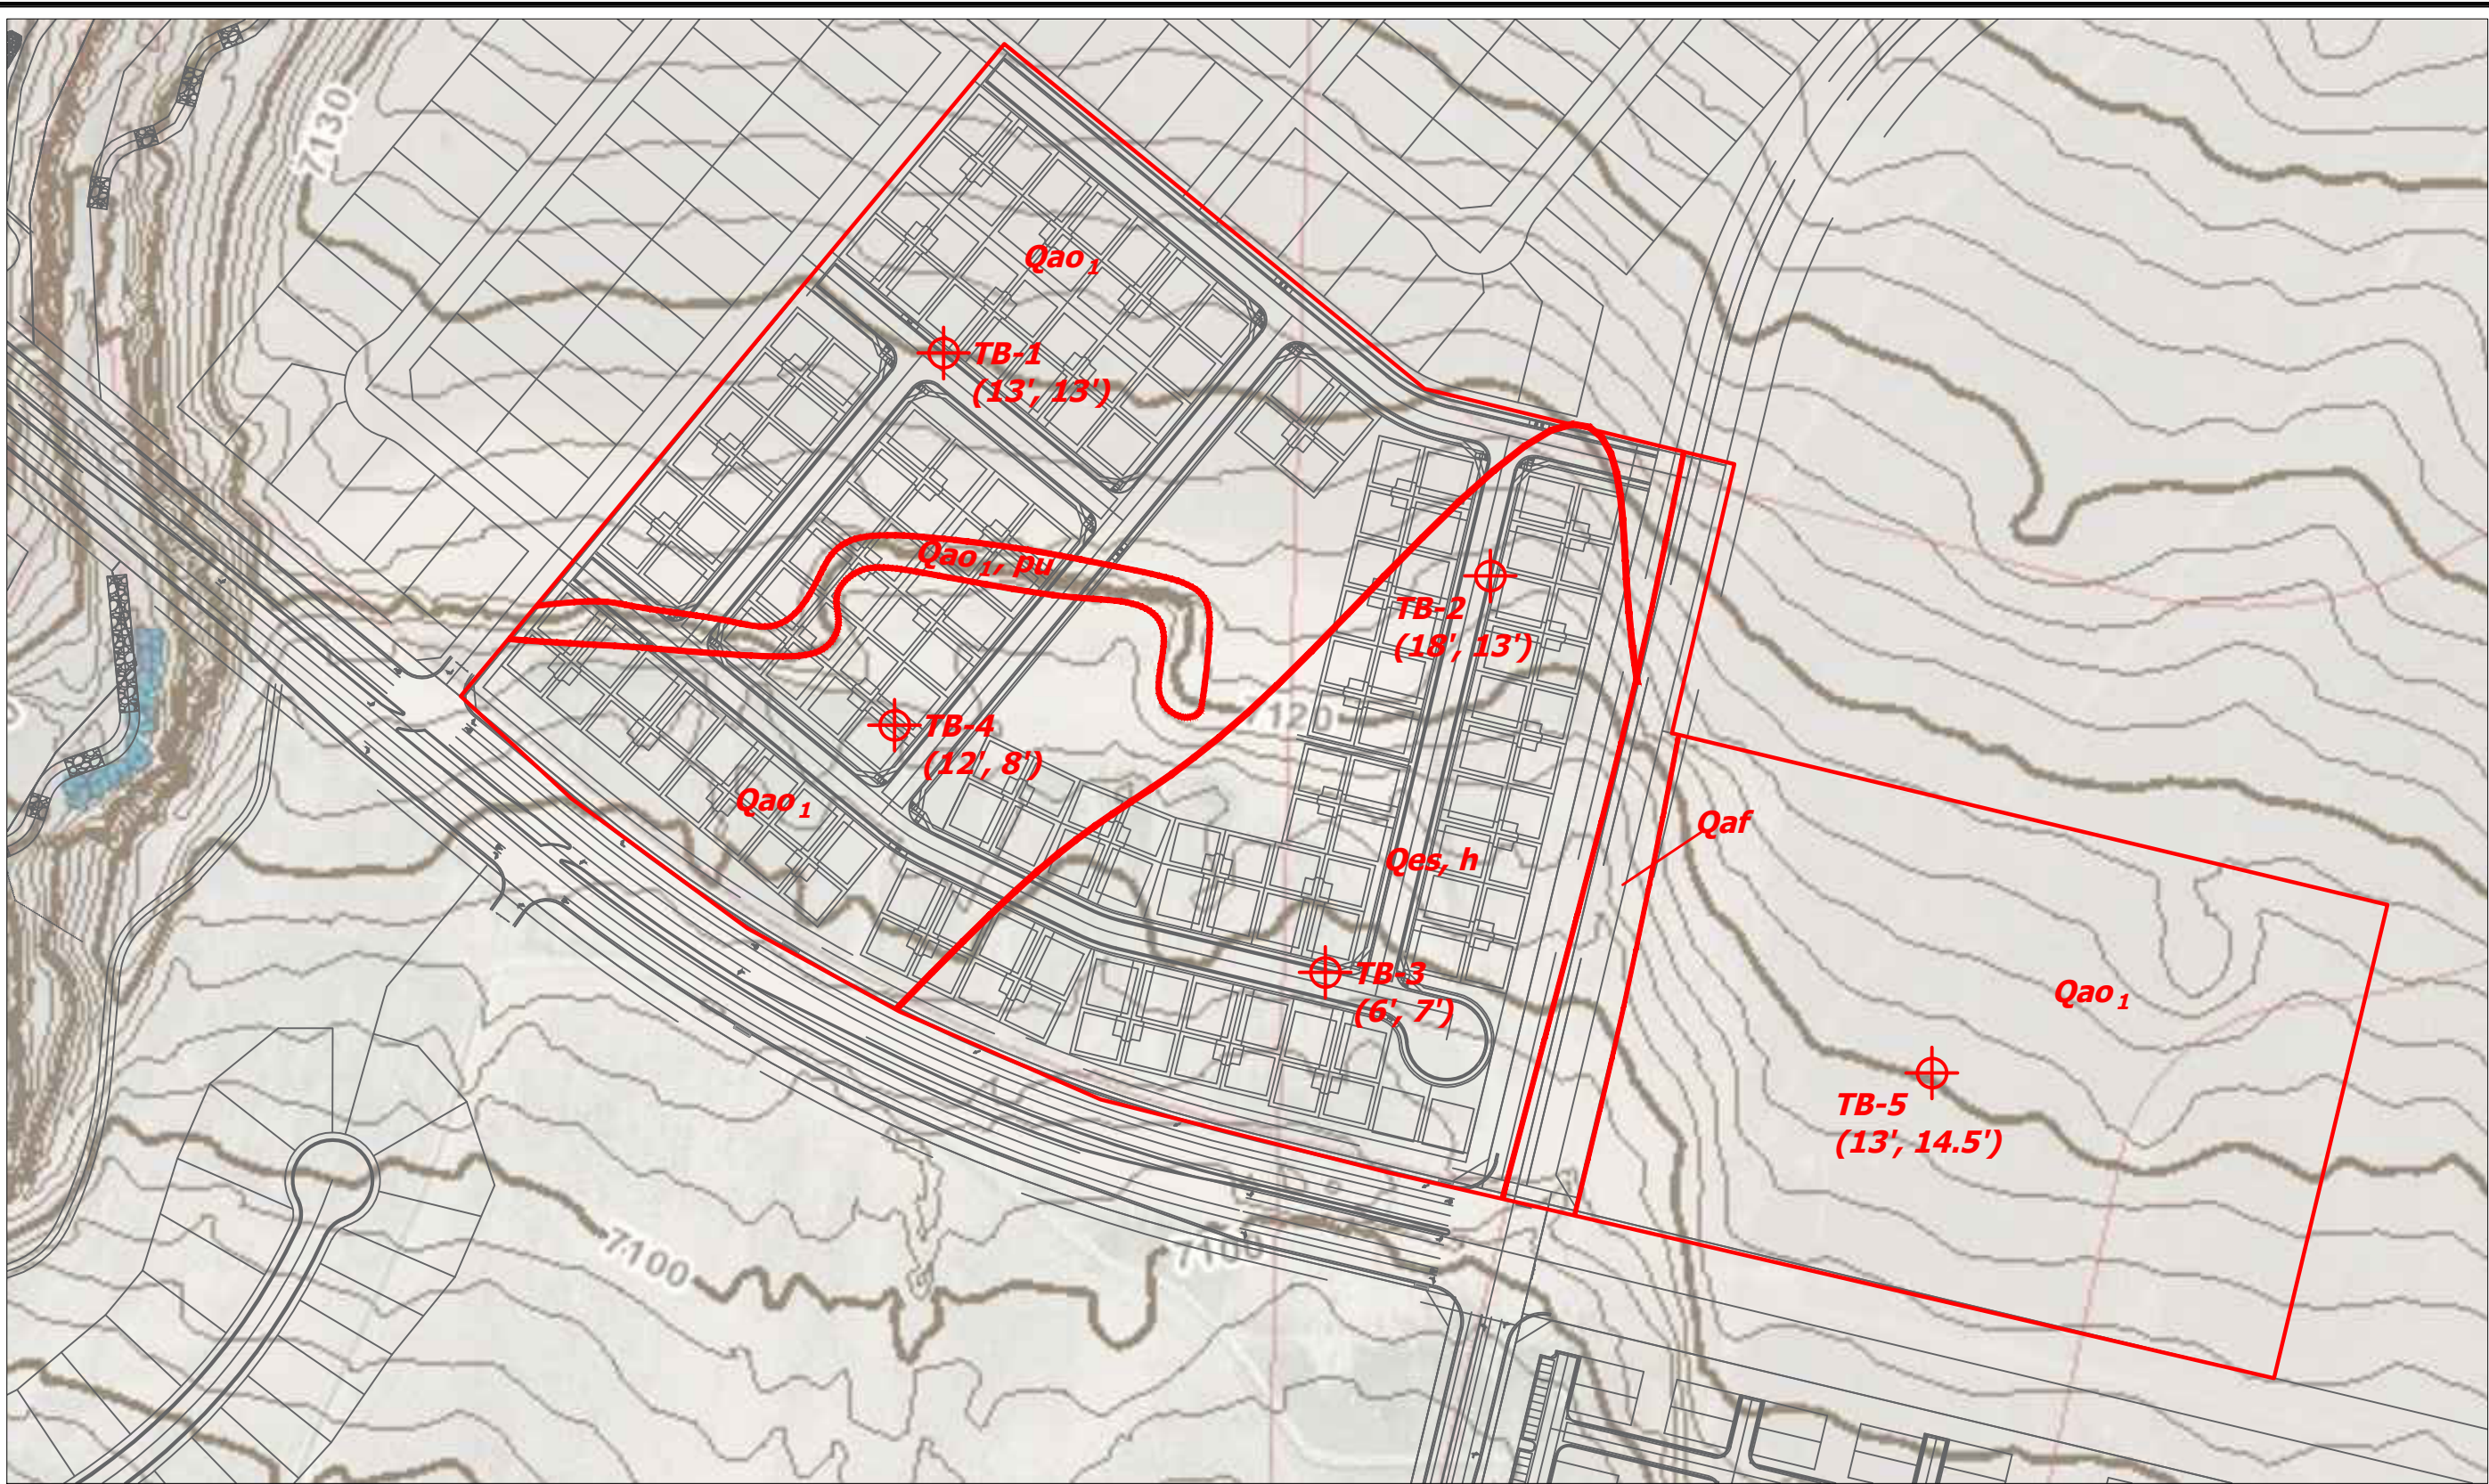
GEOLOGY/ENGINEERING GEOLOGY MAP
STERLING RANCH EAST
PRELIMINARY PLAN NO. 2
COLORADO SPRINGS, CO.
FOR: CLASSIC SRJ

As mentioned previously, detailed mapping has been performed on this site to produce an Engineering Geology Map Figure 7. This map shows the location of various geologic conditions of which the developers should be cognizant during the planning, design and construction stages of the project. These hazards and the recommended mitigation techniques are as follows:

Areas of fill were observed along the eastern side of the site associated with the existing water main within the proposed Sterling Ranch Road.

The majority of the soils encountered on-site do not exhibit collapsible characteristics, however, areas of loose soils were encountered in the test borings drilled on site. Additionally, areas mapped as Qes (eolian sand) have the potential for hydrocompaction.

These are areas that are undergoing erosion by water and sheetwash producing gullies and rill erosion. The areas significant erosion observed on the site are located in the former borrow areas where most of the vegetation had been removed.

These slopes are considered stable in their present condition; however, considerable care must be exercised in these areas not to create a condition which would tend to activate instability. These areas are primarily located along the cut slope of the former borrow area in the central portion of the site.

Mitigation: Should loose or collapsible soils be encountered beneath foundations, recompaction and moisture conditioning of the upper 2 feet of soil at 95% of its maximum Modified Proctor Dry Density ASTM D-1557 will be required. Exterior flatwork and parking areas may also experience movement. Proofrolling and recompaction of soft areas should be performed during site work.

Mitigation: Due to the nature of the soils on this site, virtually all the soils are subject to erosion by wind and water. Other minor areas of erosion were observed on site other than those mapped, particularly where some rill erosion has occurred. Areas of erosion can occur across the entire site, particularly if the soils are disturbed during construction. Vegetation reduces the potential for erosion. The areas identified where erosion is actually taking place may require check dams, regrading and revegetation using channel lining mats to anchor vegetation. Further recommendations for erosion control are discussed under Section 8.0 "Erosion Control" of this report. Recommendations pertaining to revegetation may require input from a qualified landscape architect and/or the Natural Resource Conservation Service (previously Soil Conservation Service).

Mitigation: Building should be avoided in these areas unless properly mitigated. These areas will likely be regraded during the site development. Fill placed along these slopes should be properly benched into the slope as to not create unstable conditions.

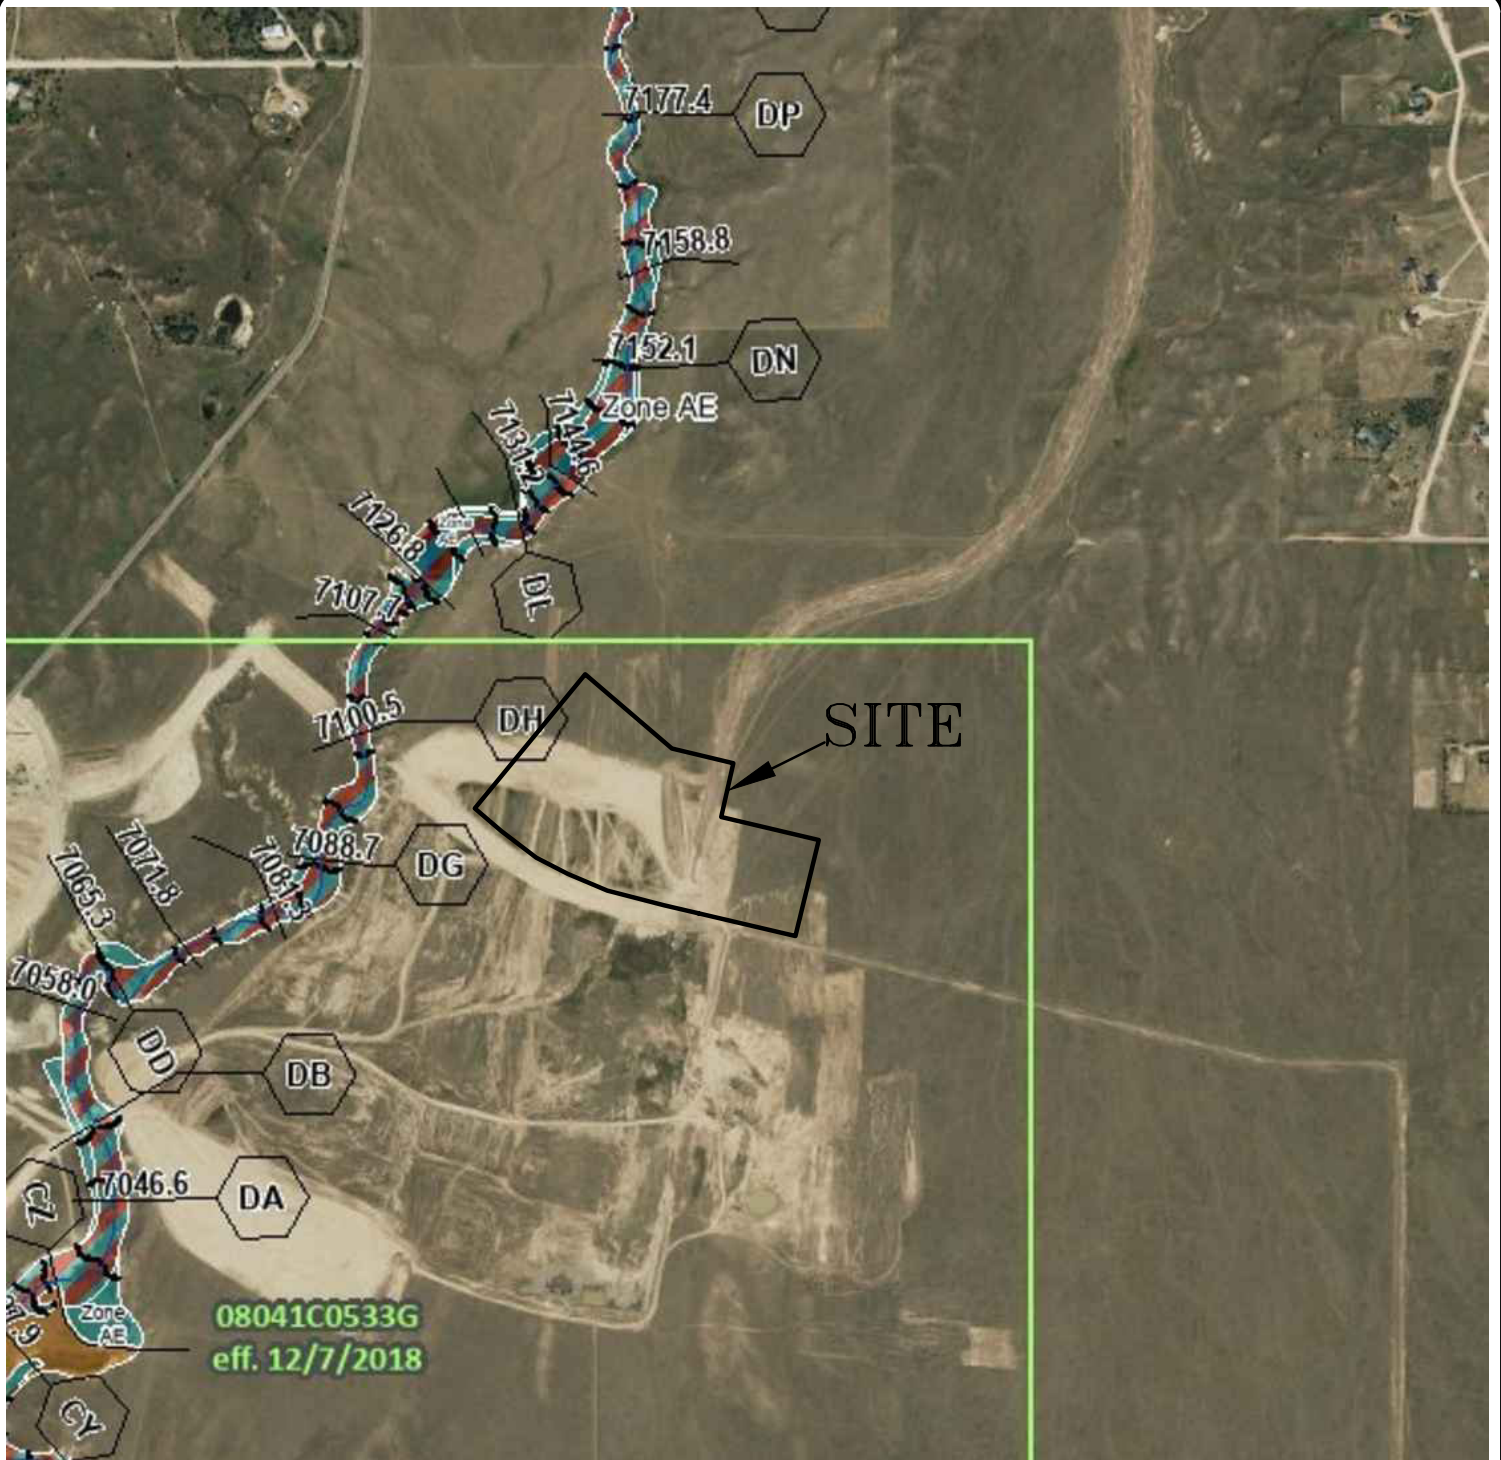
FIG NO.:
8

The site is not mapped within floodplain zones according to the FEMA Map No. 08041CO535G, Figure 8 (Reference 7). No drainages were observed on the site, however, standing water was observed to the south of the site at the northwest corner of future Briargate Parkway and Sterling Ranch Road. Groundwater was encountered in all of the test borings at depths of 7 to 13 feet. A minimum separation of 3 feet between foundation components and groundwater levels are recommended. The proposed housing has crawlspace.

Mitigation: Foundations must have a minimum 30-inch depth for frost protection. In areas where high subsurface moisture conditions are anticipated periodically, subsurface perimeter drains are recommended to help prevent the intrusion of water into areas below grade. Typical drain details are presented in Figures 9 through 11. Any grading in these areas should be done to direct surface flow around construction to avoid areas of ponded water. Structures should not block drainages. All organic material should be completely removed prior to any fill placement. Finished floor levels must be located a minimum of one foot above floodplain levels.

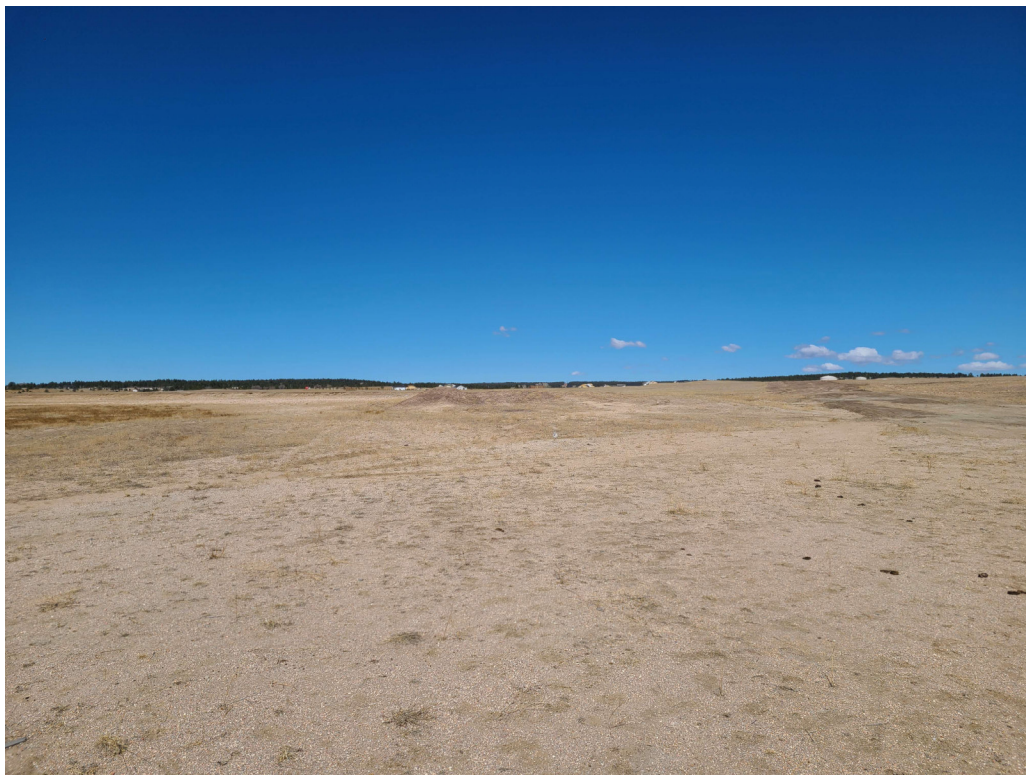
**Looking north from the
southeastern portion
of the site.**

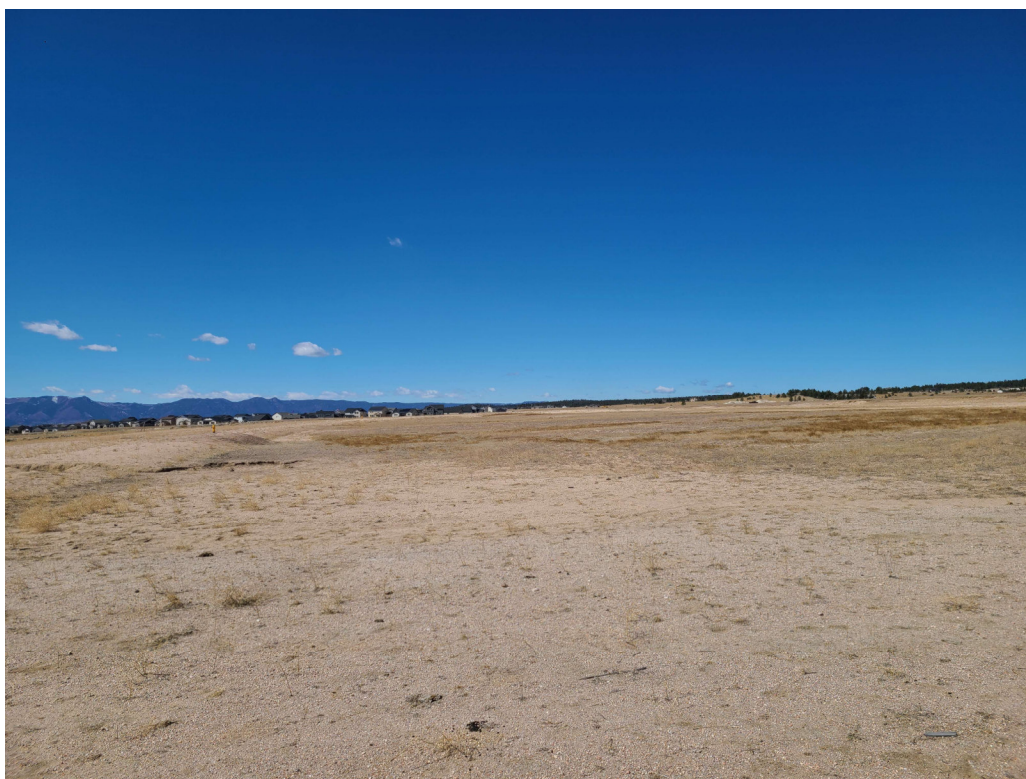
**Looking northwest
from the southeastern
portion of the site.**

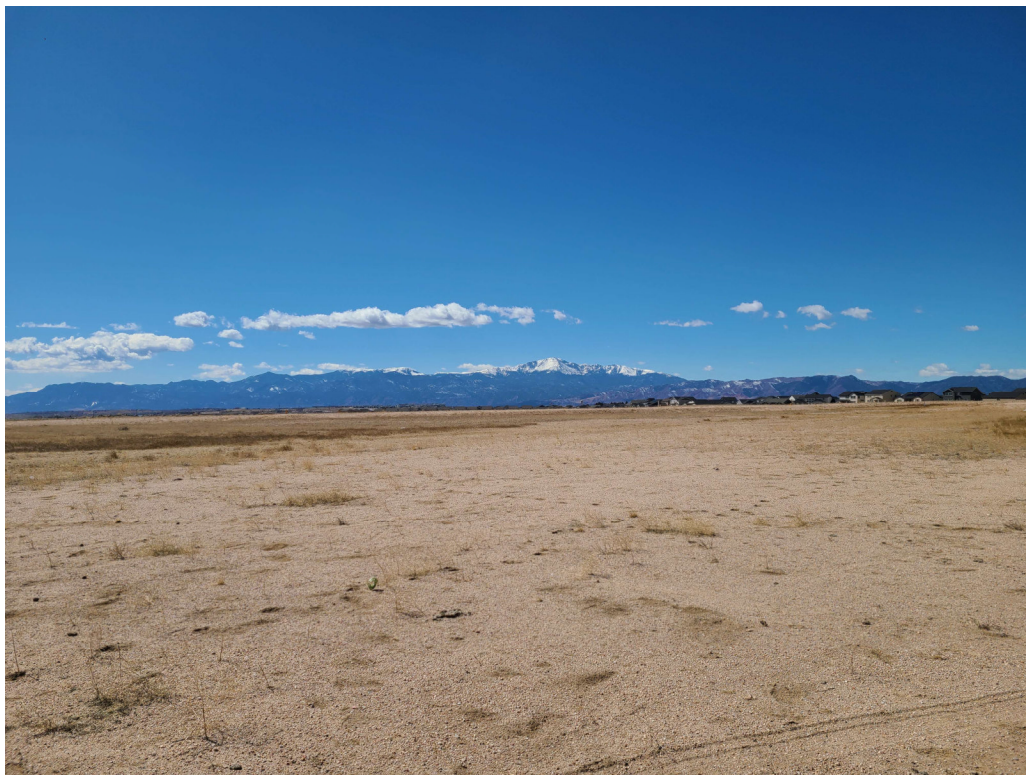
**Looking west from the
central portion of the
site.**

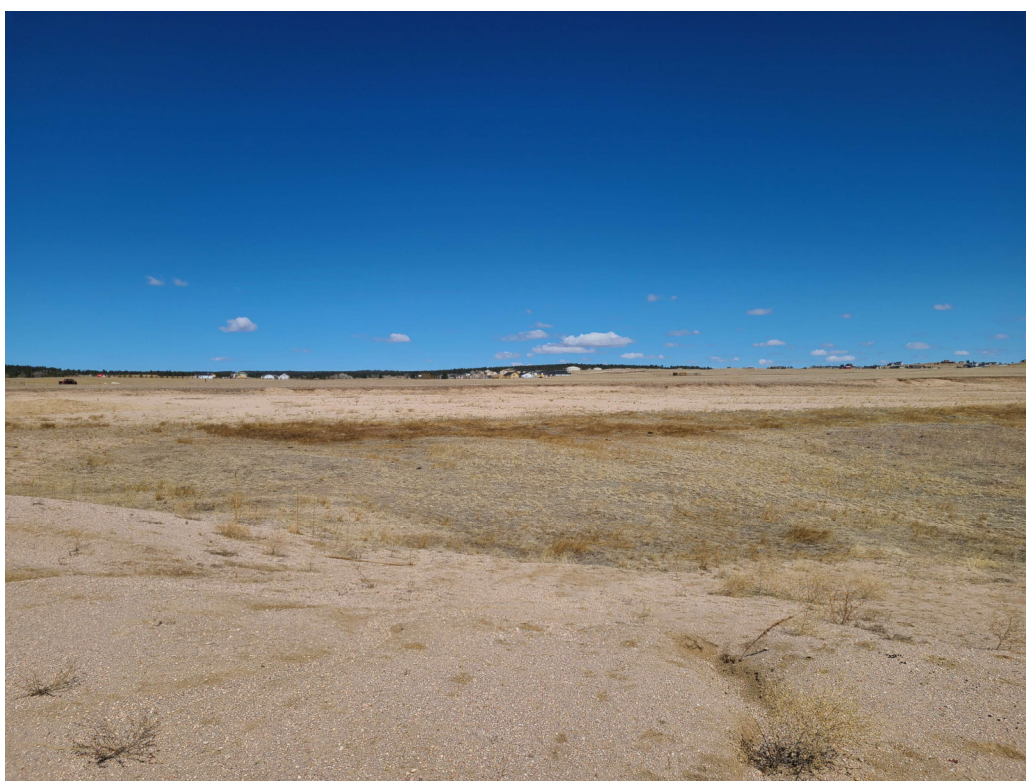
**Looking northeast
from the southwestern
portion of the site.**
