**SOIL, GEOLOGY AND
GEOLOGIC HAZARD STUDY
BANNING LEWIS RANCH
FREESTYLE NORTH
COLORADO SPRINGS, COLORADO**

Norwood Development
111 South Tejon Street, Suite 222
Colorado Springs, Colorado 80903

December 14, 2021

Entech Job No. 213235
AAPProjects/2021/213235 soils geo

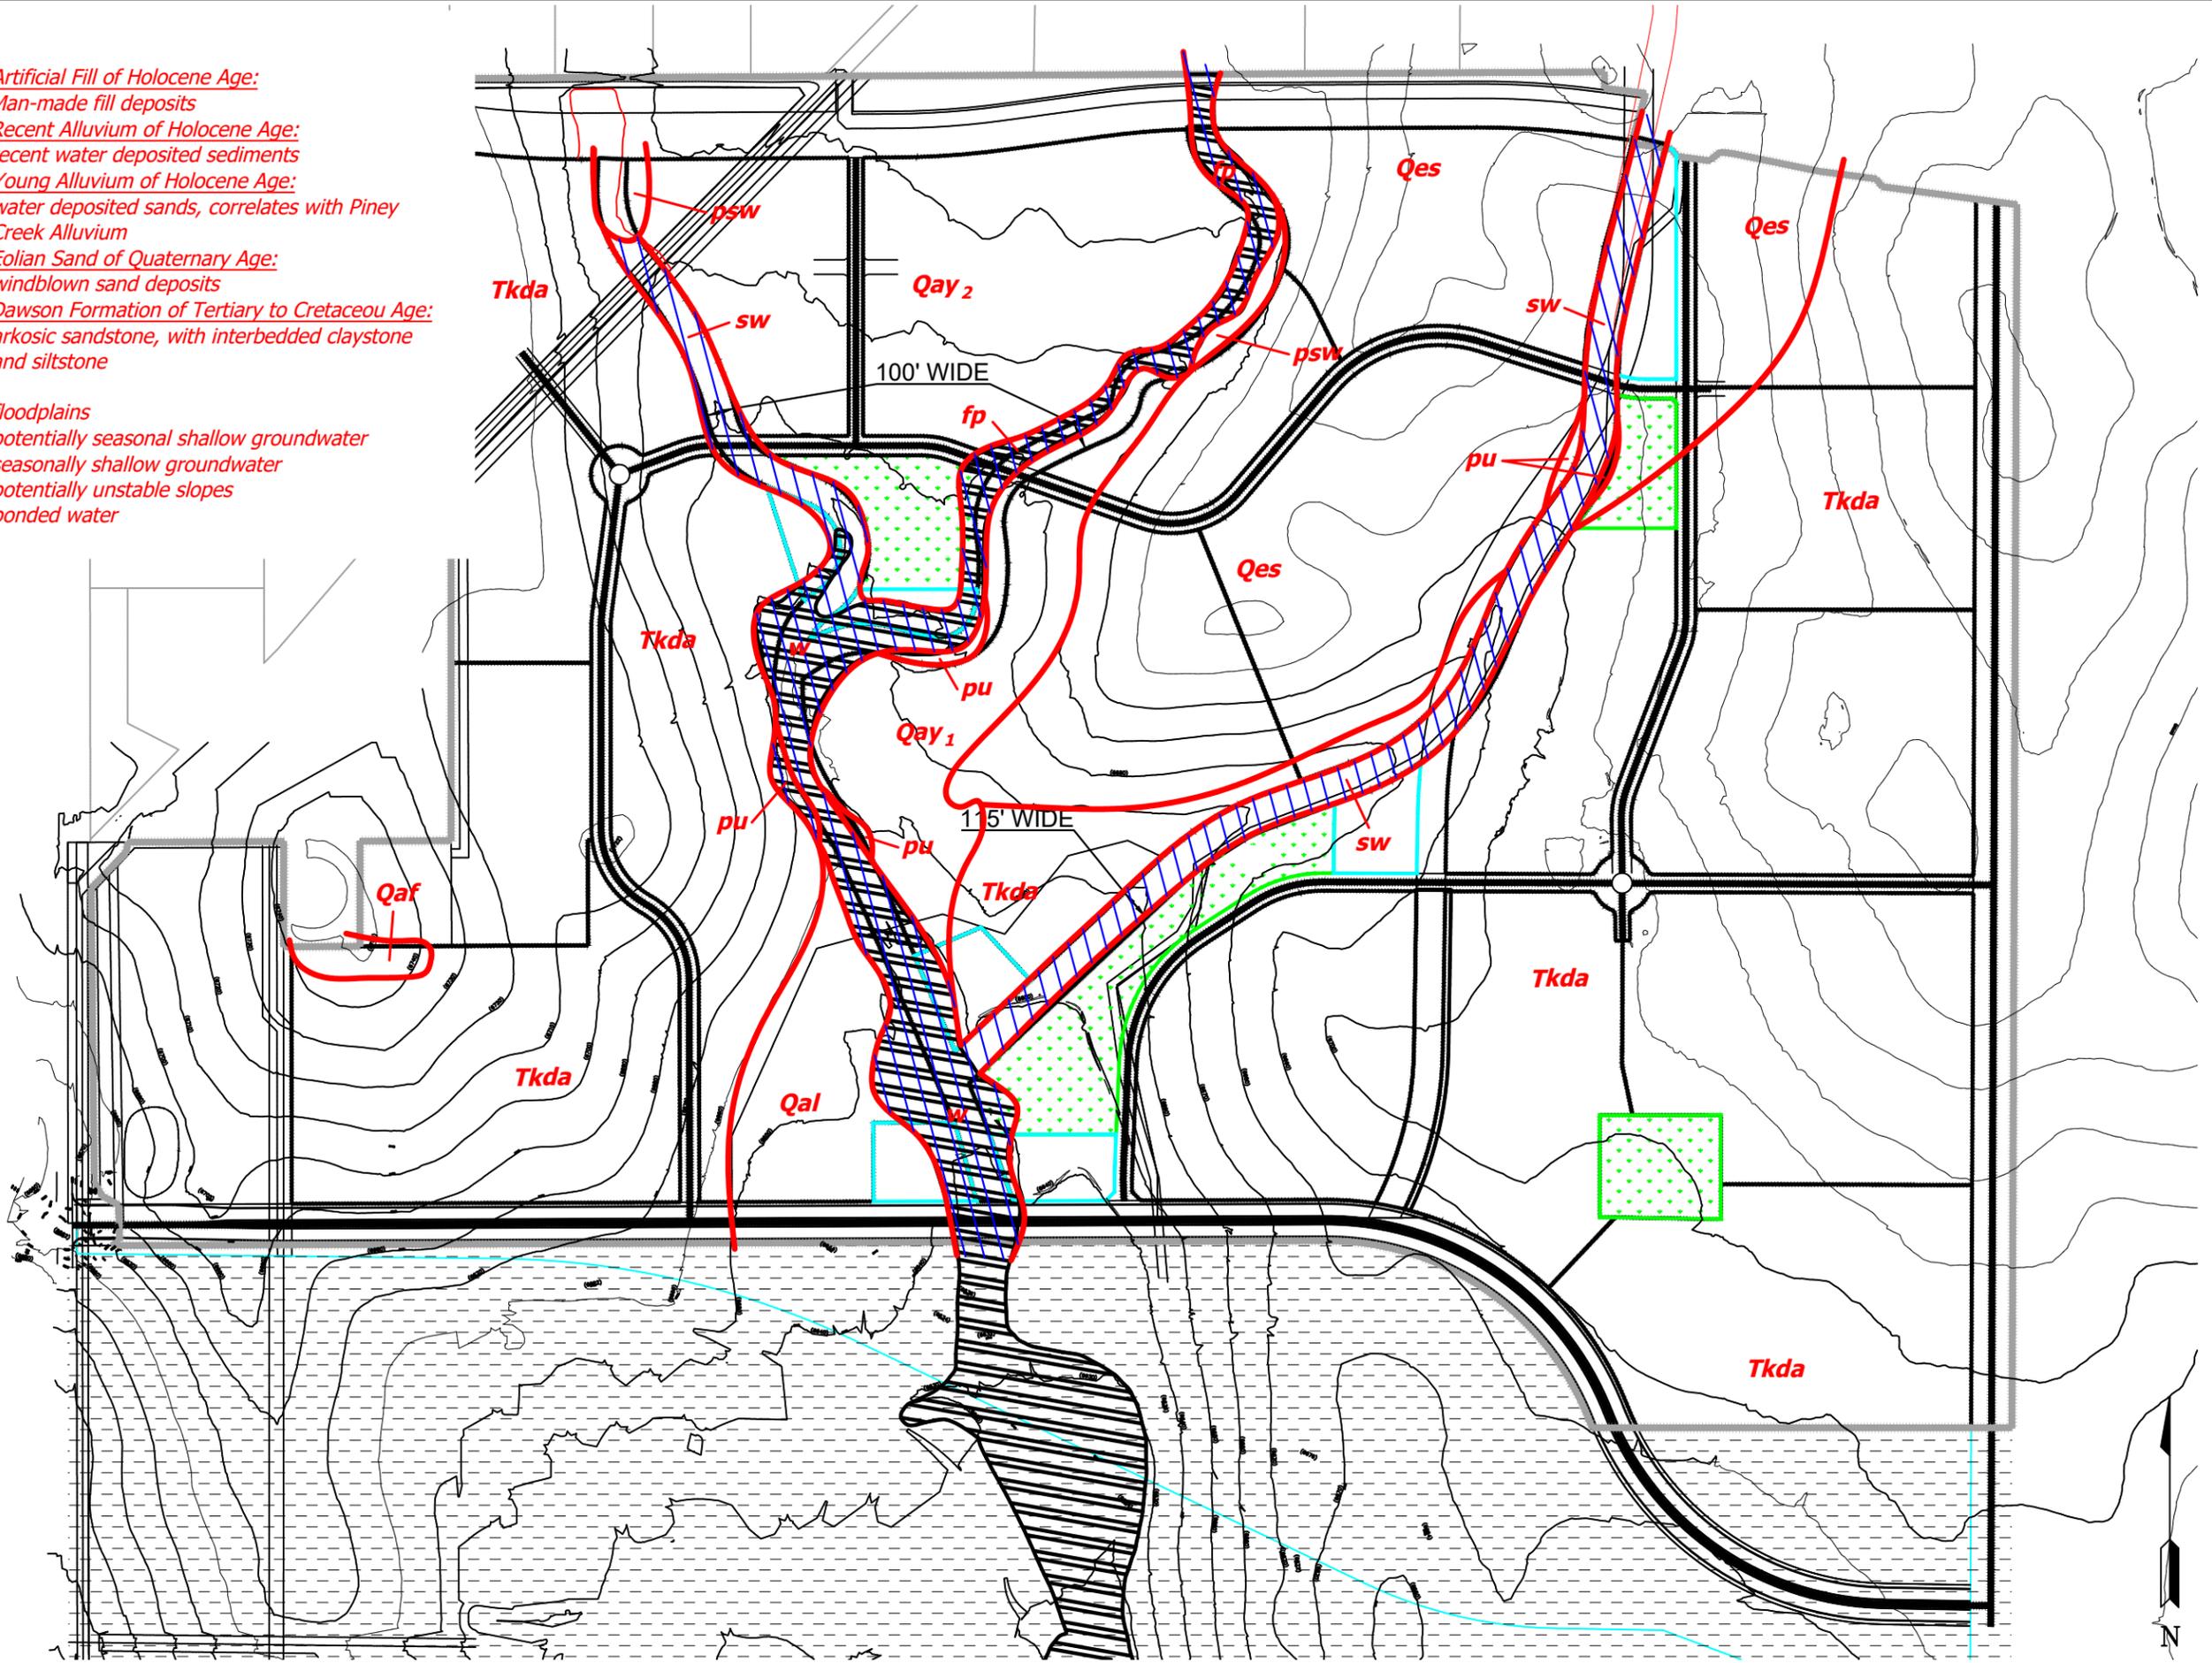
DRAWN	JAC
CHECKED	DPS
DATE	12/14/21
SCALE	AS SHOWN
JOB NO.	213235
FIGURE No.	7

Detailed mapping has been performed on this site to produce an Engineering Geology Map (Figure 7). This map shows the location of various geologic conditions of which the developers and planners should be cognizant during the planning, design and construction stages of the project. The hazards identified on this site include hydrocompaction, erosion, artificial fill, potentially expansive soils, seasonal and potentially seasonal shallow groundwater areas, springs, and areas of ponded water. The following hazards have been addressed as a part of this investigation:

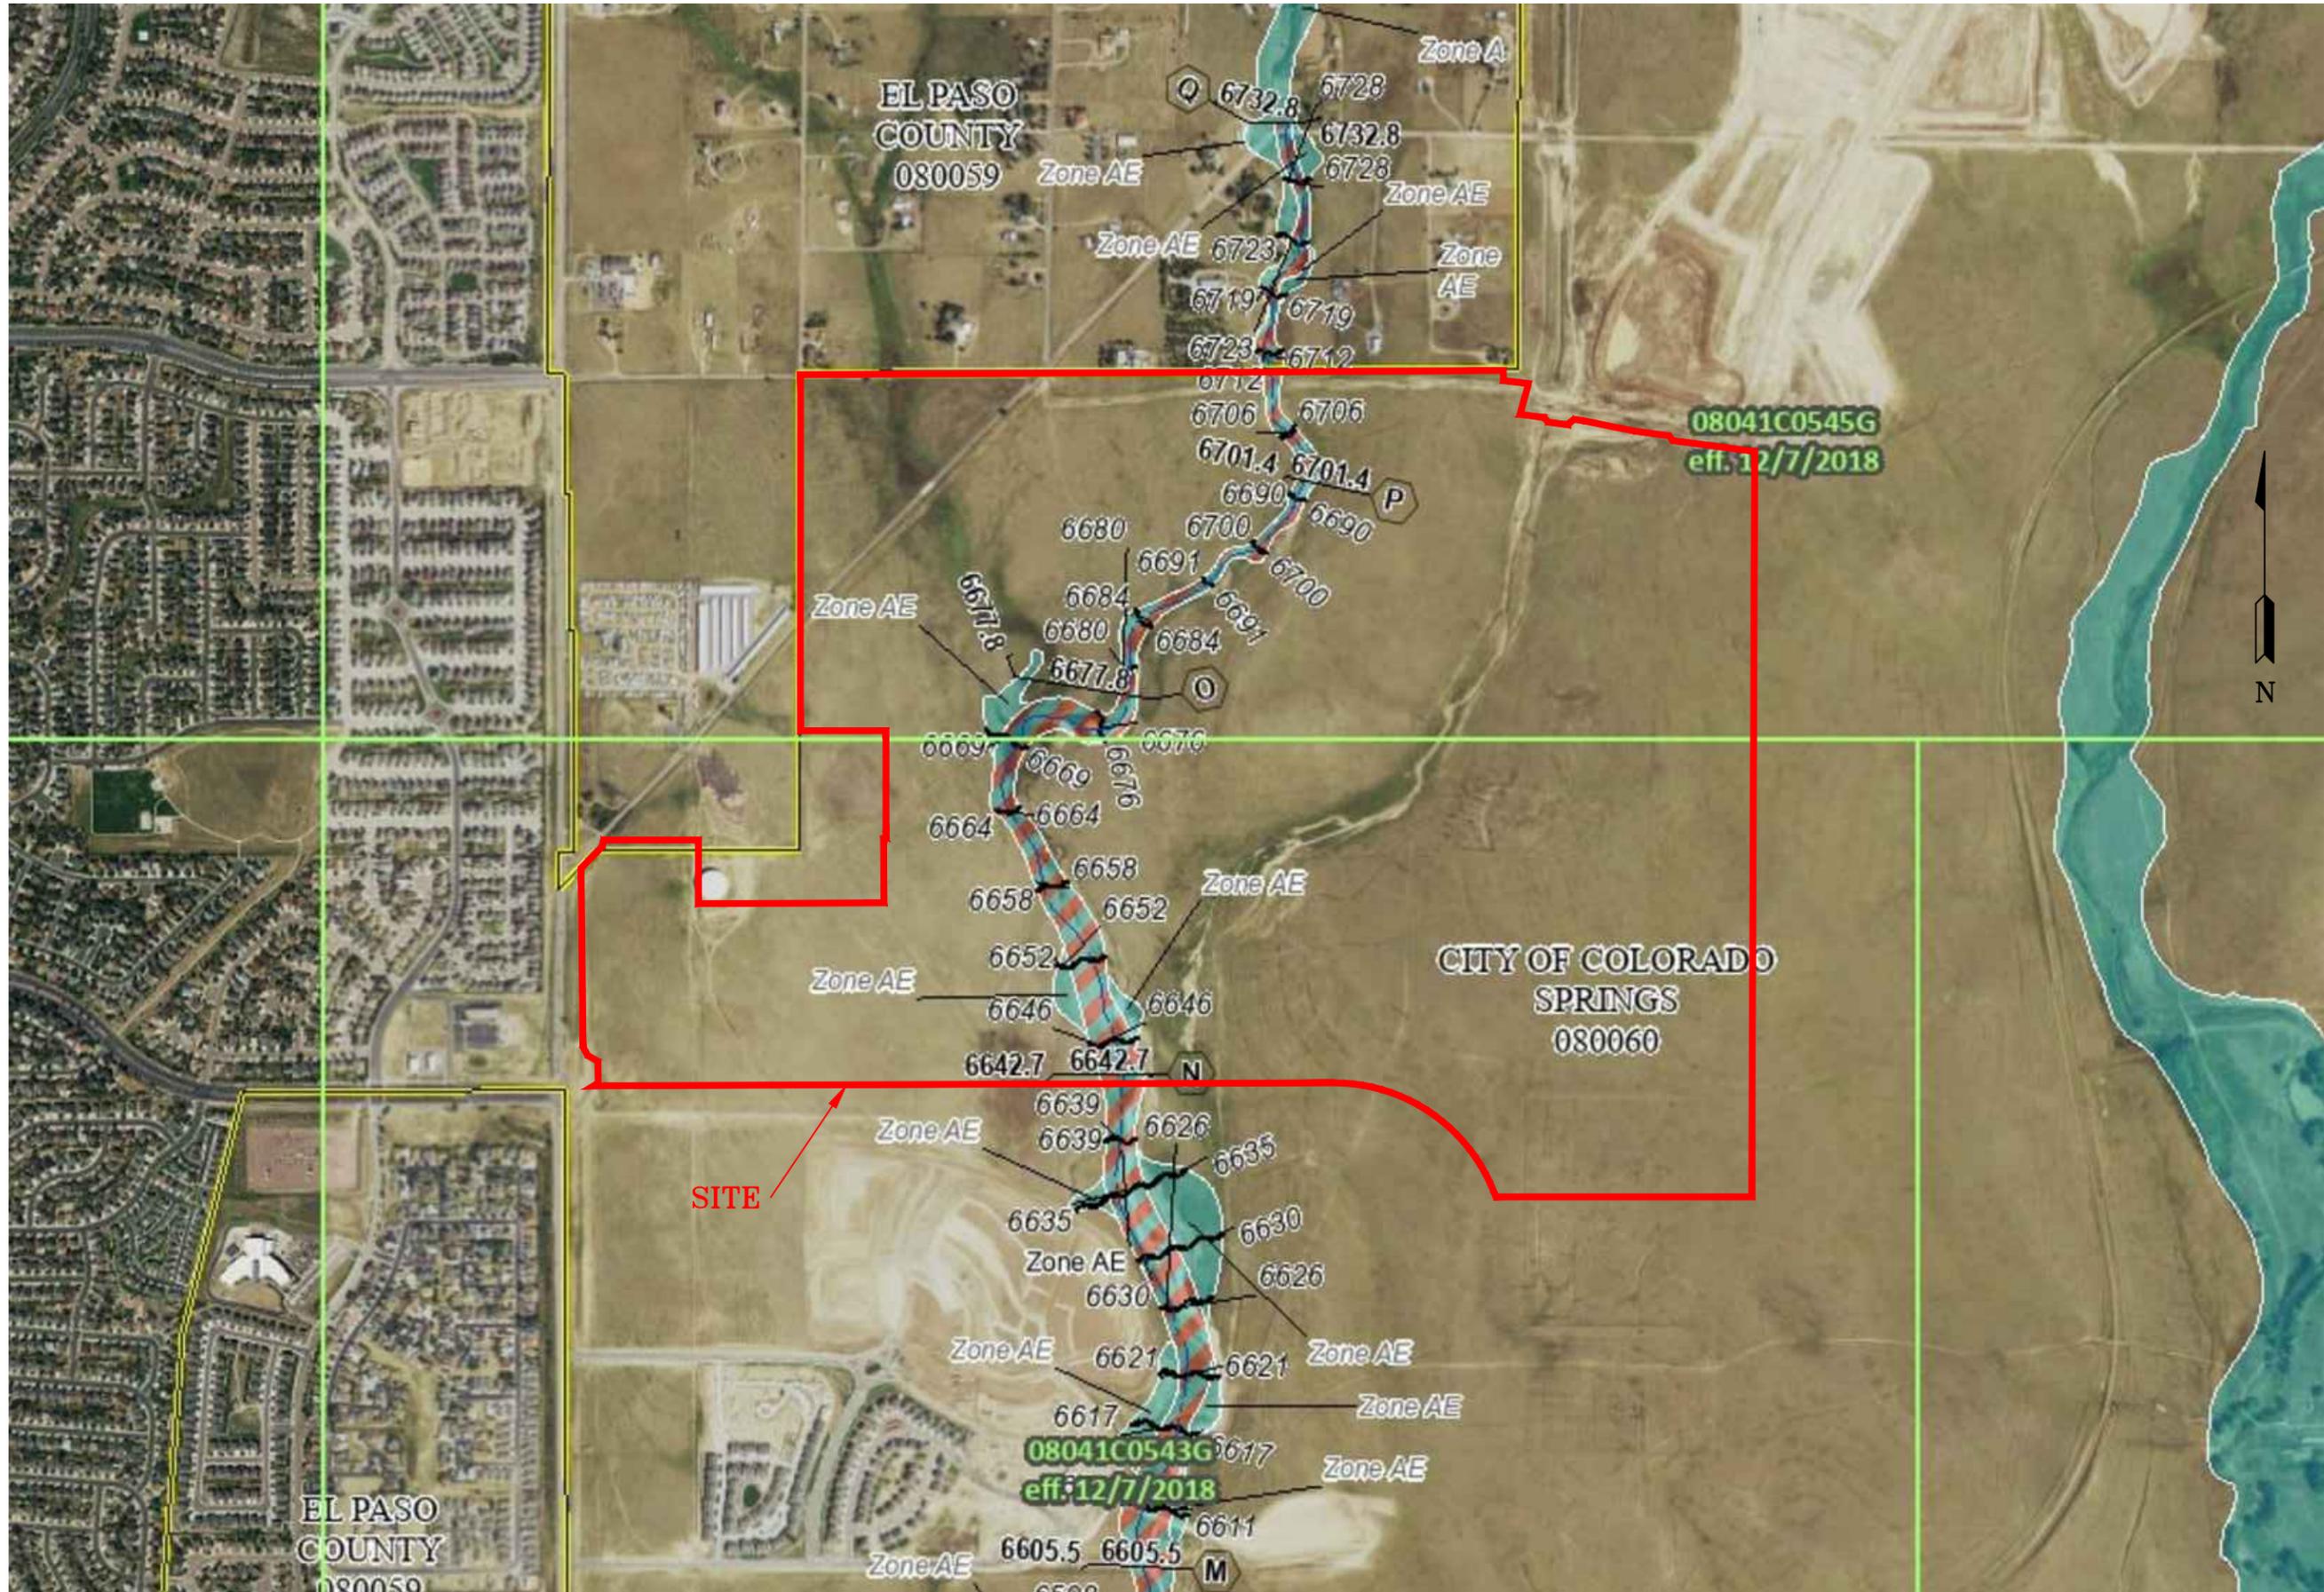
DRAWN	JAC
CHECKED	DPS
DATE	12/14/21
SCALE	AS SHOWN
JOB NO.	213235
FIGURE No.	8

Groundwater was encountered in one of the test borings at a depth of 13 feet. Areas within the drainages on-site have been identified as seasonal and potentially seasonal shallow groundwater. Only minor areas with water flowing in the drainages were noted at the time of this investigation, however, areas of ponded and standing water were observed. Areas of the site have been mapped as floodplain zones according to the FEMA Map Nos. 08041CO545G and 08041CO561G, Figure 8 (Reference 11).

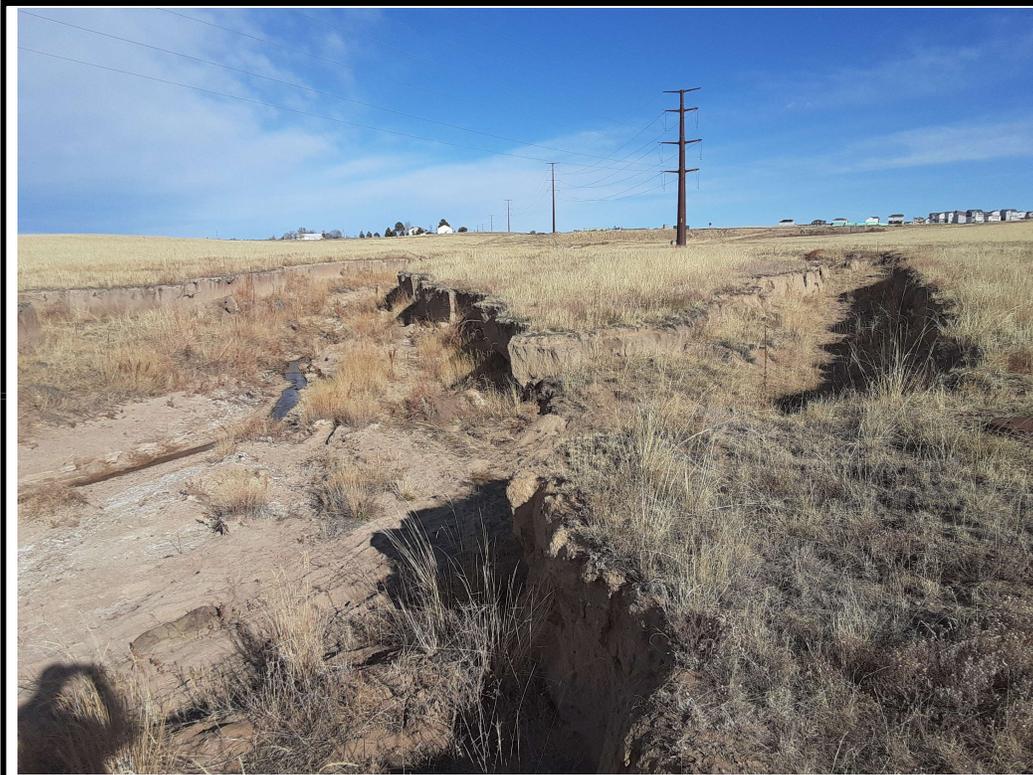
Looking north at an erosion channel along the east drainage.

Cut and fill slope areas will be subjected primarily to sheetwash and rill erosion. Unchecked rill erosion can eventually lead to concentrated flows of water and gully erosion. The best means to combat this type of erosion is, where possible, the adequate re-vegetation of cut and fill slopes. Cut and fill slopes having gradients more than three (3) horizontal to one (1) vertical become increasingly more difficult to re-vegetate successfully. Therefore, recommendations pertaining to the vegetation of the cut and fill slopes may require input from a qualified landscape architect and/or the Soil Conservation Service.

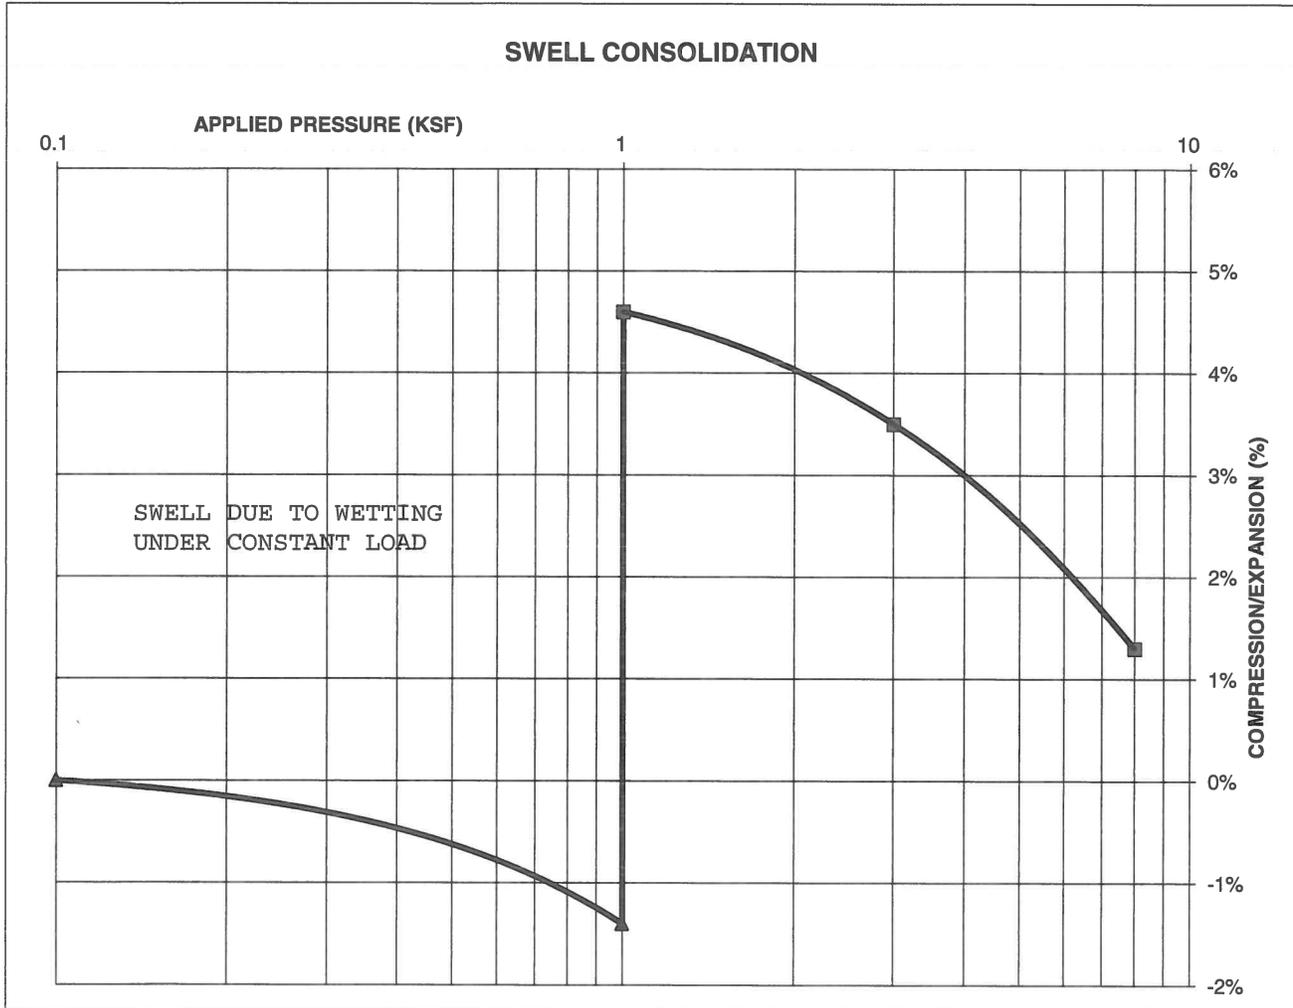
TEST BORING #	3	DEPTH(ft)	5
DESCRIPTION	CH	SOIL TYPE	2
NATURAL UNIT DRY WEIGHT (PCF)	104		
NATURAL MOISTURE CONTENT	20.7%		
SWELL/CONSOLIDATION (%)	6.0%

Mitigation: Should expansive soils be encountered beneath foundations; mitigation will be necessary. Mitigation of expansive soils will require special foundation design. Overexcavation and replacement with non-expansive soils at 95 percent of its maximum Modified Proctor Dry Density, ASTM D-1557 is a suitable mitigation which is common in the area. Drilled piers are another option that is used in areas where highly expansive soils are encountered. Typical minimum pier depths are on the order of 25 feet or more and require penetration into the bedrock material a minimum of 4 to 6 feet, depending on building loads. Floor slabs on expansive soils should be expected to experience movement. Overexcavation and replacement has been successful in minimizing slab movements. The use of structural floors should be considered for basement construction on highly expansive clays. Final recommendations should be determined after additional investigation of each building site.
