**SOILS AND GEOLOGY STUDY  
TIMBERS AT BLACK FOREST SUBDIVISION  
9220 ARROYA LANE  
PARCEL NO. 52054-00-041  
EL PASO COUNTY, COLORADO**

March 5, 2026

Entech Job No. 251875  
LLL/JCG

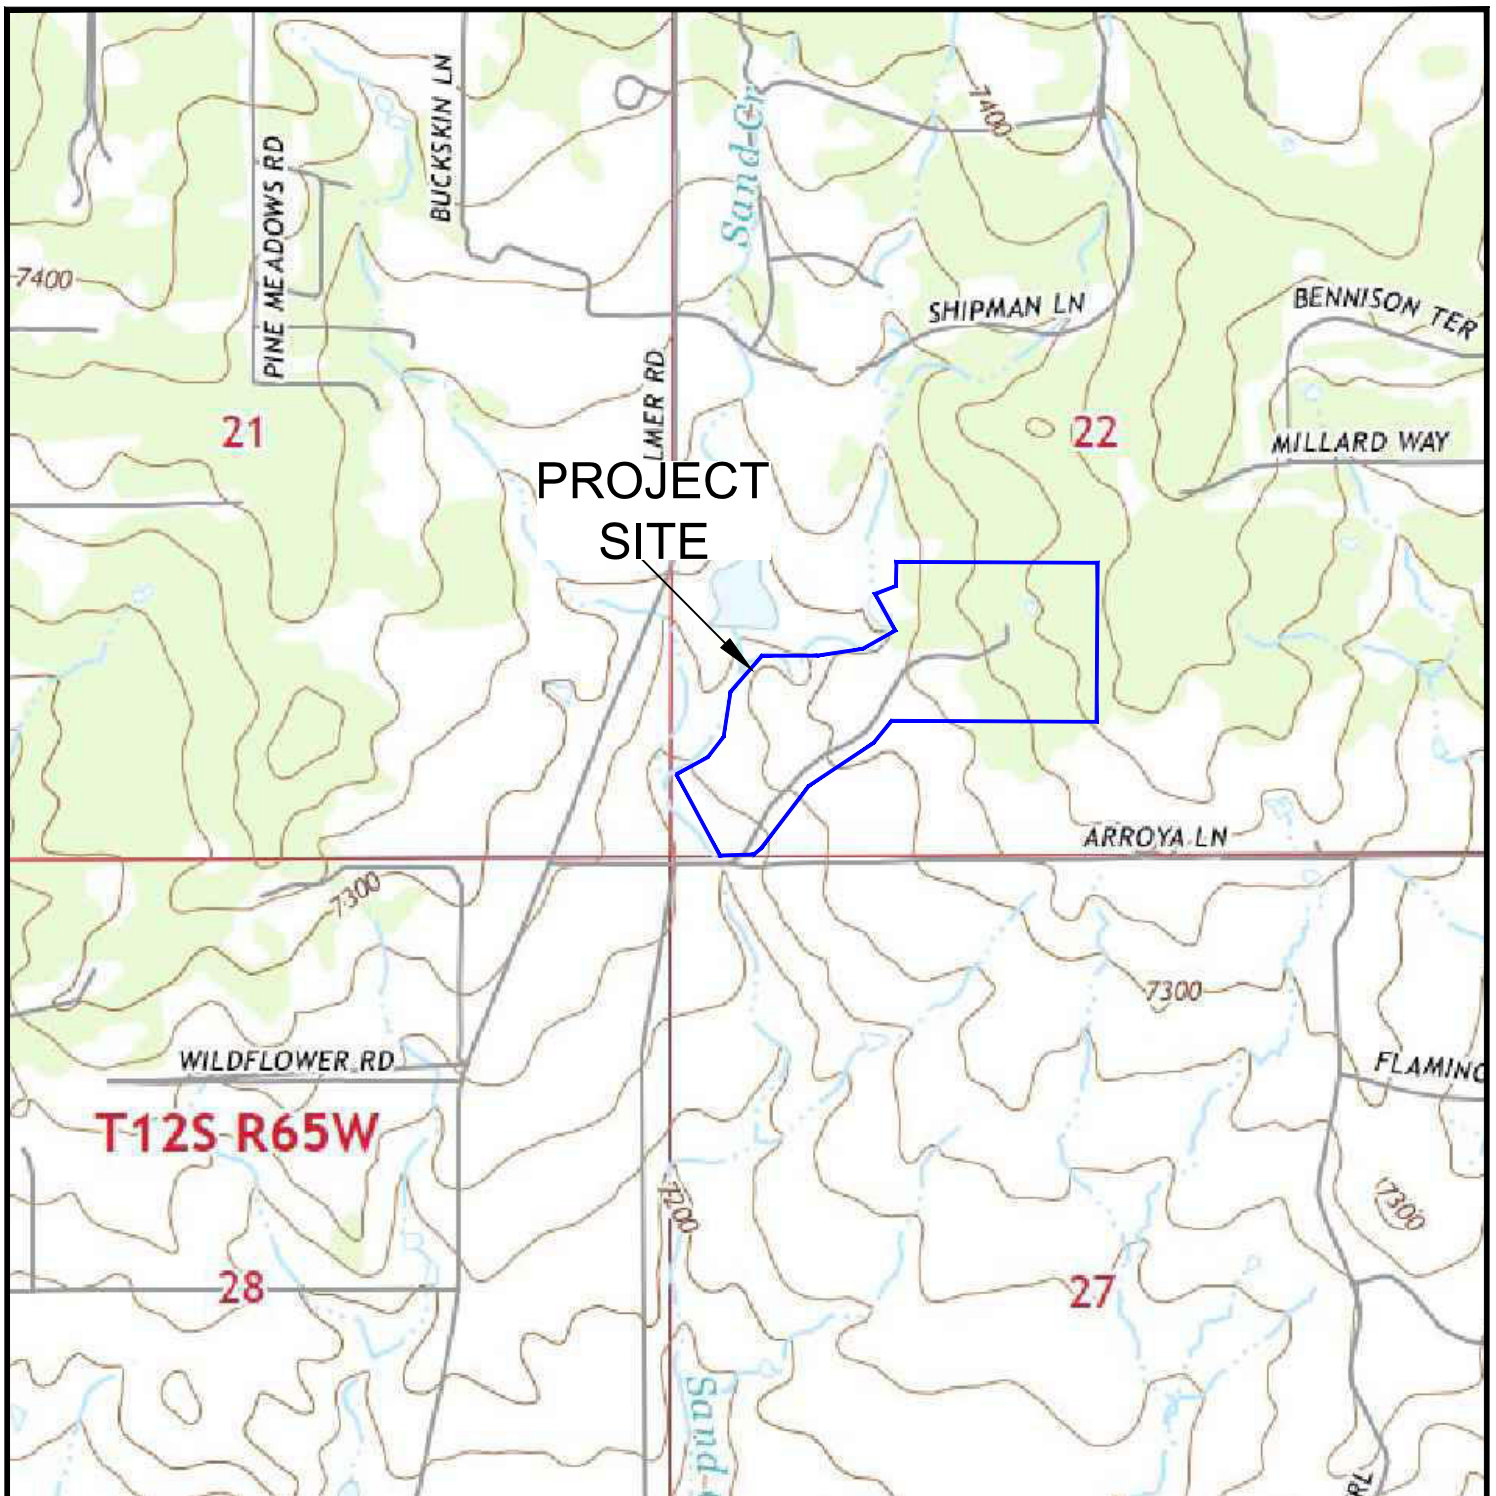
FIG. 2

please identify all slopes 30% or greater; these are to be placed in no build areas.

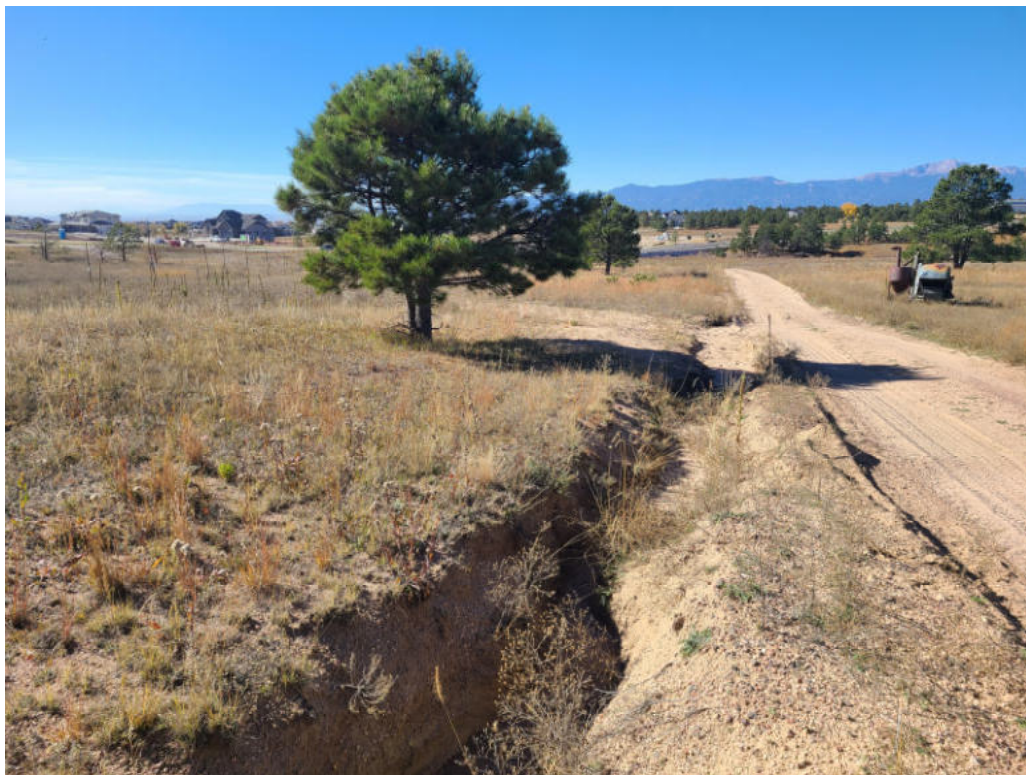
**Looking southwest  
along gravel driveway  
in area of erosion from  
southern portion of the  
site.**

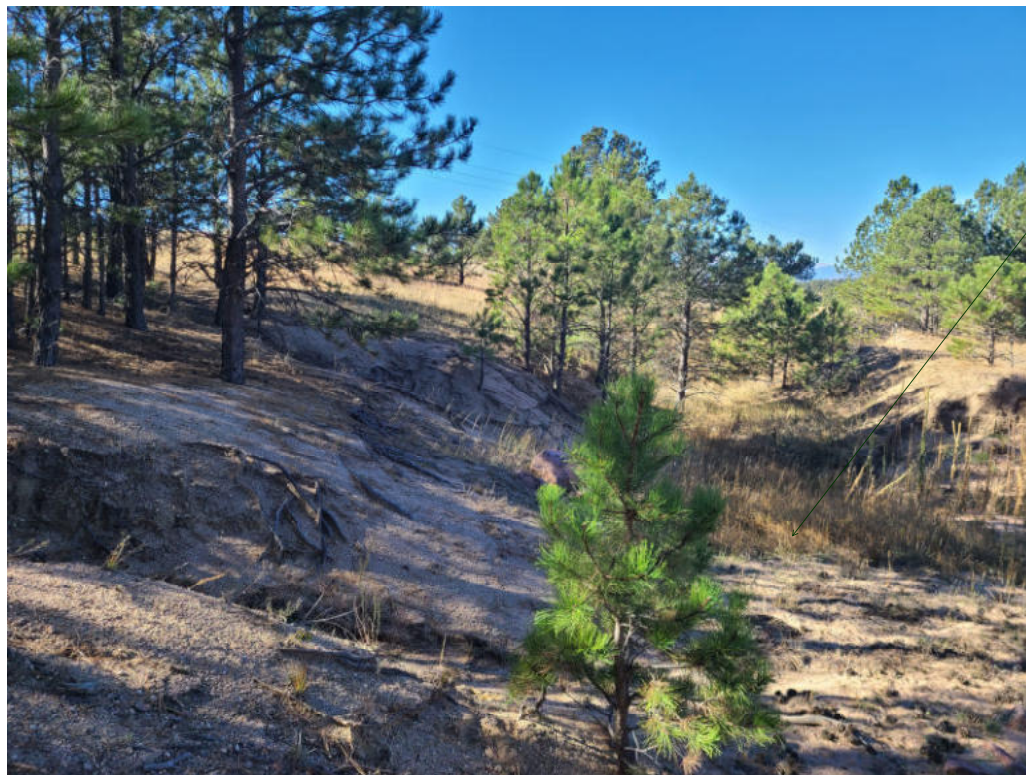
These slopes are considered stable in their present condition; however, considerable care must be exercised in these areas not to create a condition which would tend to activate instability. These areas are primarily located along the banks of Sand Creek, which are proposed as open space.

**Looking southwest  
along the potentially  
unstable slopes from  
the northern portion of  
the site.**

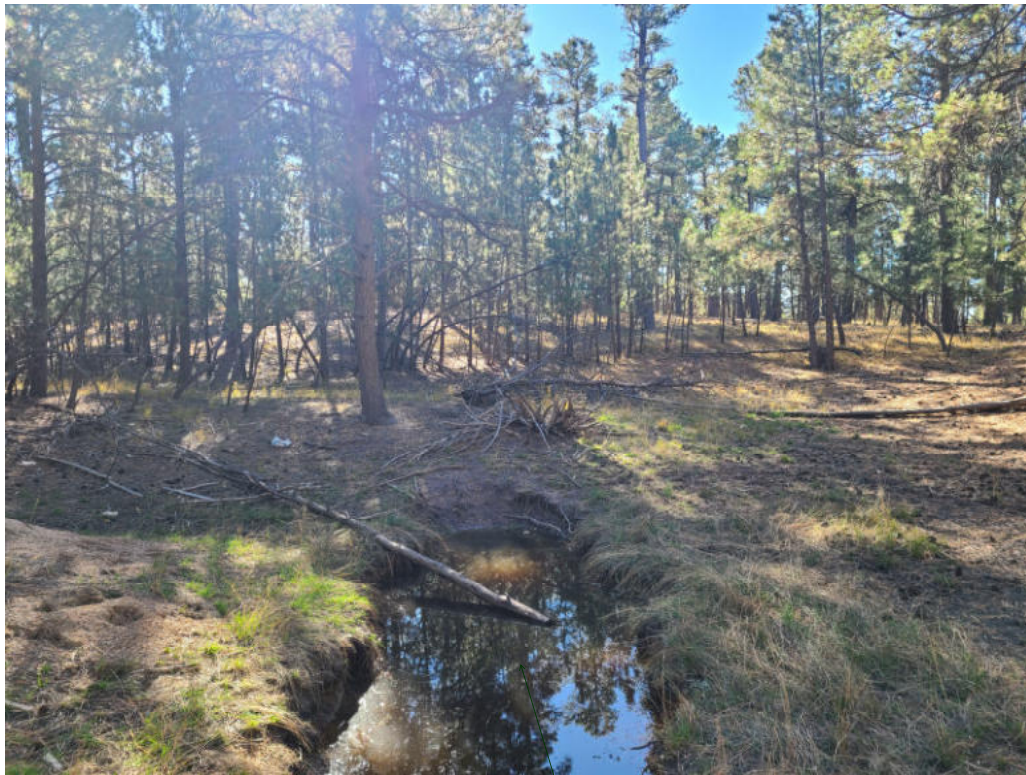
The Sand Creek drainage in the western portion of the site, and existing stock ponds have been identified as shallow groundwater areas. The other drainages and minor drainage swales on the site have been identified as potentially seasonal shallow groundwater areas. In these areas, we would anticipate periodic high subsurface moisture conditions and frost heave potential on a seasonal basis. Groundwater was encountered in three of the test borings (TB-1, TB-2, and TB-6) at depths of 10 to 16 feet bgs which were drilled to 20 feet during or subsequent to drilling. The remaining three borings were dry to the depths explored. Redoximorphic features were encountered in two of the five test pits (TP-3 and TP-4) at depths of 4 to 6 feet bgs. Any structures in or adjacent to these areas should follow the mitigation discussed below.

**Looking south towards  
area of ponded water  
in stock pond along  
Lots 11 and 12.**

Mitigation: We anticipate that structures will not be located in these zones. Foundations must have a minimum 30-inch depth for frost protection. Buildings should be a minimum of 3 feet above groundwater levels. Subsurface perimeter drains are recommended for any usable below-grade areas including crawlspaces. Should groundwater be encountered within 3 feet of foundation grade, additional drains that could include but are not limited to interceptor drains, underslab drains (capillary break), and overexcavation drains may be needed. Typical drain details are presented in Figures 9 to 11. Any grading in these areas should be done to direct surface flow around construction to avoid areas of ponded water. Structures should not block drainages. All organic material should be completely removed prior to any fill placement. Septic fields should not be placed in areas where there is the potential for shallow groundwater.
