**ENTECH**  
ENGINEERING, INC.

**WASTEWATER STUDY  
TIMBERS AT BLACK FOREST SUBDIVISION  
9220 ARROYA LANE  
PARCEL NO. 52054-00-041  
EL PASO COUNTY, COLORADO**

March 5, 2026

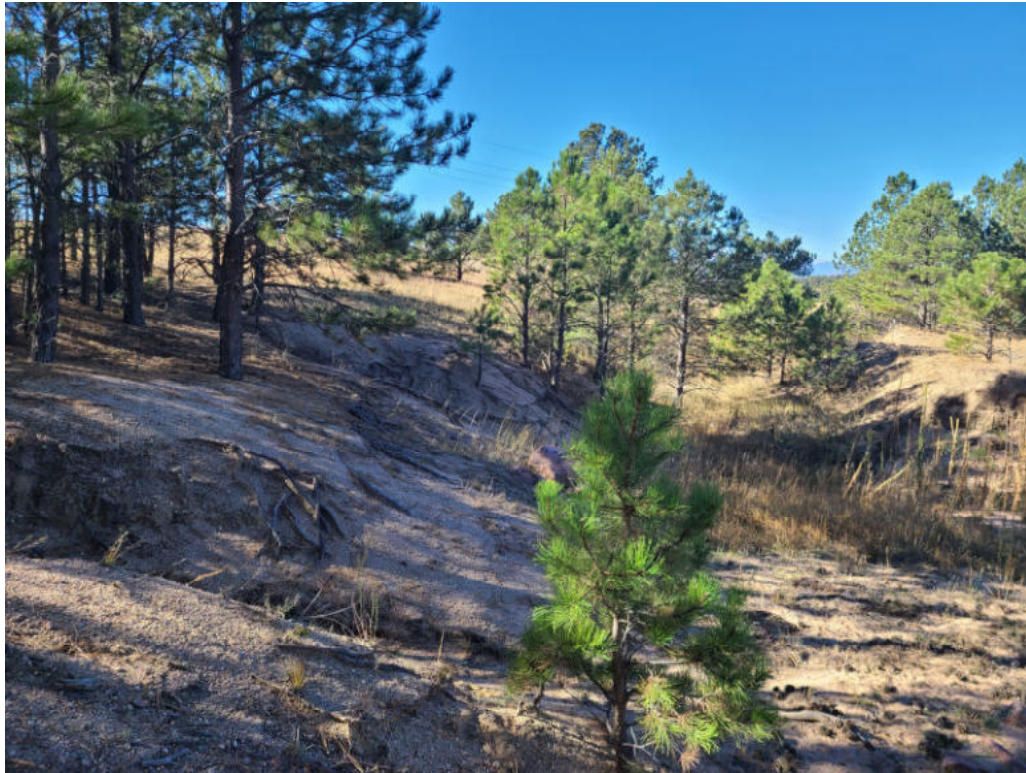
**Looking southwest  
along the potentially  
unstable slopes from  
the northern portion of  
the site.**

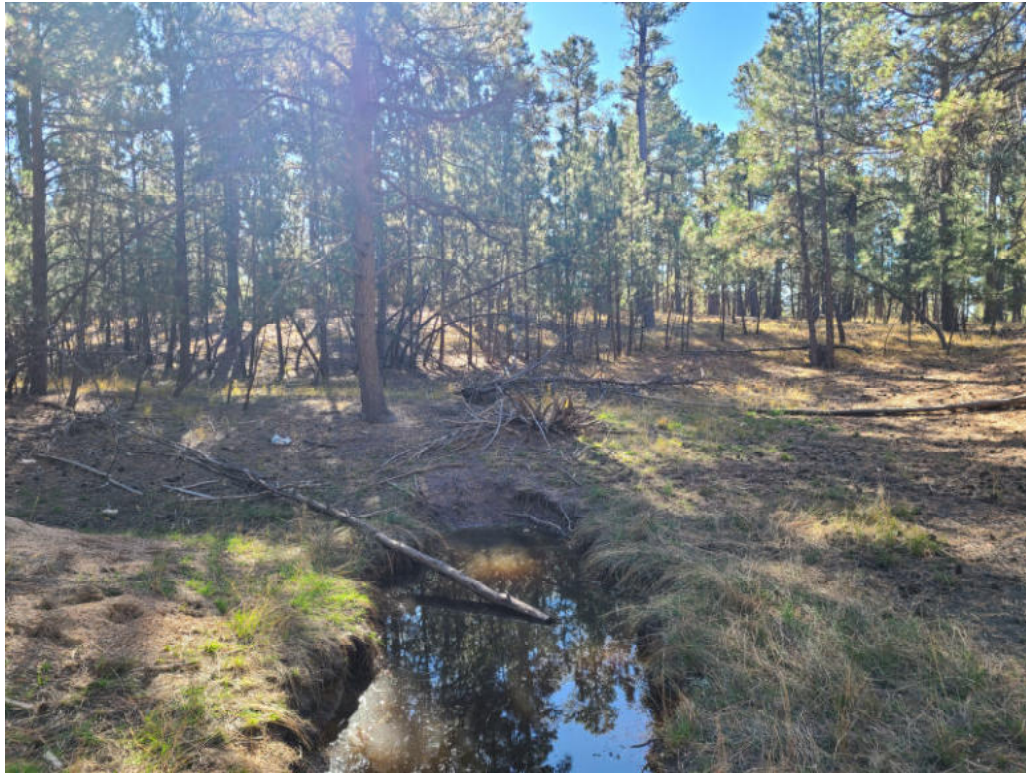
**Looking south towards  
area of ponded water  
in stock pond along  
Lots 11 and 12.**
