**SOILS AND GEOLOGY STUDY  
TIMBERS AT BLACK FOREST SUBDIVISION  
9220 ARROYA LANE  
PARCEL NO. 52054-00-041  
EL PASO COUNTY, COLORADO**

March 5, 2026

Entech Job No. 251875  
LLL/JCG

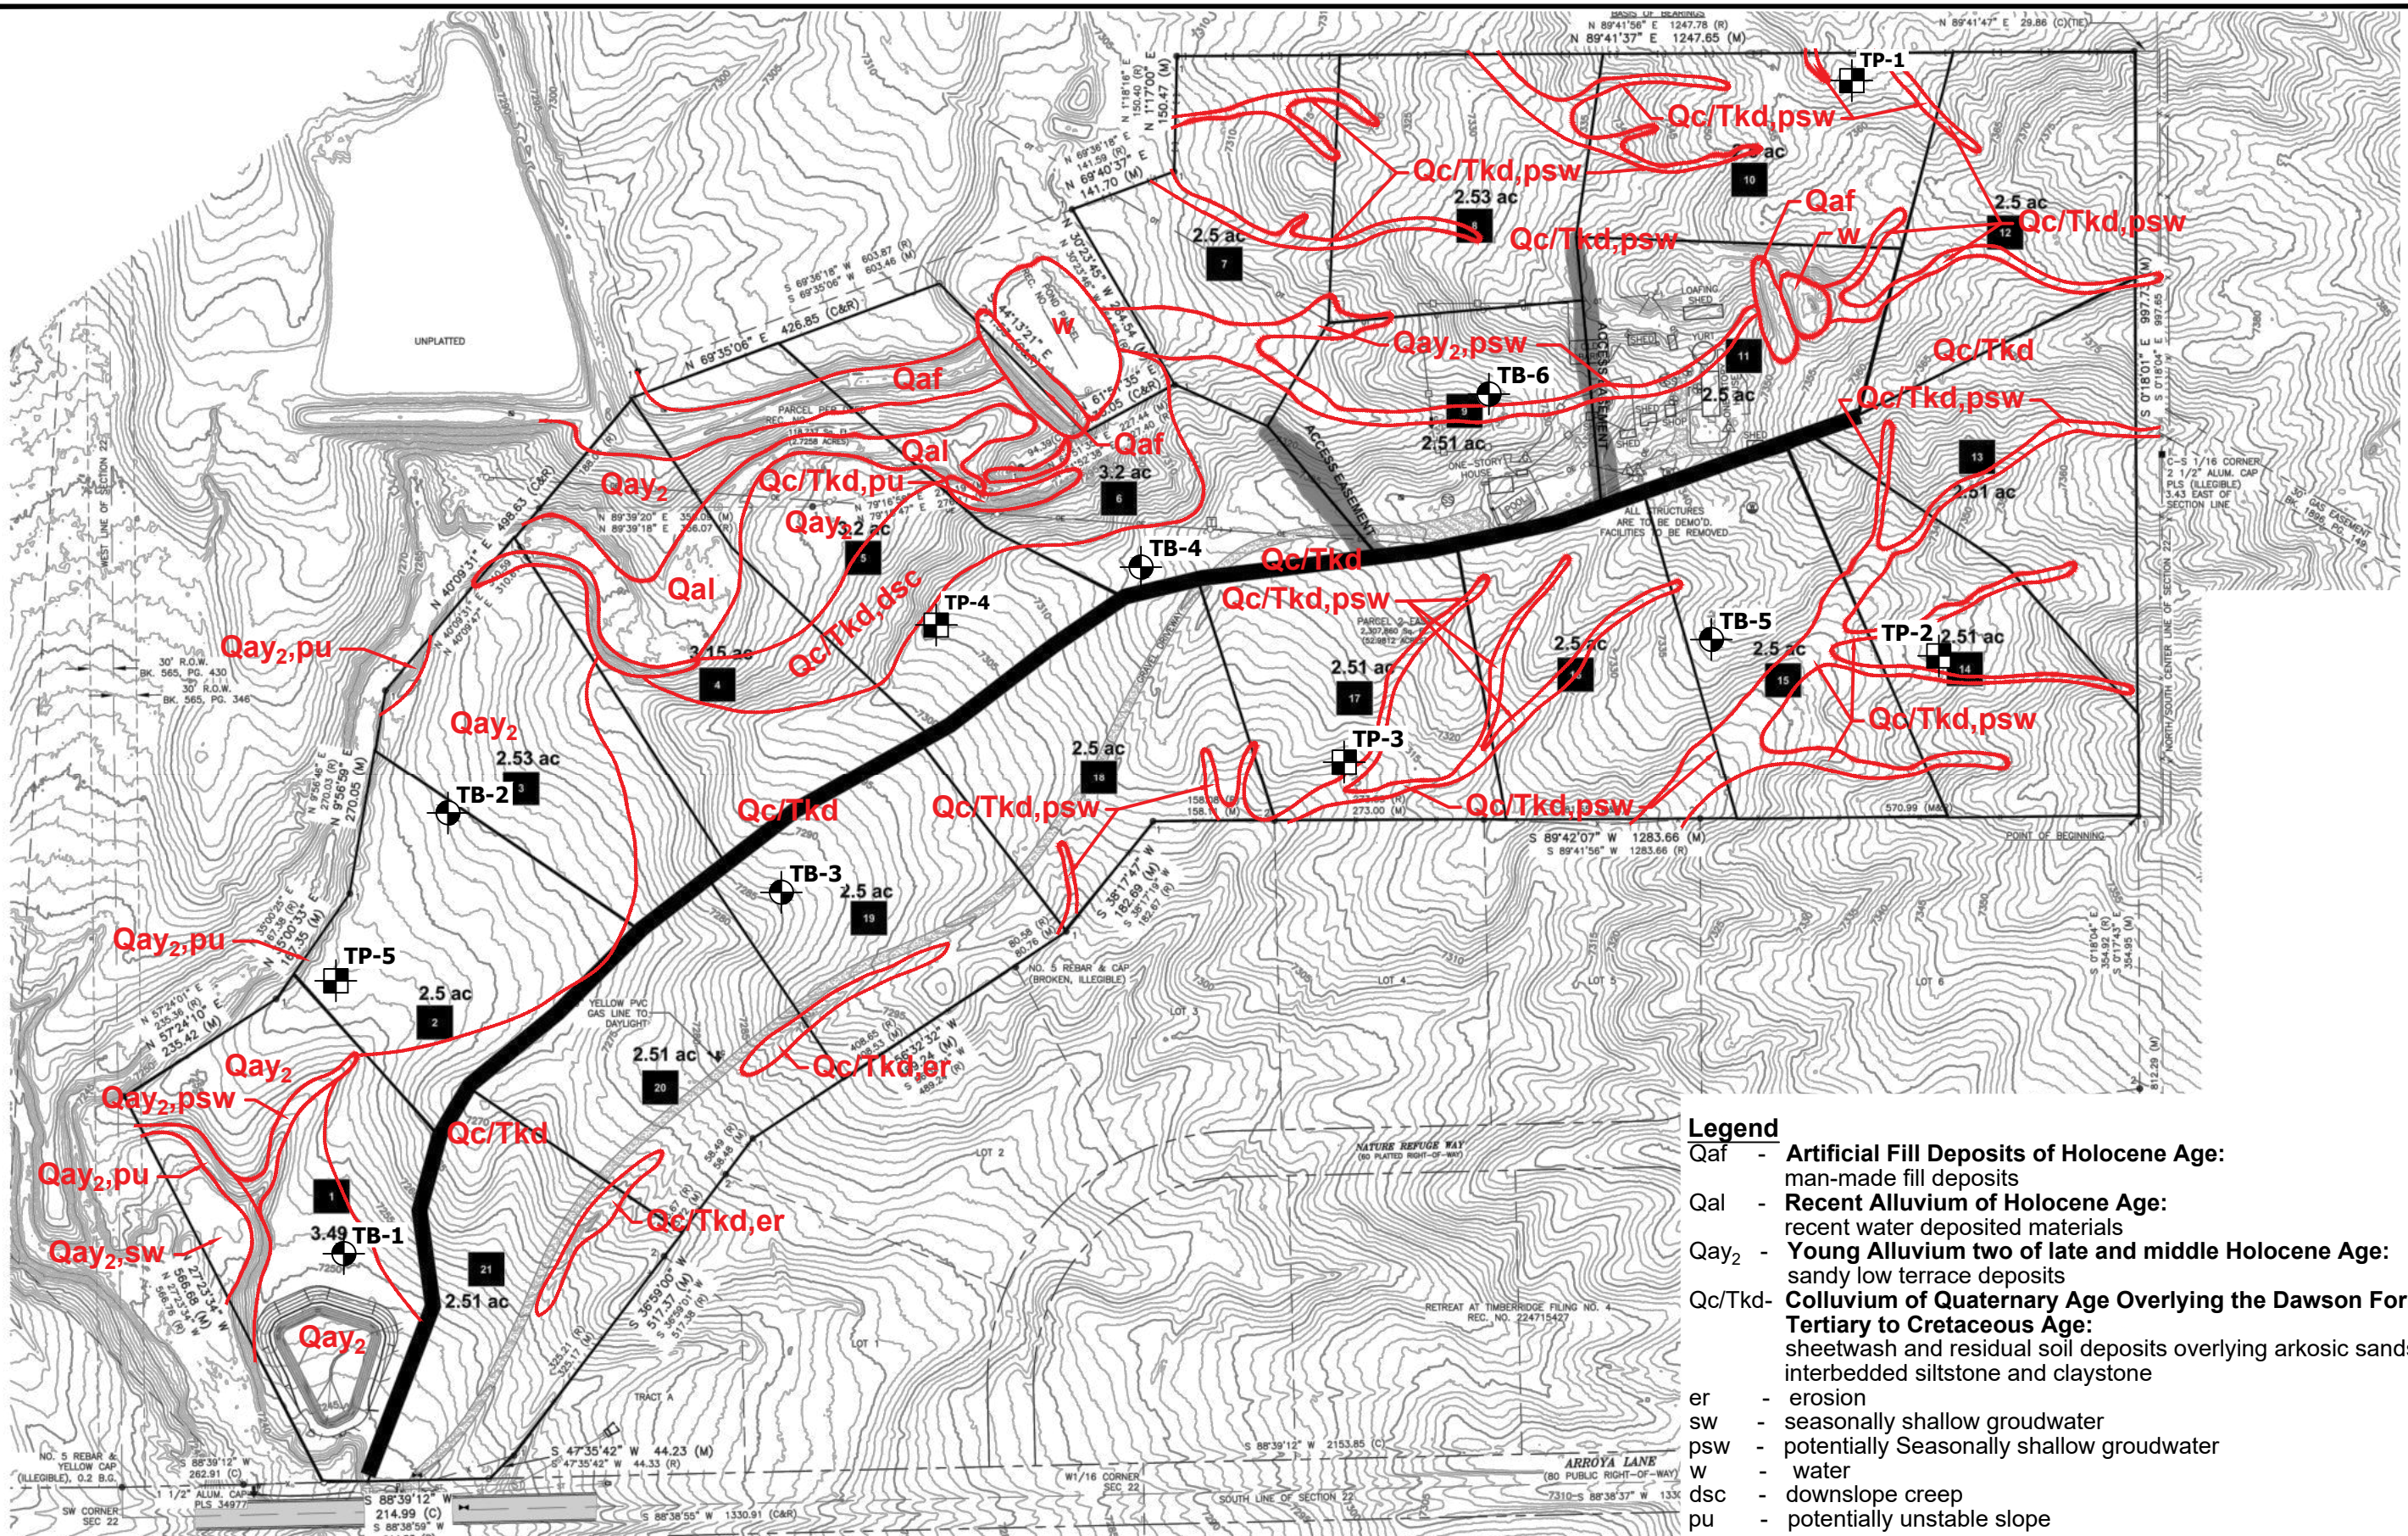
FIG. 6

Detailed mapping has been performed on this site to produce a Geology/Engineering Geology Map (Figure 6). This map shows the location of various geologic conditions the developers should monitor during the planning, design, and construction stages of the project. The following constraints/hazards have been identified on the site: artificial fill, potentially expansive soils, shallow bedrock, seasonal shallow and shallow groundwater areas, drainage areas, downslope
