November 30, 2022

ENTECH
ENGINEERING, INC.

Re: Soil, Geology, and Geologic Hazard Study
Double Spur Ranch
12420 North Meridian Road
Parcel No. 52130-00-007
El Paso County, Colorado
Entech Job No. 222160

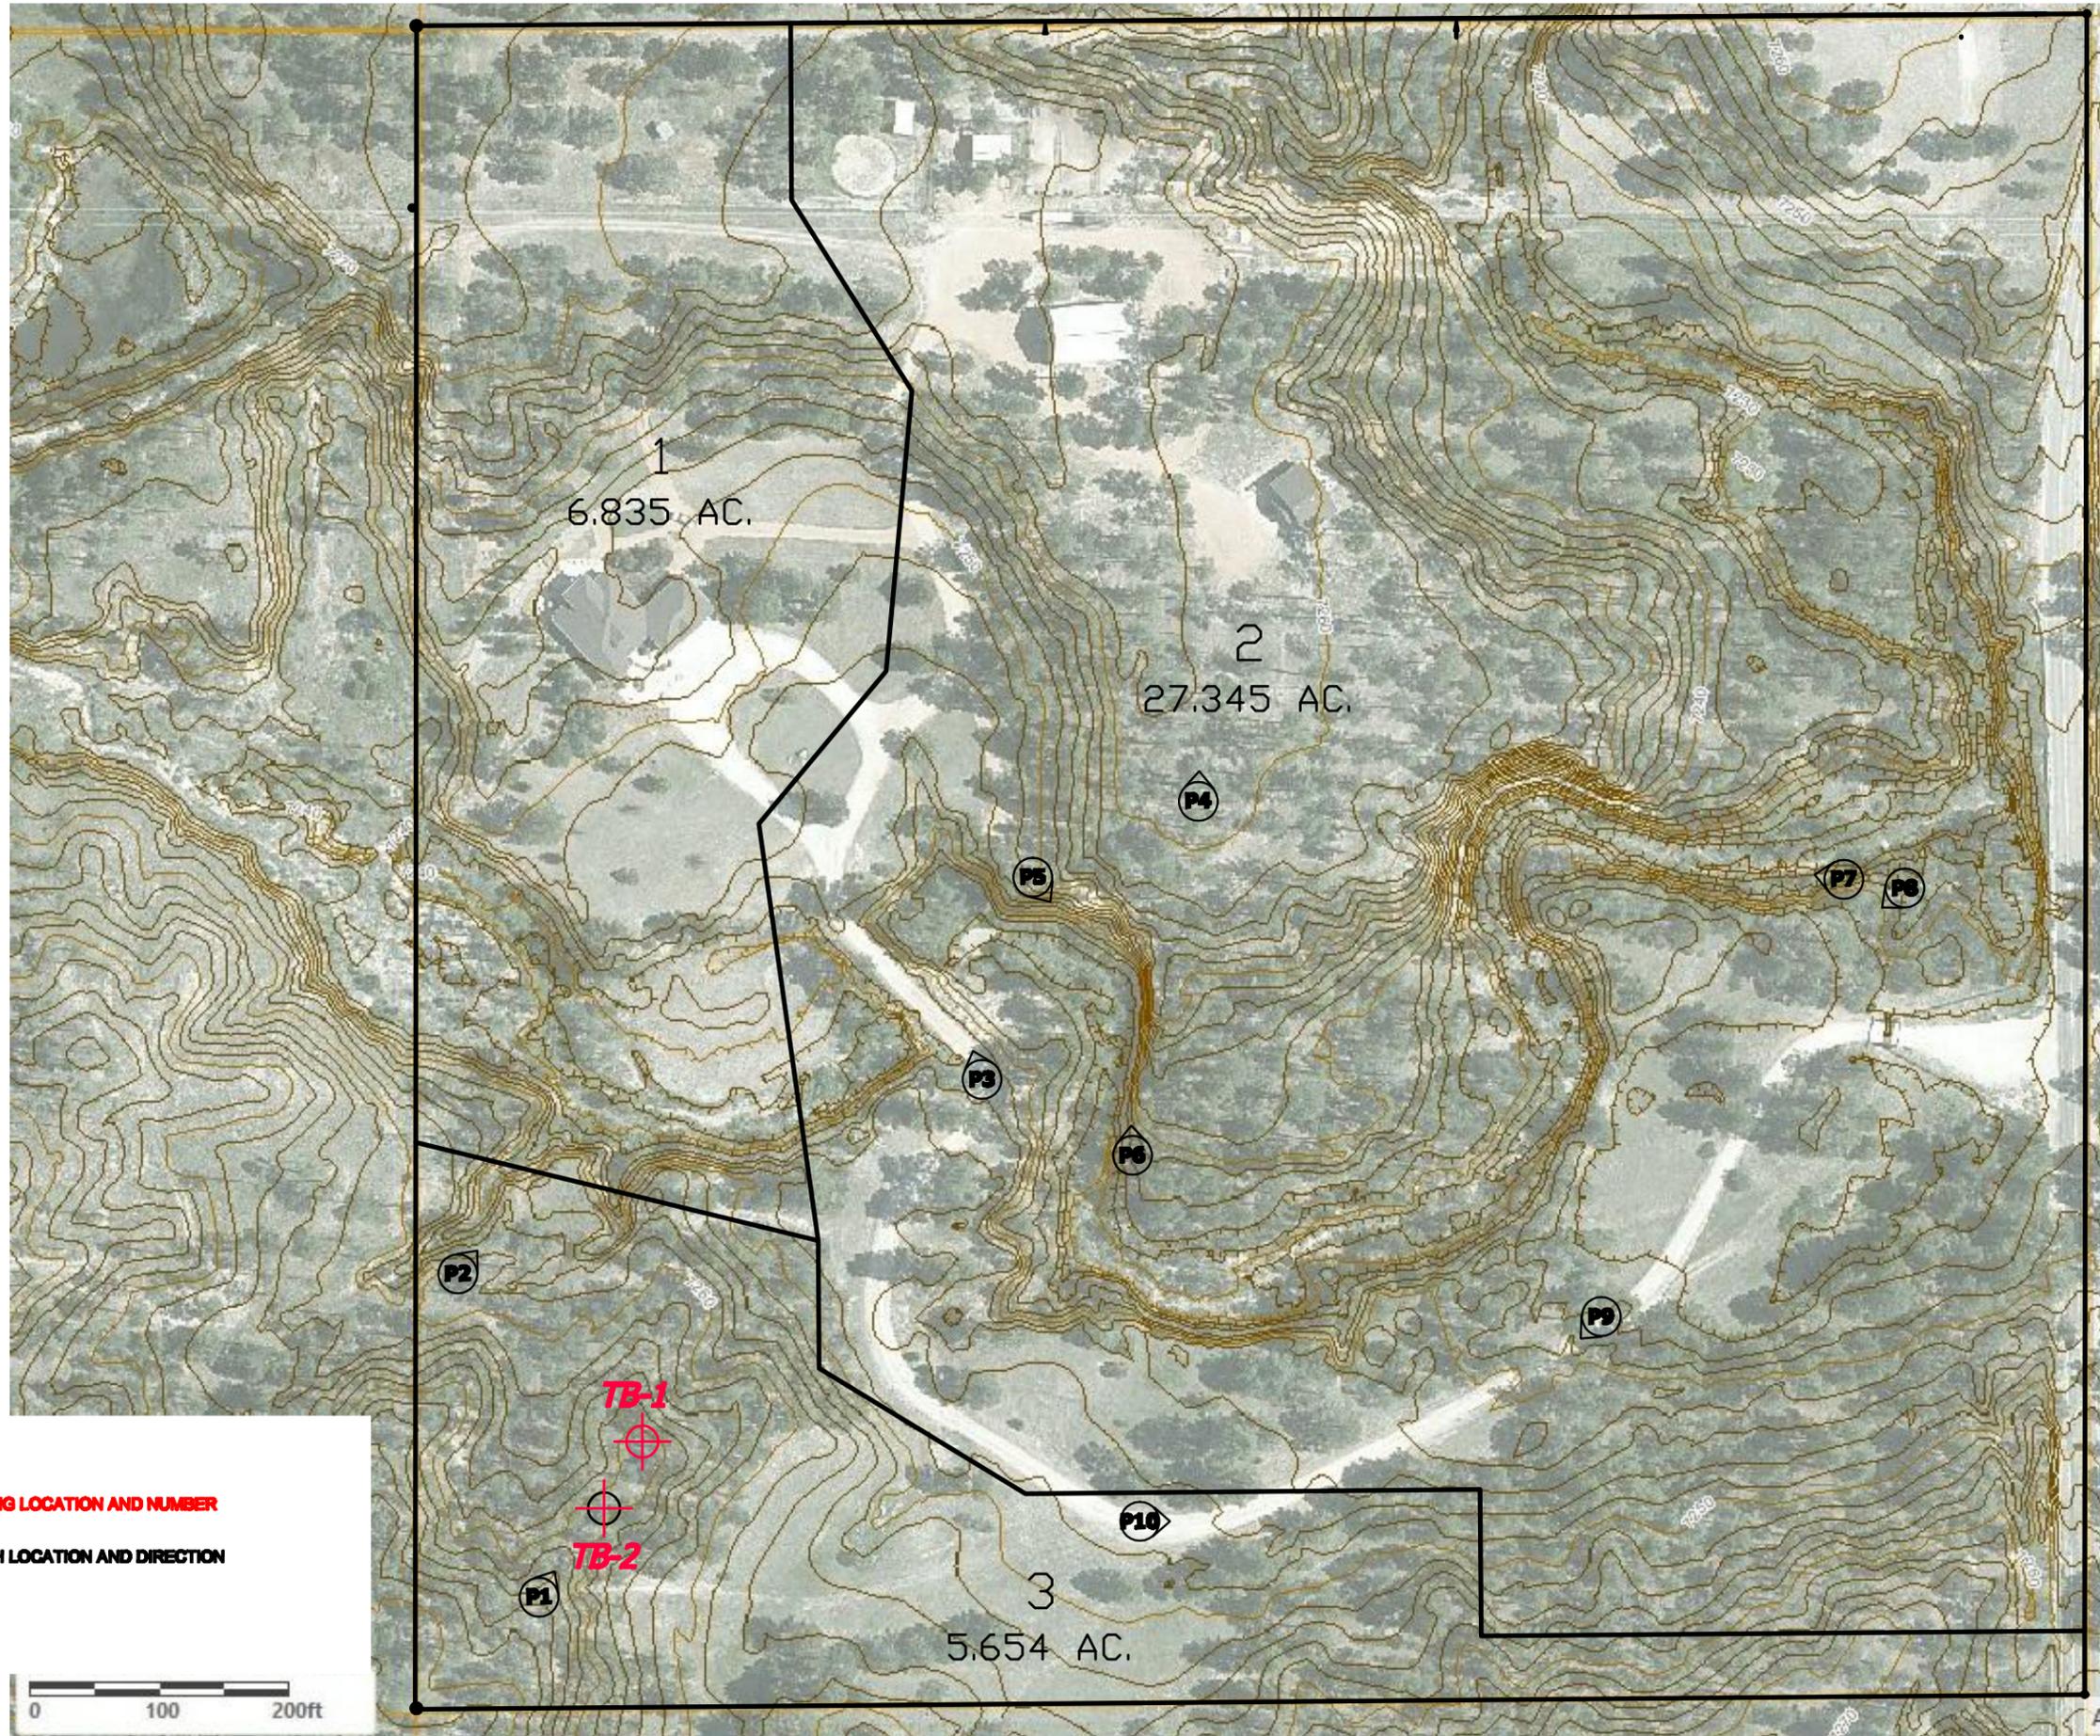
DRAWN LLL
CHECKED
DATE 11/30/22
SCALE AS SHOWN
JOB NO. 222160
FIGURE No. 3

Total acreage involved in the proposed subdivision is 40-acres. Three rural residential lots are proposed as part of the subdivision. Two existing homes and several outbuildings on Lots 1 and 2 will remain, and one new lot is proposed along the southwestern side of the property. The new lot will be serviced by an individual well and on-site wastewater treatment system. The Site Plan/Test Boring Location Map is presented in Figure 3.

Two test borings were drilled on the site to determine general suitability of the soil characteristics for residential construction. The locations of the test borings are indicated on the Site Plan/Test Boring Location Map, Figure 3. The Test Boring Logs are presented in Appendix B. Results of this testing will be discussed later in this report.

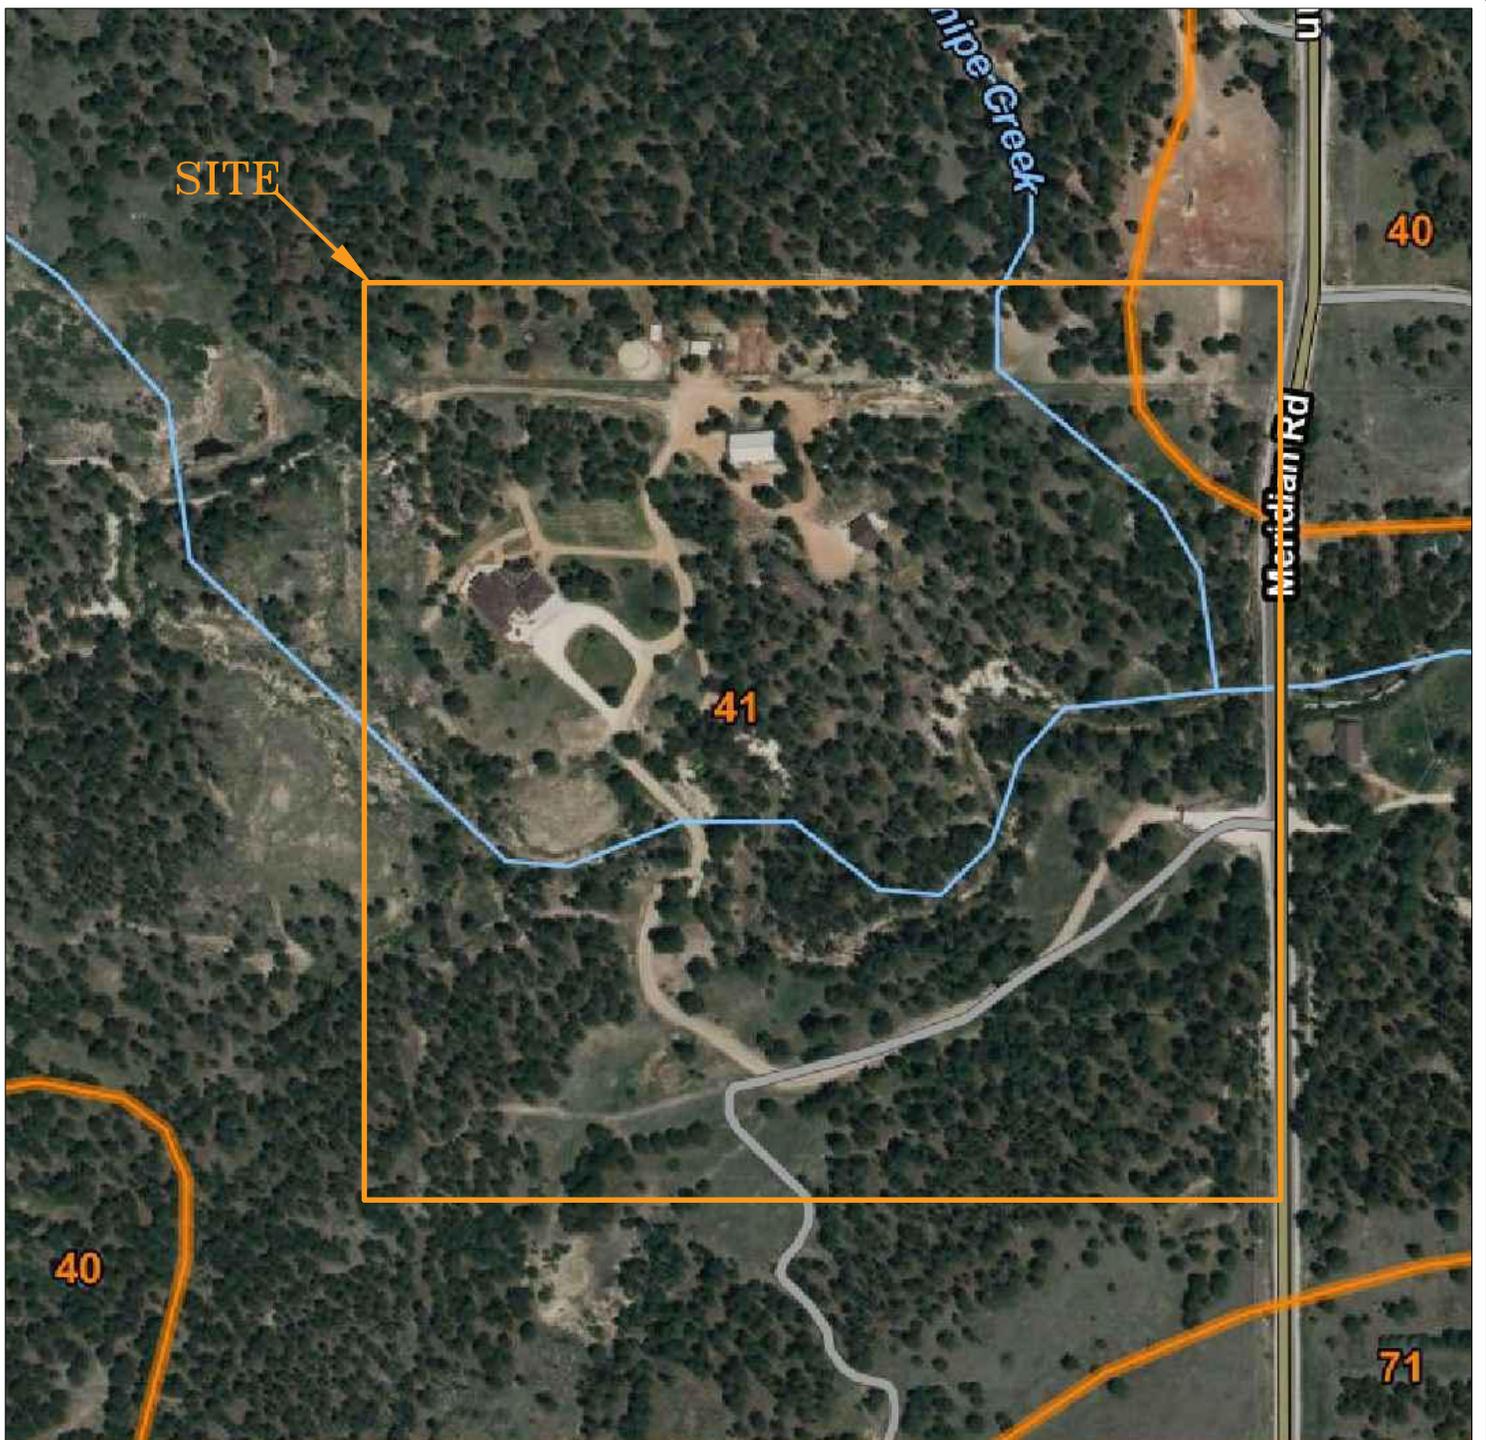
FIG NO.:
4

The Natural Resource Conservation Service (NRCS) (Reference 1, Figure 4), previously the Soil Conservation Service (Reference 2) has mapped two soil types on the site. Complete description of the soil types is presented in Appendix D. In general, the soils consist of gravelly loamy sand. The soils are described as follows:

The soils have been described to have moderate to rapid permeabilities. The soils are described as well suited for use as home sites. Possible hazards with soils erosion are present

on the site. The erosion potential can be controlled with vegetation. The soils have been described to have moderate erosion hazards (Reference 2).

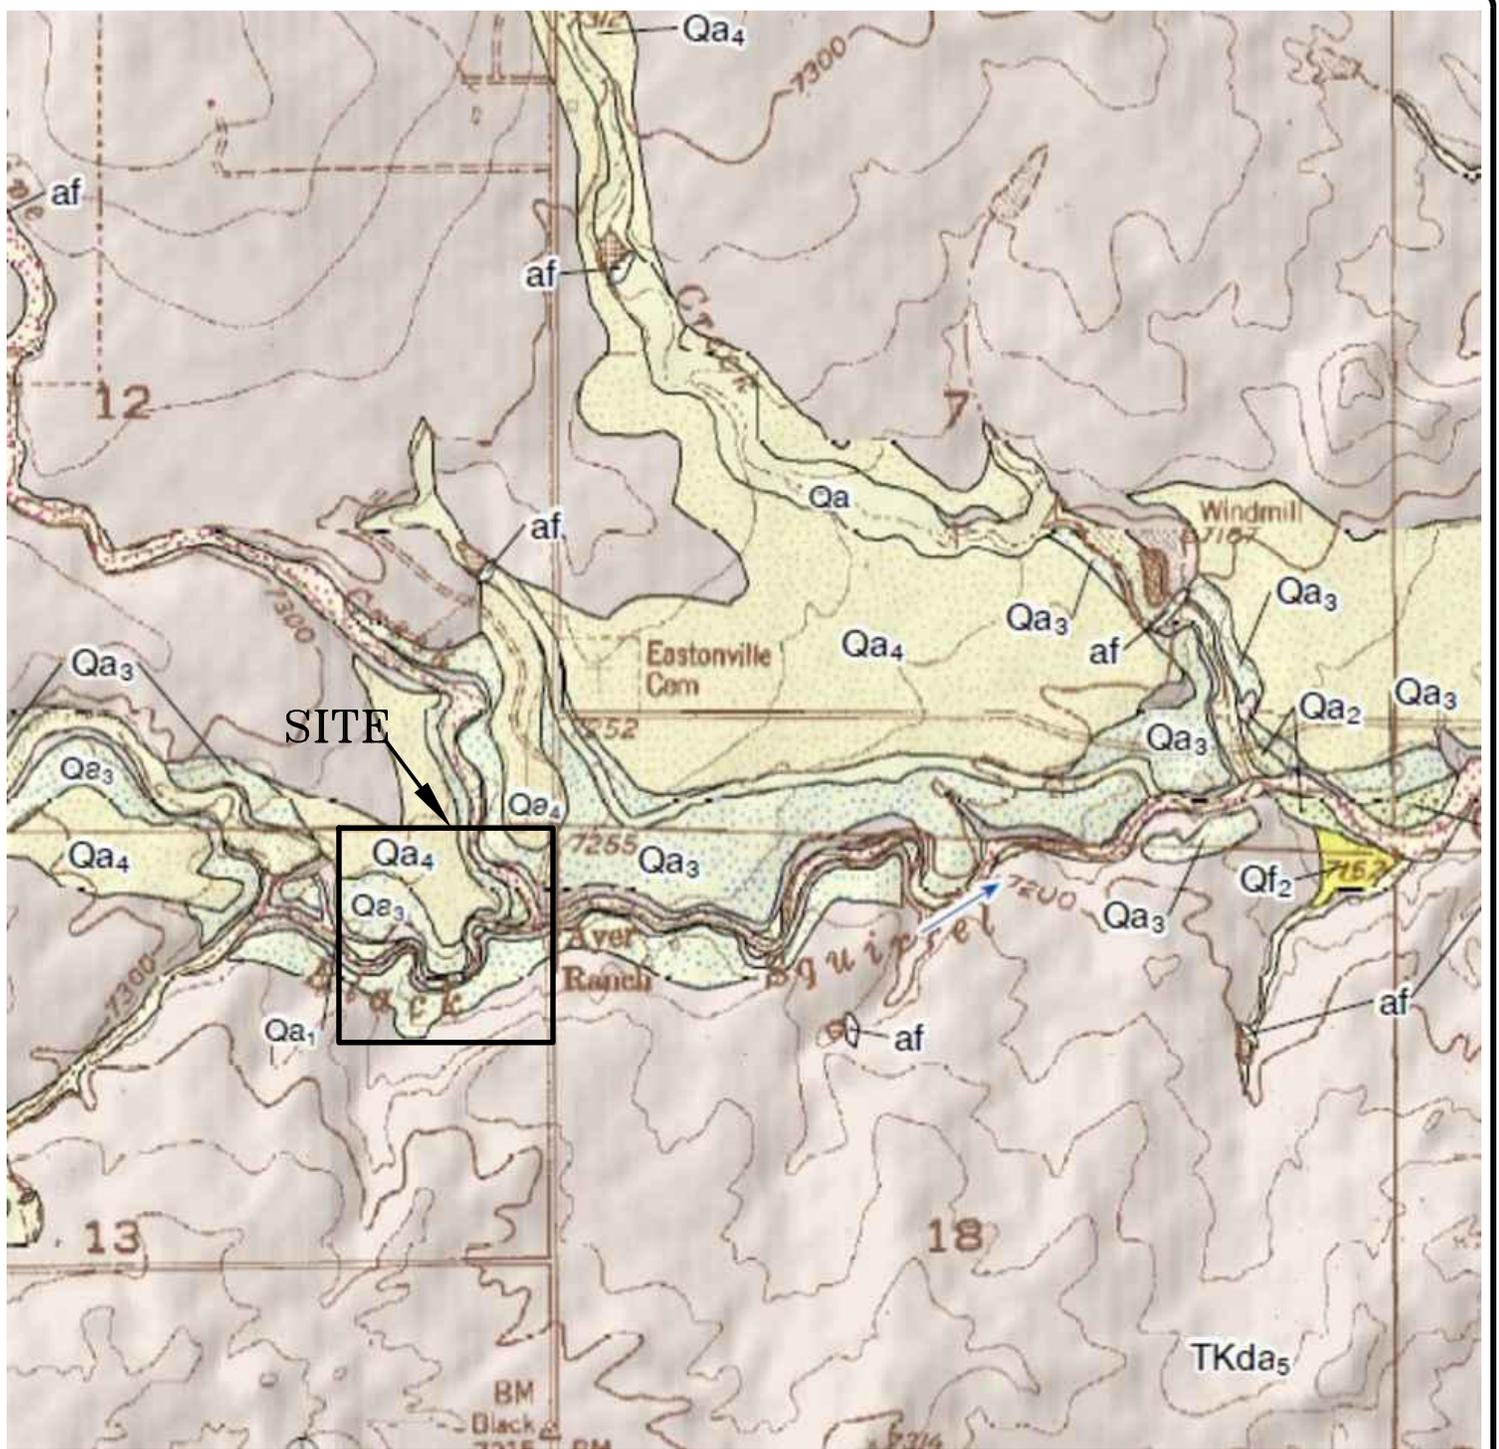
FIG NO.:
 5

The geology of the site was evaluated using the *Geologic Map of the Black Forest Quadrangle*, by Thorson and Madole in 2003, (Reference 4, Figure 5). The Geology Map for the site is presented in Figure 6. Five mappable units were identified on this site which are described as follows:

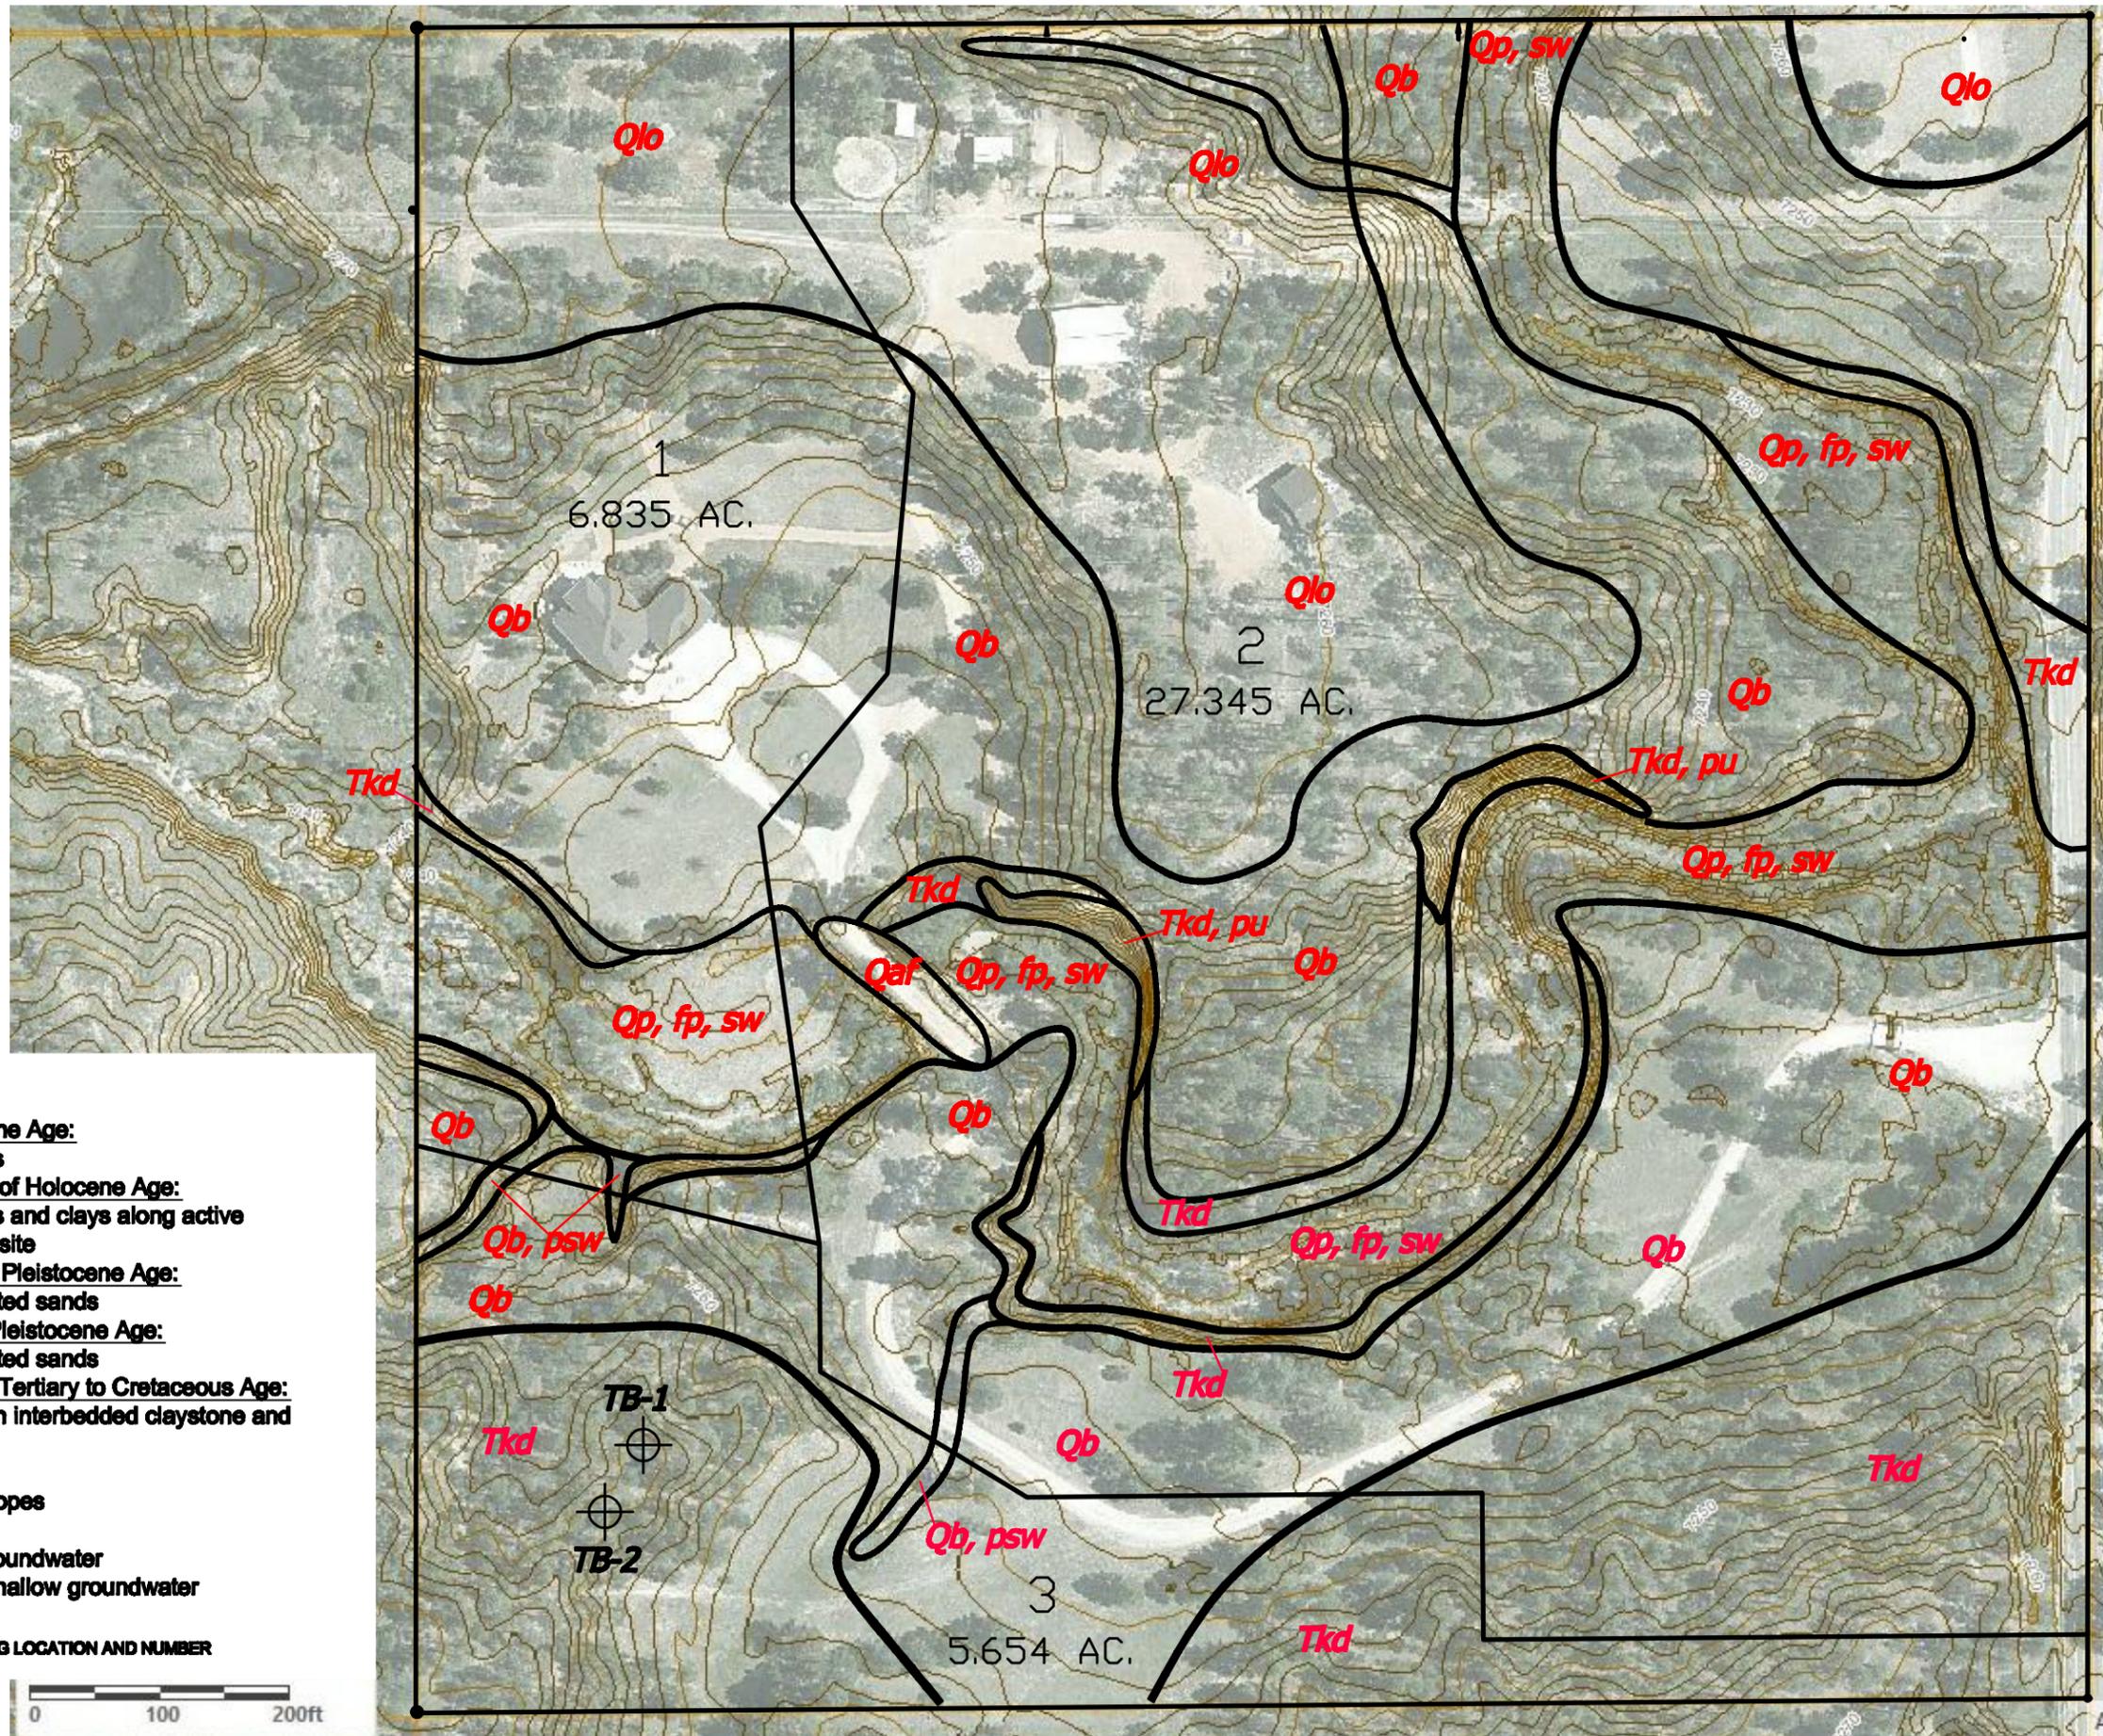
DRAWN L.L.L. CHECKED
DATE 11/30/22
SCALE AS SHOWN
JOB NO. 222160
FIGURE No. 6

Areas of artificial fill were observed along the gravel road for an embankment crossing Black Squirrel Creek and are indicated on the Geology Map presented on Figure 6. Additional areas of artificial fill other than those mapped may be present on the site.

The majority of the slopes in the proposed building area and around the existing structures on site are generally gradually to moderately sloping and do not exhibit any past or potential unstable slopes or landslides. Areas along Black Squirrel Creek and Snipe Creek in the central and northeastern portions of the site have steep slopes along portions of the drainages that been identified as potentially unstable slopes. These areas are identified on the Engineering Geology Map, Figure 6. The recommendations for these areas are as follows:

The areas identified with this hazard include the steep slopes along the main drainages on the site have been mapped as potentially unstable. These slopes are considered stable in their present condition; however, considerable care must be exercised in these areas not to create a condition which would tend to activate instability. Due to the lot sizes these areas will be avoided by the proposed structures.

Several minor drainage swales are located across the site. Water was not observed in these drainage swales at the time of this investigation; however, these areas have the potential for seasonal shallow groundwater. These areas are indicated in the Geology/Engineering Geology Map (Figure 6). Due to the size of the proposed lots these areas can either be avoided or regraded and redirected around proposed structures or proposed soil treatment areas.

Mitigation: Where uncontrolled fill is encountered beneath foundations, mitigation will be necessary. Mitigation typically involves removal and recompaction at a minimum of 95 percent of its maximum Modified Proctor Dry Density, ASTM D-1557. Any new fill added to the site should be placed on native or controlled fill soils, compacted as recommended above.

Mitigation: Should any future building be considered near these potentially unstable slopes a minimum 30-foot setback is recommended from the crest of the potentially unstable slopes. Building should be avoided in these areas. Proper control of drainage at both the surface and the subsurface is extremely important. Areas of ponded water at the surface should be avoided. Utility trenches, basement excavations and other subsurface features should not be permitted to become water traps which may promote saturation of the subsurface materials. Drainage should not be permitted over the potentially unstable slope but directed in a non-erosive manner away from the slope. Irrigation above these slopes should be kept to a minimum to prevent saturation of the subsurface soils.

Mitigation: In these locations, foundations are subject to severe frost heave potential should penetrate sufficient depth so as to discourage the formation of ice lenses beneath foundations. At this location and elevation, a foundation depth for frost protection of 2.5 feet is recommended. In areas where high subsurface moisture conditions are anticipated periodically, a subsurface perimeter drain will be necessary to help prevent the intrusion of water into areas located below grade. A typical perimeter drain detail is presented in Figure 8. Additionally, swales should be created to intercept surface runoff and carry it safely around and away from structures. It is anticipated that the site grading may mitigate the drainages in some areas. The water table may be of sufficient depth to minimize the effects on buildings in some areas.

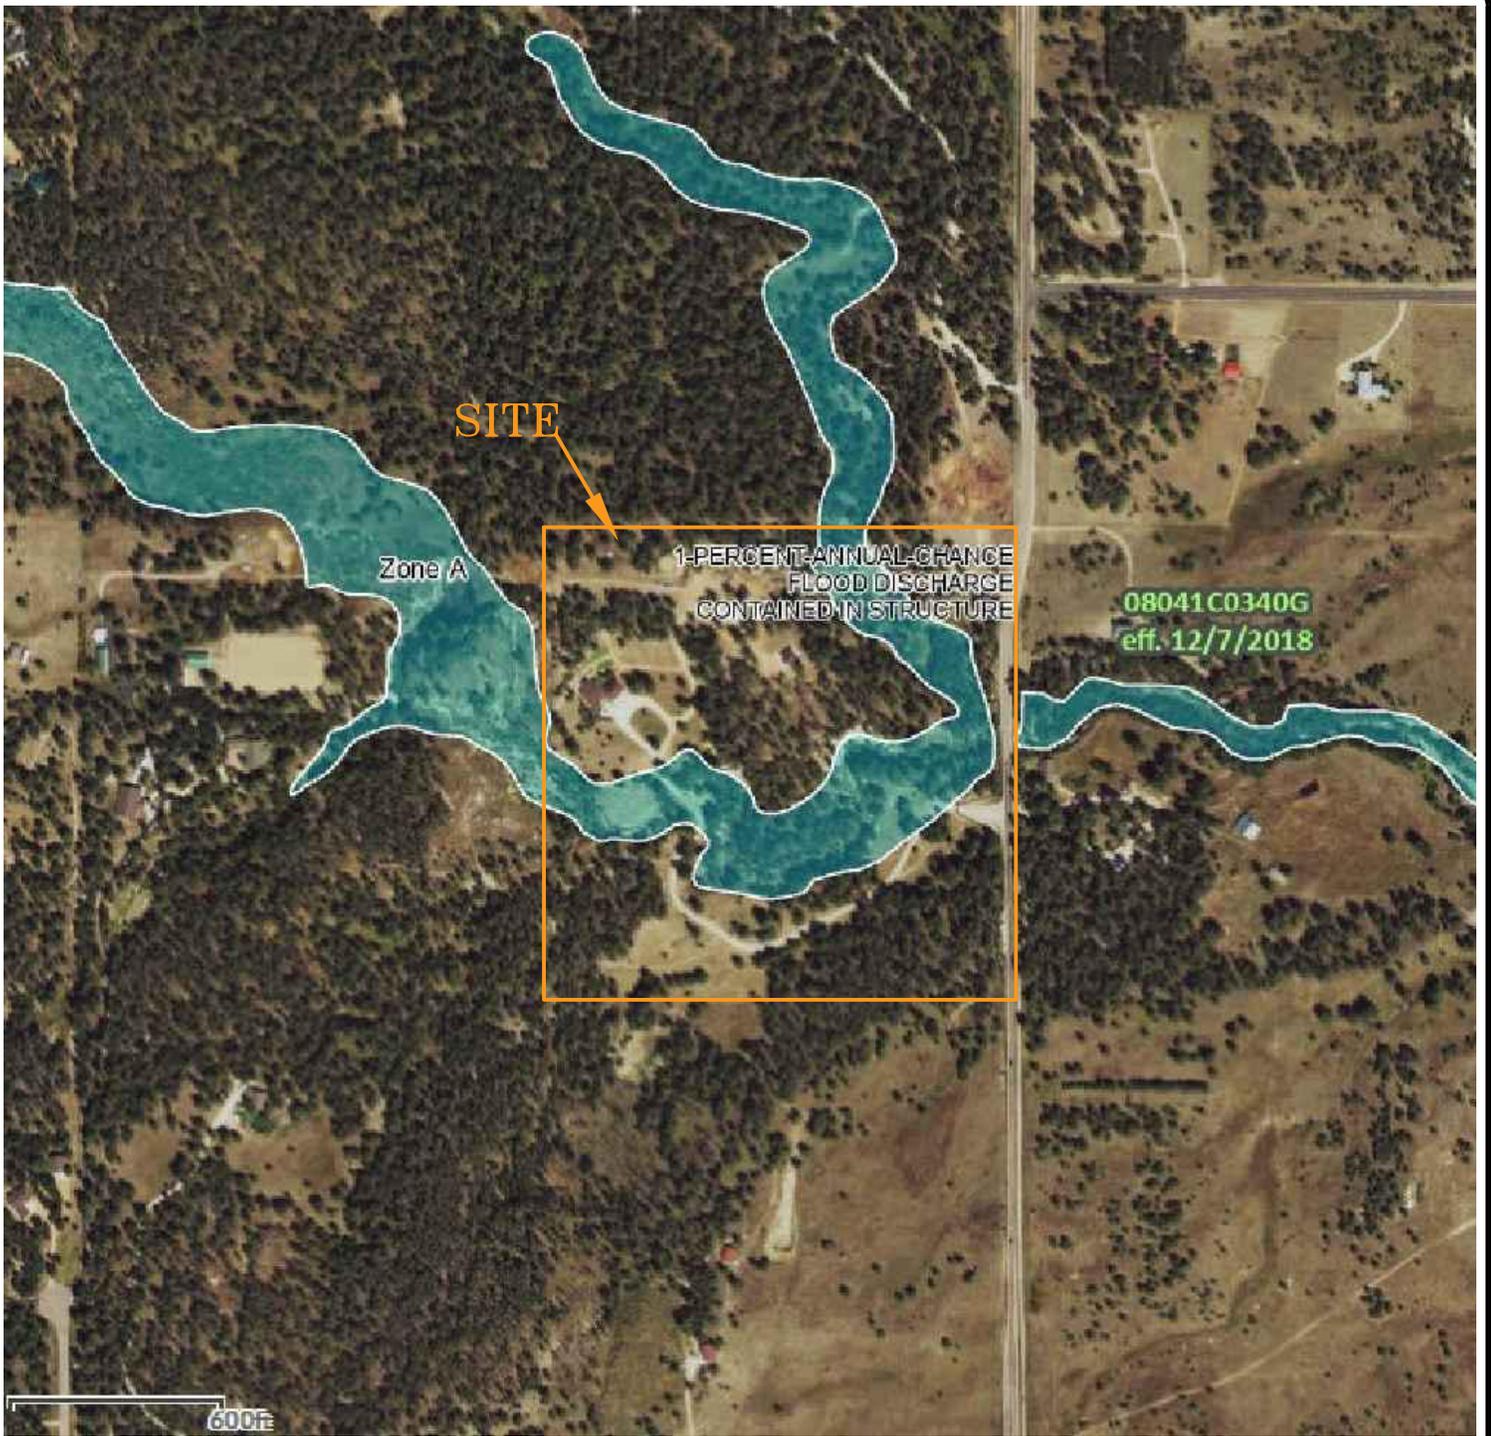
FIG NO.:
 7

Portions of the site along Black Squirrel Creek and Snipe Creek are mapped within floodplains according to the FEMA Map No. 08041CO340G, dated December 7, 2018 (Figure 8, Reference 7). The existing structures and proposed residence are located outside of the mapped floodplain. Additionally, areas of seasonal and potentially seasonal shallow groundwater were mapped on the site (Figure 6). In these areas, we would anticipate the potential for periodically high subsurface moisture conditions and frost heave potential. These areas lie within low-lying areas and along the minor drainage swales and creeks located across the site. Water was not observed in the drainages at the time of our site investigation. These areas can likely be avoided or properly mitigated by development. The potential exists for high groundwater levels during high moisture periods and should structures encroach on these areas the following precautions should be followed. Exact locations of floodplain and specific drainage studies are beyond the scope of this report.

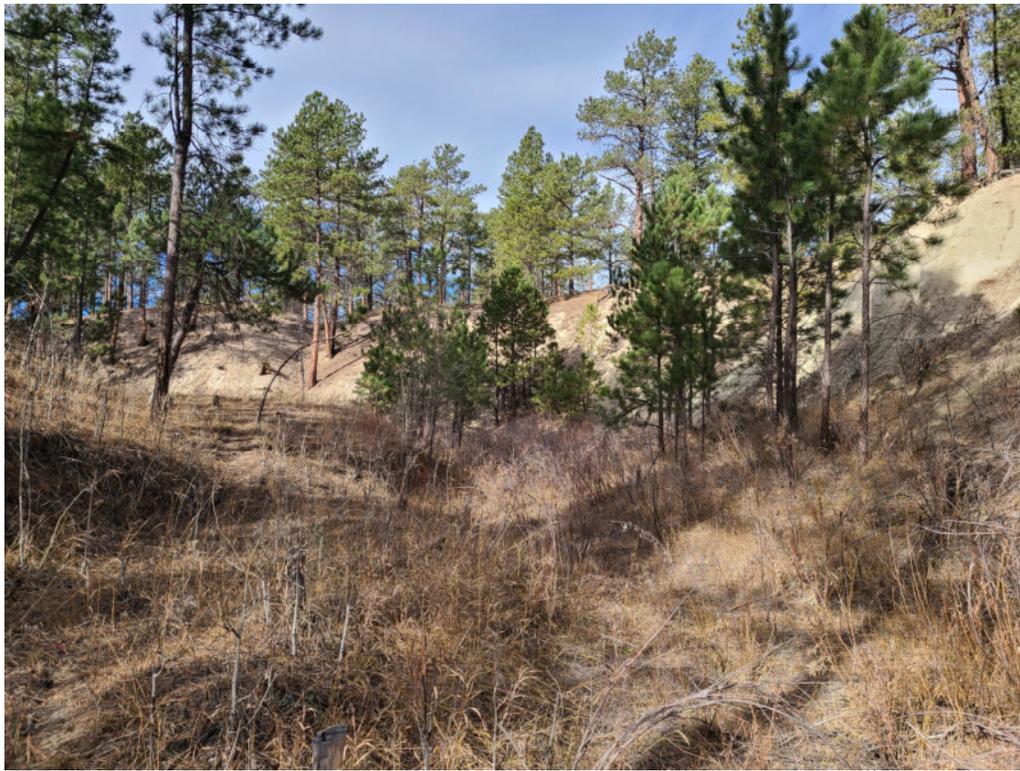
**Looking west along
drainage from the
eastern portion of the
site.**
