Aquatic Resources Delineation Report
for the
Eagle Forest Subdivision Project
June 2021

Eagle Forest Development, Inc.

Heritage Environmental Consultants

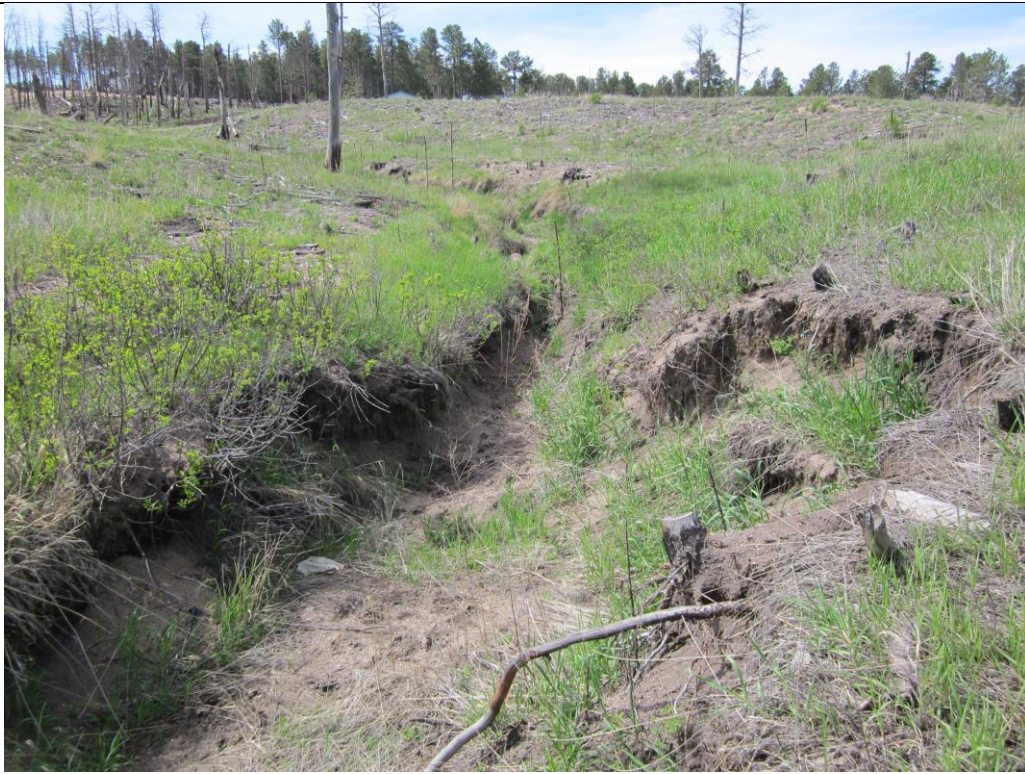
Photo 1: Burgess Creek near the eastern boundary

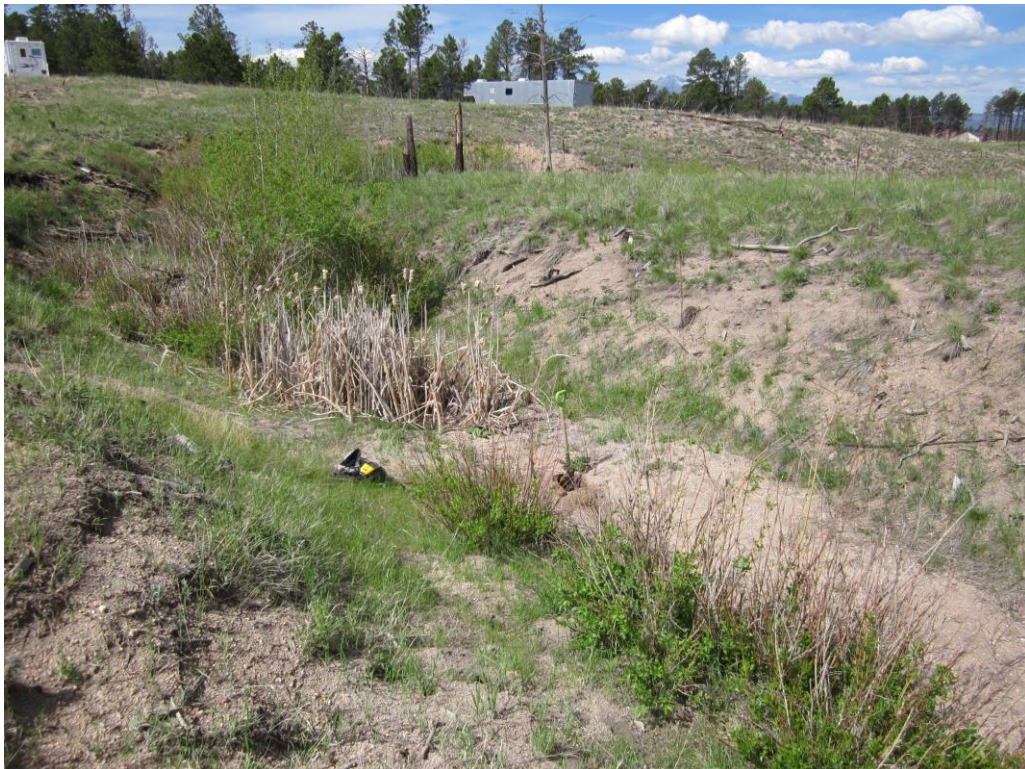
Photo 2: Upstream transition from channel to wetland. Groundwater was at 15 in.

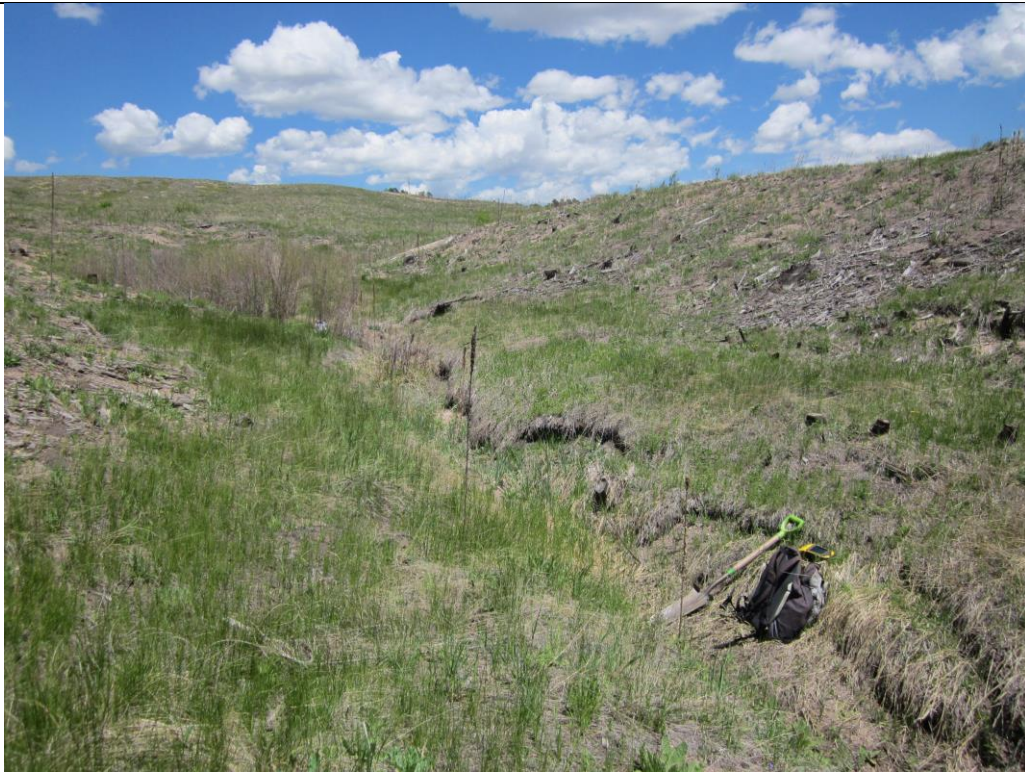
Photo 3: Facing upstream to WL-1, the transition from wetland back to channel.

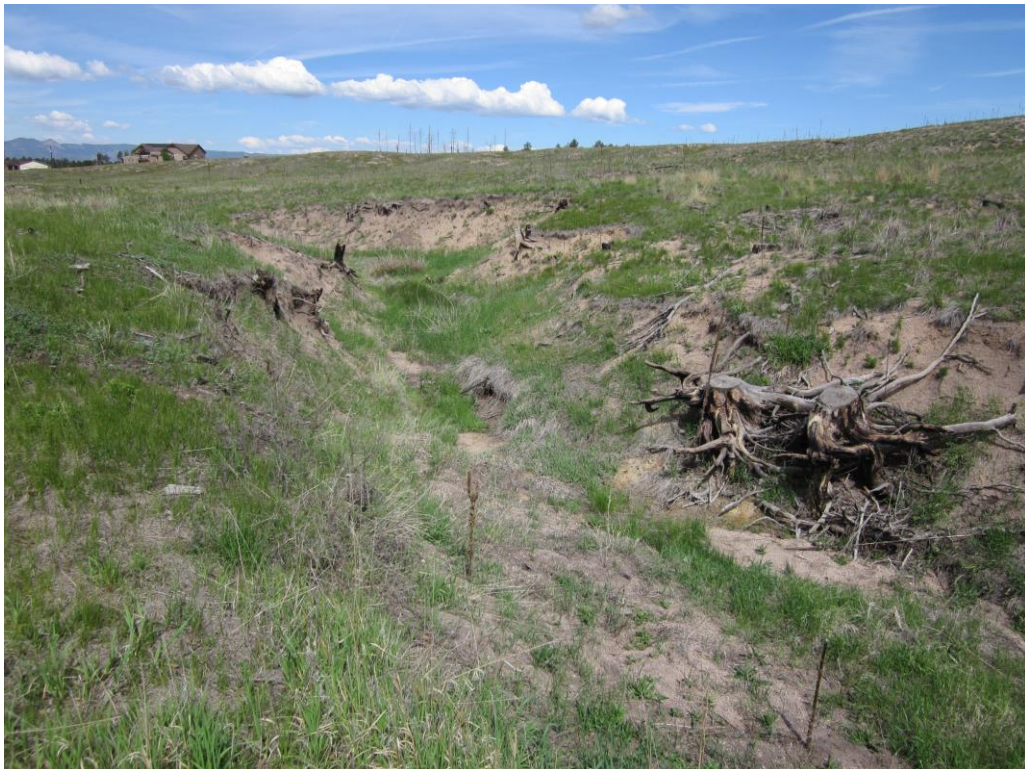
Most of the upstream watershed was burned in 2013. Post-fire erosion has been substantial, altering the channel in several ways. Loss of vegetation and increased input from runoff have incised the channel up to 10 feet in reaches, though the channel was likely incised to some degree pre-disturbance. Visual evidence of the changes remains in both the banks (Photo 4) and in the channel bottom. Several inches of newly-deposited loose sand has accumulated in portions of the channel (Photo 7).

Photo 4: Burgess Creek channel. Note burned stumps still rooted in bank suspended over channel indicating magnitude of post-fire erosion

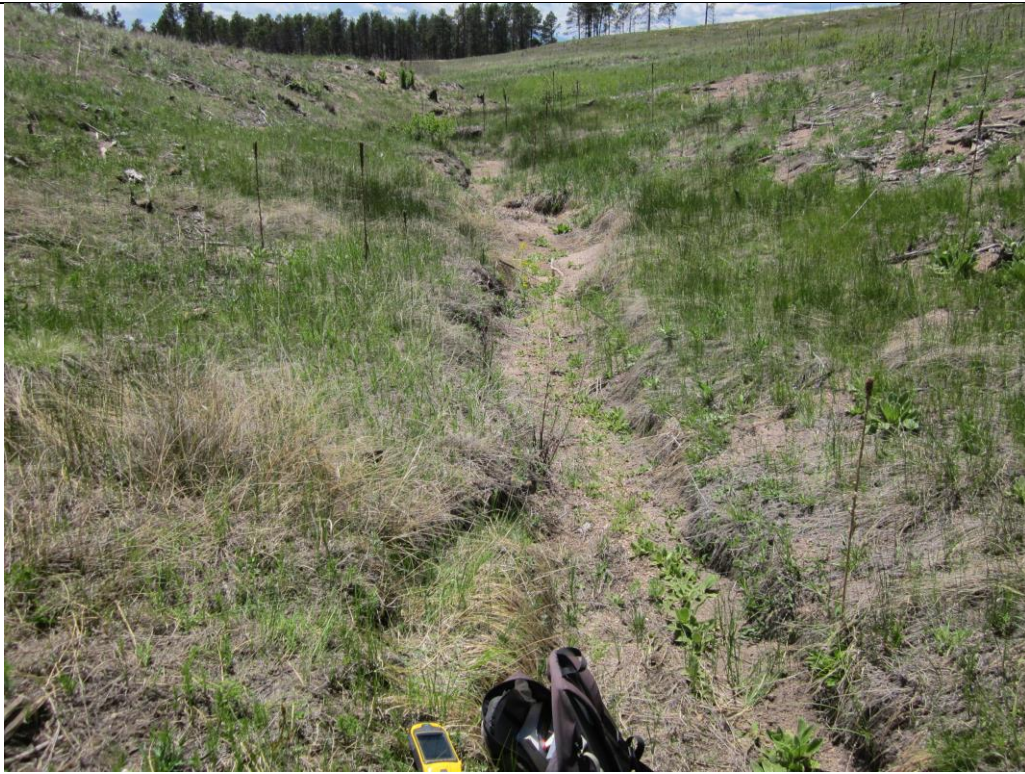
Photo 5: Facing downstream from the end of WL-1

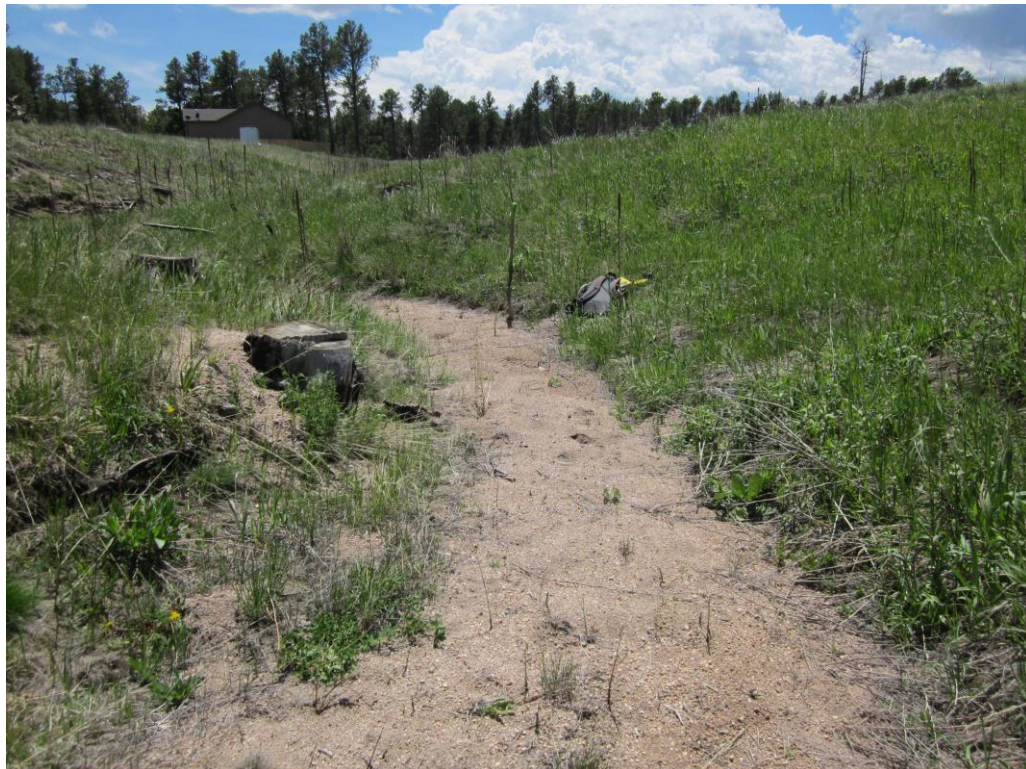
Photo 6: Location of OHWM datasheet, facing downstream

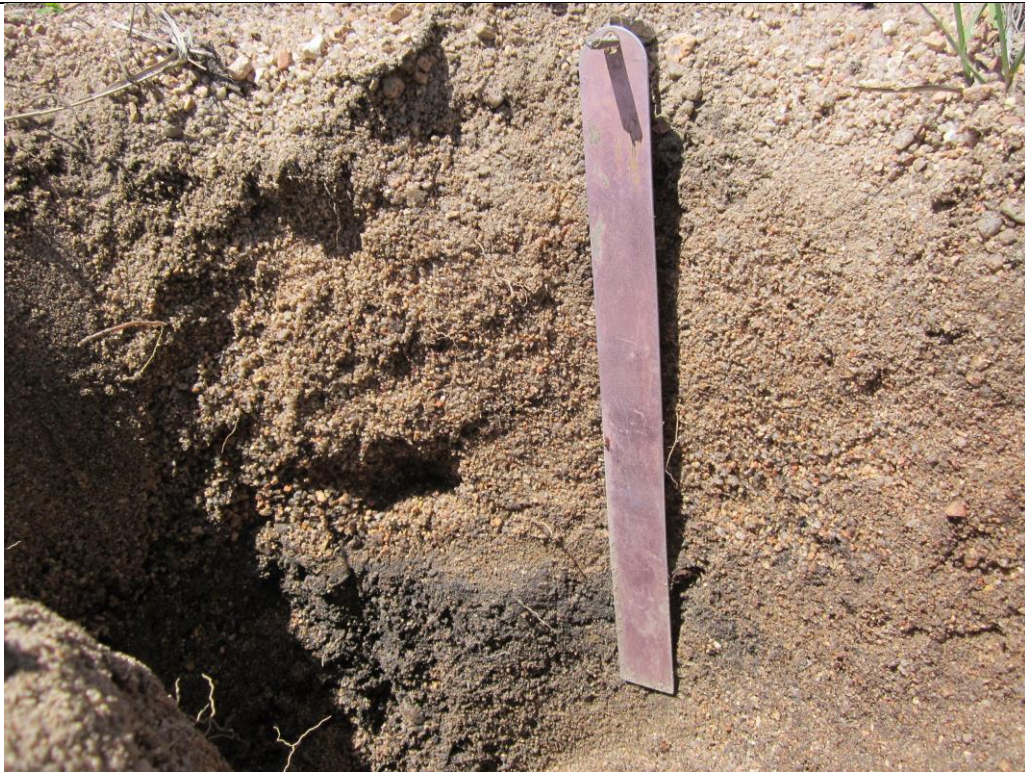
Photo 7: Soil profile at OHWM datasheet showing recent sandy erosional deposit

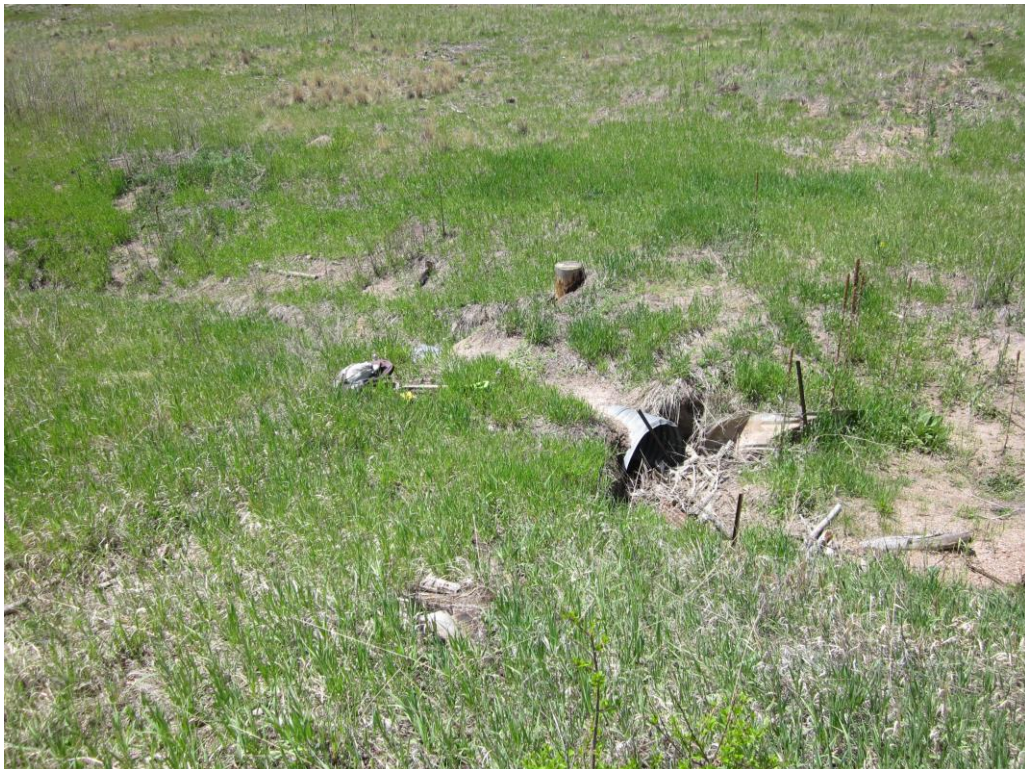
WUS-1 – Burgess Creek: One non-wetland water was identified within the survey area. Details of the feature are presented in Table 3, and shown in Figure 2 and Figure 3. Photographs of the feature are presented in Appendix A (Photos 1 through 10), the OHWM datasheet is in Appendix B. Burgess Creek is an intermittent drainage formed by a combination of groundwater and precipitation. The channel ranges 3 to 10 feet wide and is well-defined through the majority of the survey corridor. The channel does not extend upstream (east) of the survey area. OHWMs begin near the property line, though a vegetated swale does extend upstream off-property. Two small depressions near the western boundary held shallow water; however, the remainder of the reach was dry (excepting WL-1). OHWM indicators are a break in slope and clear change in soil, and in reaches, changes in vegetation. There is a 36-inch corrugated metal pipe culvert in the channel that appears to provide a pedestrian or OHV crossing (Figure 3 and Photo 8). The inlet is partially obstructed with debris and is likely overtopped in high flow events.

Photo 8: 36-in culvert in the channel, see location on Figure 3

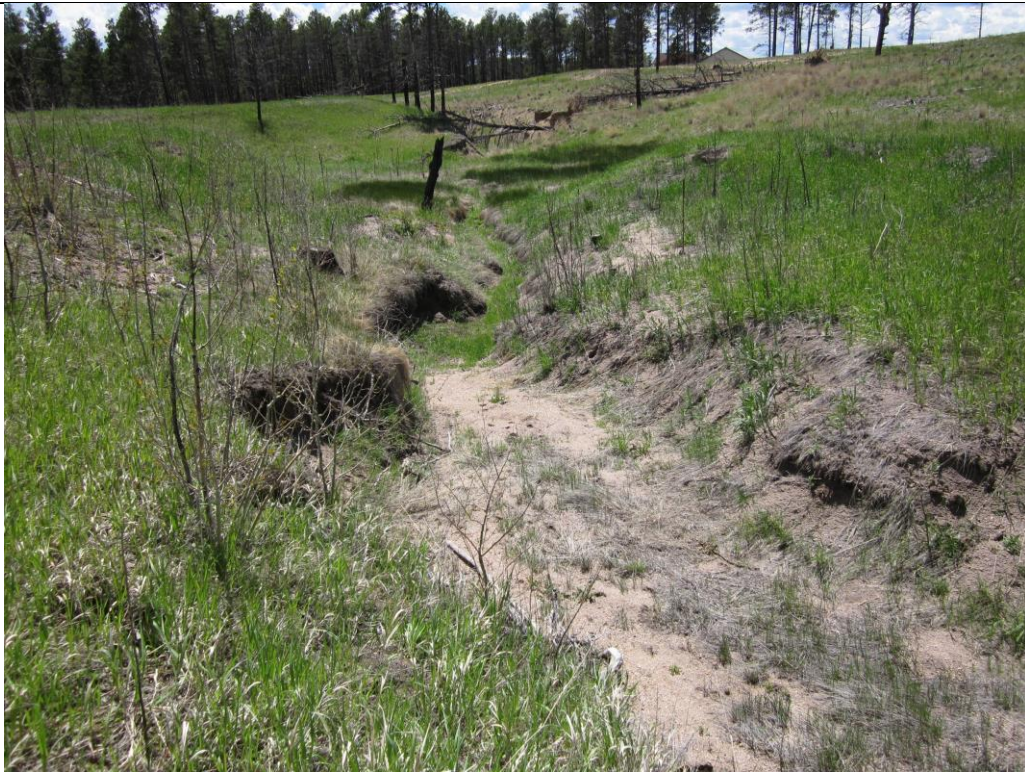
Photo 9: Creek channel in the western portion of the reach

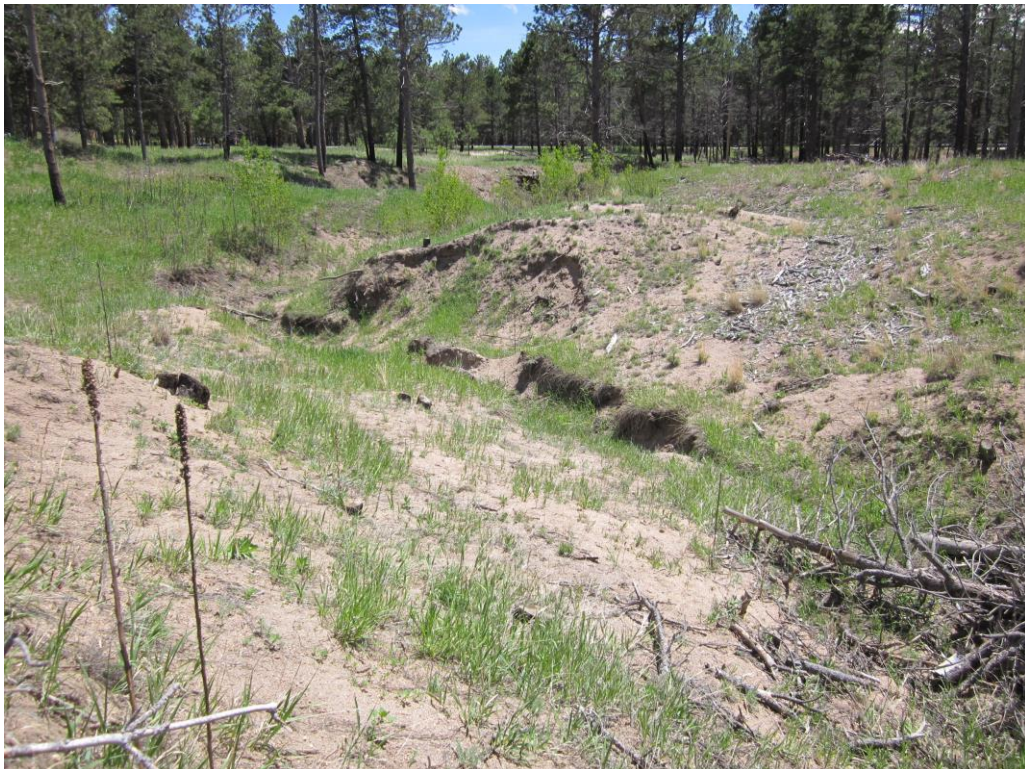
Photo 10: Facing southeast towards the property boudary, note the intact Ponderosa pine representative of pre-fire conditions

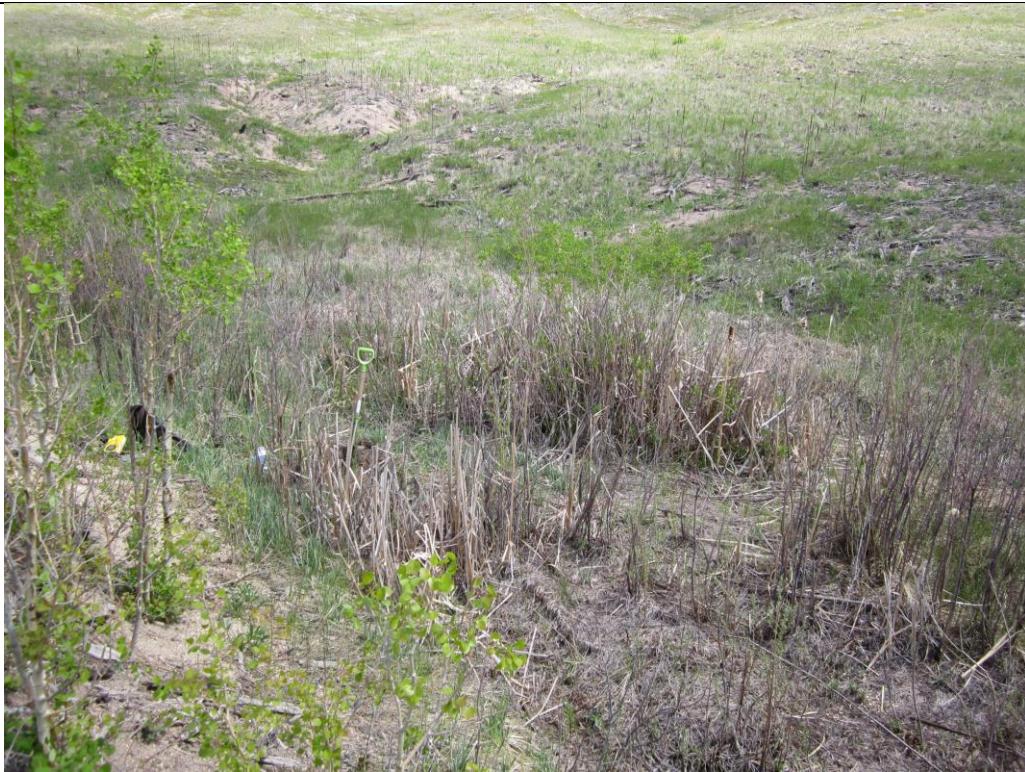
Photo 11: WL-1 sampling location, feature is about 20 feet wide

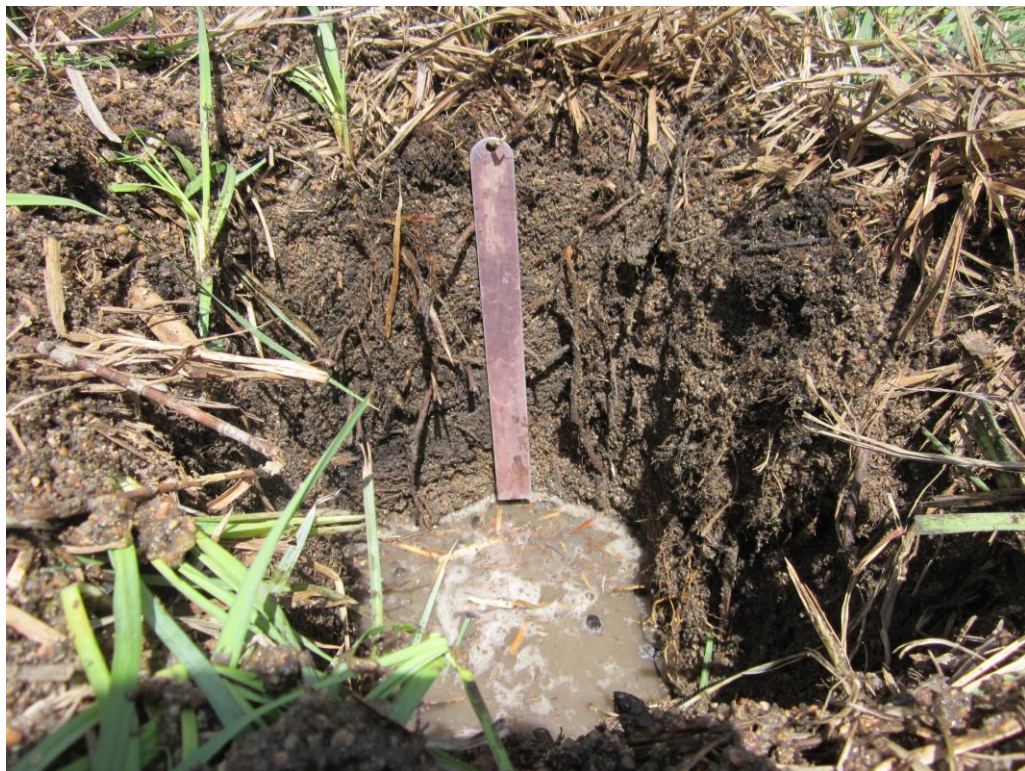
Photo 12: WL-1 soil profile, water table was at 13 inches

Remarks: No redox were observed and the soil does not meet hydric indicators. However, epipedon appears to be erosional deposit following 2013 fire, hydric soils have not yet had time to develop fully. Given this and the low value/chromas of the matrices, soils are deemed problematic and hydric soils are granted.

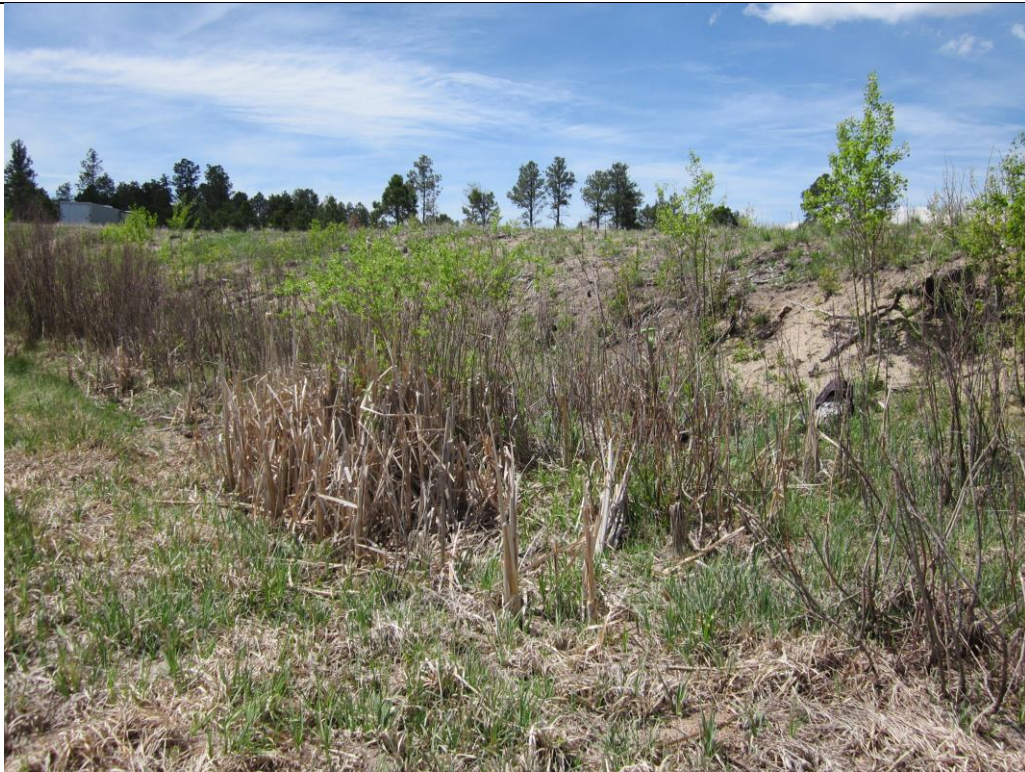
Photo 13: WL-1 sampling location facing upstream

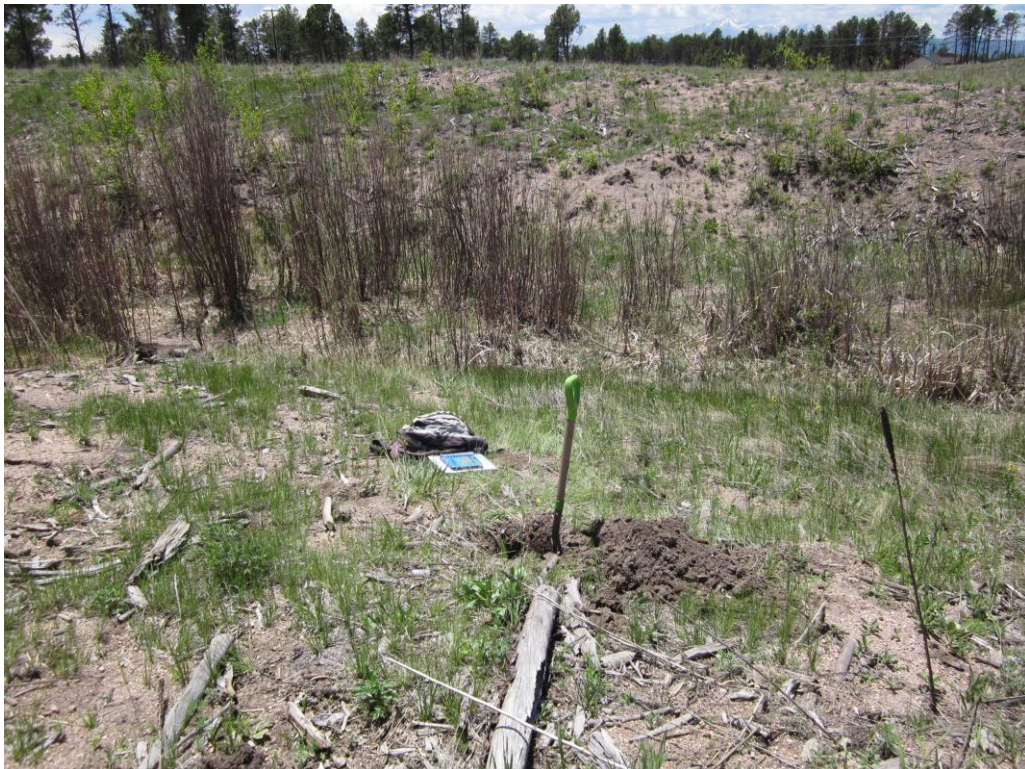
Photo 14: Upland sampling location, WL-1 in background

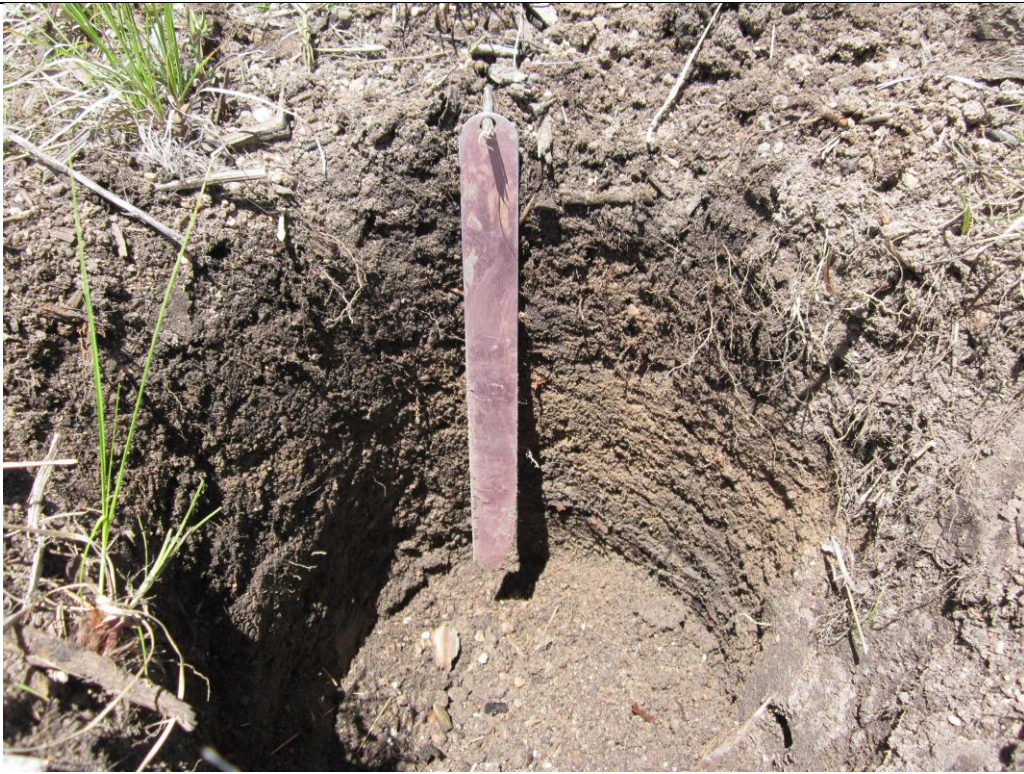
Photo 15: Upland soil profile

Remarks: Very dry at surface, field moist at 11 inches. Translocation of clay evident to lower horizons
