**SOIL, GEOLOGY, AND GEOLOGIC HAZARD STUDY
HOMESTEAD AT STERLING RANCH FILING NO. 3
EL PASO COUNTY, COLORADO**

July 22, 2020

Entech Job No. 201421
F:/AAPProjects/2020/201421 Geohaz

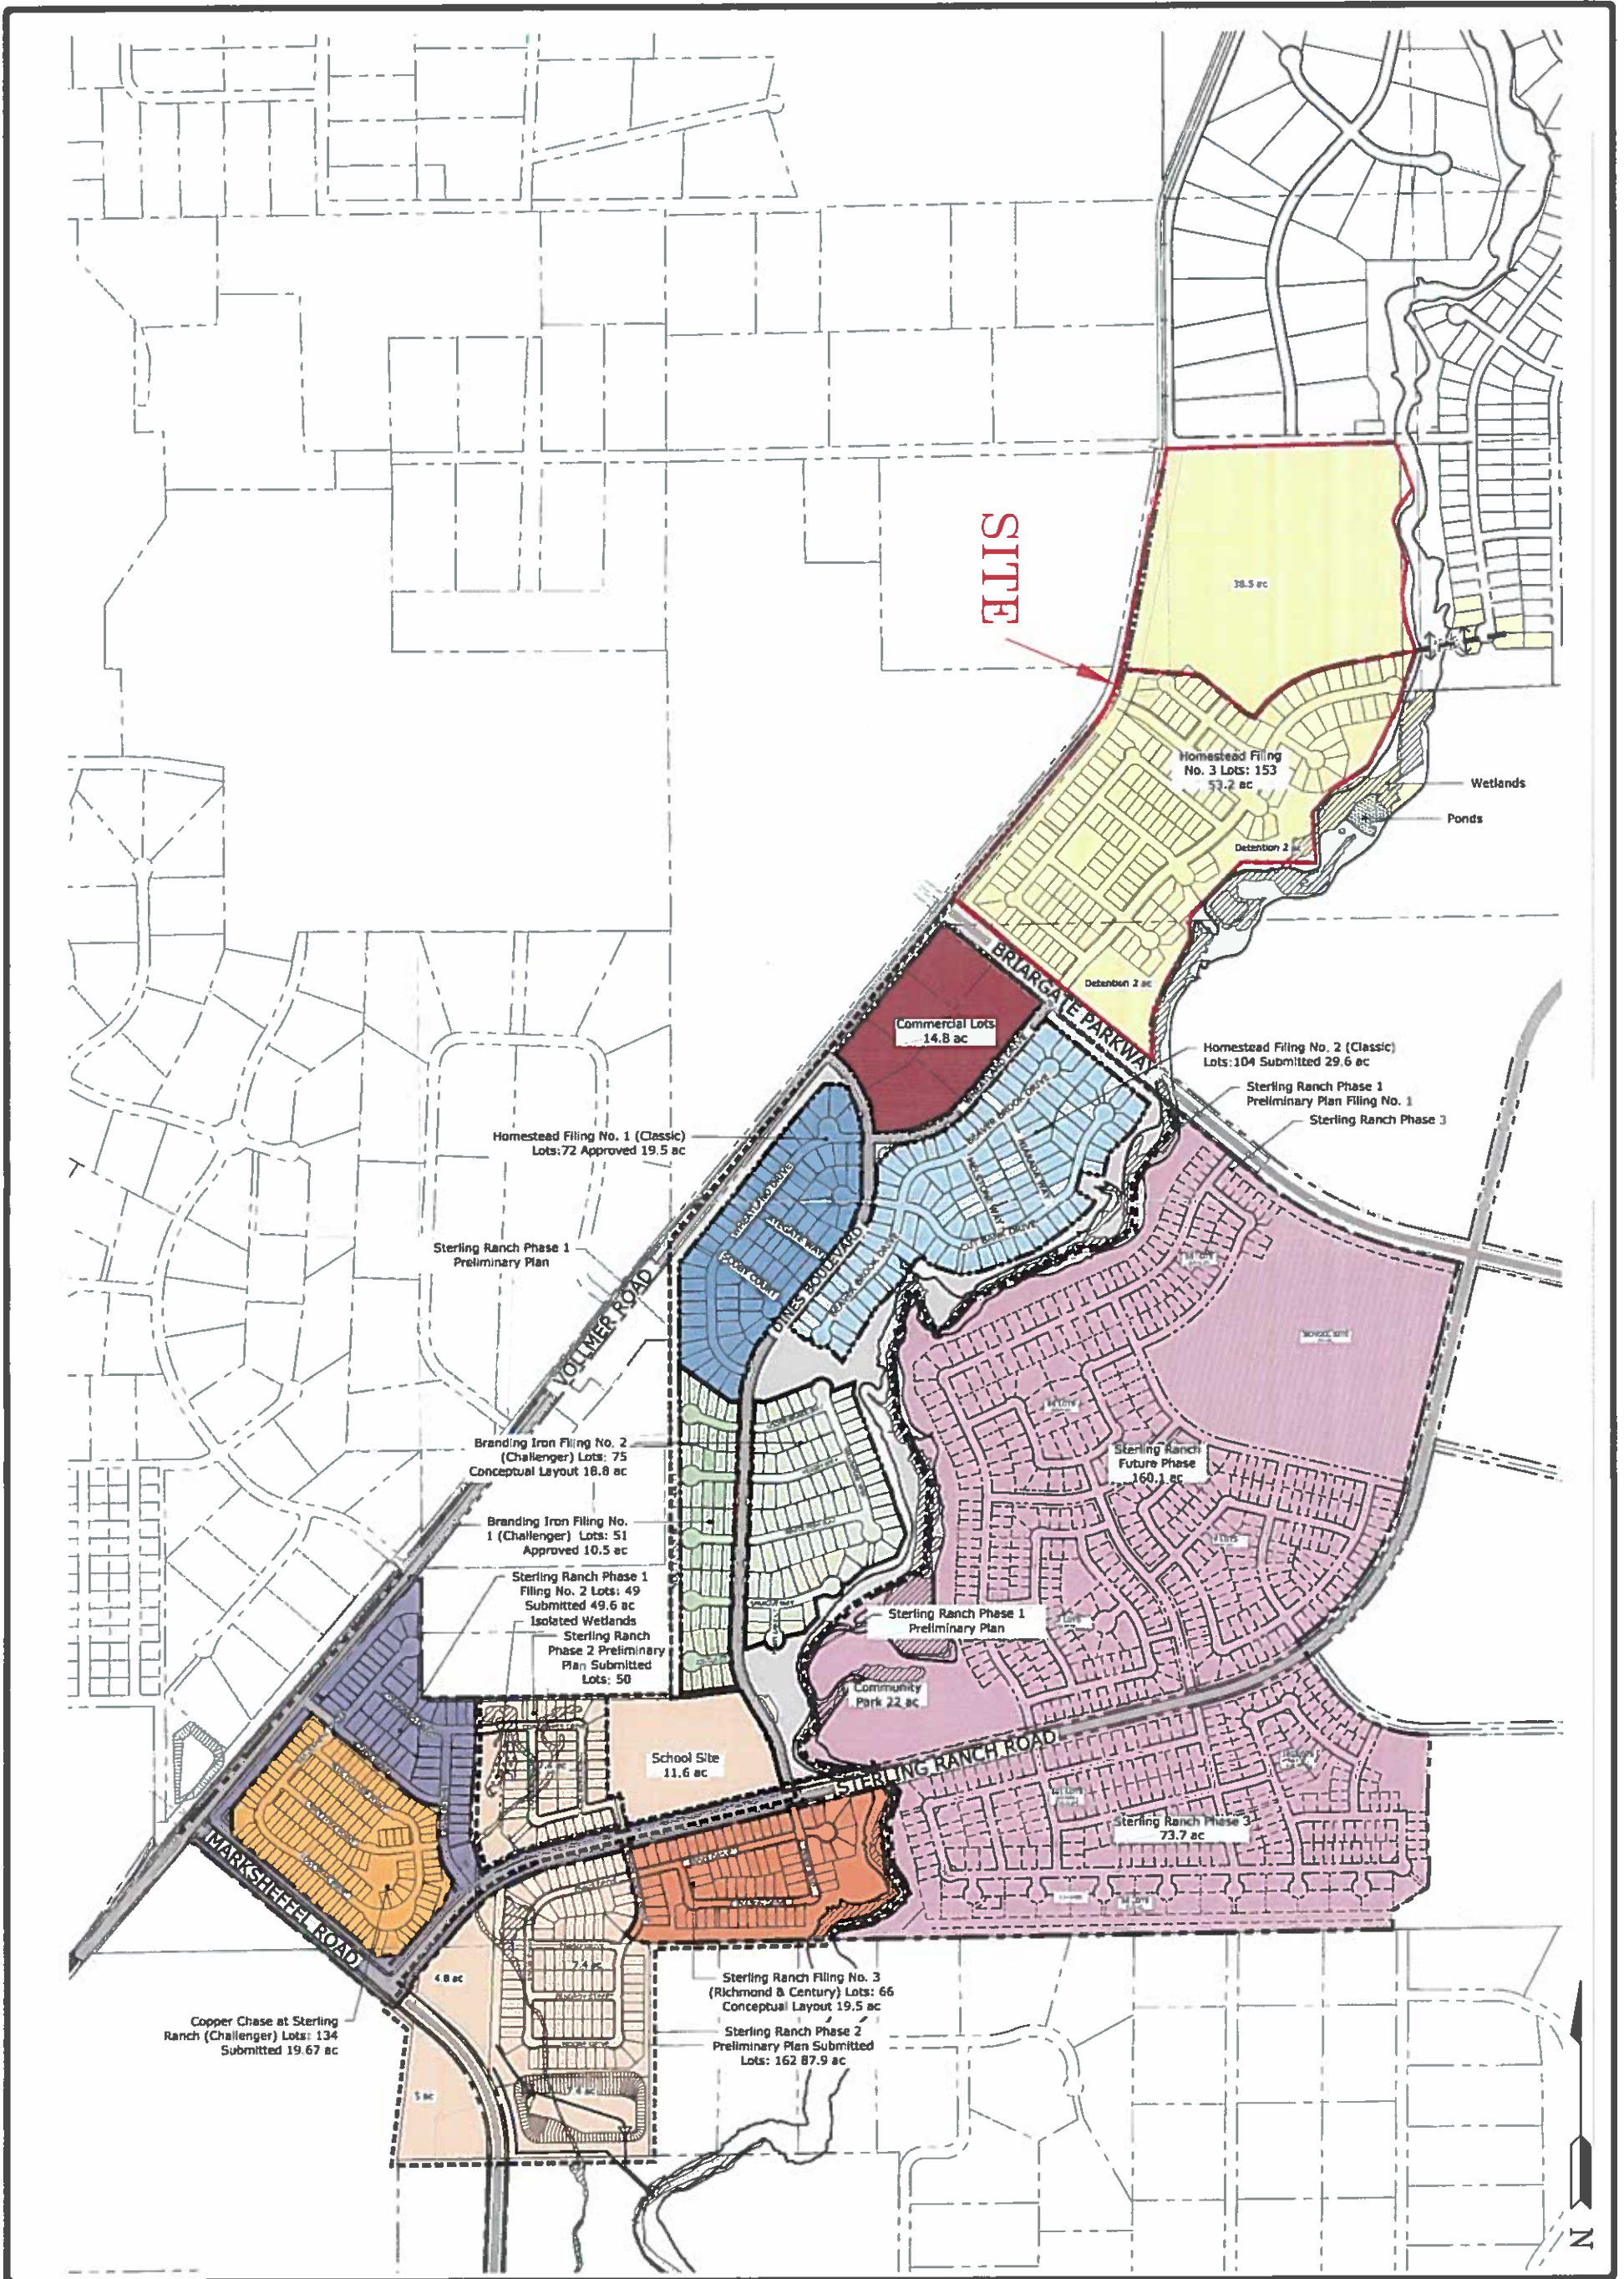
OVERALL SITE PLAN
HOMESTEAD AT STERLING RANCH FILING NO. 3
COLORADO SPRINGS, COLORADO
FOR: MORLEY-BENTLEY INVESTMENTS, LLC

The floodplain areas of the Sand Creek drainage exist along the eastern boundary of the site. According to the Overall Site Plan, Figure 3, this area is to be preserved as open space. Should development be considered in the floodplain, channelization and drainage improvements would be necessary as well as raising building site grades above the floodplain level. According to the development plan, the lots are proposed outside the floodplain zone. Finished floor elevations must be a minimum of one foot above the floodplain level. Drains may be necessary for foundations immediately adjacent to the floodplain to help prevent the intrusion of water into areas below grade. Specific floodplain location and drainage studies are beyond the scope of this report.

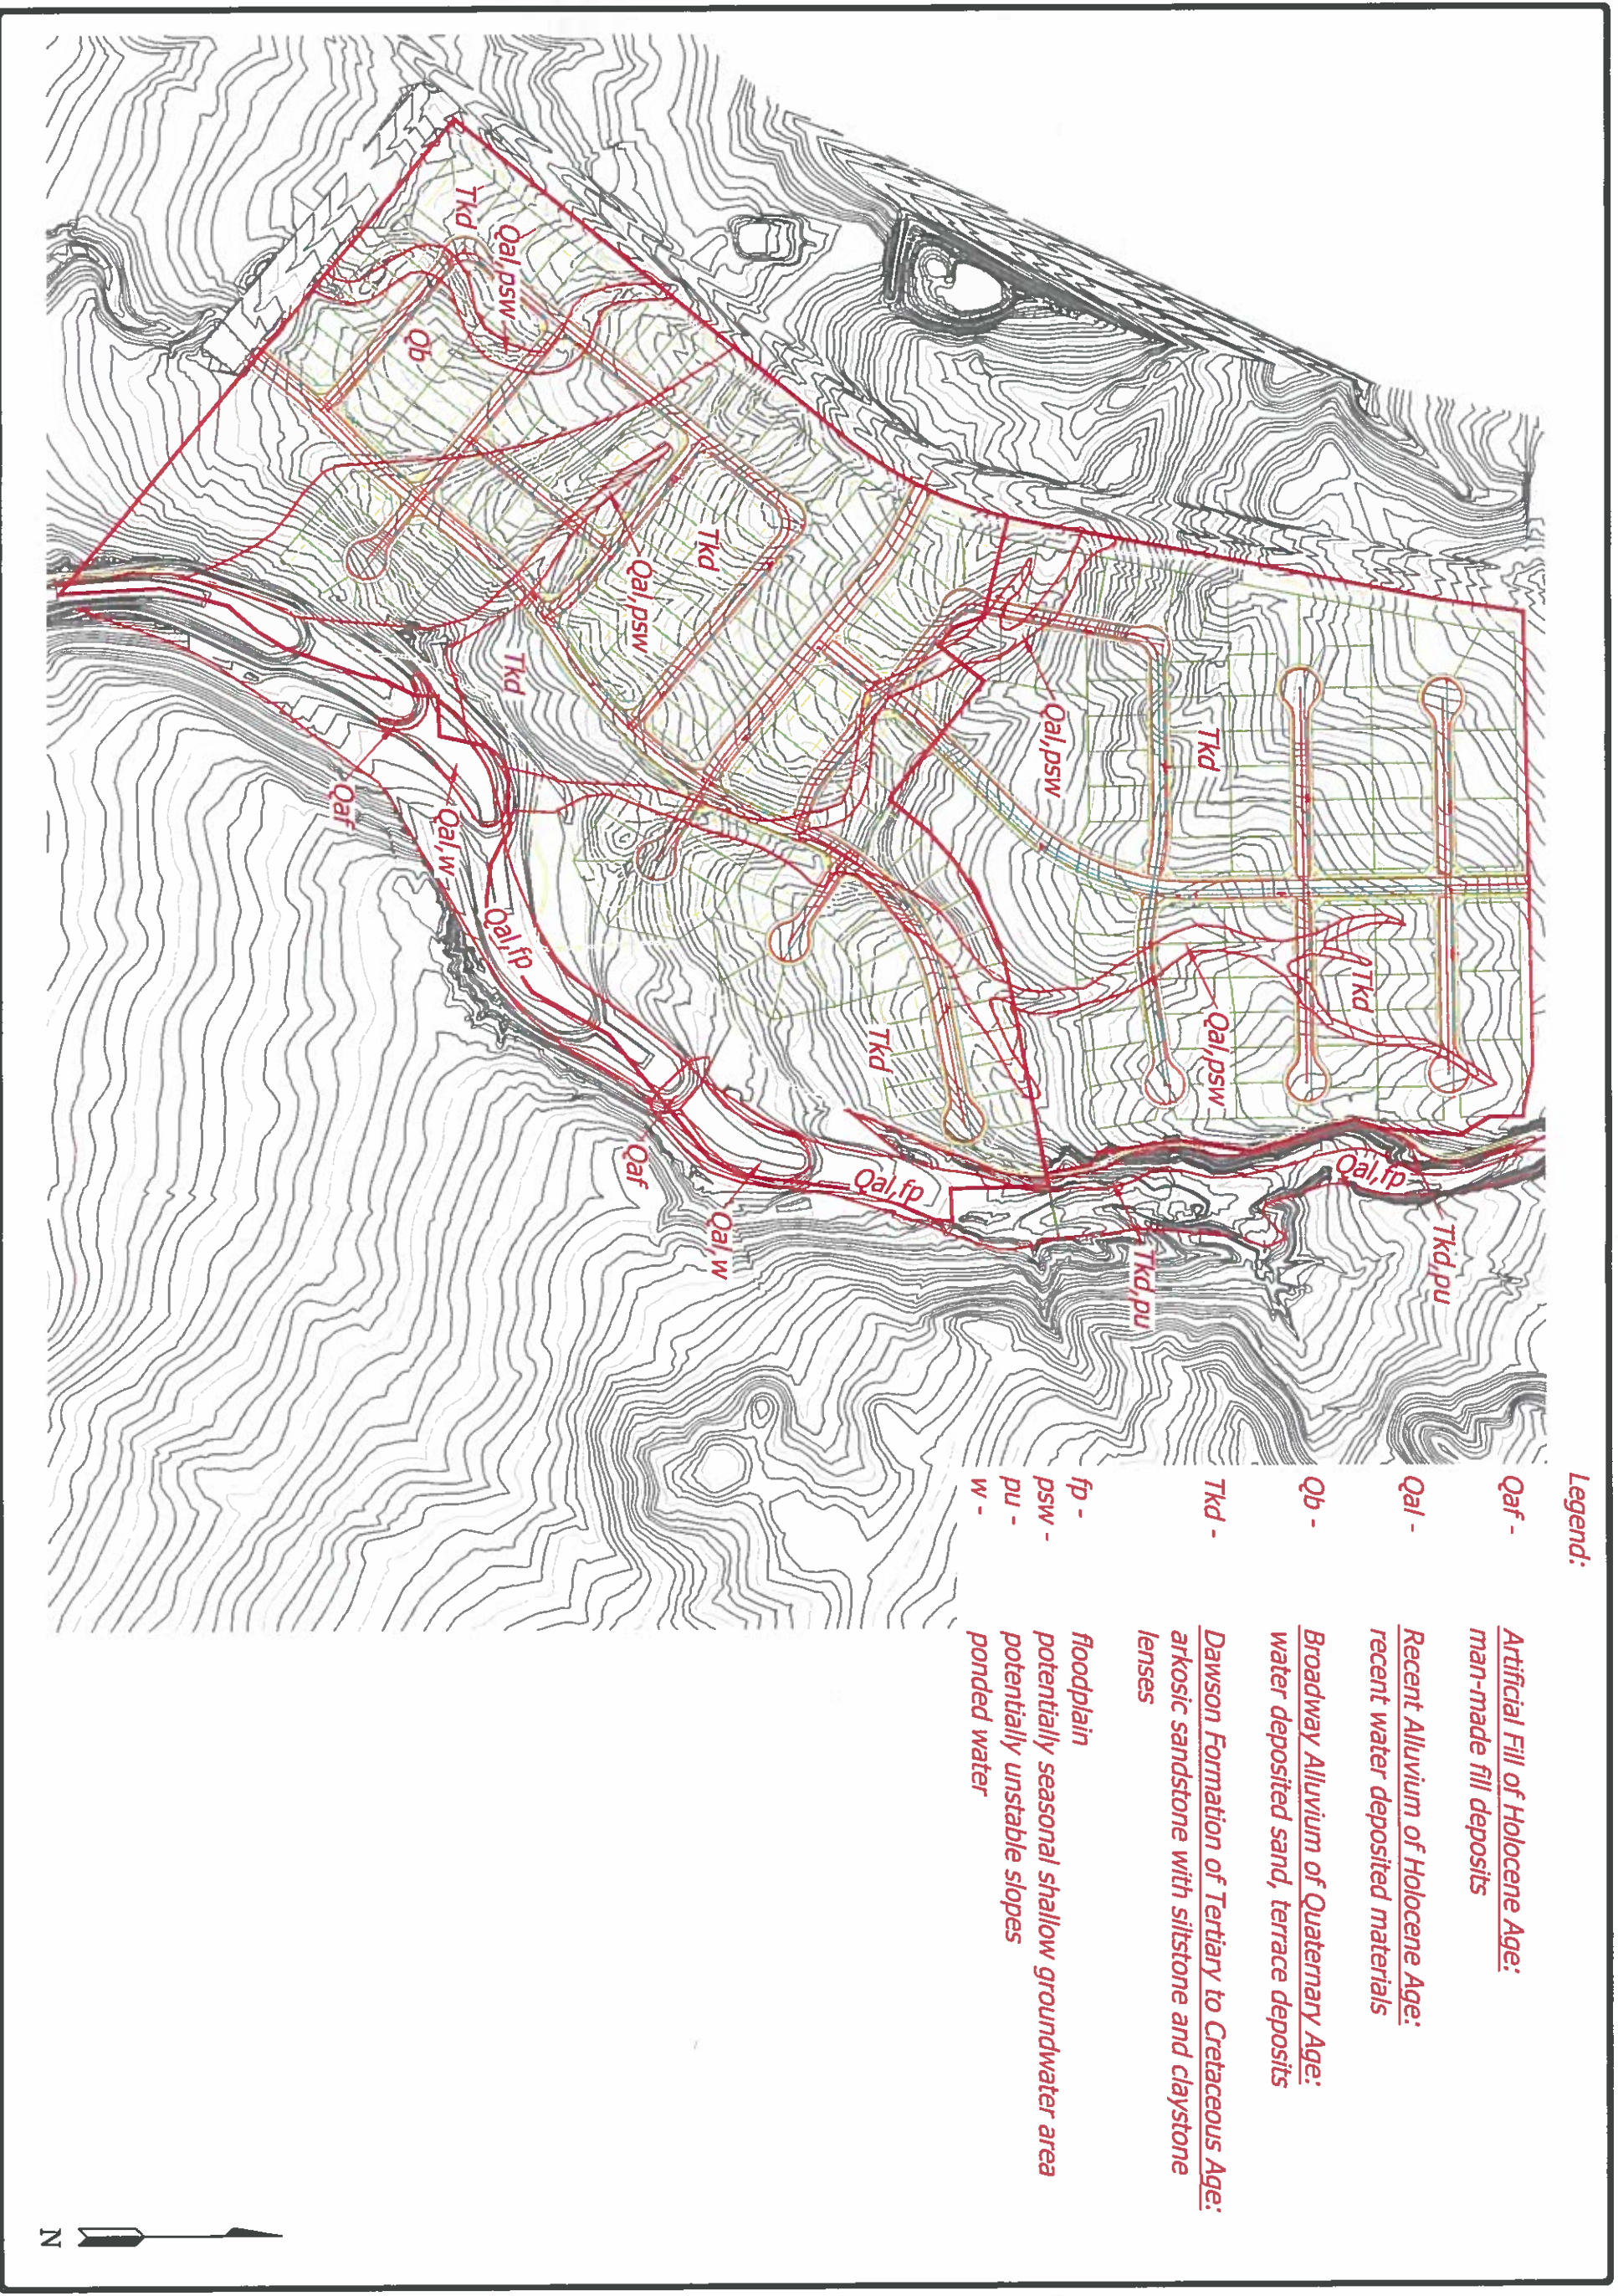
Detailed mapping has been performed on this site to produce an Engineering Geology Map (Figure 7). This map shows the location of various geologic conditions of which the developers and planners should be cognizant during the planning, design and construction stages of the project. The hazards identified on this site include artificial fill, potentially unstable slopes, potentially expansive soils, floodplains, and potentially seasonal shallow groundwater areas. The following hazards have been addressed:

Some of the steep slopes along the Sand Creek drainage have been identified as potentially unstable. Considerable care must be exercised in these areas not to create a condition which would tend to activate instability.

Potentially Seasonal Shallow Groundwater: In these areas, we would anticipate the potential for periodically high subsurface moisture conditions and possible frost heave potential, depending on the soil conditions. These areas are located in areas of minor drainage swales and low areas located on the site. According to the grading plans, these areas are to be regraded and detention ponds created. Areas of shallow groundwater may exhibit unstable subgrade conditions in terms of bearing support of construction equipment during overlot grading. Lots immediately adjacent to the detention ponds or the Sand Creek drainage may also experience higher subsurface moisture conditions during periods of higher flows.

Areas of artificial fill were observed associated with earthen dams east of the site. Other areas of fill associated with recent grading along Briargate Parkway may be encountered.

Mitigation: According to the grading plan shown on Figure 7, Much of this area is to be regraded or avoided by development. Building should be avoided on any remaining potentially unstable slopes unless stabilized. A setback of 20 feet from the crest of these slopes is recommended. Stabilization could involve regrading to slope angles no steeper than 3:1 or the use of engineer-designed retaining walls, tiebacks, or buttresses. Where retaining walls are not used, erosion protection may be necessary to prevent undercutting by the creek during periods of high water. It is our understanding the project will include drainage improvements and the construction of a regional trail along the Sand Creek

Mitigation: In these locations, foundations subject to severe frost heave potential should penetrate sufficient depth so as to discourage the formation of ice lenses beneath foundations. At this location and elevation, a foundation depth for frost protection of 30 inches is recommended. In areas where high subsurface moisture conditions are anticipated periodically, subsurface perimeter drains are recommended to help prevent the intrusion of water into areas located below grade. A typical perimeter drain detail is presented in Figure 9. Structures should not block drainages. Swales should be created to intercept surface runoff and carry it safely around and away from structures. Groundwater was not encountered in the test borings drilled on the site. It is anticipated groundwater will not affect shallow foundations on the majority of the site.

Mitigation: The earthen dams will be avoided by development. Where uncontrolled fill is encountered beneath foundations, mitigation will be necessary. Mitigation typically involves removal and recompaction at a minimum of 95 percent of its maximum Modified Proctor Dry Density, ASTM D-1557.
