**GEOLOGIC HAZARD STUDY
KARMAN LINE
SOUTH CURTIS ROAD AND DRENNAN ROAD
EL PASO COUNTY, COLORADO**

October 19, 2022
Revised March 30, 2023

Entech Job No. 230486
AAprojects/2023/230486 Geohaz

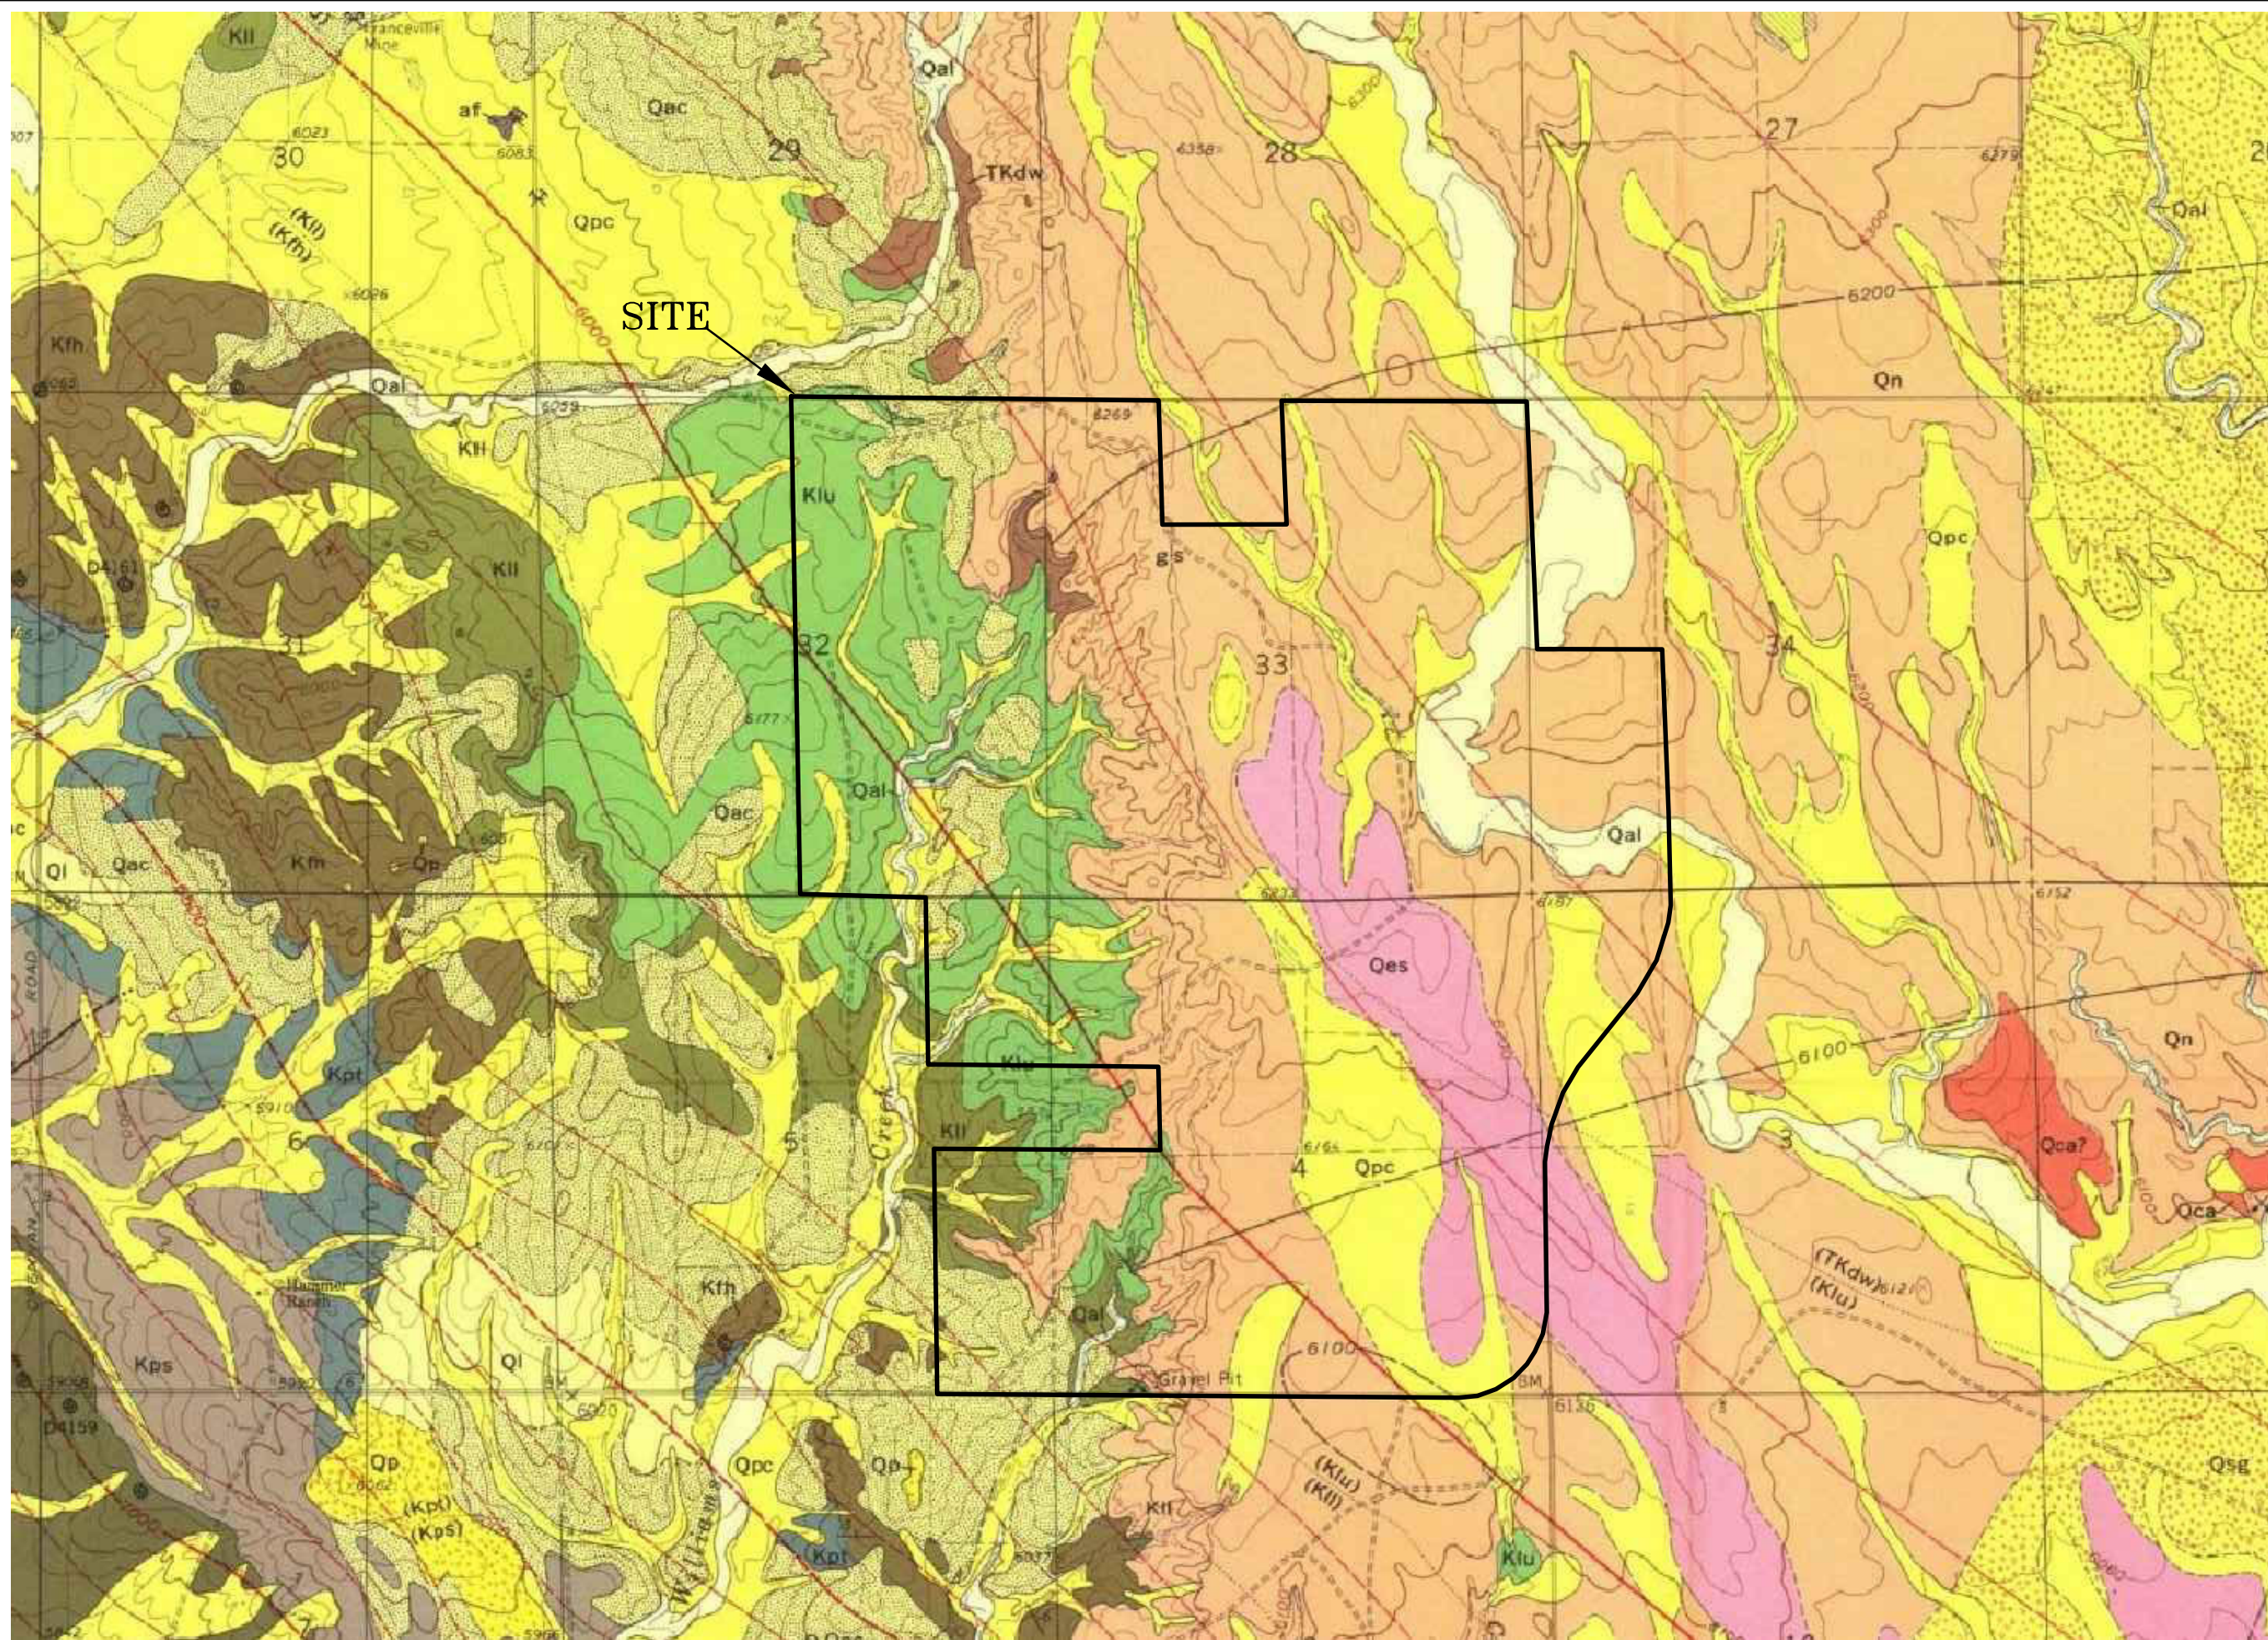
DRAWN	L.L.
CHECKED	
DATE	3/30/23
SCALE	AS SHOWN
JOB NO.	230486
FIGURE No.	6

Detailed mapping has been performed on this site to produce an Engineering Geology Map Figure 6. This map shows the location of various geologic conditions of which the developers should be cognizant during the planning, design and construction stages of the project. These hazards and the recommended mitigation techniques are as follows:

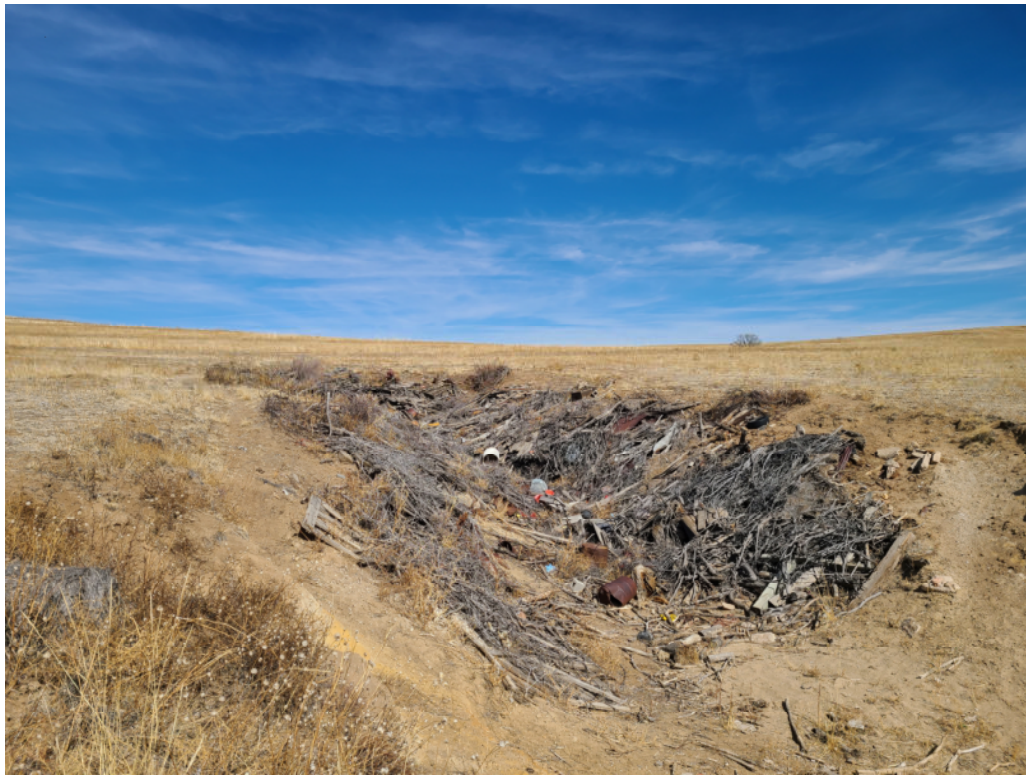
Areas of artificial fill were observed in areas of the site associated with erosion berms, earthen dams, fill piles, and trash and debris in the head of a drainage in the southern portion of the site.

Looking north at trash pit in the head of a drainage southern portion of the site.

Mitigation: It is anticipated the fill can be avoided or removed (regraded) during site development. Where uncontrolled fill is encountered beneath foundations or roadways, mitigation will be necessary. Mitigation typically involves removal and recompaction at a minimum of 95 percent of its maximum Modified Proctor Dry Density, ASTM D-1557. Any new fill placed to the site should be placed on native or controlled fill soils, and compacted as structural fill.

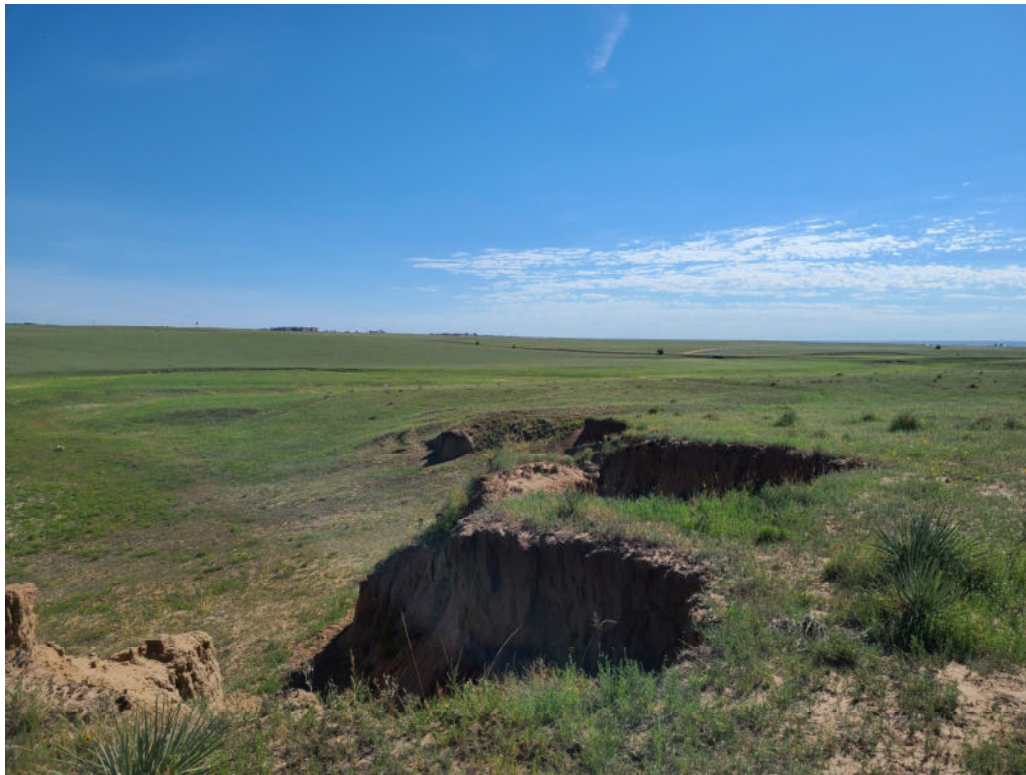
These slopes are considered stable in their present condition; however, considerable care must be exercised in these areas not to create a condition which would tend to activate instability. The steeper slopes along portions of Williams Creek and other drainages across the site should be avoided by development unless properly mitigated with regrading. Structures can also be placed at a sufficient distance from the potentially unstable slopes. Additional investigation is recommended once development plans are created. Based on the size of the site and anticipated development these areas can likely be avoided or mitigated.

**Looking east from
potentially unstable
slopes along drainage
in the east-central
portion of the site.**

Mitigation: According to the Master Plan shown on Figure 3, it is anticipated the majority of these areas are to be avoided. Building should be avoided on the potentially unstable slopes unless they are stabilized. A minimum setback of 30 feet from the crest of these slopes is recommended. Stabilization could involve regrading to slope angles no steeper than 3:1 or the use of engineer-designed retaining walls, tiebacks, or buttresses. Where retaining walls are not used, erosion protection may be necessary to prevent undercutting by the creek during periods of high water. **Specific slope stabilization recommendations are beyond the scope of this report.**

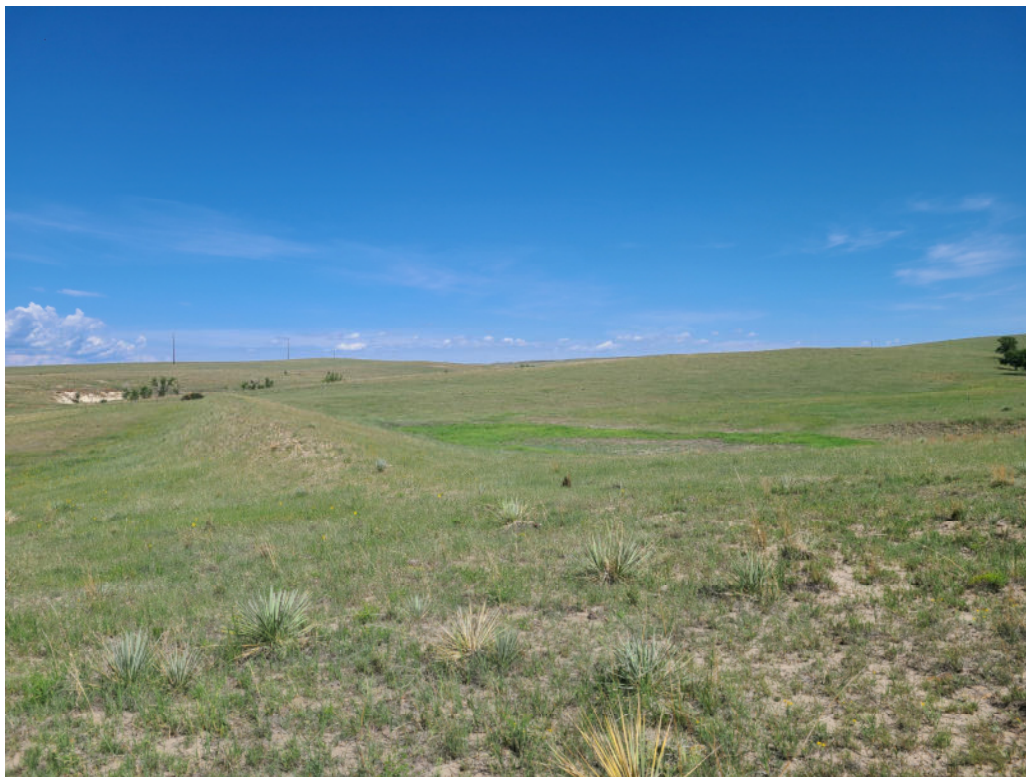
Looking north from the western portion of the site along embankment near Williams Creek.
