7/19/2024

Soils & Geology Report

**Pikes Peak BOCES Educational Park
Northeast of Judge Orr Rd & Elbert Rd
Peyton, Colorado
VIVID Project No.: D24-2-759**

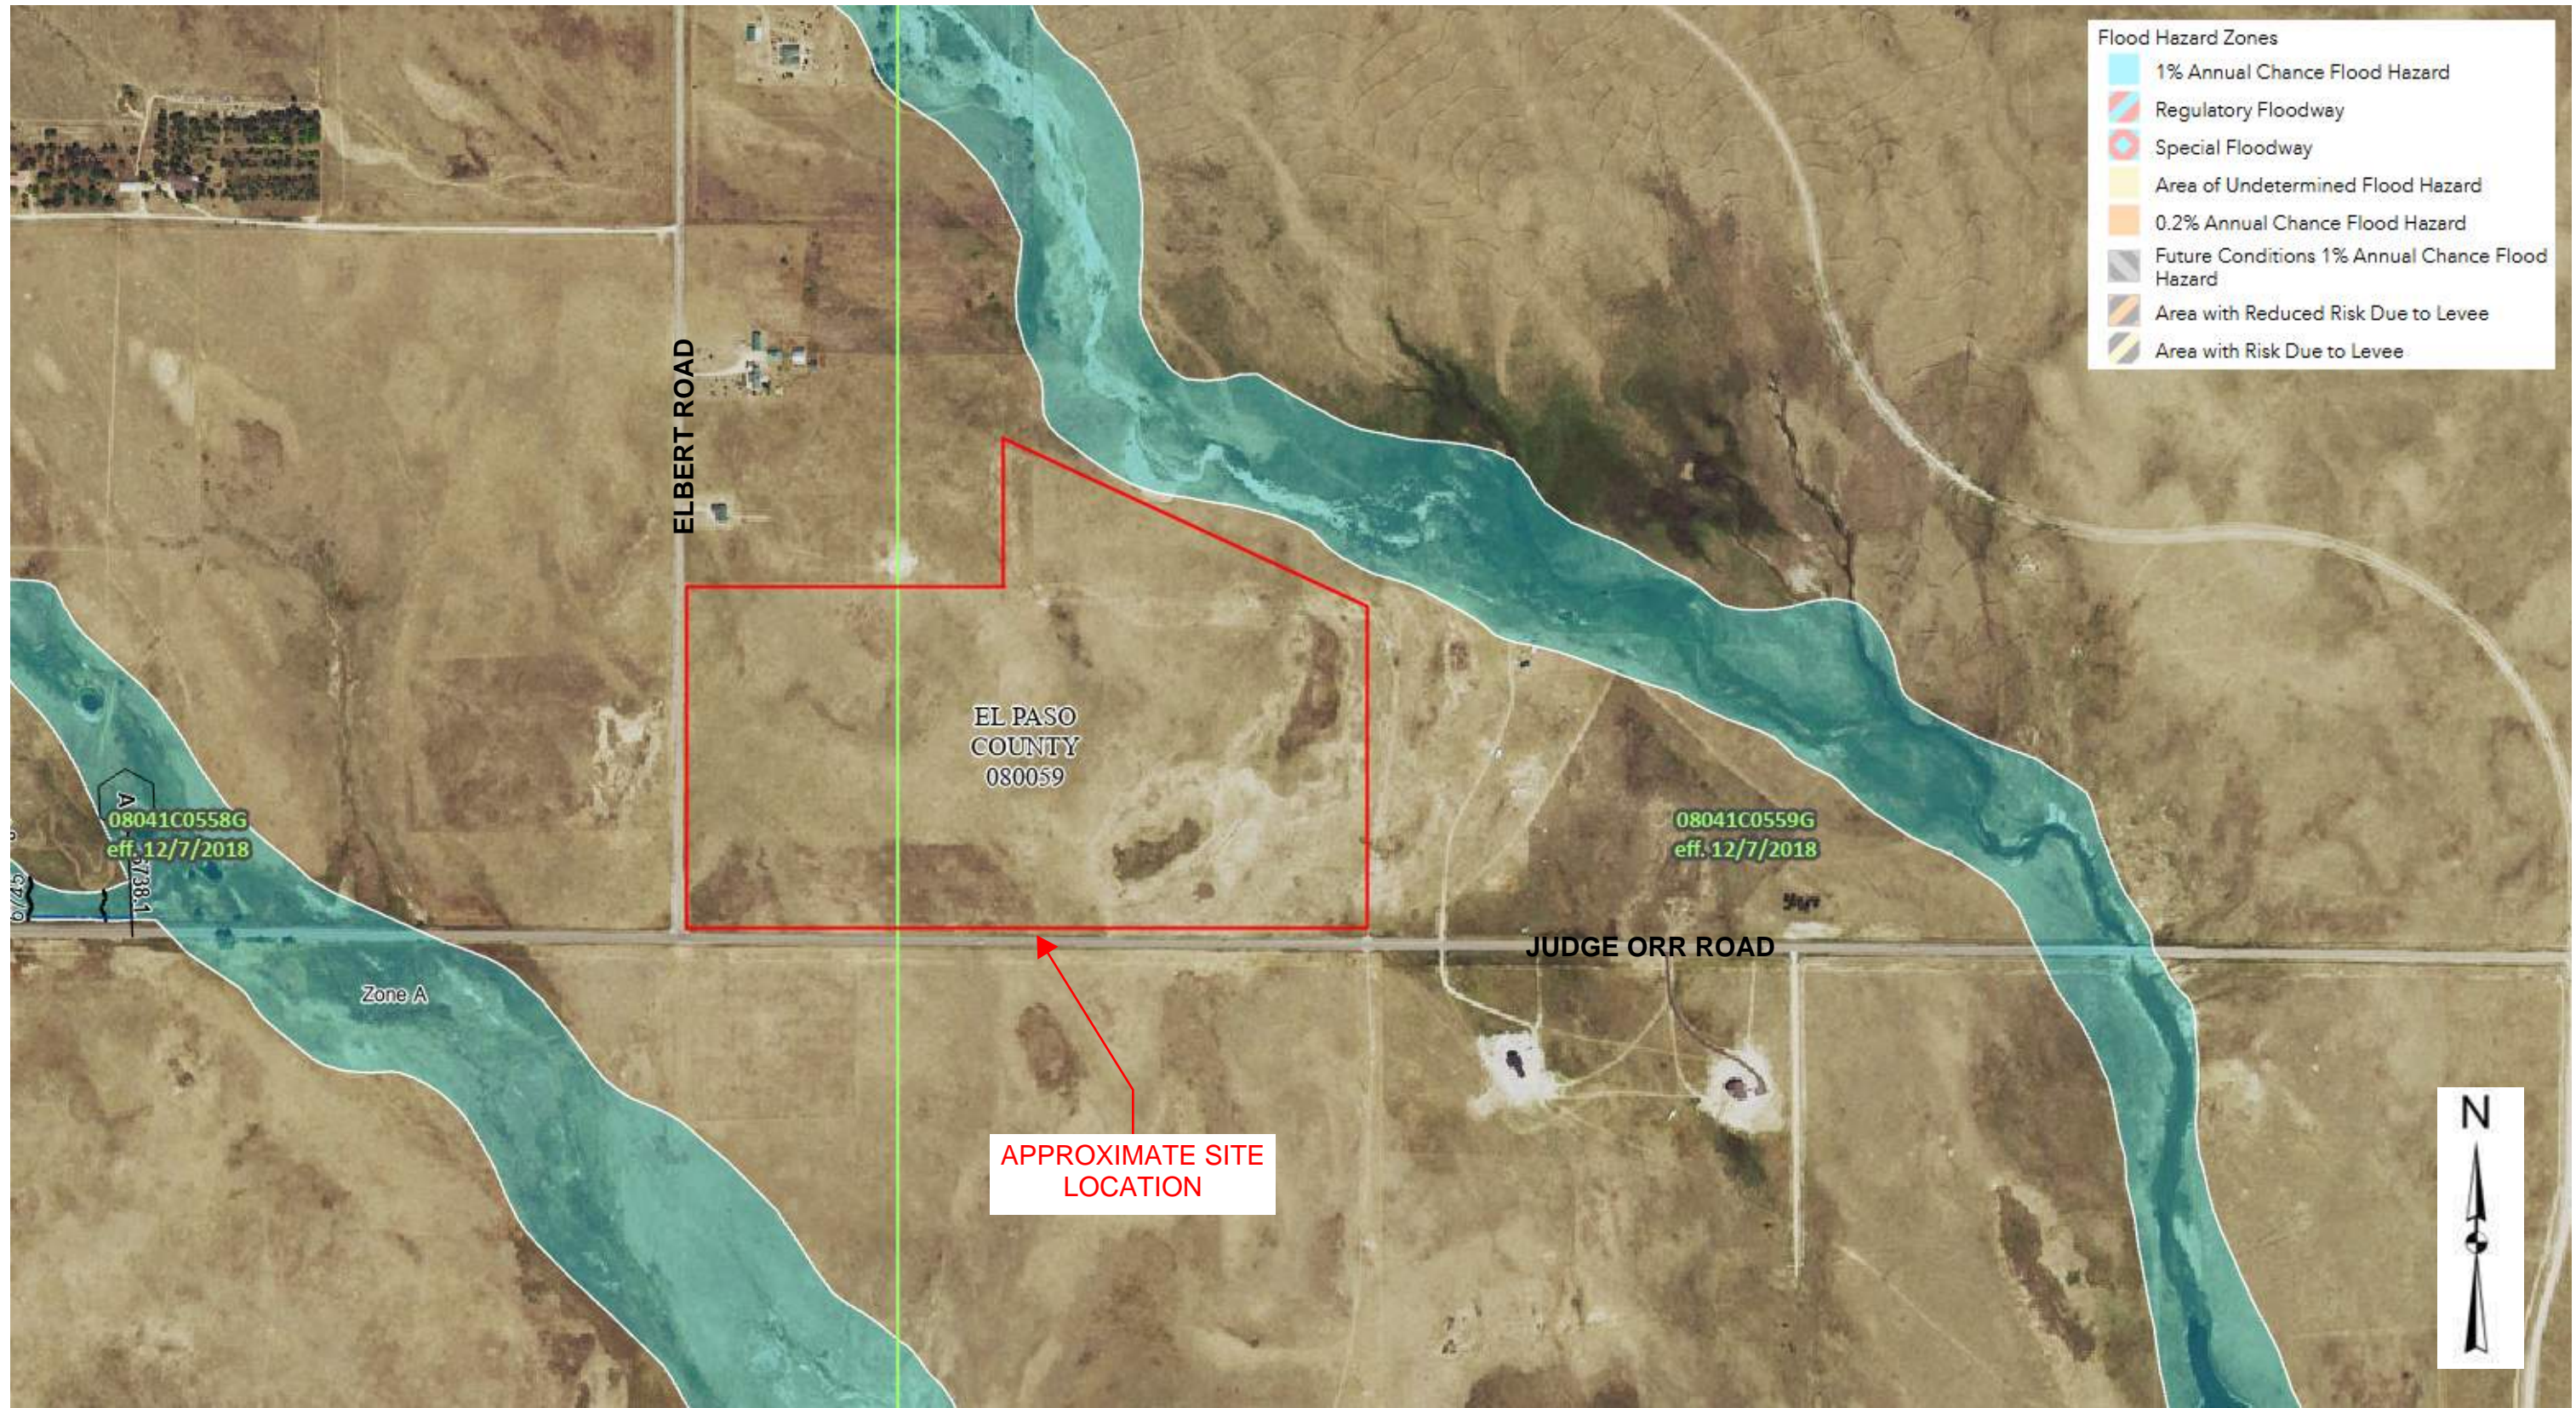
FLOOD HAZARD MAP

As shown on Figure 4, the project site is outside of mapped flood hazard areas. Based on the mapping and our site observations, flooding is not considered to be a hazard for this development.

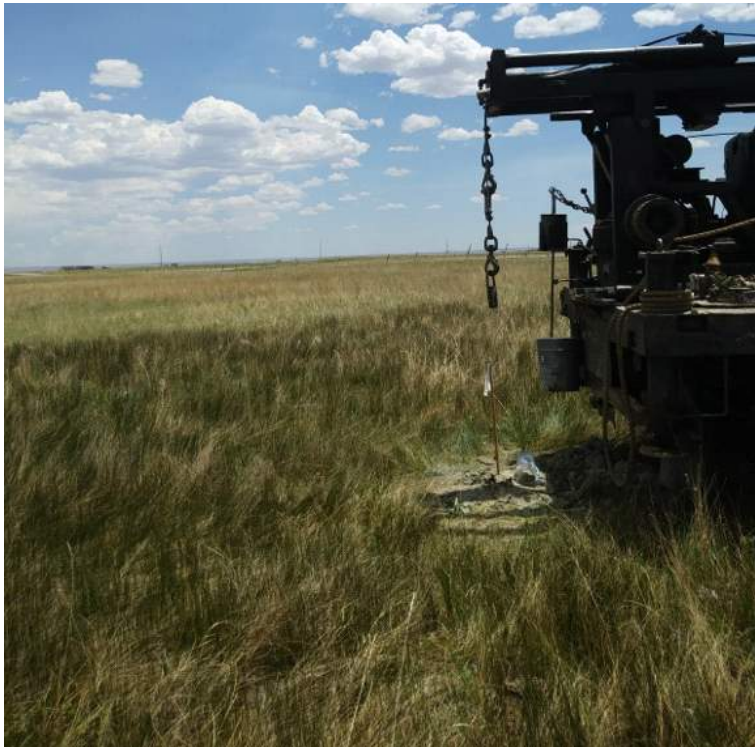
SITE CONDITIONS AT BORING B-1 - LOOKING SOUTHEAST

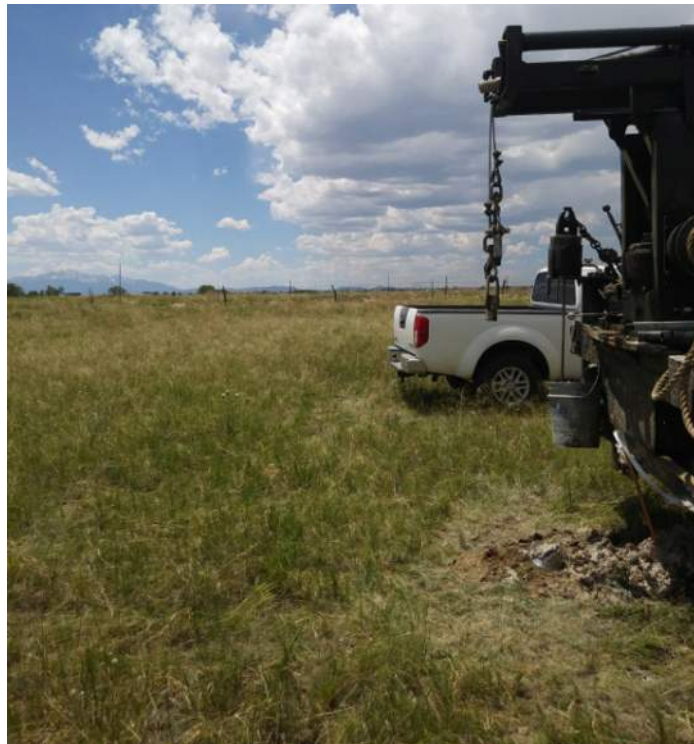
SITE CONDITIONS AT BORING B-2 - LOOKING WEST

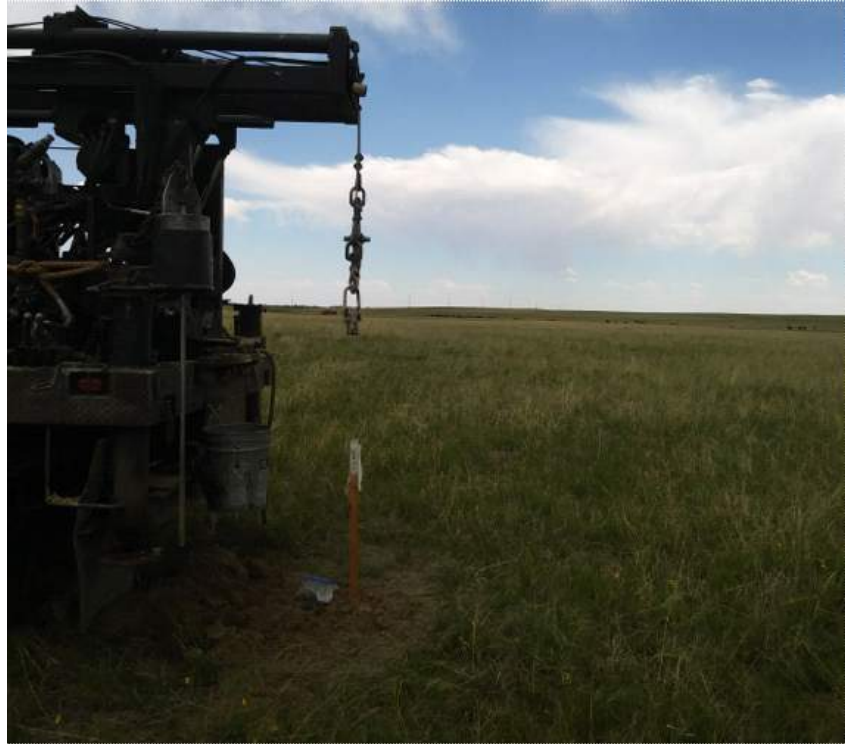
SITE CONDITIONS AT BORING B-5 - LOOKING SOUTHEAST

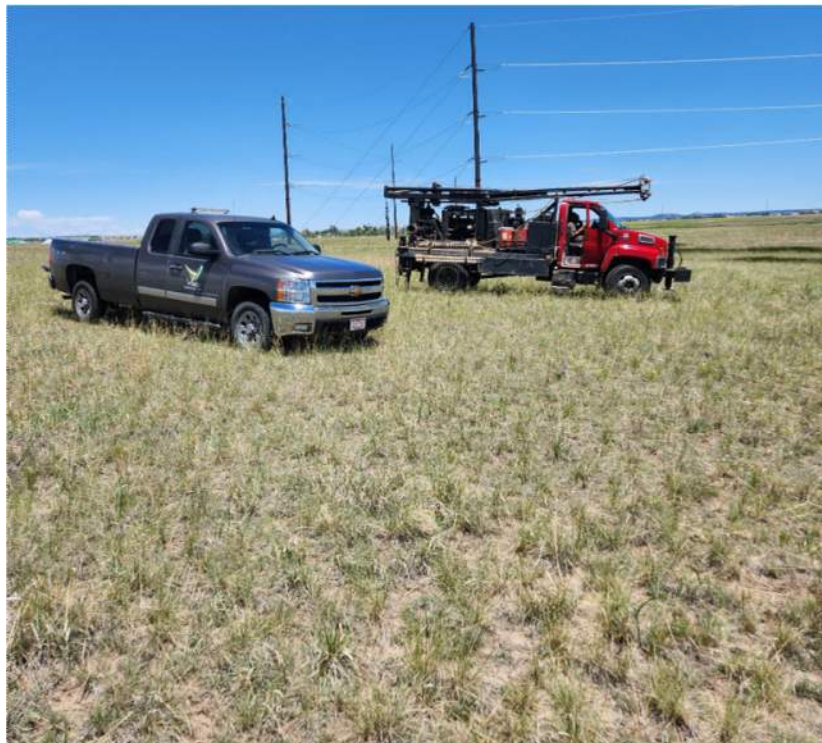
SITE CONDITIONS AT BORING B-11 - LOOKING NORTH
