Re: Soil, Geology and Geologic Hazard Evaluation
The Estates at Rolling Hills Ranch, Filing 1 & 2
Sunrise Ridge Drive and Rex Road
El Paso County, Colorado PUD 19-007, SF 19-019, PUD-SP-204, SF-20-018

Tech Contractors
Soil, Geology and Geologic Hazard Evaluation
The Estates at Rolling Hills Ranch, Filing No. 1 & 2
Sunrise Ridge Drive and Rex Road
El Paso County, Colorado

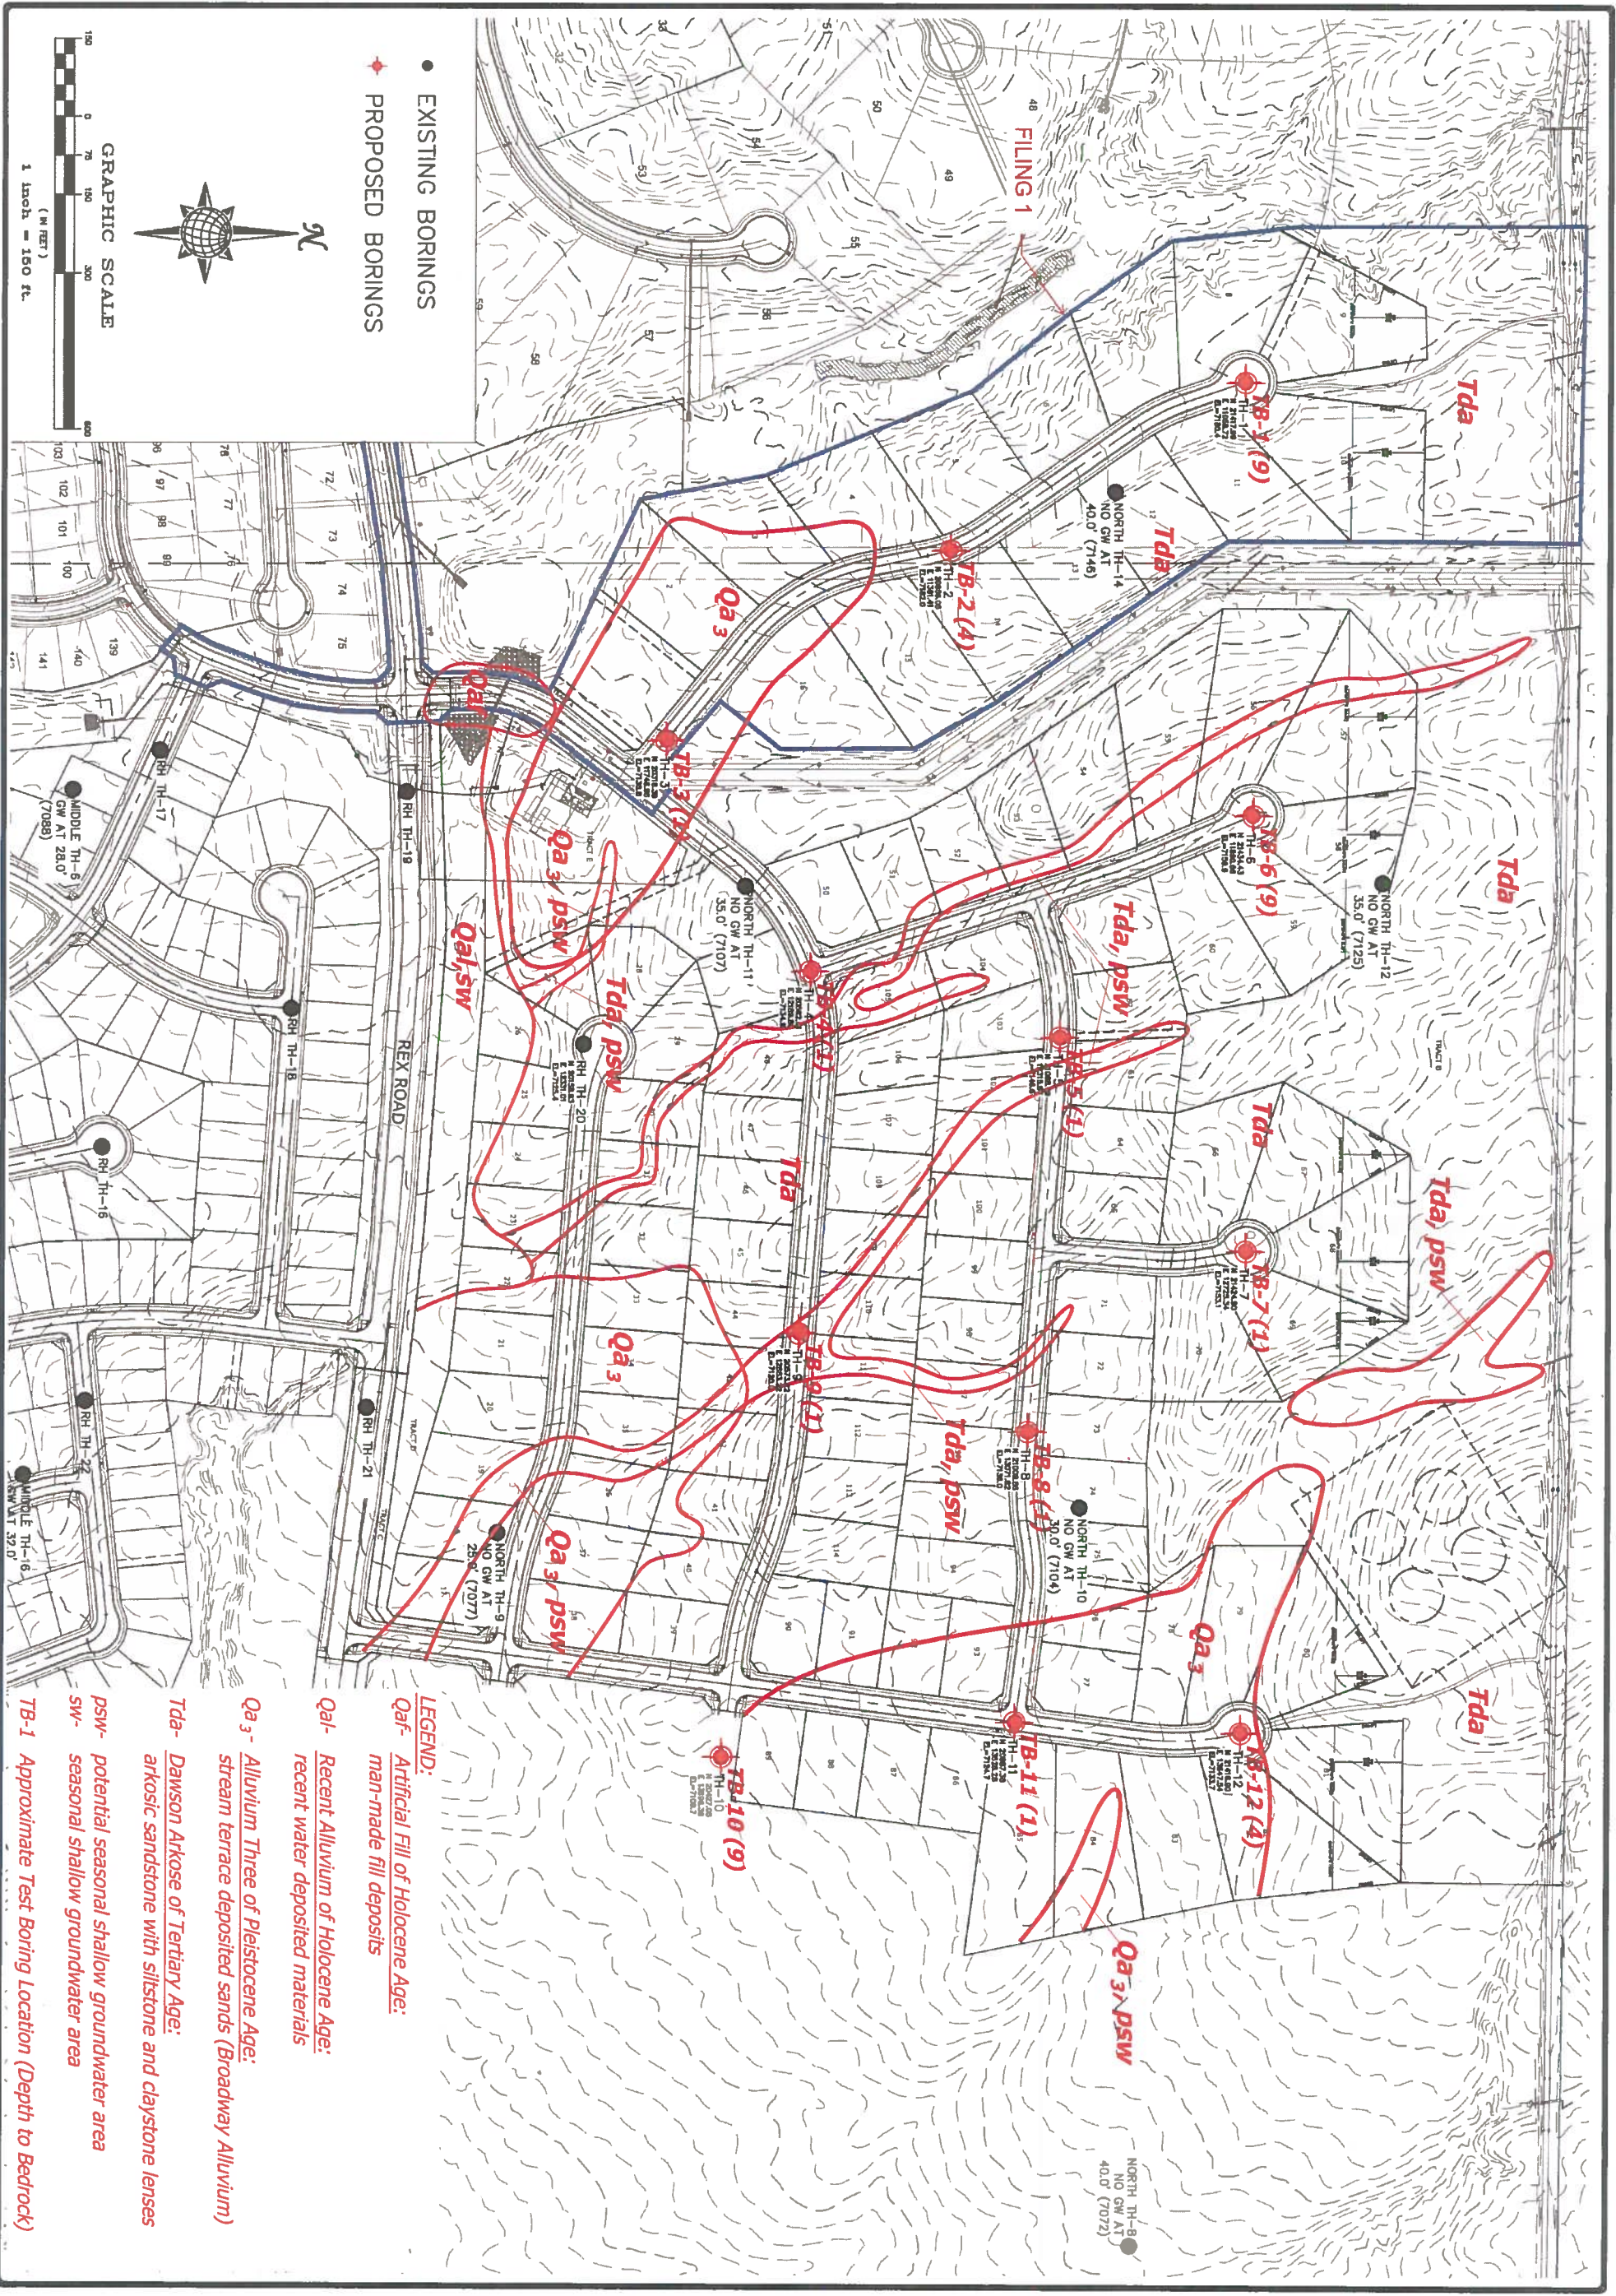
DRAWN KAH	DATE 4/18/18
CHECKED	SCALE AS SHOWN
	JOB NO. 181234
	FIGURE No. 6

An area of fill was mapped on the site in the southwestern corner that is associated with a road and a dam embankment. Other minor areas not mapped are associated with small fill piles that are considered uncontrolled, and areas of fill may exist that are not mapped due to on-going site grading.

Expansive soils were encountered in some of the test borings drilled on-site. These occurrences are typically sporadic; therefore, none have been indicated on the maps. These clays, if encountered beneath foundations, can cause differential movement in the structure foundation. These occurrences should be identified and dealt with on an individual basis.

In these areas, we should anticipate the potential for periodically high subsurface moisture conditions and frost heave potential. In these areas, the potential exists for shallow groundwater during high moisture periods. The minor drainages will likely be regraded during site development, and the seasonal shallow groundwater area will be avoided by the proposed development.

Mitigation: It is anticipated the uncontrolled fill piles will be removed during site grading. Any uncontrolled fill encountered beneath foundations should be removed and recompacted at a minimum of 95% of its maximum Modified Proctor Dry Density, ASTM D-1557.

Mitigation: Should expansive soils be encountered beneath the foundation, mitigation will be necessary. Mitigation of expansive soils will require special foundation design. Overexcavation and replacement with non-expansive soils at a minimum of 95% of its maximum Modified Proctor Dry Density, ASTM D-1557 is a suitable mitigation, which is common in the area. Another alternative in areas of highly expansive soils is the use of drilled pier foundation systems. Typical minimum pier depths are on the order of 20 feet or more and require penetration into the bedrock material a minimum of 4 to 6 feet, depending upon building loads. Floor slabs on expansive soils should be expected to experience movement. Overexcavation and replacement has been successful in minimizing slab movements. The use of structural floors should be considered for basement construction on highly expansive clays. Final recommendations should be determined after additional investigation of each building site.

Mitigation: Foundations must have a minimum 30-inch depth for frost protection. In areas where high subsurface moisture conditions are anticipated periodically, subsurface perimeter drains are recommended to help prevent the intrusion of water into areas below grade. It is anticipated much of these areas would be filled during site grading further raising foundations above the groundwater level. Any grading in these areas should be done to direct surface flow around construction to avoid areas of ponded water. All organic material would be completely removed prior to fill placement. Specific recommendations concerning the affects of groundwater on site grading and construction are included in the Subsurface Soil Investigation (Reference 1). Further investigation will be necessary to determine the groundwater depth after final grading. The site does not lie within any floodplain zones according to the FEMA Map No. 08041CO552G, dated December 7, 2018 (Figure 7, Reference 6). Exact locations of floodplain and specific drainage studies are beyond the scope of this report. Finished floor levels must be located a minimum of one foot above floodplain levels.
