**SOIL, GEOLOGY, AND GEOLOGIC HAZARD
THE COTTAGES AT MESA RIDGE
PARCEL NO. 5529100006
EL PASO COUNTY, COLORADO**

December 22, 2021
Revised August 30, 2022

Entech Job No. 211100
AAprojects/2021/211100 county soil/geo

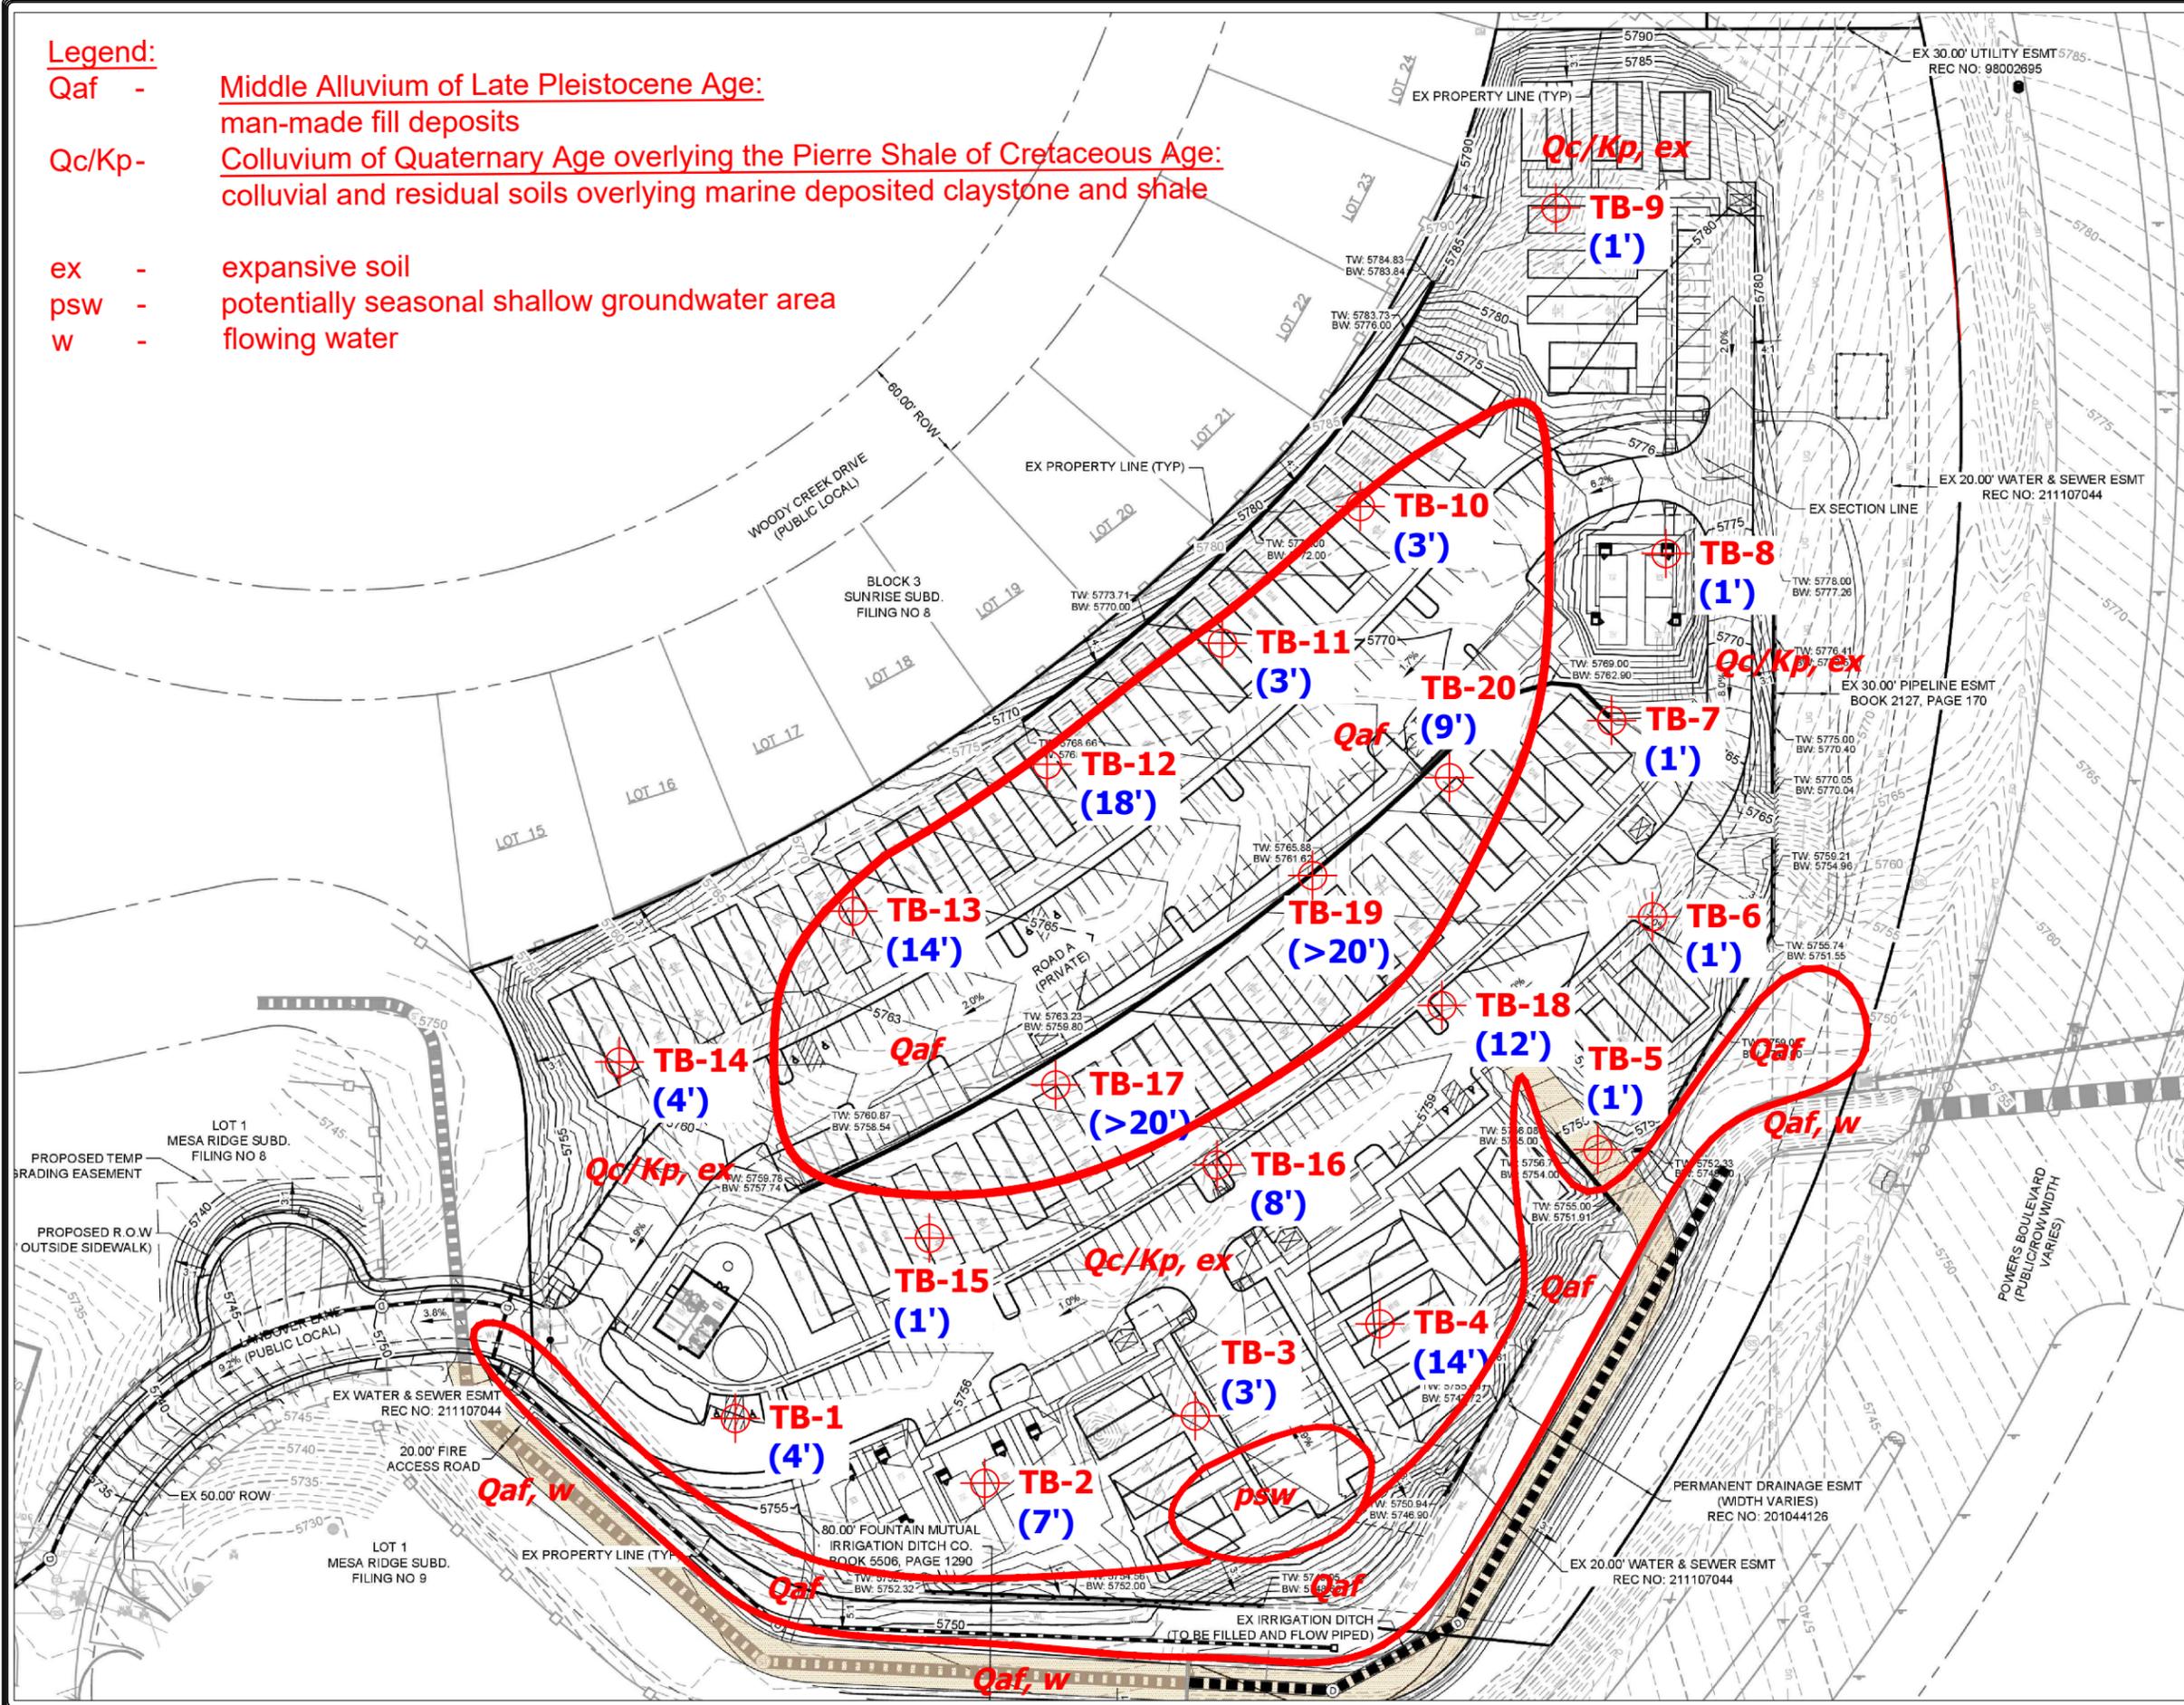
DRAWN L.L.
CHECKED
DATE 12/22/21
SCALE AS SHOWN
JOB NO. 211100
FIGURE No. 6

Detailed mapping has been performed on this site to produce a Geology Map/Engineering Geology Map Figure 6. This map shows the location of various geologic conditions of which the developers should be cognizant during the planning, design and construction stages of the project. Constraints/Hazards include artificial fill, collapsible soils, expansive soils, potential seasonal shallow groundwater, shallow bedrock, and flowing water. These hazards and the recommended mitigation techniques are as follows:

Fill was encountered in some of the test borings, and fill piles were observed across portions of site, and review of historical images indicate that dumping of fill has occurred on the site. Fill associated with the irrigation ditch has also been indicated on the site Geology Map/Engineering Geology Map, Figure 6. Additionally, other areas of artificial fill may be encountered in areas other than those mapped. These piles are considered uncontrolled for construction purposes. It is anticipated the uncontrolled fill will be mitigated during site grading and development. Cut areas of up to 10.5 feet and fill areas of up to 3 feet are proposed.

Some of the soils encountered in the test borings exhibited collapsible characteristics. In areas identified for this hazard classification, however, we anticipate a potential for settlement movements upon saturation of these surficial soils. The low density, uniform grain sized, windblown sand deposits are particularly susceptible to this type of phenomenon. Additionally, loose or collapsible soils may be encountered on this site.

Expansive soils are common in the area, and were encountered in the test borings drilled on site. Swells ranged from low to moderately high in the soils tested. The clay and claystone, if encountered beneath foundations, can cause differential movement in the structure foundation. These occurrences should be identified and dealt with on an individual basis or possibly mitigated during site grading.

The areas mapped with this hazard are located a low area in the southeastern portion of the site adjacent to a fill berm along the irrigation ditch. In these areas, we would anticipate the potential for periodically high subsurface moisture conditions and possible frost heave potential, depending on the soil conditions.

Mitigation: It is anticipated the fill would be removed/mitigated during site grading. All uncontrolled fill should be completely removed prior to new fill placement. Any uncontrolled fill encountered beneath foundations will require removal and recompaction at a minimum of 95% of its maximum Modified Proctor Dry Density, ASTM D-1557. Any organic material or debris should be removed.

Mitigation: Should loose or collapsible soils be encountered beneath foundations, recompaction and moisture conditioning of the upper 2 to 3 feet of soil at 95 percent of its maximum Modified Proctor Dry Density ASTM D-1557 will be required. Exterior flatwork and parking areas may also experience movement. Proofrolling and recompaction of soft areas should be performed during site work.

Mitigation Expansive soils encountered beneath foundations will require mitigation. Mitigation of expansive soils may require special foundation design. Overexcavation and replacement with non-expansive soils at a minimum of 95 percent of its maximum Modified Proctor Dry Density, ASTM D-1557 is a suitable mitigation, which is common in the area. Floor slabs on expansive soils should be expected to experience movement. Overexcavation and replacement has been successful in minimizing slab movements. Overexcavation depths of 4 to 5 feet are anticipated for the site. Mitigation may also include moisture conditioning and recompaction of the clay soils.

Mitigation In these locations, foundations in areas subject to severe frost heave potential should penetrate sufficient depth so as to discourage the formation of ice lenses beneath foundations. At this location and elevation, a foundation depth for frost protection of 2.5 feet is recommended. In areas where high subsurface moisture conditions are anticipated periodically, a subsurface perimeter drain will be necessary to help prevent the intrusion of water into areas located below grade. A typical perimeter drain detail is presented in Figure 9. Additionally, swales should be created to intercept surface runoff and carry it safely around and away from structures. It is anticipated that the site grading will likely mitigate potentially seasonal shallow groundwater area on the site. Prior to placing any fill all organic soils should be removed.

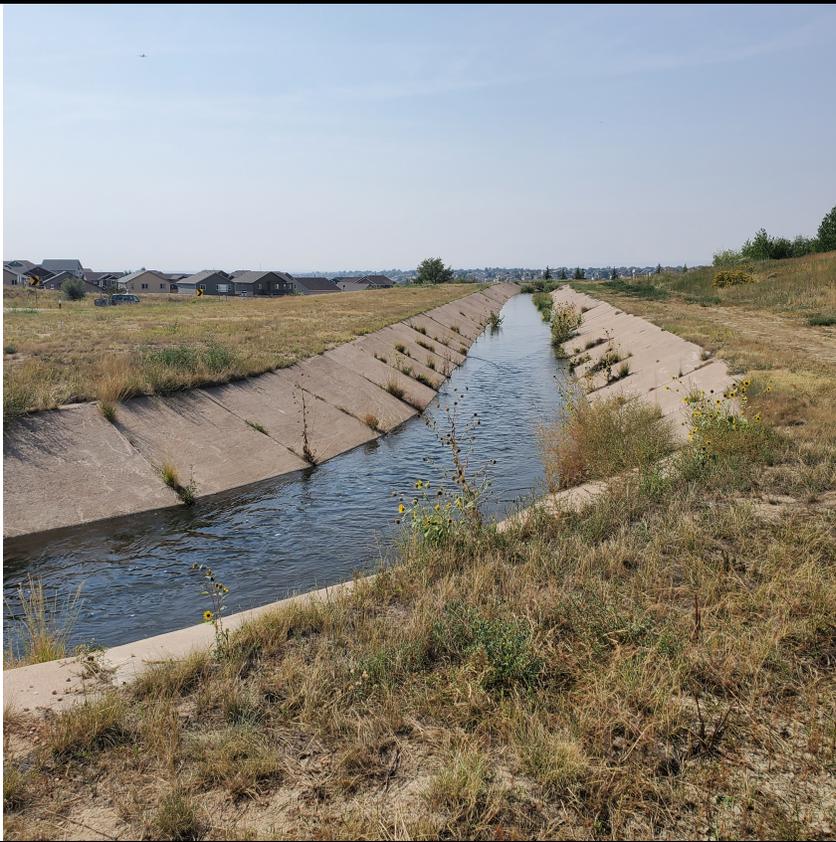
**Looking west along
irrigation ditch
southwestern portion
of the site.**
