**SOIL, GEOLOGY, AND GEOLOGIC HAZARD
THE COTTAGES AT MESA RIDGE
PARCEL NO. 5529100006
EL PASO COUNTY, COLORADO**

December 22, 2021

Entech Job No. 211100
AAprojects/2021/211100 county soil/geo

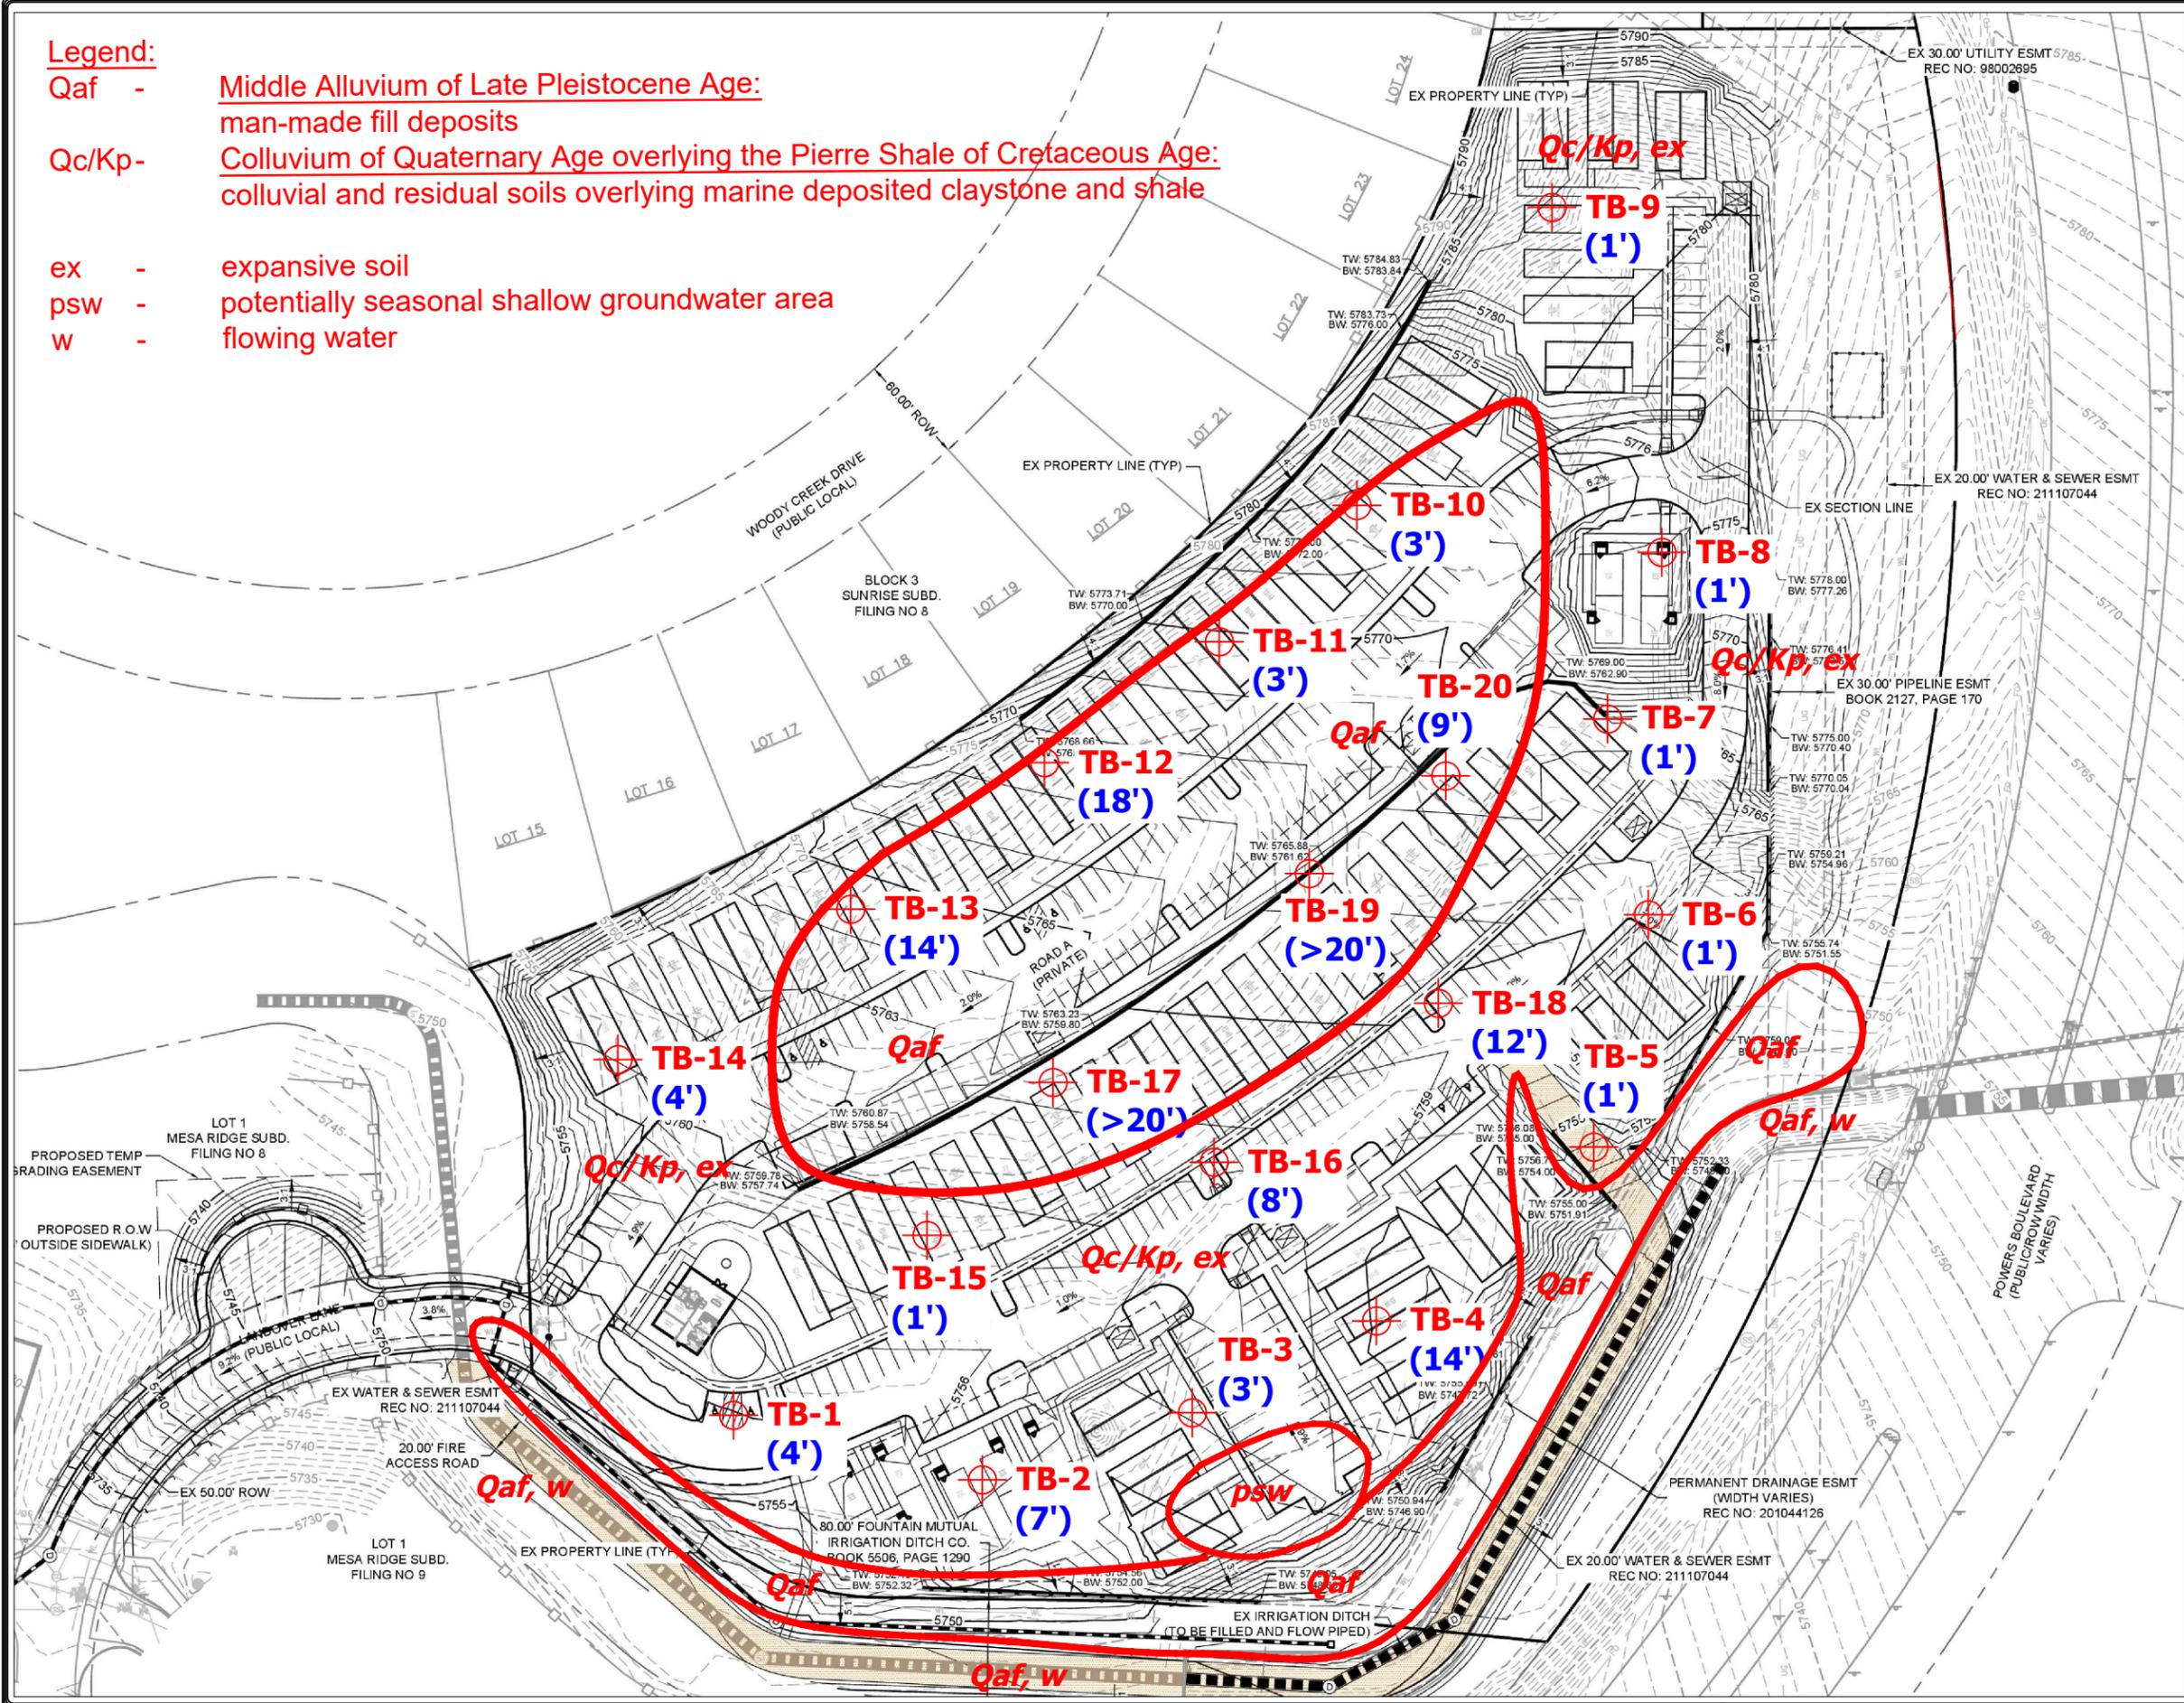
DRAWN L.L.
CHECKED
DATE 12/22/21
SCALE AS SHOWN
JOB NO. 211100
FIGURE No. 6

Detailed mapping has been performed on this site to produce a Geology Map/Engineering Geology Map Figure 6. This map shows the location of various geologic conditions of which the developers should be cognizant during the planning, design and construction stages of the project. Constraints/Hazards include artificial fill, collapsible soils, expansive soils, potential seasonal shallow groundwater, shallow bedrock, and flowing water. These hazards and the recommended mitigation techniques are as follows:

The areas mapped with this hazard are located a low area in the southeastern portion of the site adjacent to a fill berm along the irrigation ditch. In these areas, we would anticipate the potential

for periodically high subsurface moisture conditions and possible frost heave potential, depending on the soil conditions.

Mitigation In these locations, foundations in areas subject to severe frost heave potential should penetrate sufficient depth so as to discourage the formation of ice lenses beneath foundations. At this location and elevation, a foundation depth for frost protection of 2.5 feet is recommended. In areas where high subsurface moisture conditions are anticipated periodically, a subsurface perimeter drain will be necessary to help prevent the intrusion of water into areas located below grade. A typical perimeter drain detail is presented in Figure 9. Additionally, swales should be created to intercept surface runoff and carry it safely around and away from structures. It is anticipated that the site grading will likely mitigate potentially seasonal shallow groundwater area on the site. Prior to placing any fill all organic soils should be removed.
