**SOIL, GEOLOGY, AND GEOLOGIC HAZARD
THE COTTAGES AT MESA RIDGE
PARCEL NO. 5529100006
EL PASO COUNTY, COLORADO**

December 22, 2021

Entech Job No. 211100
AAprojects/2021/211100 county soil/geo

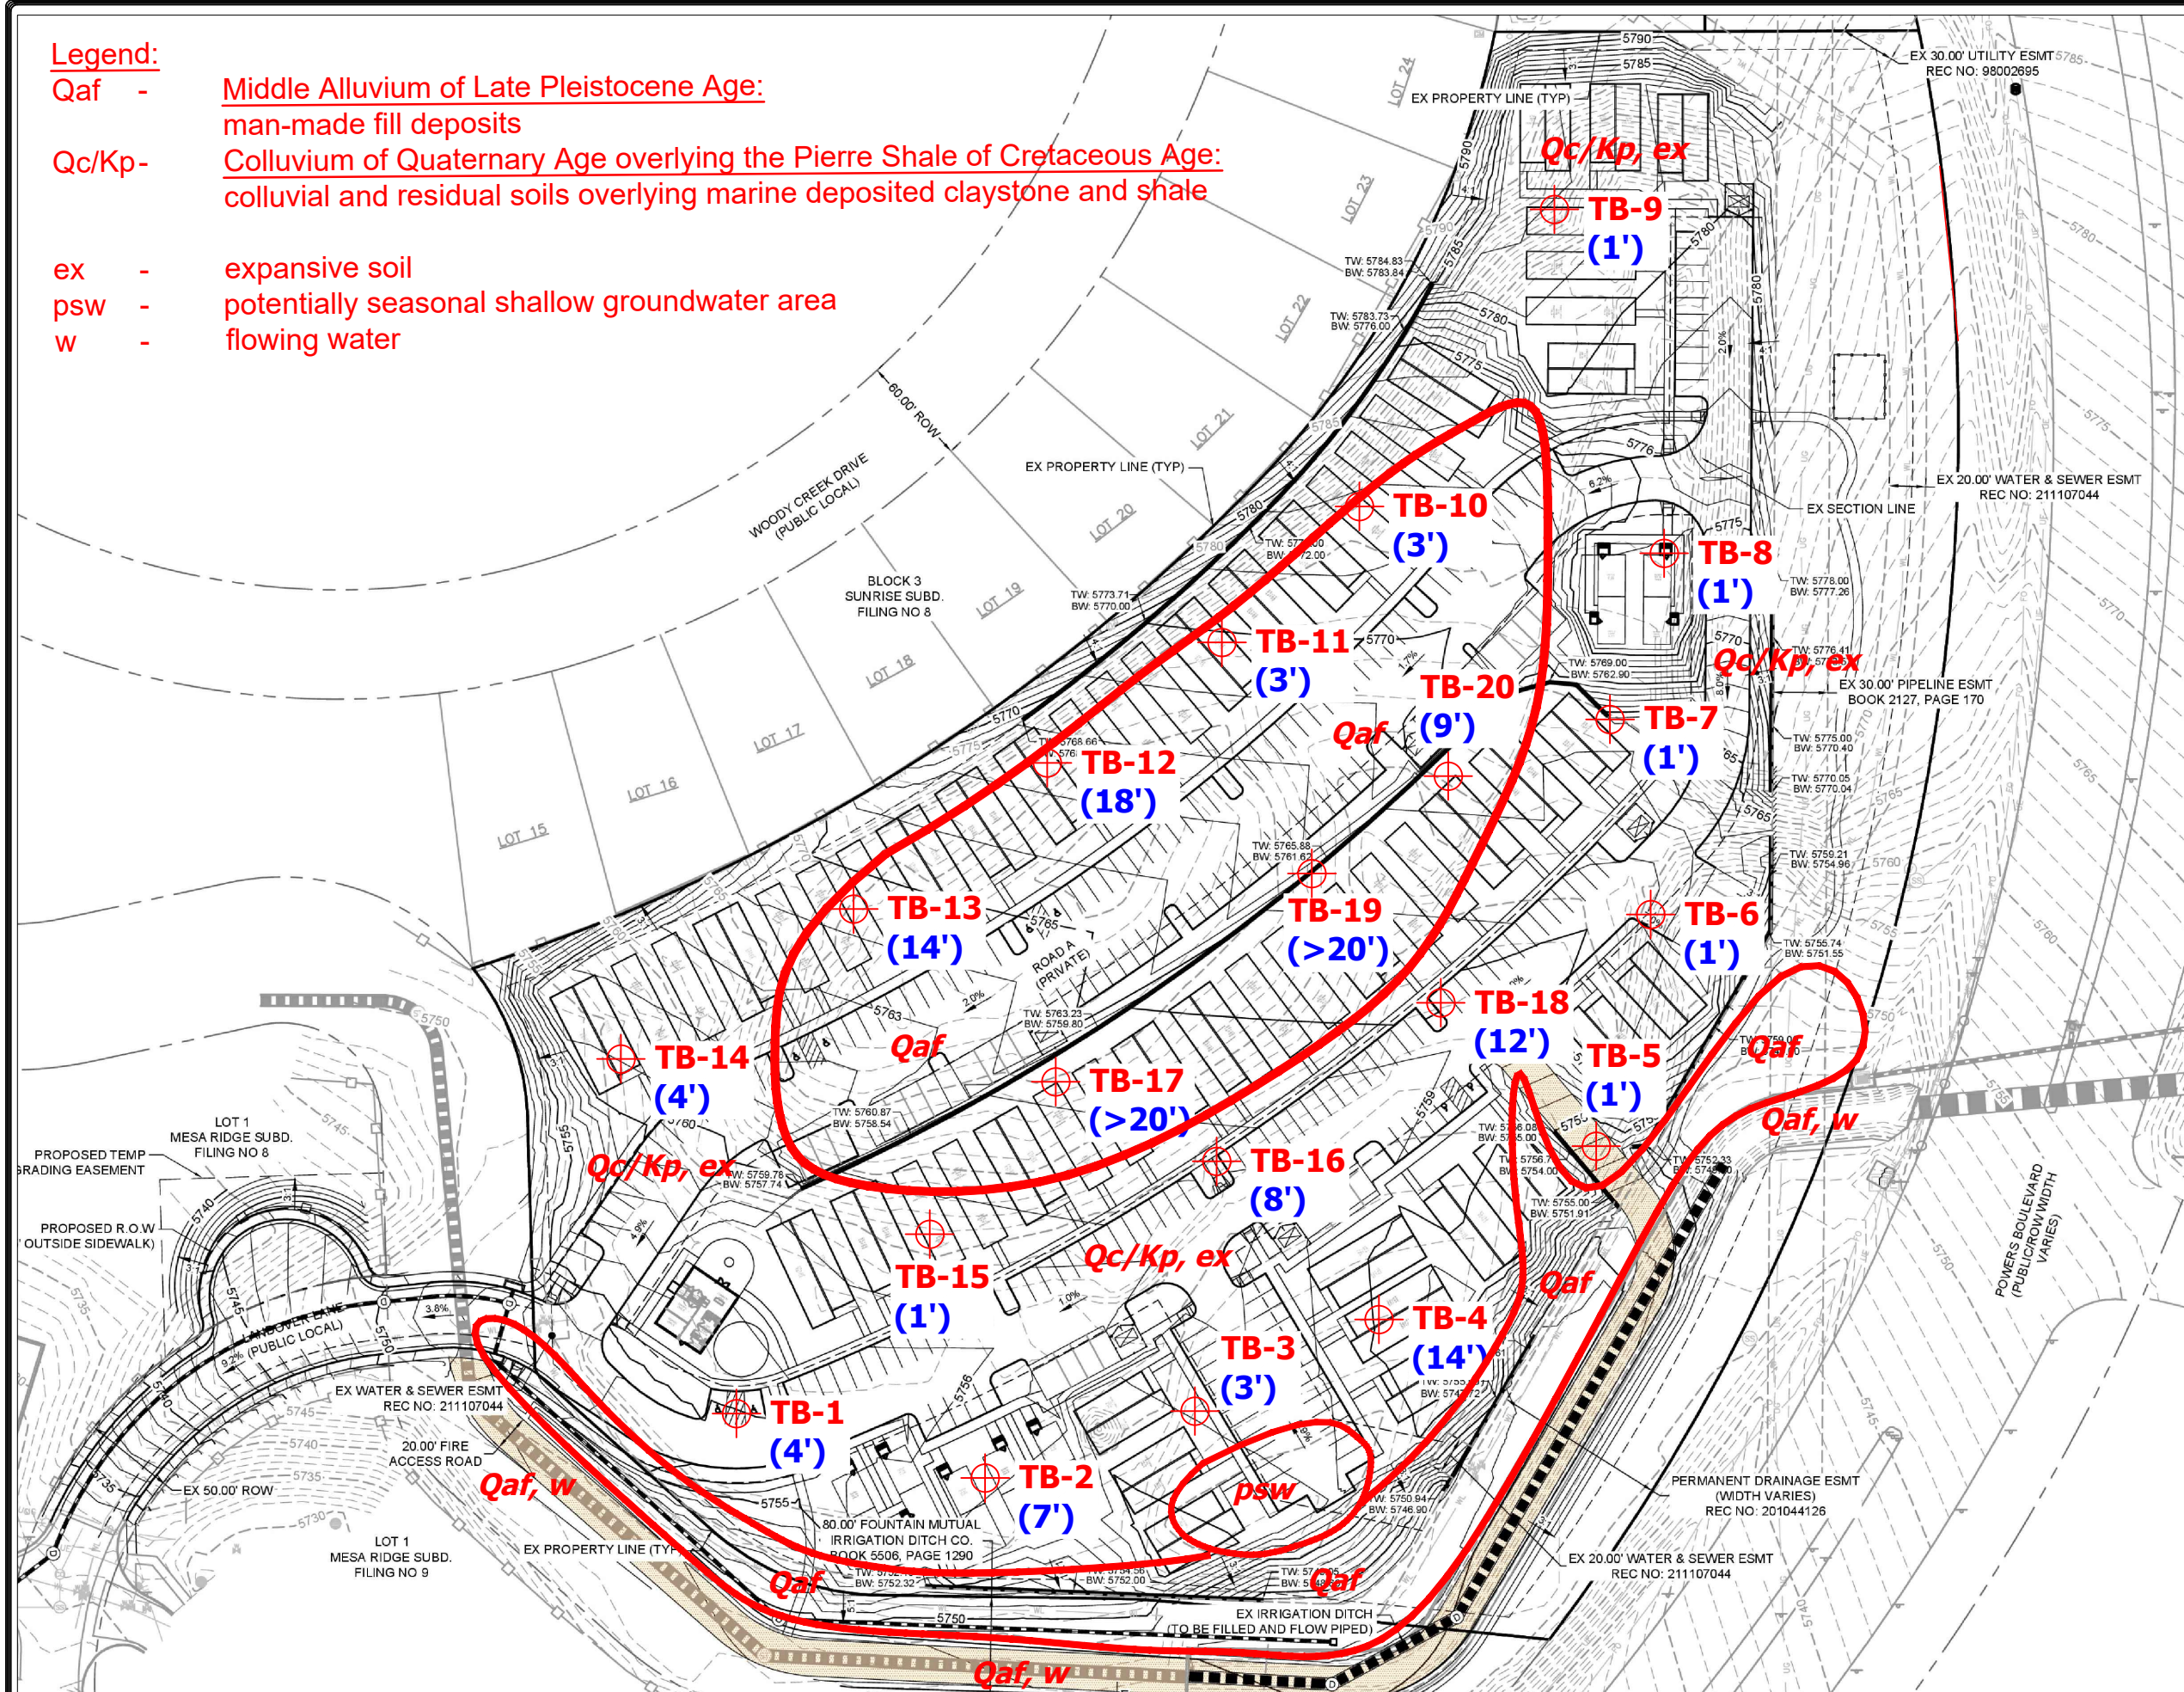
DRAWN
L.L.L.
CHECKED
DATE
12/22/21
SCALE
AS SHOWN
JOB NO.
211100
FIGURE No.
6

Detailed mapping has been performed on this site to produce a Geology Map/Engineering Geology Map Figure 6. This map shows the location of various geologic conditions of which the developers should be cognizant during the planning, design and construction stages of the project. Constraints/Hazards include artificial fill, collapsible soils, expansive soils, potential seasonal shallow groundwater, shallow bedrock, and flowing water. These hazards and the recommended mitigation techniques are as follows:

associated with the irrigation ditch has also been indicated on the site Geology Map/Engineering Geology Map, Figure 6. Additionally, other areas of artificial fill may be encountered in areas other than those mapped. These piles are considered uncontrolled for construction purposes. It is anticipated the uncontrolled fill will be mitigated during site grading and development. Cut areas of up to 10.5 feet and fill areas of up to 3 feet are proposed.

The areas mapped with this hazard are located a low area in the southeastern portion of the site adjacent to a fill berm along the irrigation ditch. In these areas, we would anticipate the potential

for periodically high subsurface moisture conditions and possible frost heave potential, depending on the soil conditions.

Mitigation: It is anticipated the fill would be removed/mitigated during site grading. All uncontrolled fill should be completely removed prior to new fill placement. Any uncontrolled fill encountered beneath foundations will require removal and recompaction at a minimum of 95% of its maximum Modified Proctor Dry Density, ASTM D-1557. Any organic material or debris should be removed.

Mitigation In these locations, foundations in areas subject to severe frost heave potential should penetrate sufficient depth so as to discourage the formation of ice lenses beneath foundations. At this location and elevation, a foundation depth for frost protection of 2.5 feet is recommended. In areas where high subsurface moisture conditions are anticipated periodically, a subsurface perimeter drain will be necessary to help prevent the intrusion of water into areas located below grade. A typical perimeter drain detail is presented in Figure 9. Additionally, swales should be created to intercept surface runoff and carry it safely around and away from structures. It is anticipated that the site grading will likely mitigate potentially seasonal shallow groundwater area on the site. Prior to placing any fill all organic soils should be removed.

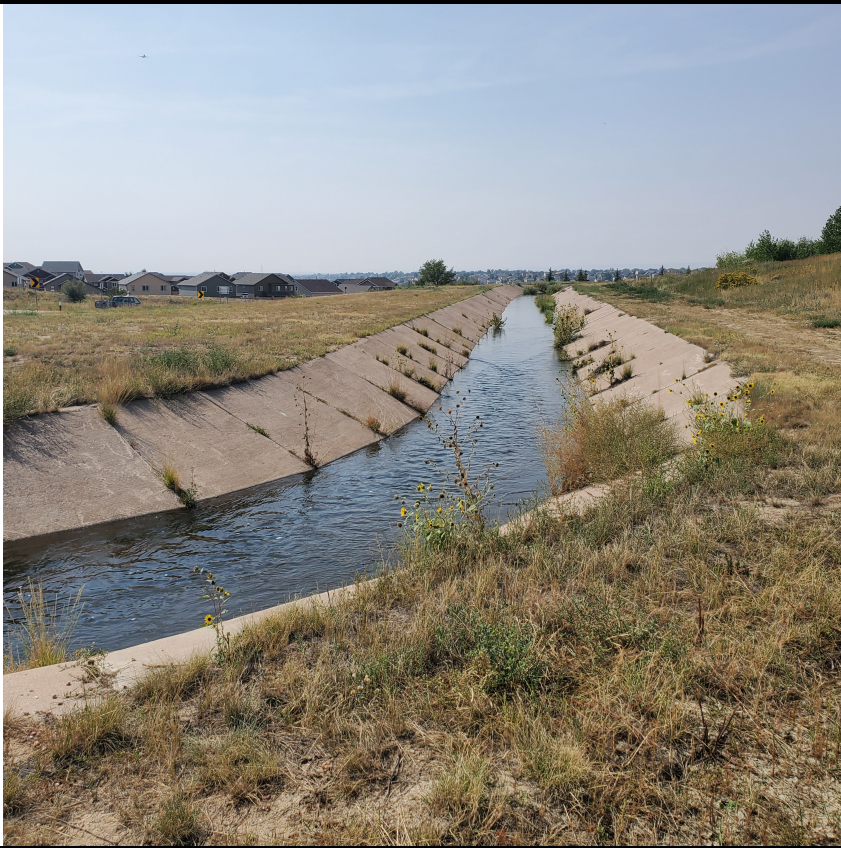
**Looking west along
irrigation ditch
southwestern portion
of the site.**
