**SOILS AND GEOLOGY STUDY
WATERVIEW EAST COMMERCIAL
PARCEL NO. 55092-00-002
SOUTH POWERS BOULEVARD AND BRADLEY ROAD
EL PASO COUNTY, COLORADO**

February 17, 2023

Entech Job No. 220689
AAprojects/2022/220689 sgs

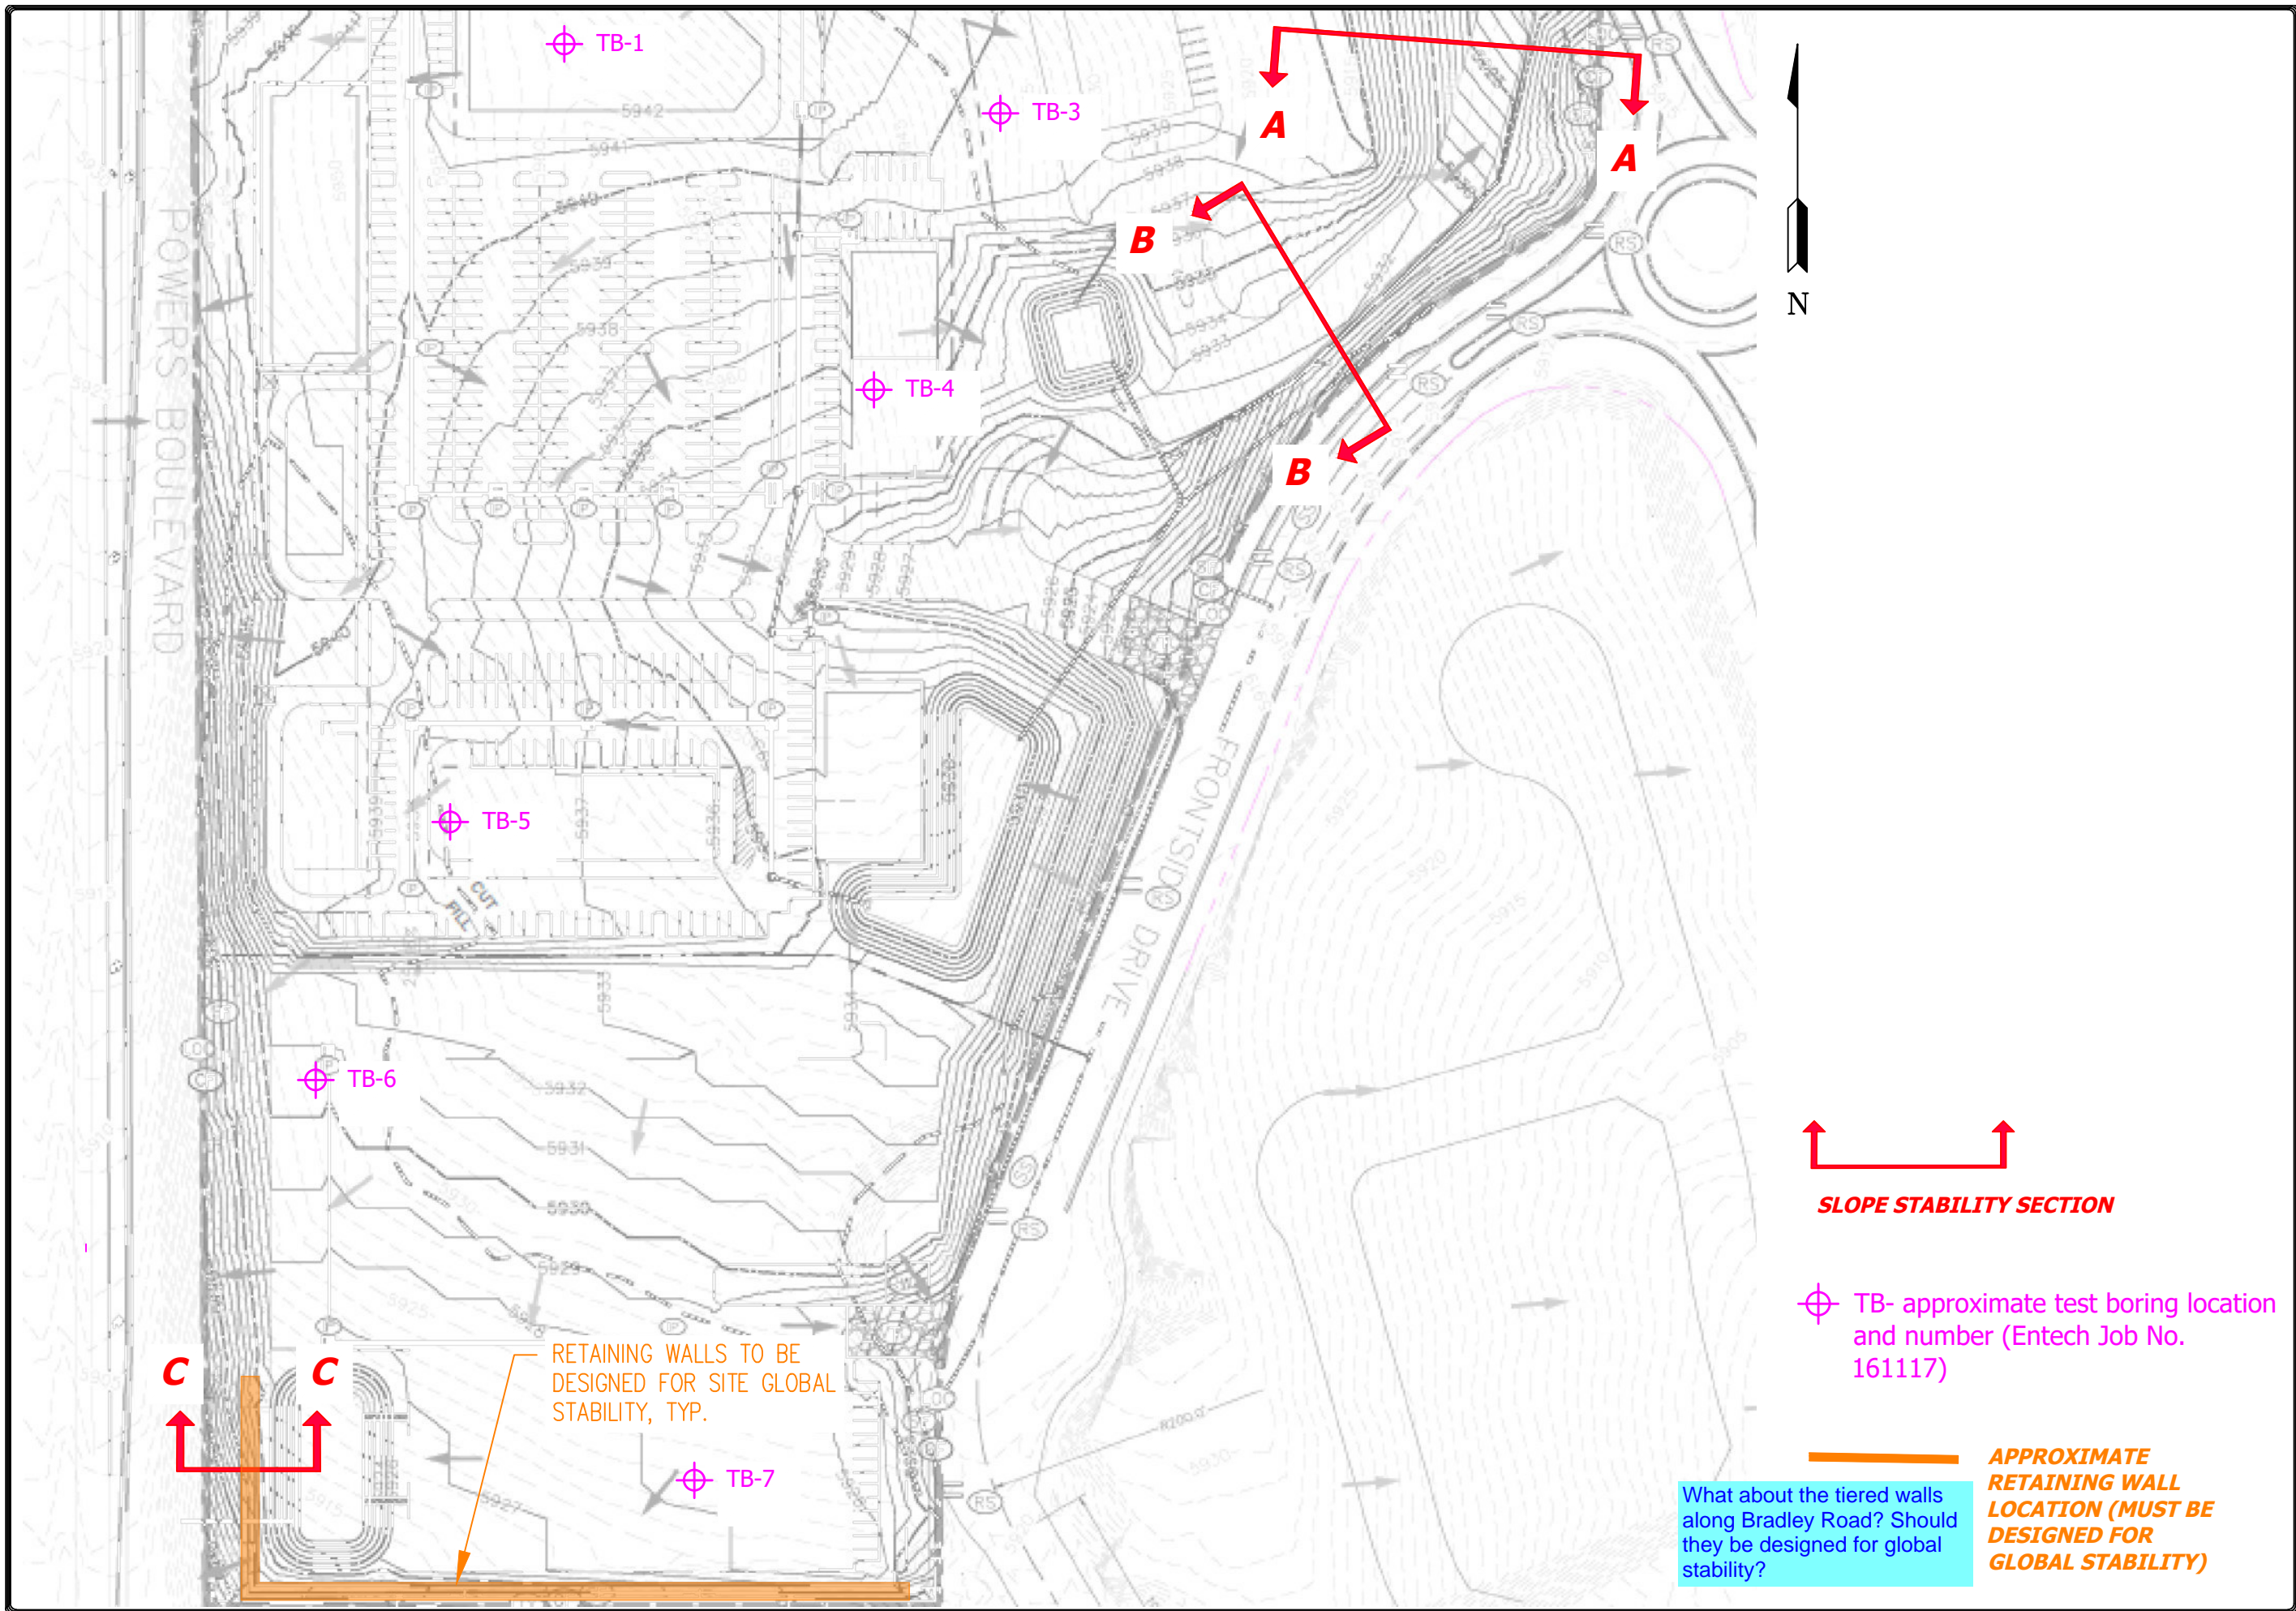
DRAWN AMN
CHECKED AMN
DATE 02/14/23
SCALE AS SHOWN
JOB NO. 220689
FIGURE No. 7

Factors of safety were calculated by the Modified Bishop Method for Circular Failure Surface for failures through the proposed fill slopes in the northeastern portion of the site, and through the tiered retaining wall and detention pond in the southwestern portion of the site utilizing a liner for the detention pond. Although groundwater was not encountered, the sections were analyzed with an elevated water table.

Factors of safety of 1.7 to 2.7 were obtained for the proposed fill slopes in the northeastern portion of the site. A factor of safety of 1.3 was obtained for the proposed detention pond with tiered retaining wall in the southwestern portion of the site. **Retaining walls should be designed for global slope stability. All slopes should be evaluated for local and global stability for final designs.** Results of the slope stability analysis are presented in Appendix D. A factor of safety of 1.5 is recommended for areas of critical structures such as buildings, and factor of safety of 1.3 for not critical structures such as roadways and parking areas. Preliminary analysis of the proposed development show that adequate factors of safety can be achieved.

Proper control of drainage at both the surface and in the subsurface is extremely important to slope performance. Areas of ponded water at the surface should be avoided. We recommend surface drainage be directed away from the slopes to prevent saturation of the slopes that could create unstable conditions. Utility trenches, basement excavations and other subsurface features should not be permitted to become water traps which may promote saturation of the subsurface materials. Additional moisture may create unstable conditions on the slopes. Drainage should be directed away from these slopes to avoid saturation of the materials. Downspouts and other concentrated flows should be piped down the slopes. Discharges and flows onto the slopes should not be permitted.
