**SOIL, GEOLOGY, GEOLOGIC HAZARD,
AND WASTEWATER STUDY,
THE RESERVE AT CORRAL BLUFFS
EL PASO COUNTY, COLORADO**

Corral Ranches Development Company
6 South Tejon Street, Suite 515
Colorado Springs, Colorado 80903

January 30, 2012

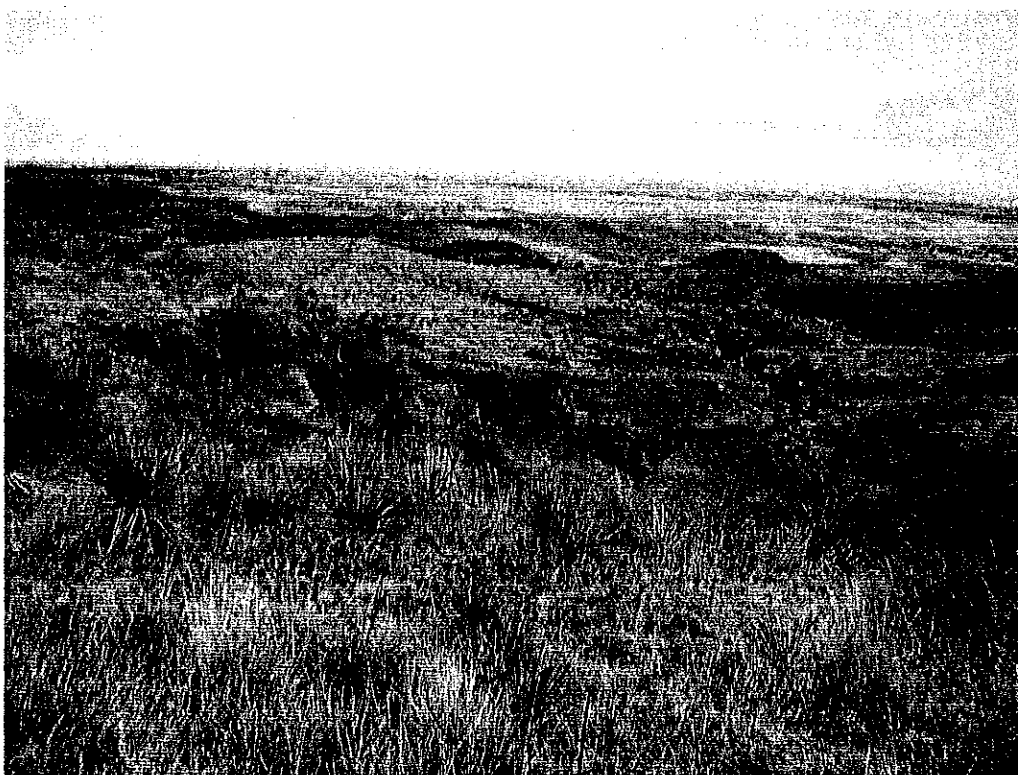
The majority of the slopes on-site are gently to moderately sloping and do not exhibit any past or potential unstable slopes or landslides. The steeply sloping areas in the southern portions of the site have been identified as potentially unstable slopes. These areas are designated as open space and non-build zones. The recommendations for these areas are as follows:

**Looking southeast at
potentially unstable
slopes in south central
portion of the site.**

Mitigation: Building should be avoided in these areas. A building setback of 50 feet from the crest of these slopes is recommended. Proper control of drainage at both the surface and in the subsurface is extremely important. Areas of ponded water at the surface should be avoided above these slopes. Utility trenches, basement excavations and other subsurface features should not be permitted to become water traps which may promote saturation of the subsurface materials.

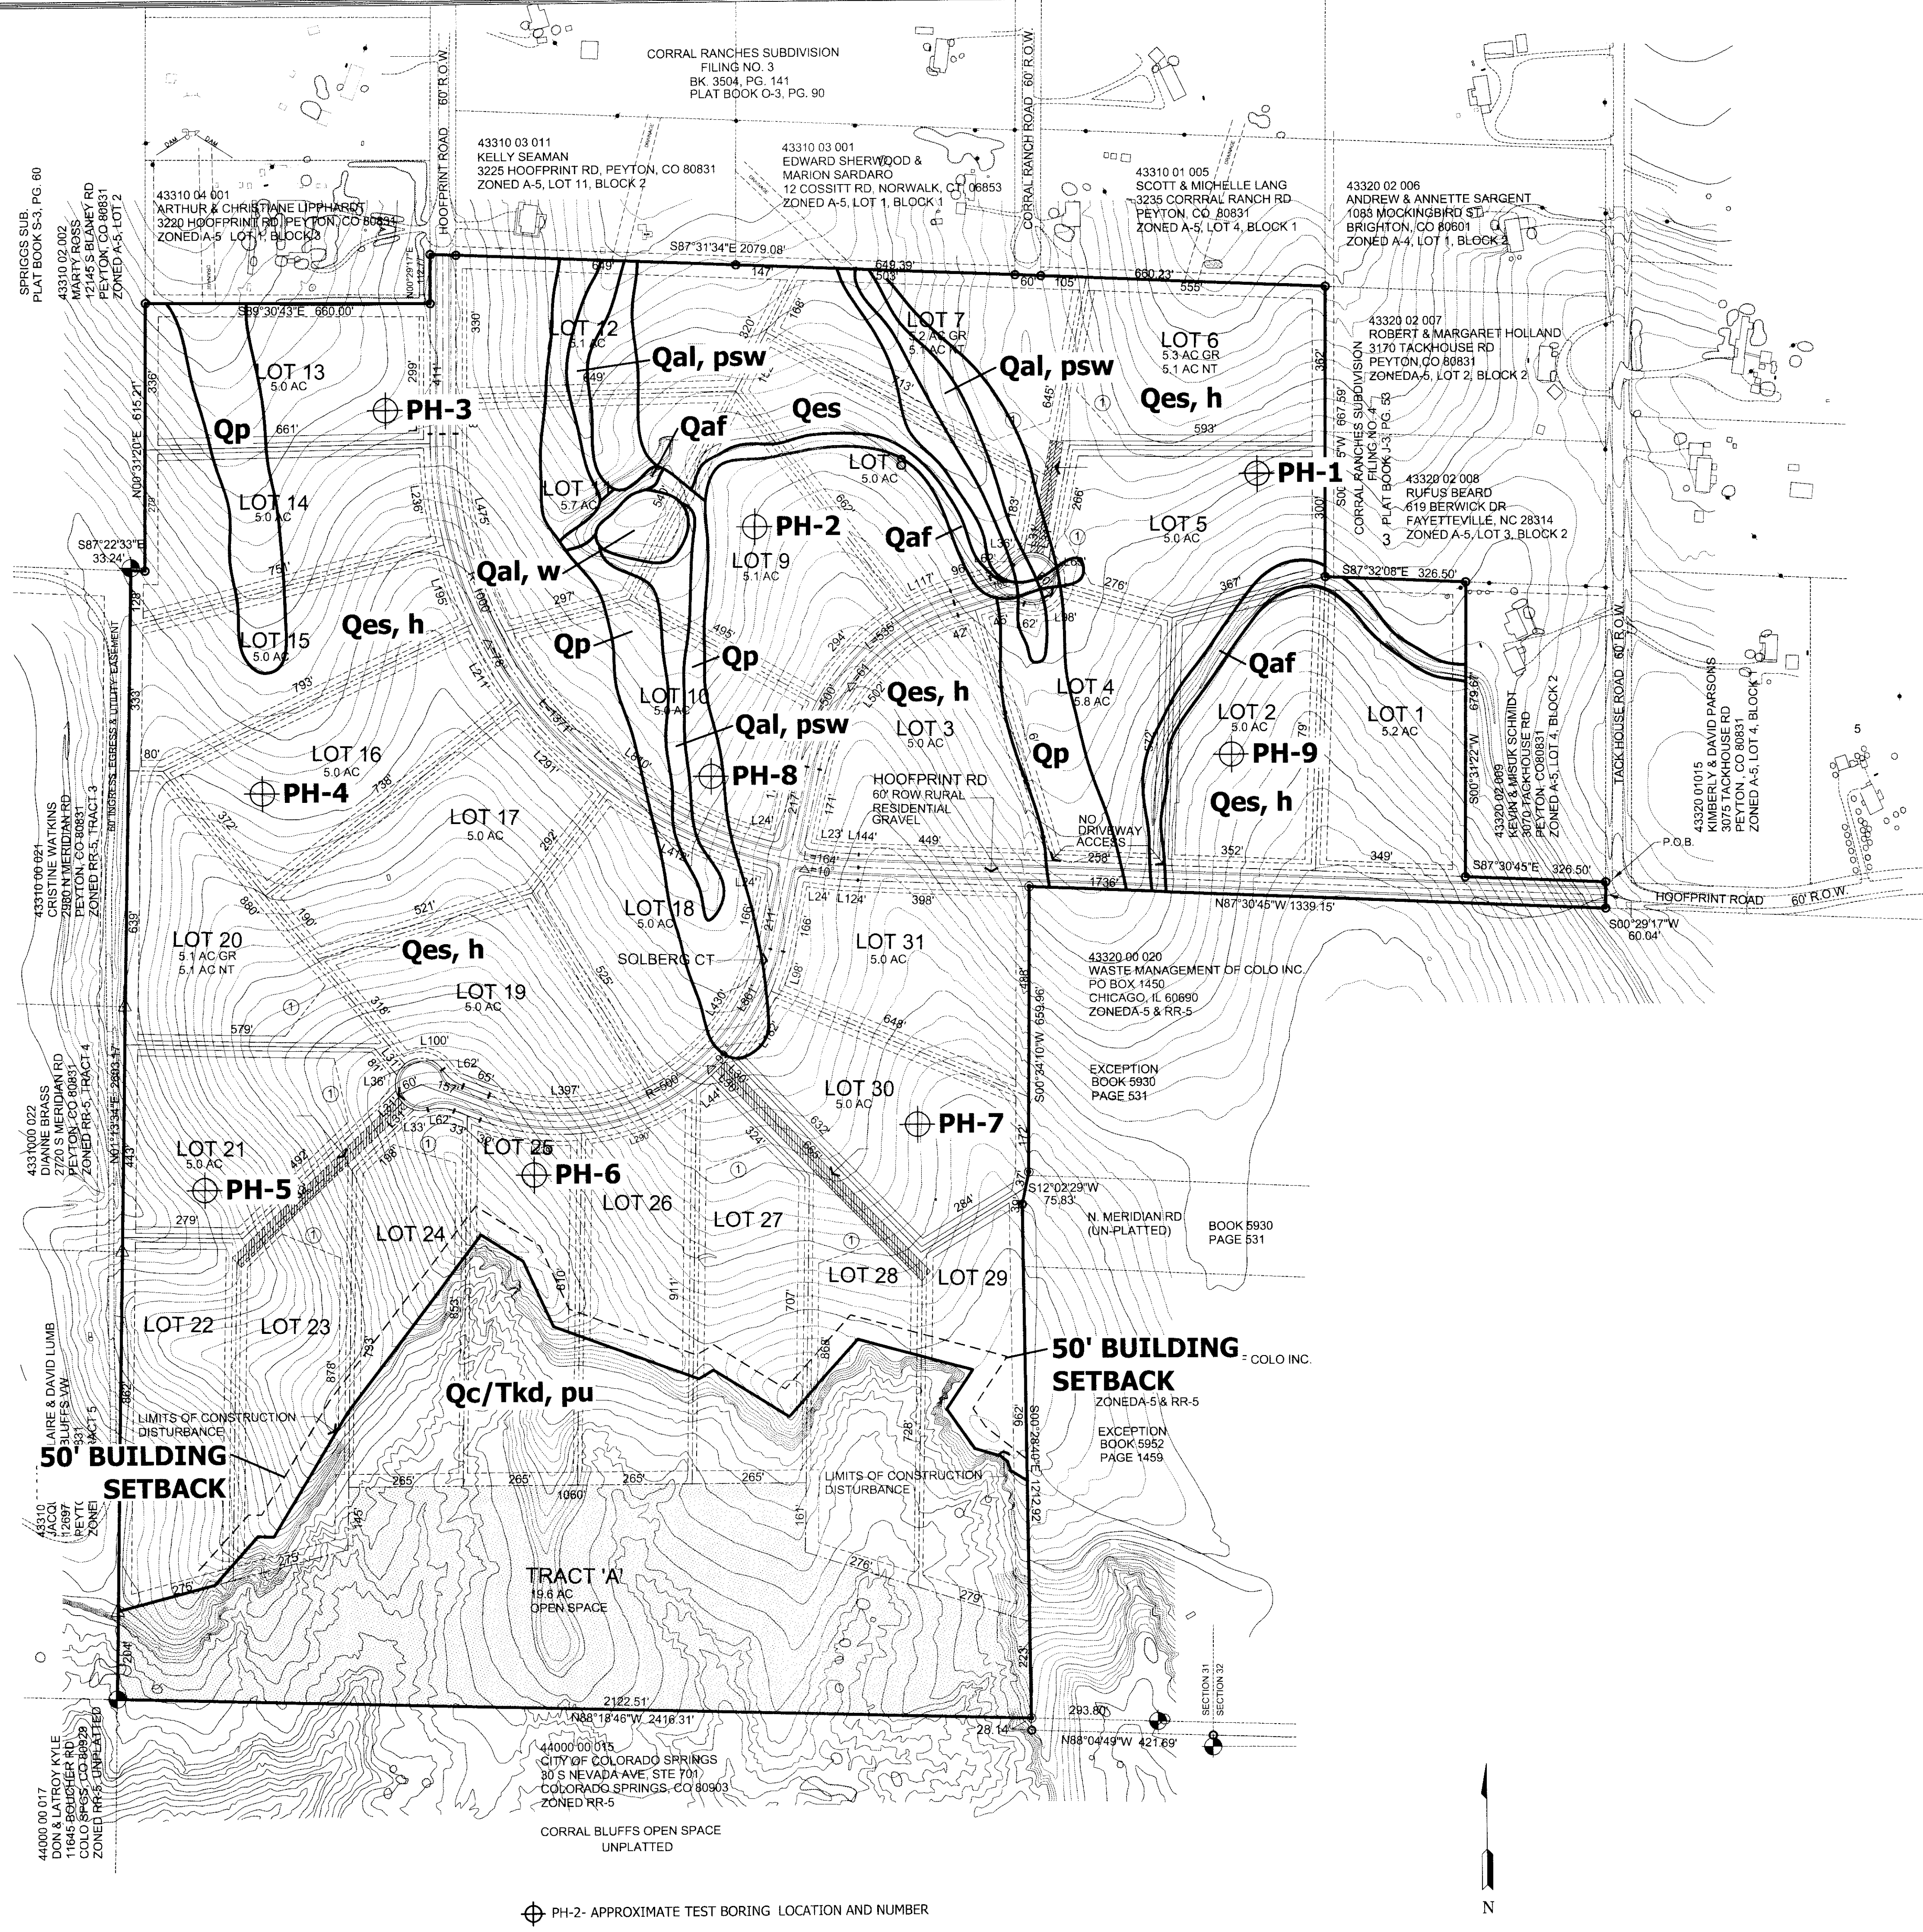
GEOLOGY/ENGINEERING GEOLOGY MAP
THE RESERVE AT CORRAL BLUFFS
EL PASO COUNTY, CO
FOR: CORRAL RANCH DEVELOPMENT

As mentioned previously, mapping has been performed on this site to produce an Engineering Geology Map (Figure 8). This map shows the location of various geologic conditions of which the developers should be cognizant during the planning, design and construction stages of the project. These hazards and the recommended mitigation techniques are as follows:
