September 10, 2019

**ENTECH**  
ENGINEERING, INC.

Re: Soil, Geology and Geologic Hazard Evaluation  
The Estates at Rolling Hills Ranch, Filing 1 & 2  
Sunrise Ridge Drive and Rex Road  
El Paso County, Colorado PUD 19-007, SF 19-019

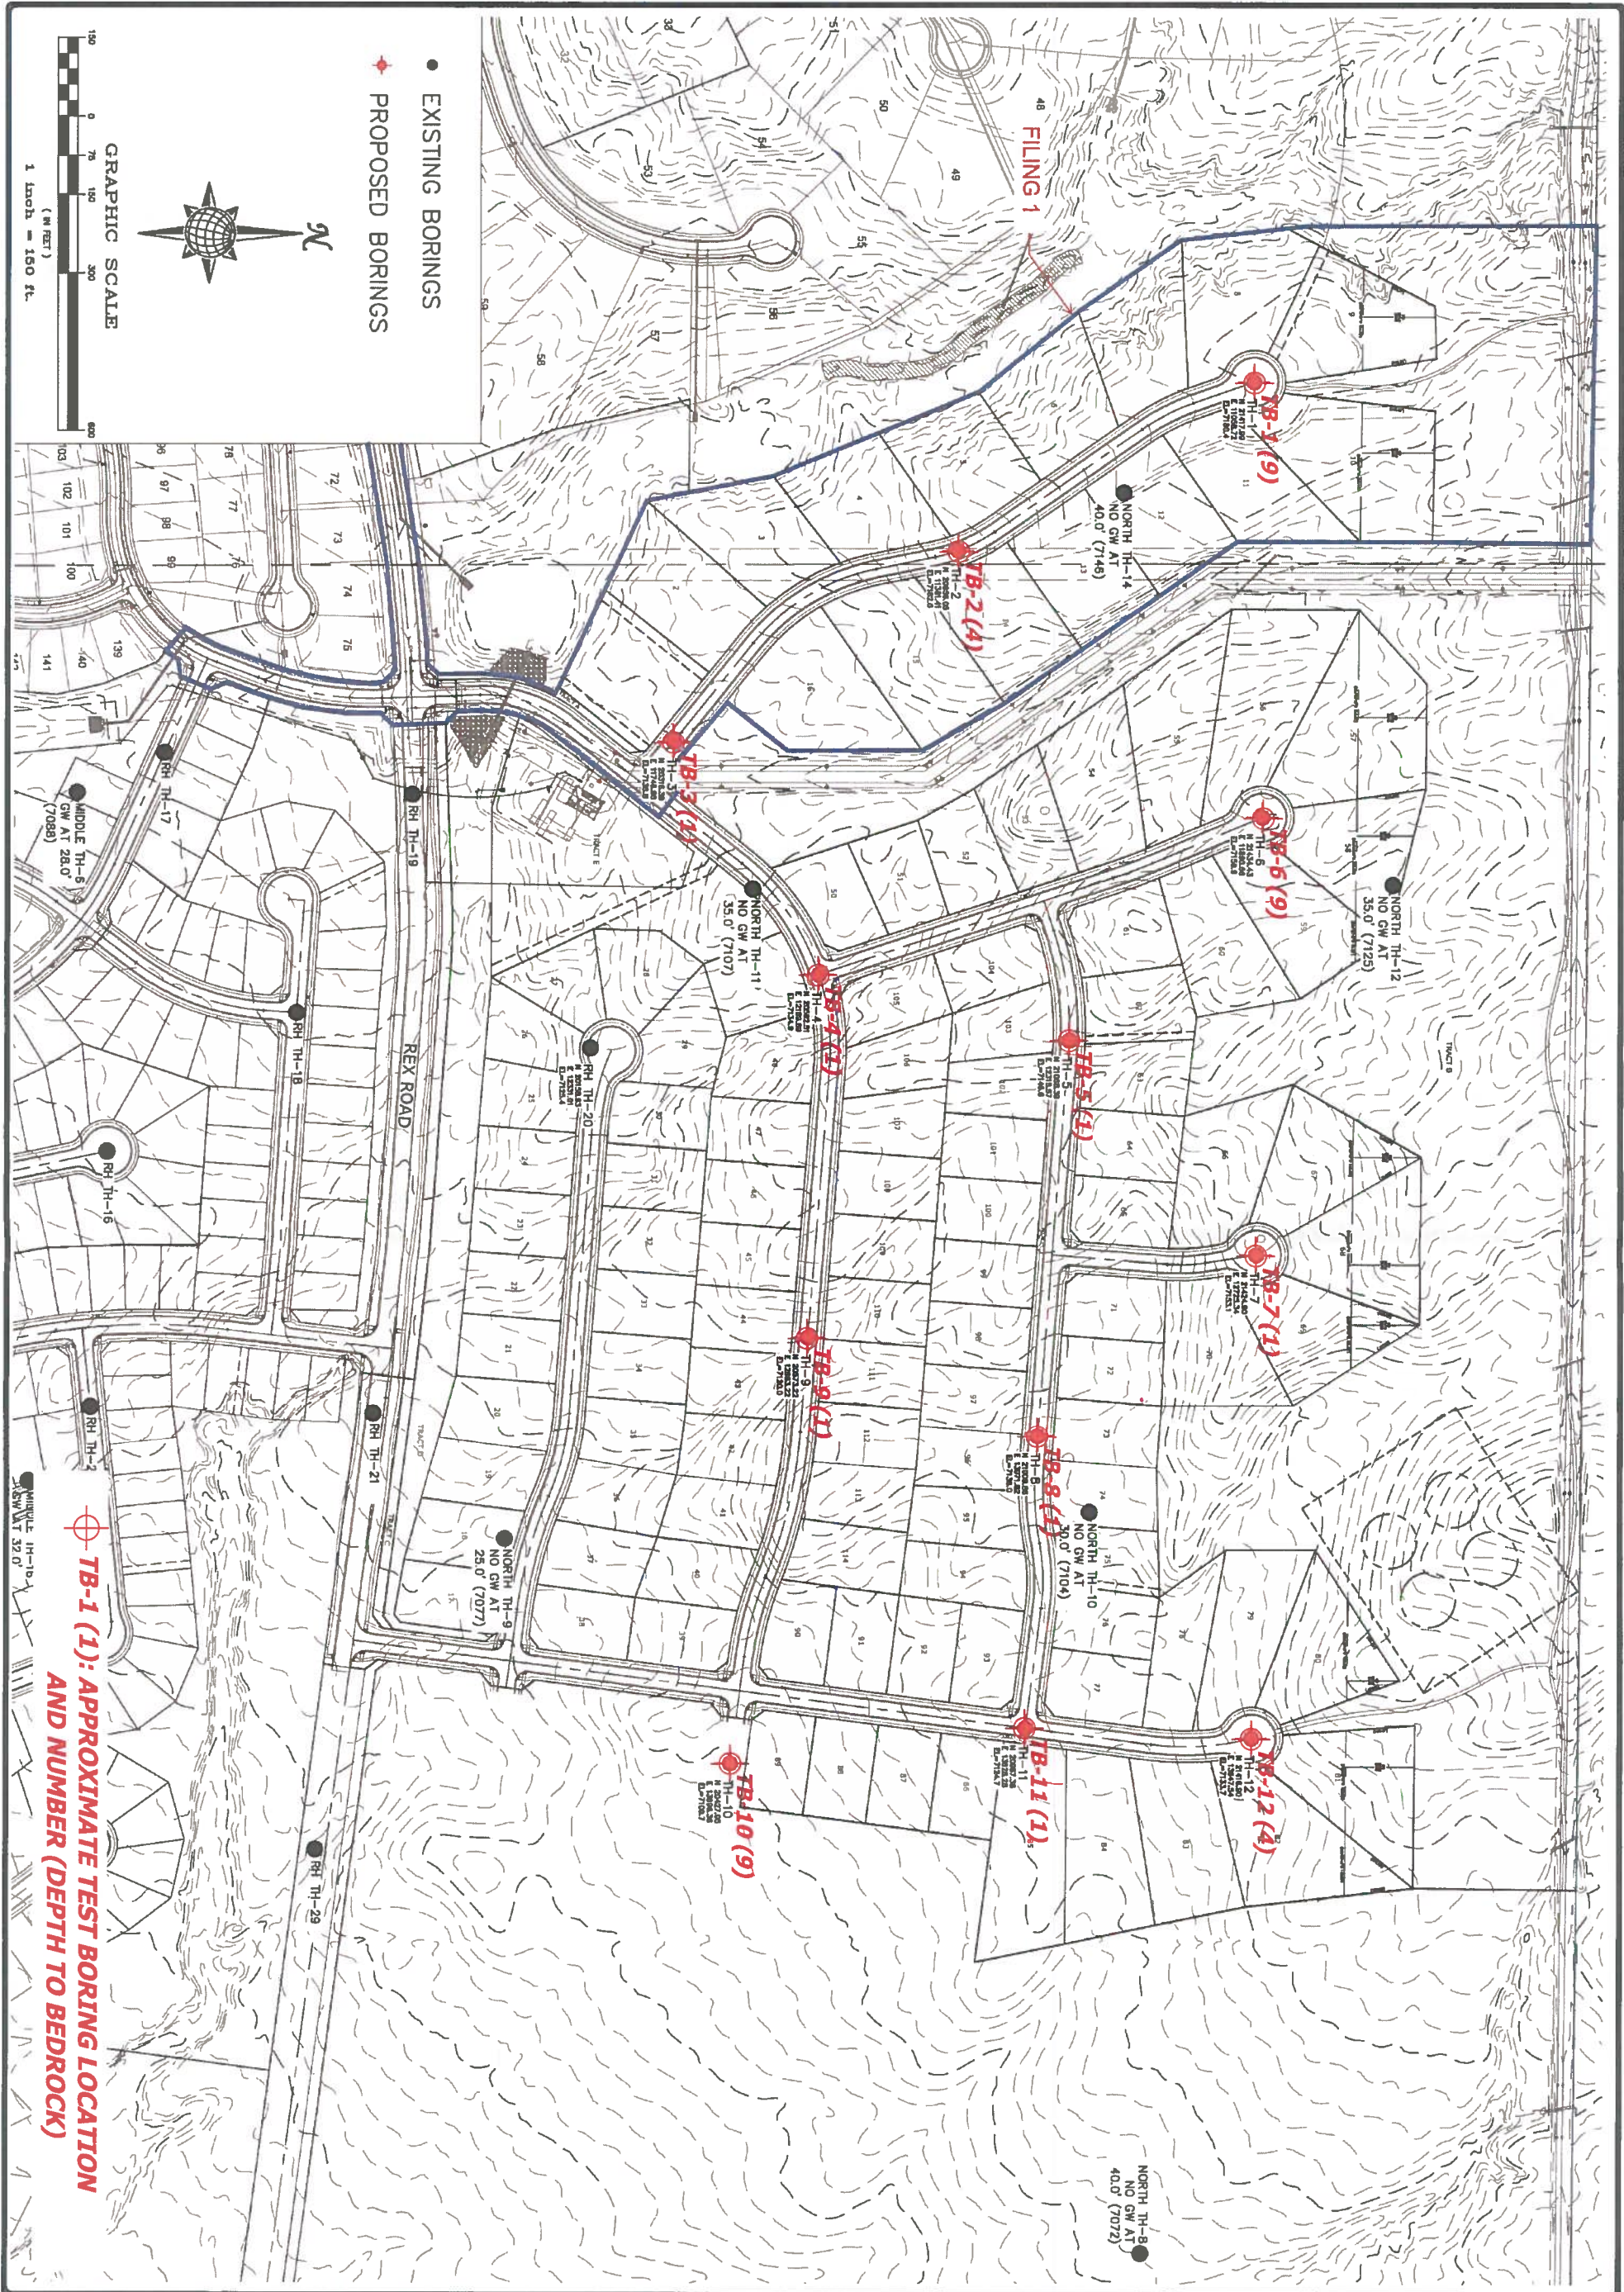
SITE PLAN/TEST BORING MAP  
 THE ESTATES AT ROLLING HILLS RANCH  
 FILING 1 & 2  
 EL PASO COUNTY, CO.  
 FOR: TECH CONTRACTORS

The topography of the site is gently to moderately sloping rolling hills that generally slope in a southeasterly direction. Minor drainages exist on the site that trend in south-southeasterly directions. The drainages were dry at the time of this investigation. The site lies in portions of NE  $\frac{1}{4}$  of Section 19, NW  $\frac{1}{4}$  of Section 20, Township 12 South, Range 64 West of the 6th Principal Meridian in El Paso County, Colorado. The site is currently vacant. The Site Plan/Test Boring Location Map is presented in Figure 3.

Twelve test borings were drilled on the site as a part of a Preliminary Subsurface Soil Investigation dated September 10, 2019, was used to evaluate the subsurface soil conditions (Reference 1). The Test Boring Logs are included in Appendix A. Laboratory Test Results are summarized in Table 1. Information from this report was used evaluating the site.

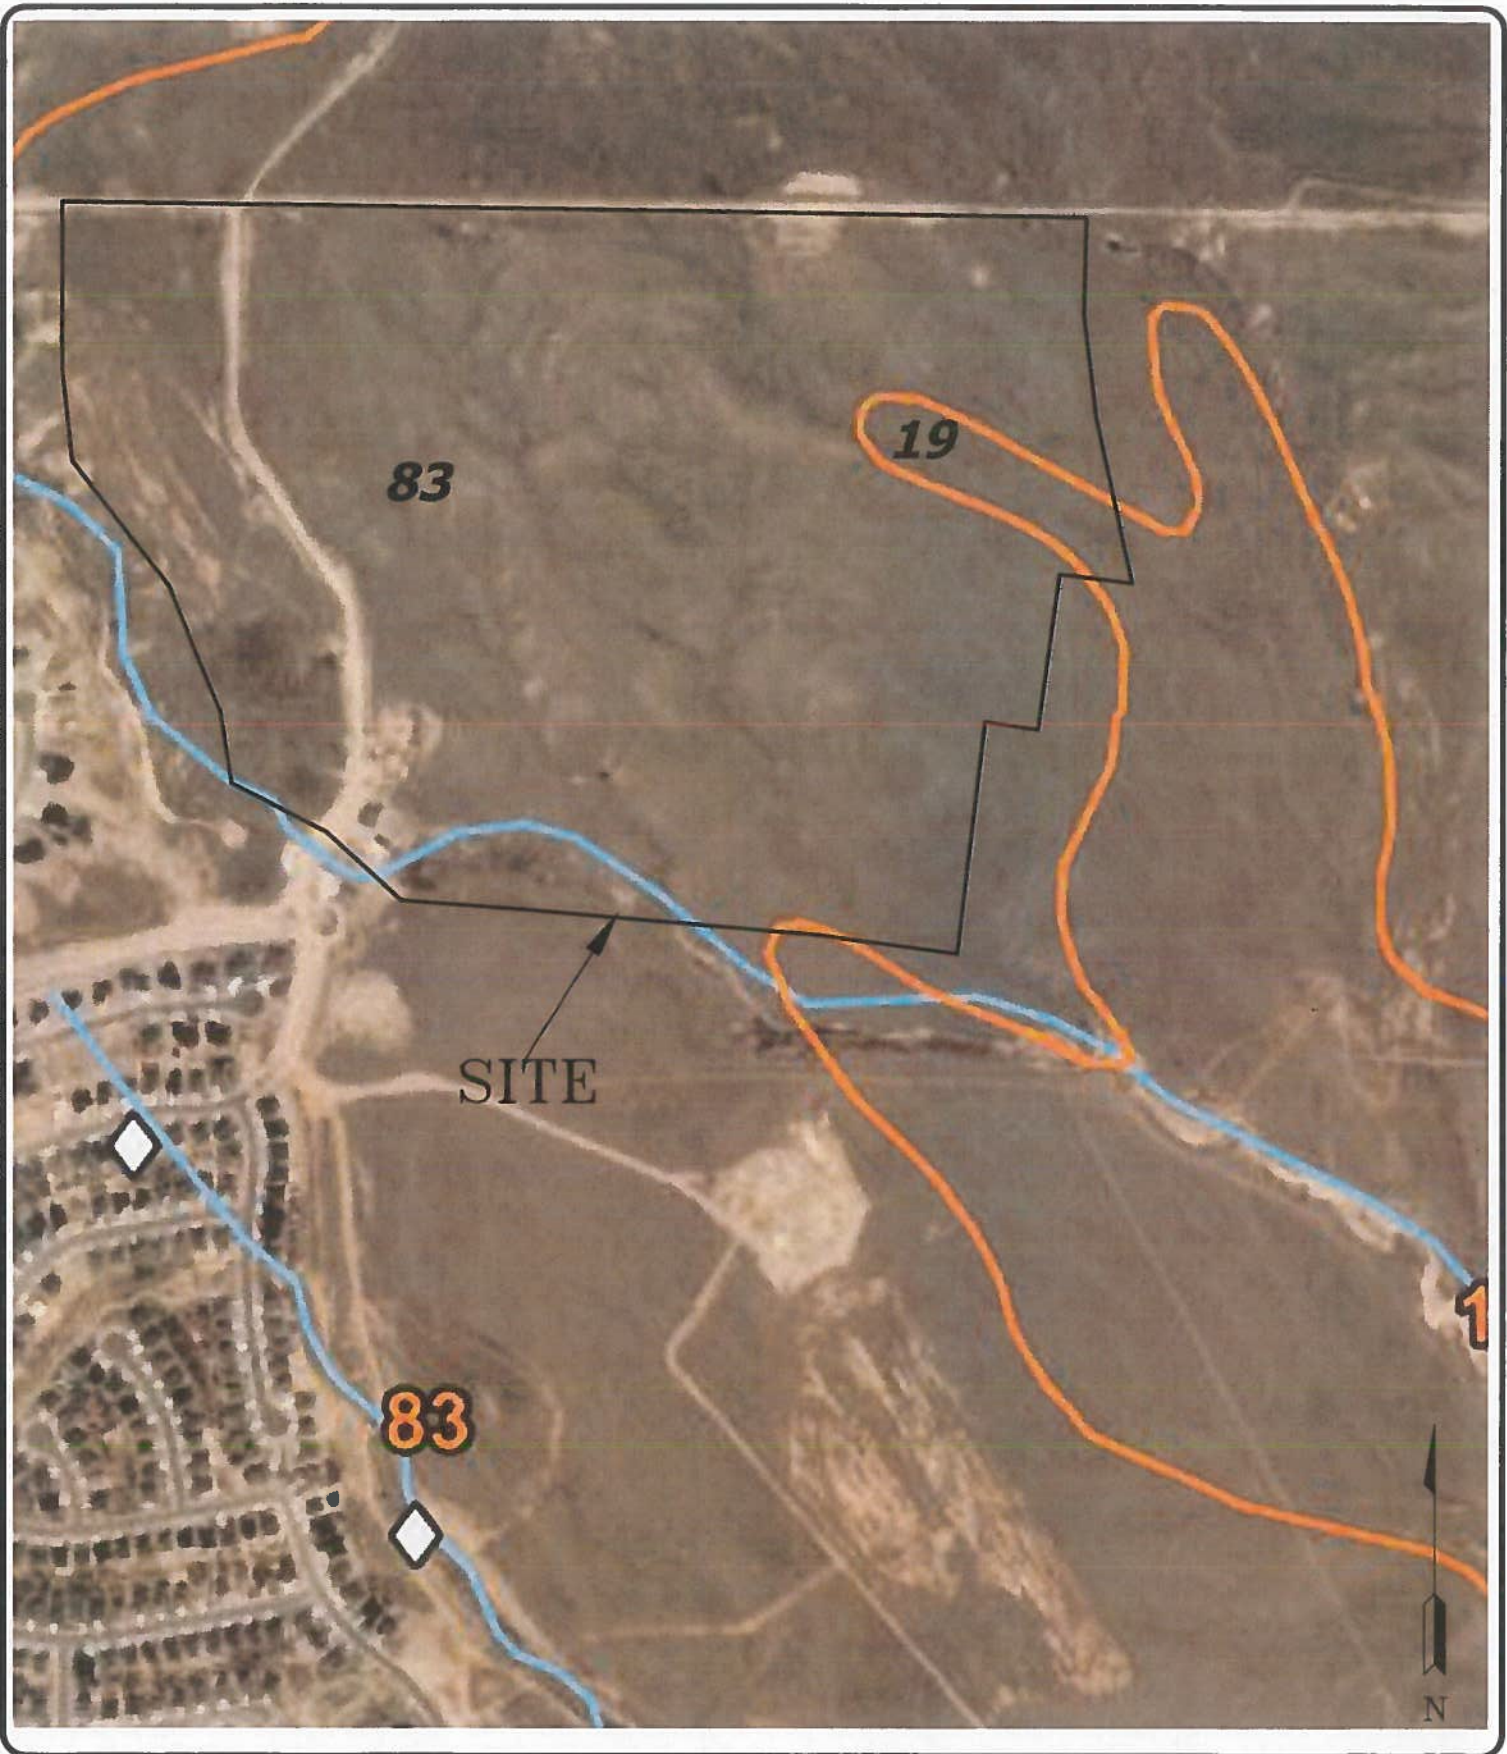
**SOIL SURVEY MAP**  
**THE ESTATES AT ROLLING HILLS RANCH**  
**FILING 1 & 2**  
**EL PASO COUNTY, CO.**  
**FOR: TECH CONTRACTORS**

The Natural Resource Conservation Service (NRCS) (Reference 2, Figure 3), previously the Soil Conservation Service (Reference 3) has mapped two soil types on the site. Complete descriptions of the soils are presented in Appendix B. In general, the soils consist of gravelly, sandy loam and sandy loam. The soils are described as follows:

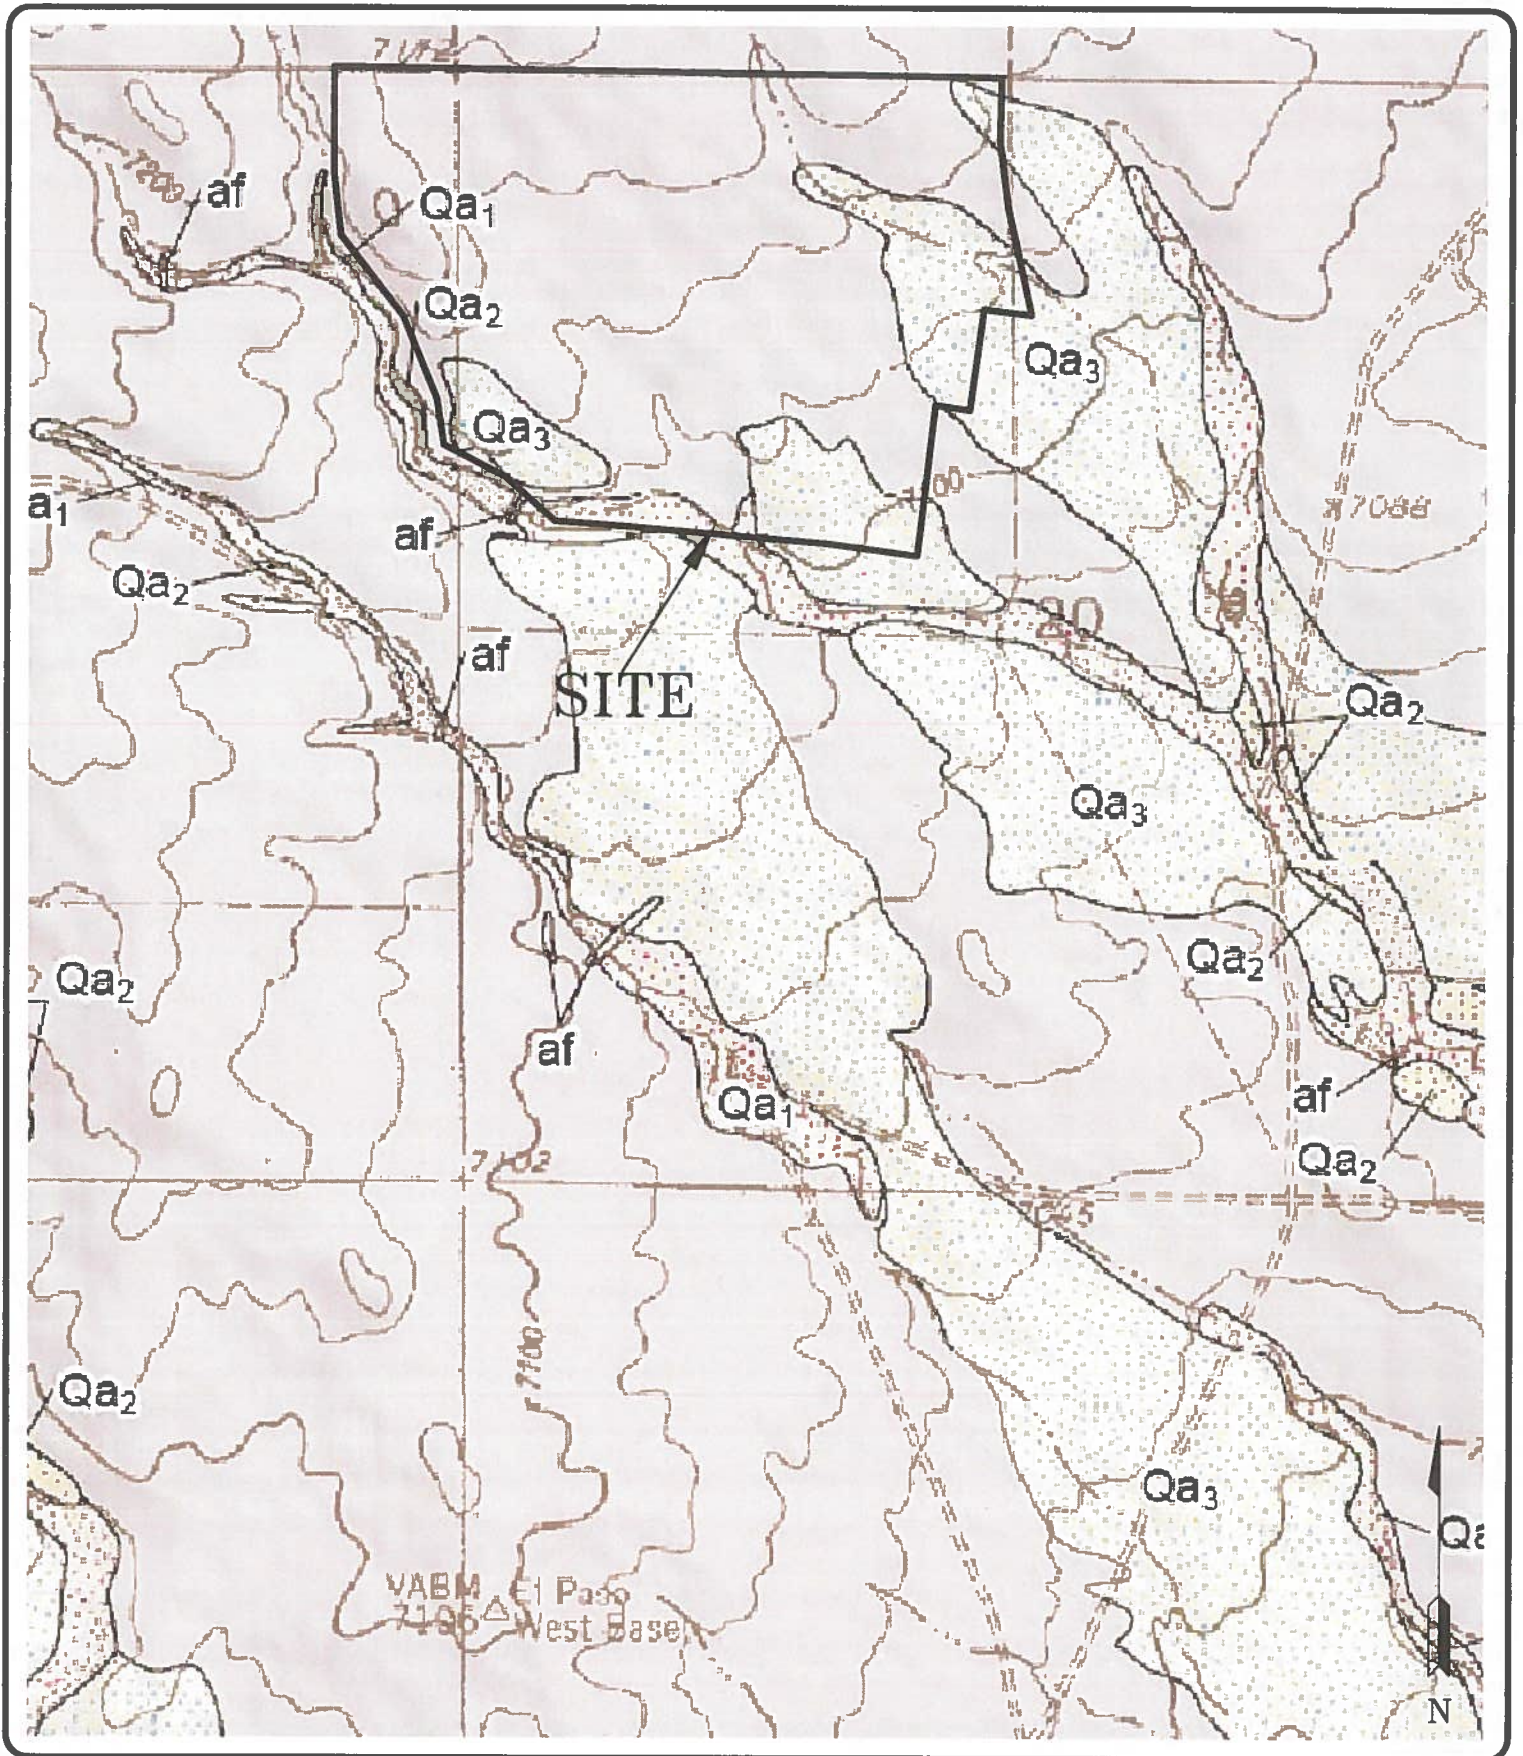
FALCON QUADRANGLE GEOLOGIC MAP  
 THE ESTATES AT ROLLING HILLS RANCH  
 FILING 1 & 2  
 EL PASO COUNTY, CO.  
 FOR: TECH CONTRACTORS

The geology of the site was evaluated using the *Geologic Map of the Falcon Quadrangle*, by Morgan and White in 2012, (Reference 5, Figure 4). The geology of the site is indicated in Figure 5. Four mappable units were identified on this site which are described as follows:

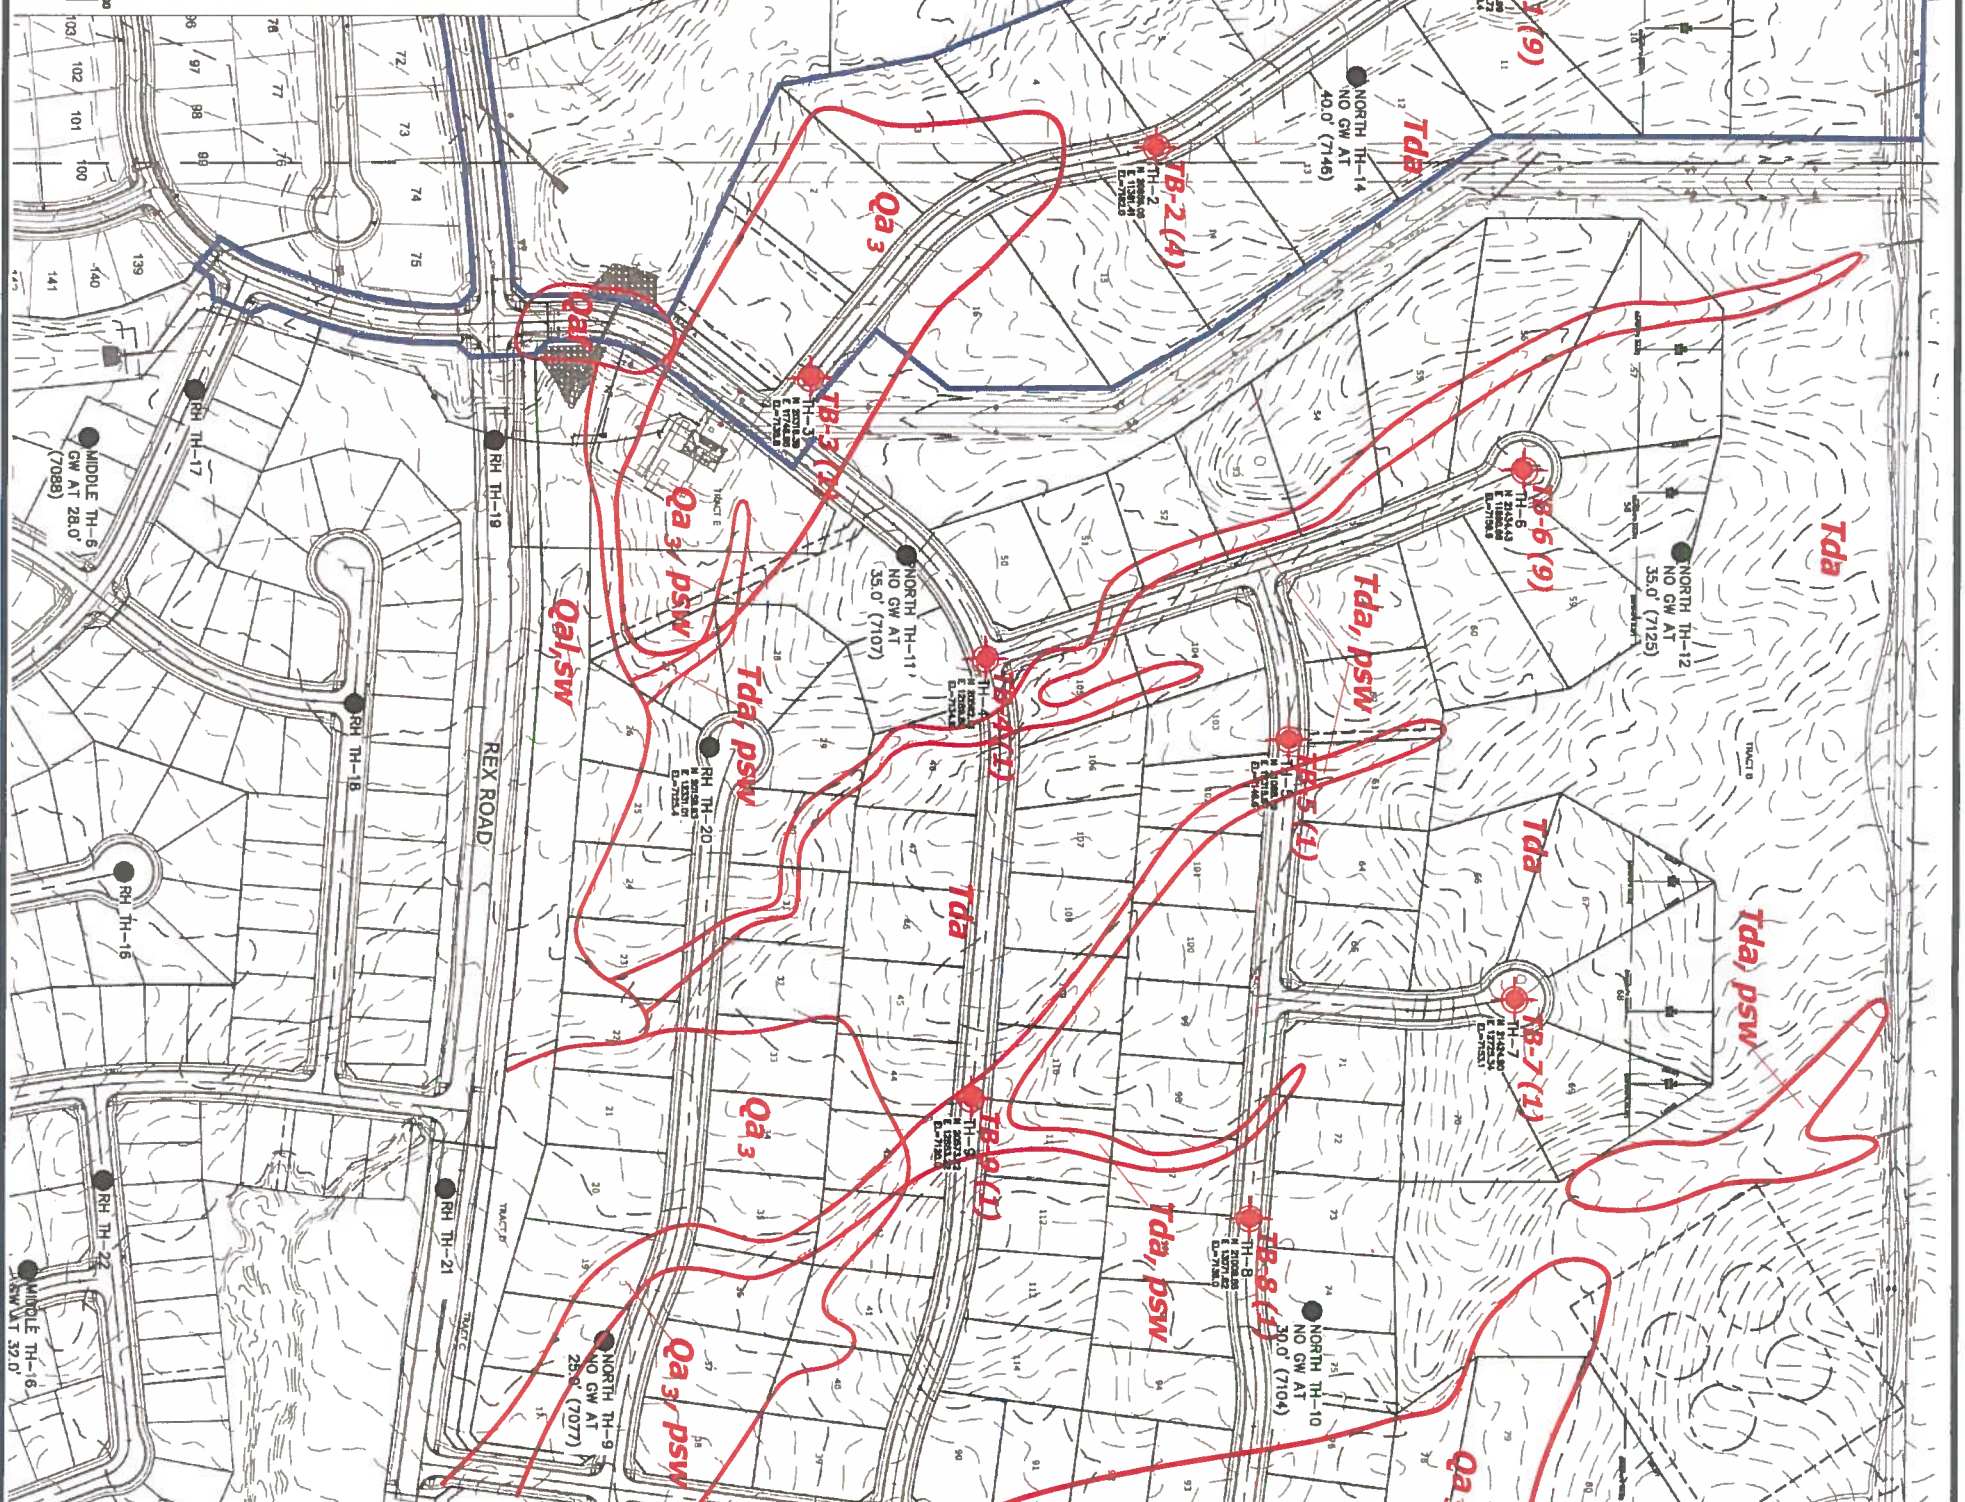
ENGINEERING GEOLOGY MAP  
 THE ESTATES AT ROLLING HILLS  
 RANCH FILING 1 & 2  
 EL PASO COUNTY, CO.  
 FOR: TECH CONTRACTORS

An area of fill was mapped on the site in the southwestern corner that is associated with a road and a dam embankment. Other minor areas not mapped are associated with small fill piles that are considered uncontrolled, and areas of fill may exist that are not mapped due to on-going site grading.

In these areas, we should anticipate the potential for periodically high subsurface moisture conditions and frost heave potential. In these areas, the potential exists for shallow groundwater during high moisture periods. The minor drainages will likely be regraded during site development, and the seasonal shallow groundwater area will be avoided by the proposed development.

Groundwater was encountered at 12 to 17 feet in the five of the twelve test borings. Groundwater depths are indicated on Table 2. Areas of potentially seasonal shallow and seasonally shallow groundwater have been mapped on this site. (Figure 6). These areas can be avoided by construction or are being regraded. Specific recommendations concerning the effects of groundwater on site grading and construction are discussed in the Preliminary Subsurface Soil Investigation (Reference 1). The site should not be affected by any delineated 100-year FEMA floodplains (Figure 7, Reference 6).

**Mitigation:** It is anticipated the uncontrolled fill piles will be removed during site grading. Any uncontrolled fill encountered beneath foundations should be removed and recompacted at a minimum of 95% of its maximum Modified Proctor Dry Density, ASTM D-1557.

Mitigation: Foundations must have a minimum 30-inch depth for frost protection. In areas where high subsurface moisture conditions are anticipated periodically, subsurface perimeter drains are recommended to help prevent the intrusion of water into areas below grade. It is anticipated much of these areas would be filled during site grading further raising foundations above the groundwater level. Any grading in these areas should be done to direct surface flow around construction to avoid areas of ponded water. All organic material would be completely removed prior to fill placement. Specific recommendations concerning the affects of groundwater on site grading and construction are included in the Subsurface Soil Investigation (Reference 1). Further investigation will be necessary to determine the groundwater depth after final grading. The site does not lie within any floodplain zones according to the FEMA Map No. 08041CO552G, dated December 7, 2018 (Figure 7, Reference 6). Exact locations of floodplain and specific drainage studies are beyond the scope of this report. Finished floor levels must be located a minimum of one foot above floodplain levels.
