ENTECH
ENGINEERING, INC.

Janaury 26, 2024
Revised March 11, 2024

Re: Soils and Geology Study
McLean Subdivision
2415 Hodgen Road
Parcel No. 61281-00-014
El Paso County, Colorado
Entech Job No. 231709

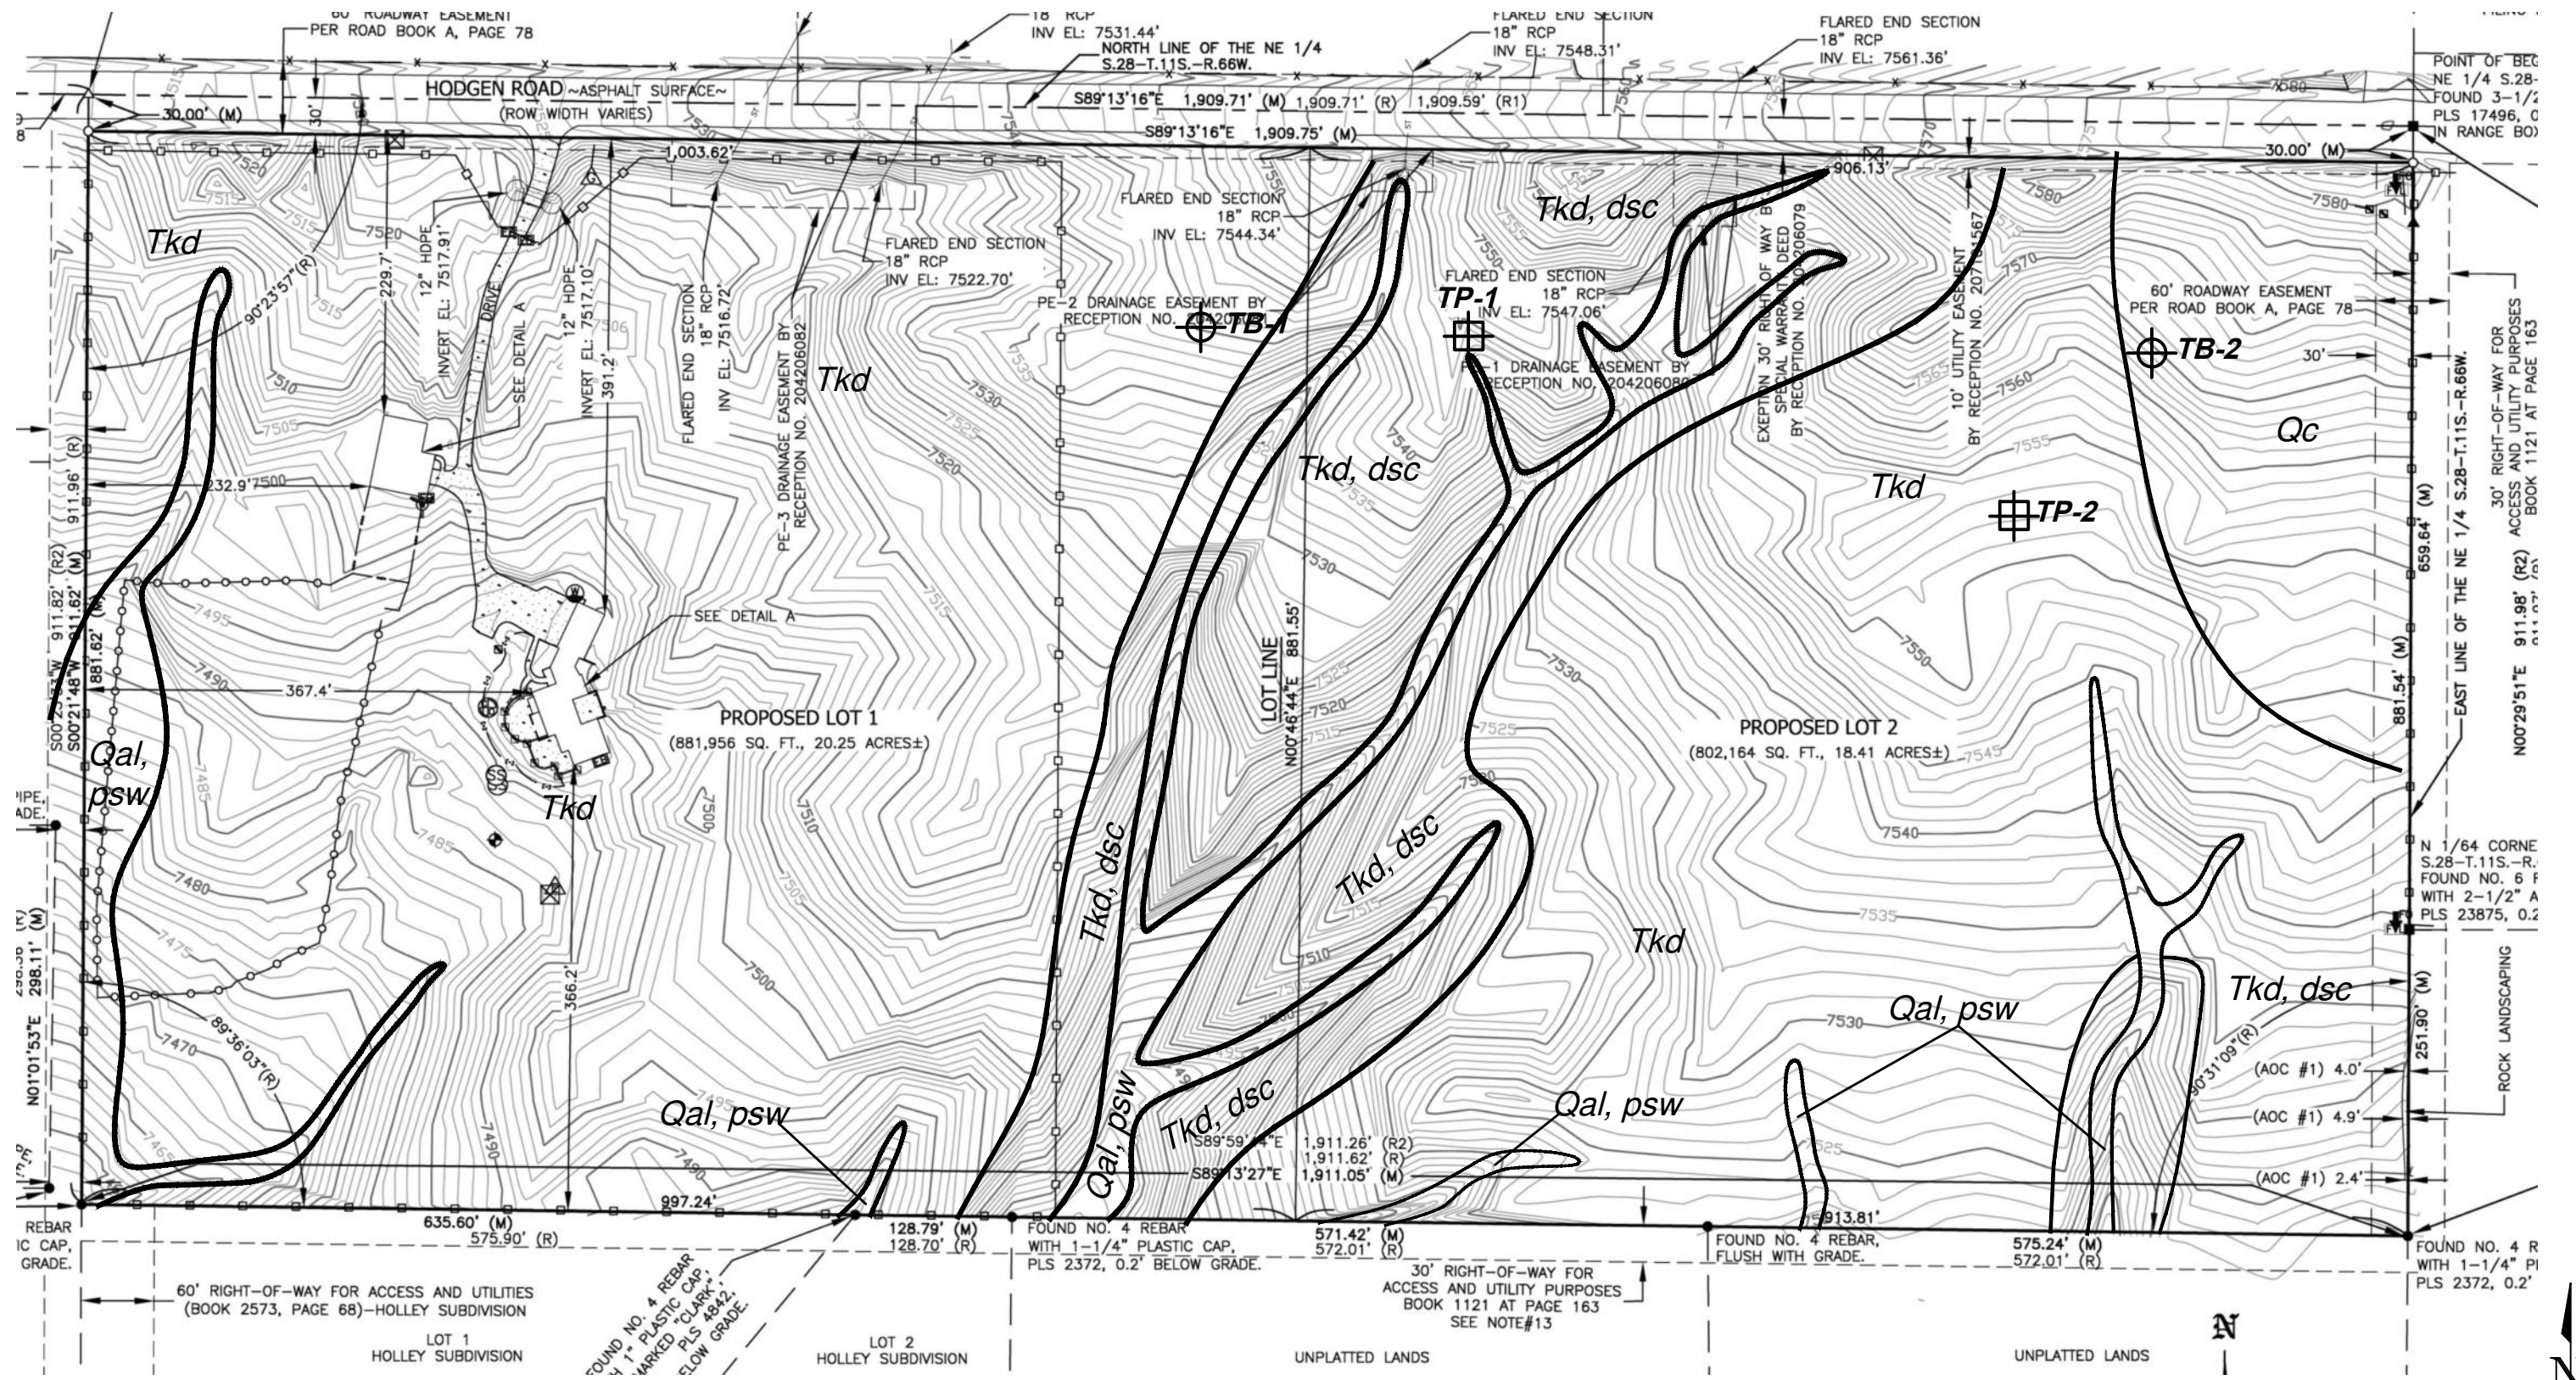
<p>GEOLOGY / ENGINEERING MAP</p> <p>2415 HODGEN ROAD VERTEX CONSULTING SERVICES</p>	<p>JOB NO. 231709</p> <p>FIG. 6</p>
---	--	--

Some of the slopes along the drainages on the site have been identified as downslope creep areas on the Geology/Engineering Geology Map, Figure 6. These areas are located within Lot 2 in the eastern portion of the site and can be avoided by future site development. The slopes were traversed to observe any signs of recent movement or failures. The slopes appeared to be stable in their current state based on our site observations. In areas within and adjacent to the area mapped as downslope creep we would anticipate to potential for accelerated lateral and vertical movement of the near surface soils in a downslope direction.

The site is not mapped within any floodplains according to the FEMA Map No. 08041CO285G, dated December 7, 2018 (Figure 8, Reference 6). Areas of potential seasonally shallow groundwater were observed on the site (Figure 6). In these areas, we would anticipate the potential for periodically high subsurface moisture conditions and frost heave potential. These areas lie along minor drainages located in the central portions of the site. Water was not observed in any of the drainages at the time of our site investigation. These areas can likely be avoided by development. The potential exists for high groundwater levels during high moisture periods and should structures encroach on these areas the following precautions should be followed.

Mitigation: The design of foundations in these areas should account for the sloping conditions. A lateral pressure diagram for the design of walls in sloping areas is included in Figure 7. Foundation stiffeners such as tie-beams, buttresses or additional reinforcement are recommended. The excavation and any fill placed on the site should be benched into the slope and native soils. Slopes in the building area should be constructed at no steeper than 3:1 unless held by engineer-designed retaining walls designed for the global slope stability.

Mitigation: Foundations must have a minimum 30-inch depth for frost protection. In areas where high subsurface moisture conditions are anticipated periodically, subsurface perimeter drains are recommended to help prevent the intrusion of water into areas below grade. Typical drain details are presented in Figure 9. If shallow groundwater is encountered, underslab drains or interceptor drains may be necessary Figures 10 and 11. Specific drainage details and recommendations should be made once building locations and plans are finalized. Any grading in these areas should be done to direct surface flow around construction to avoid areas of ponded water. All organic material would be completely removed prior to any fill placement. **Specific drainage studies are beyond the scope of this report.**

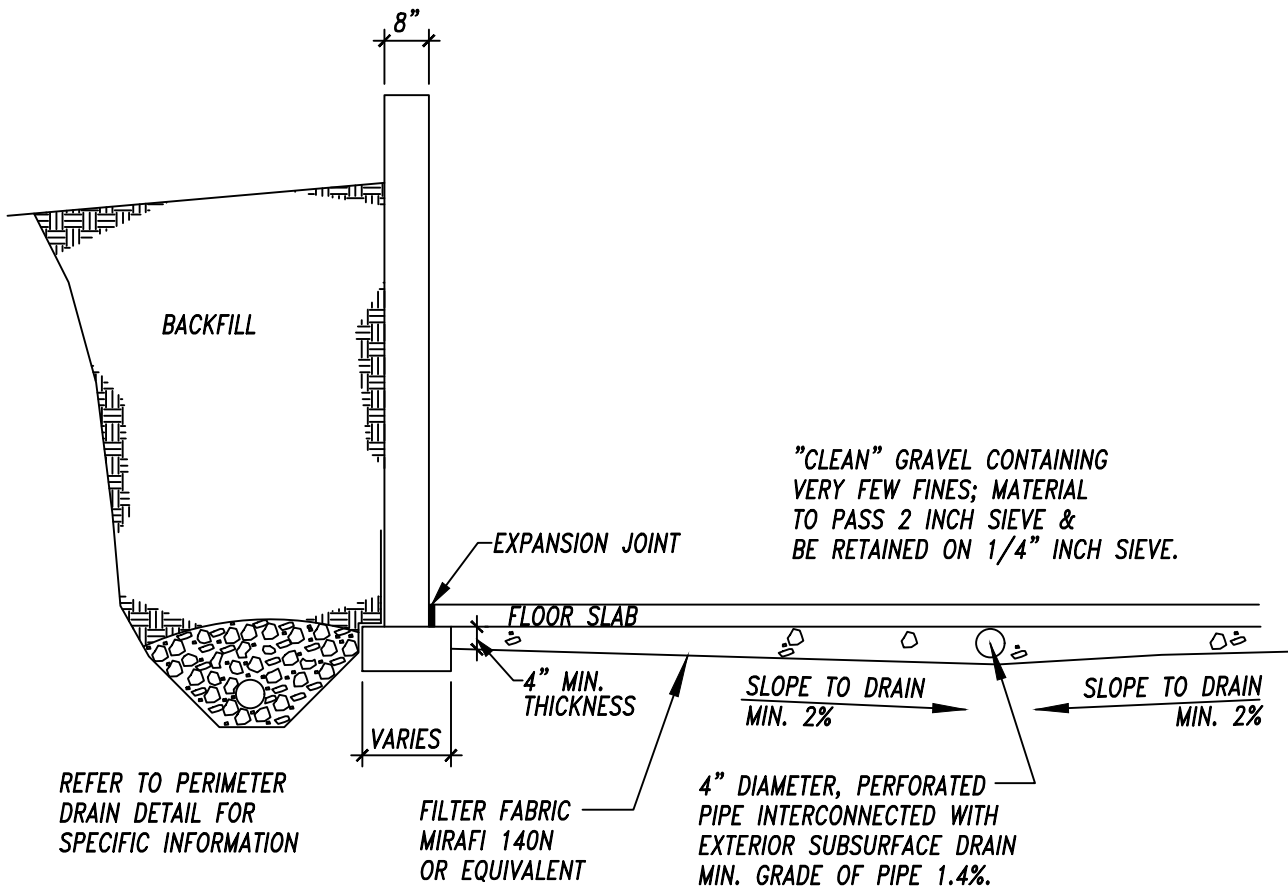
FIG. 9

attachments. Bedrock will likely be encountered in the proposed building excavations. In areas of shallow bedrock, the potential for perched groundwater conditions exist. Where perched groundwater is encountered, underslab drains or interceptor drains may be necessary Figures 9 and 10.

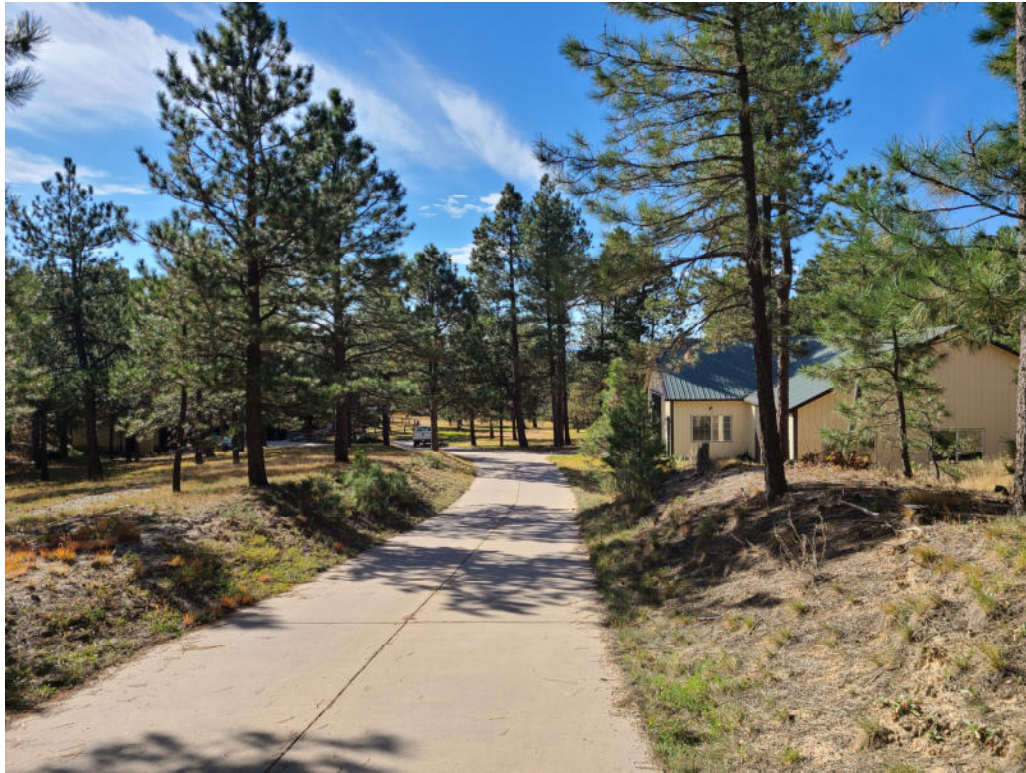
Looking south from the northwest side of the site (Lot 1).

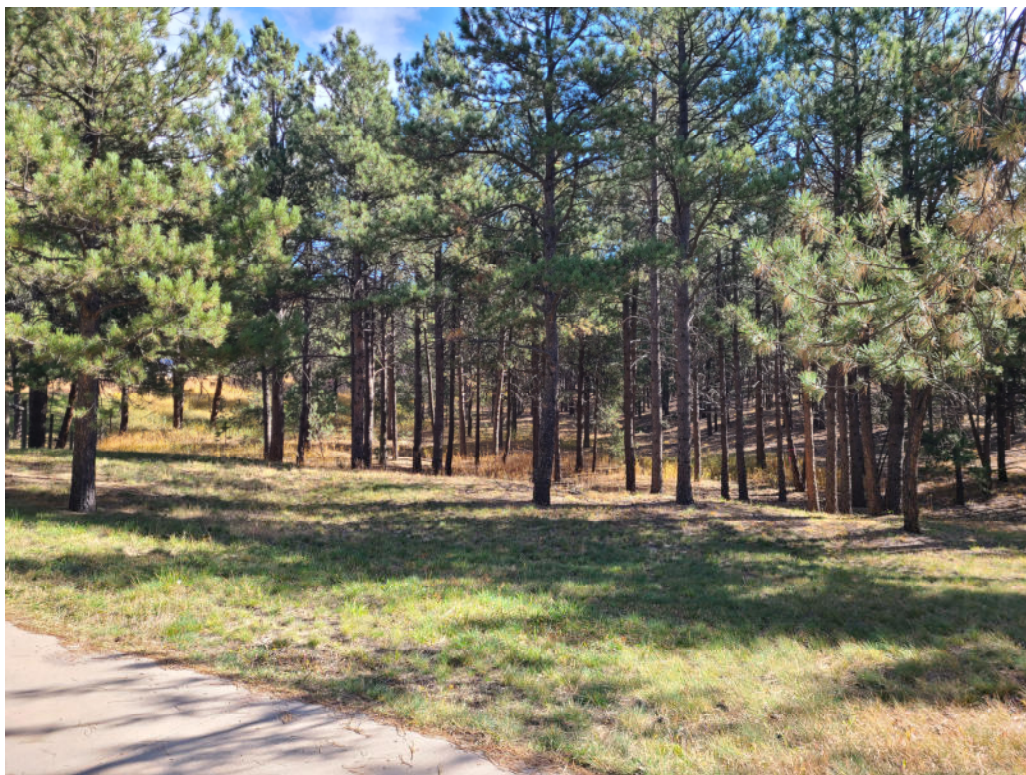
Looking east from the northwest side of the site.

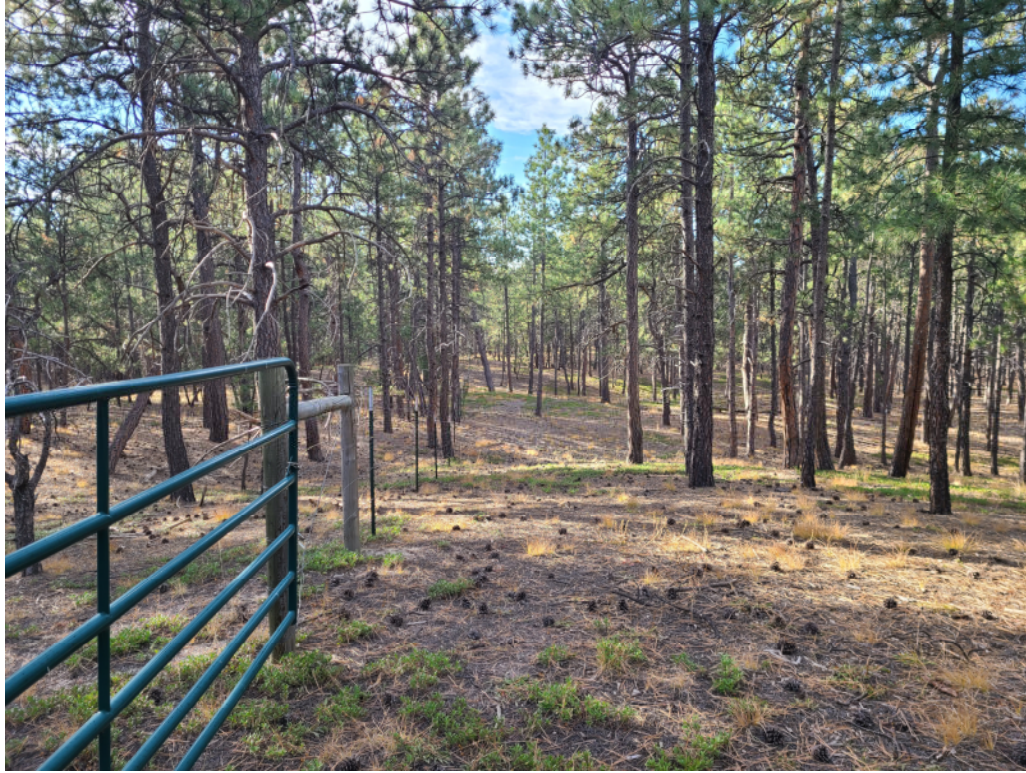
**Looking south along
the lot boundary of
Lots 1 and 2.**

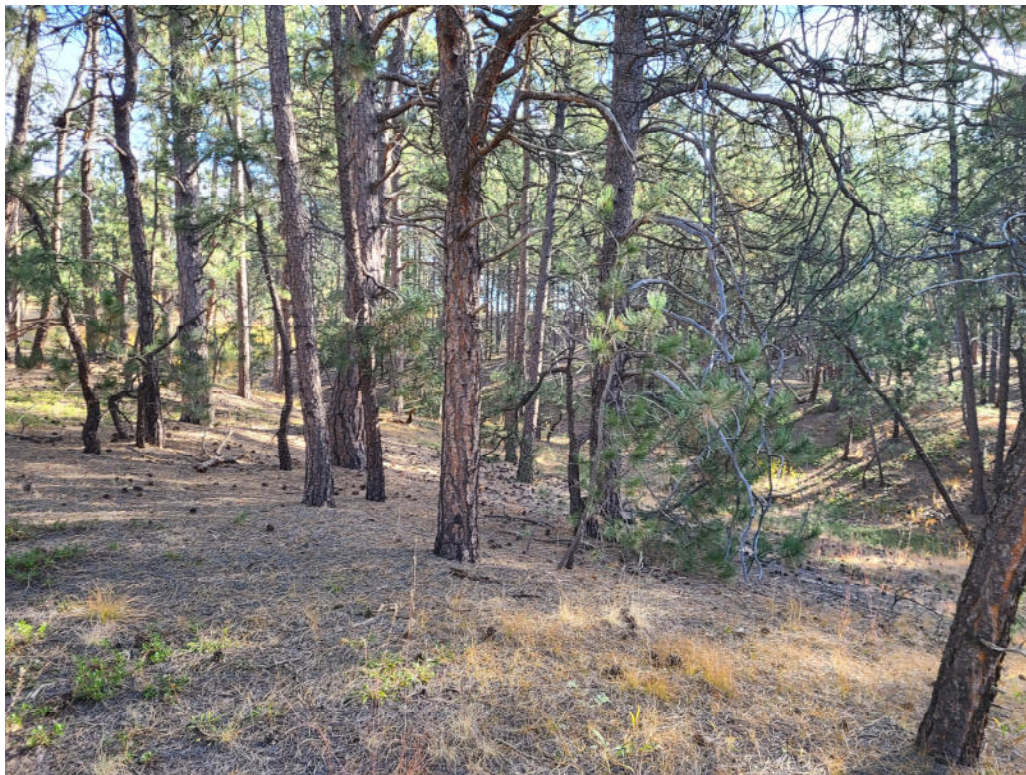
**Looking north from the
central portion of the
Lot 2.**

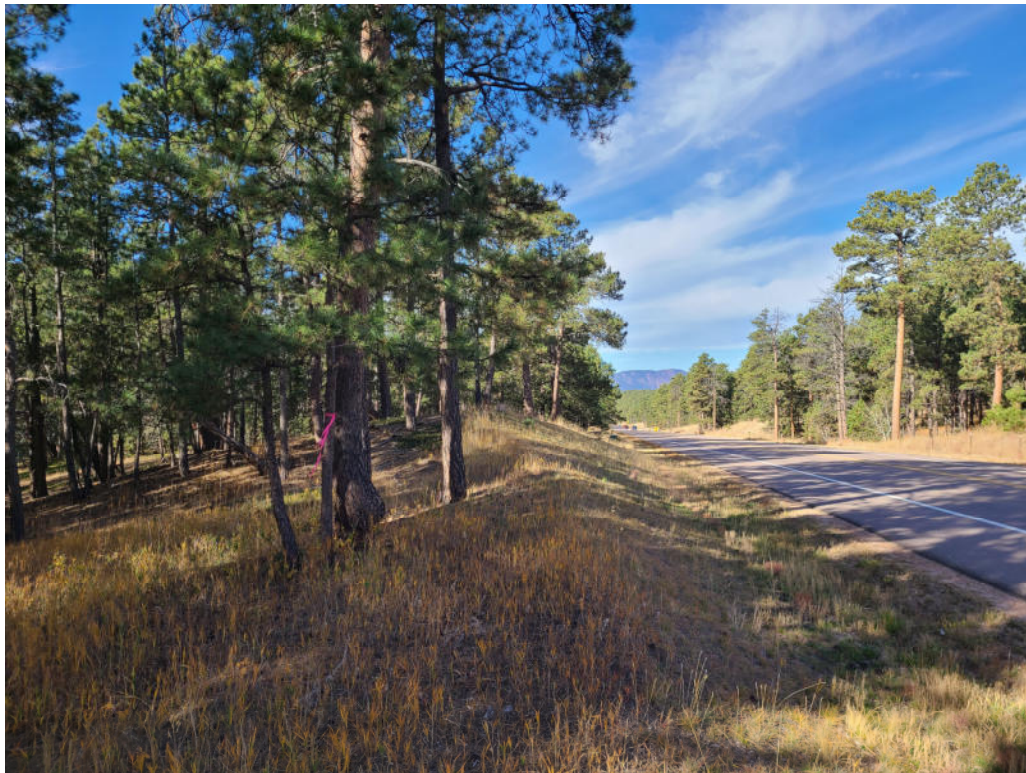
Looking west northern side of the site.

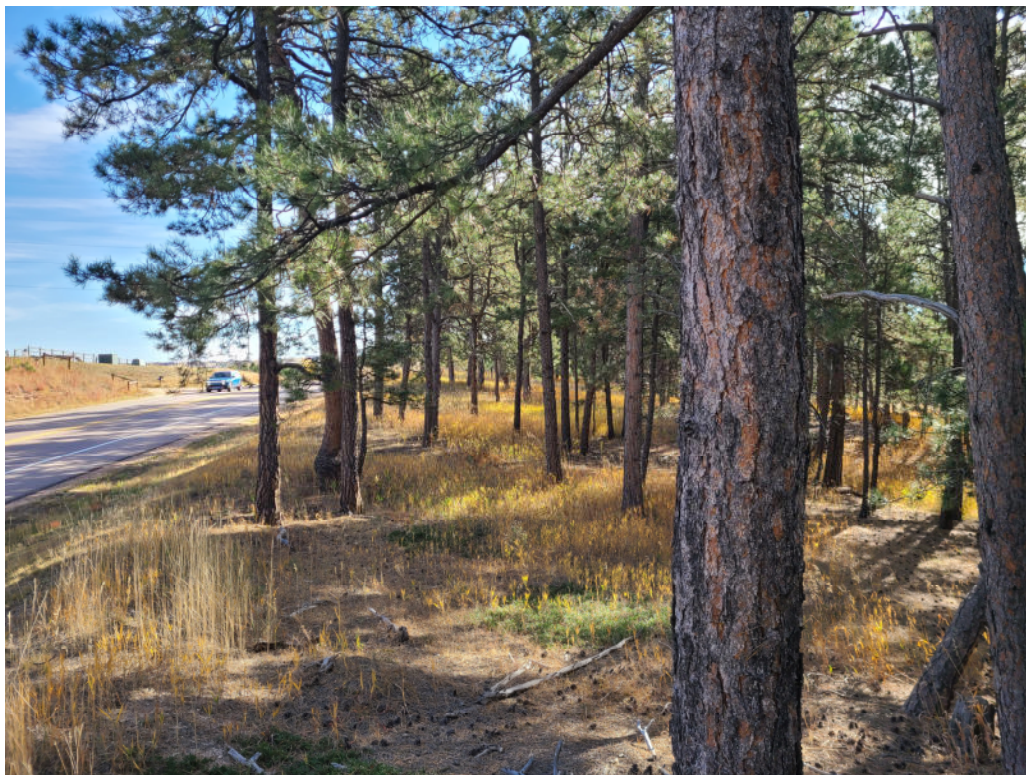
Looking east from the northern side of the site.

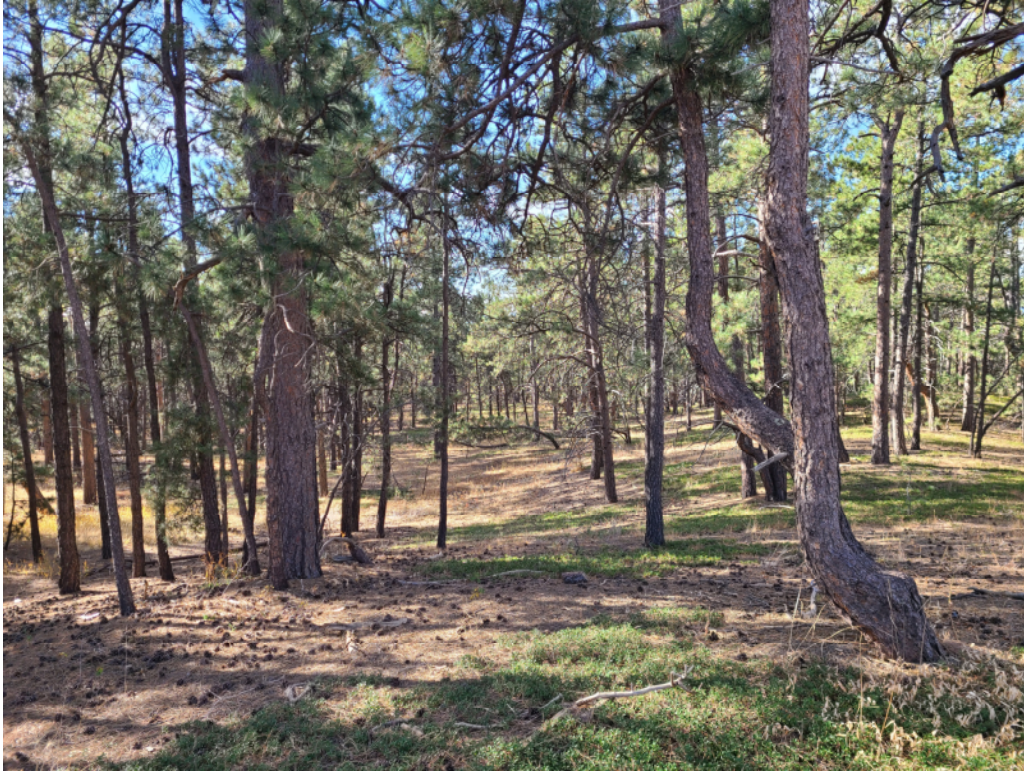
**Looking west from the
central portion of Lot
4.**

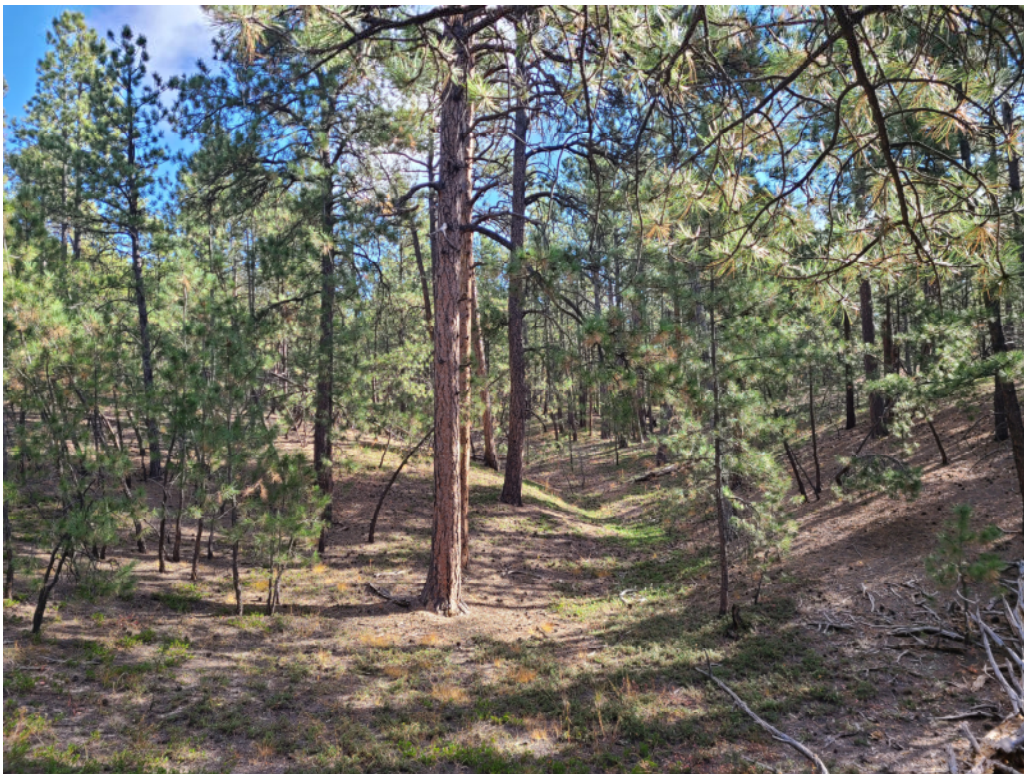
**Looking north along
minor drainage in the
southern portion of the
site.**
