June 2, 2020

Re: Wastewater Study  
Mountain's Edge Subdivision  
McClelland Road & Farmhouse Court  
Parcel No. 32000-00-740  
El Paso County, Colorado

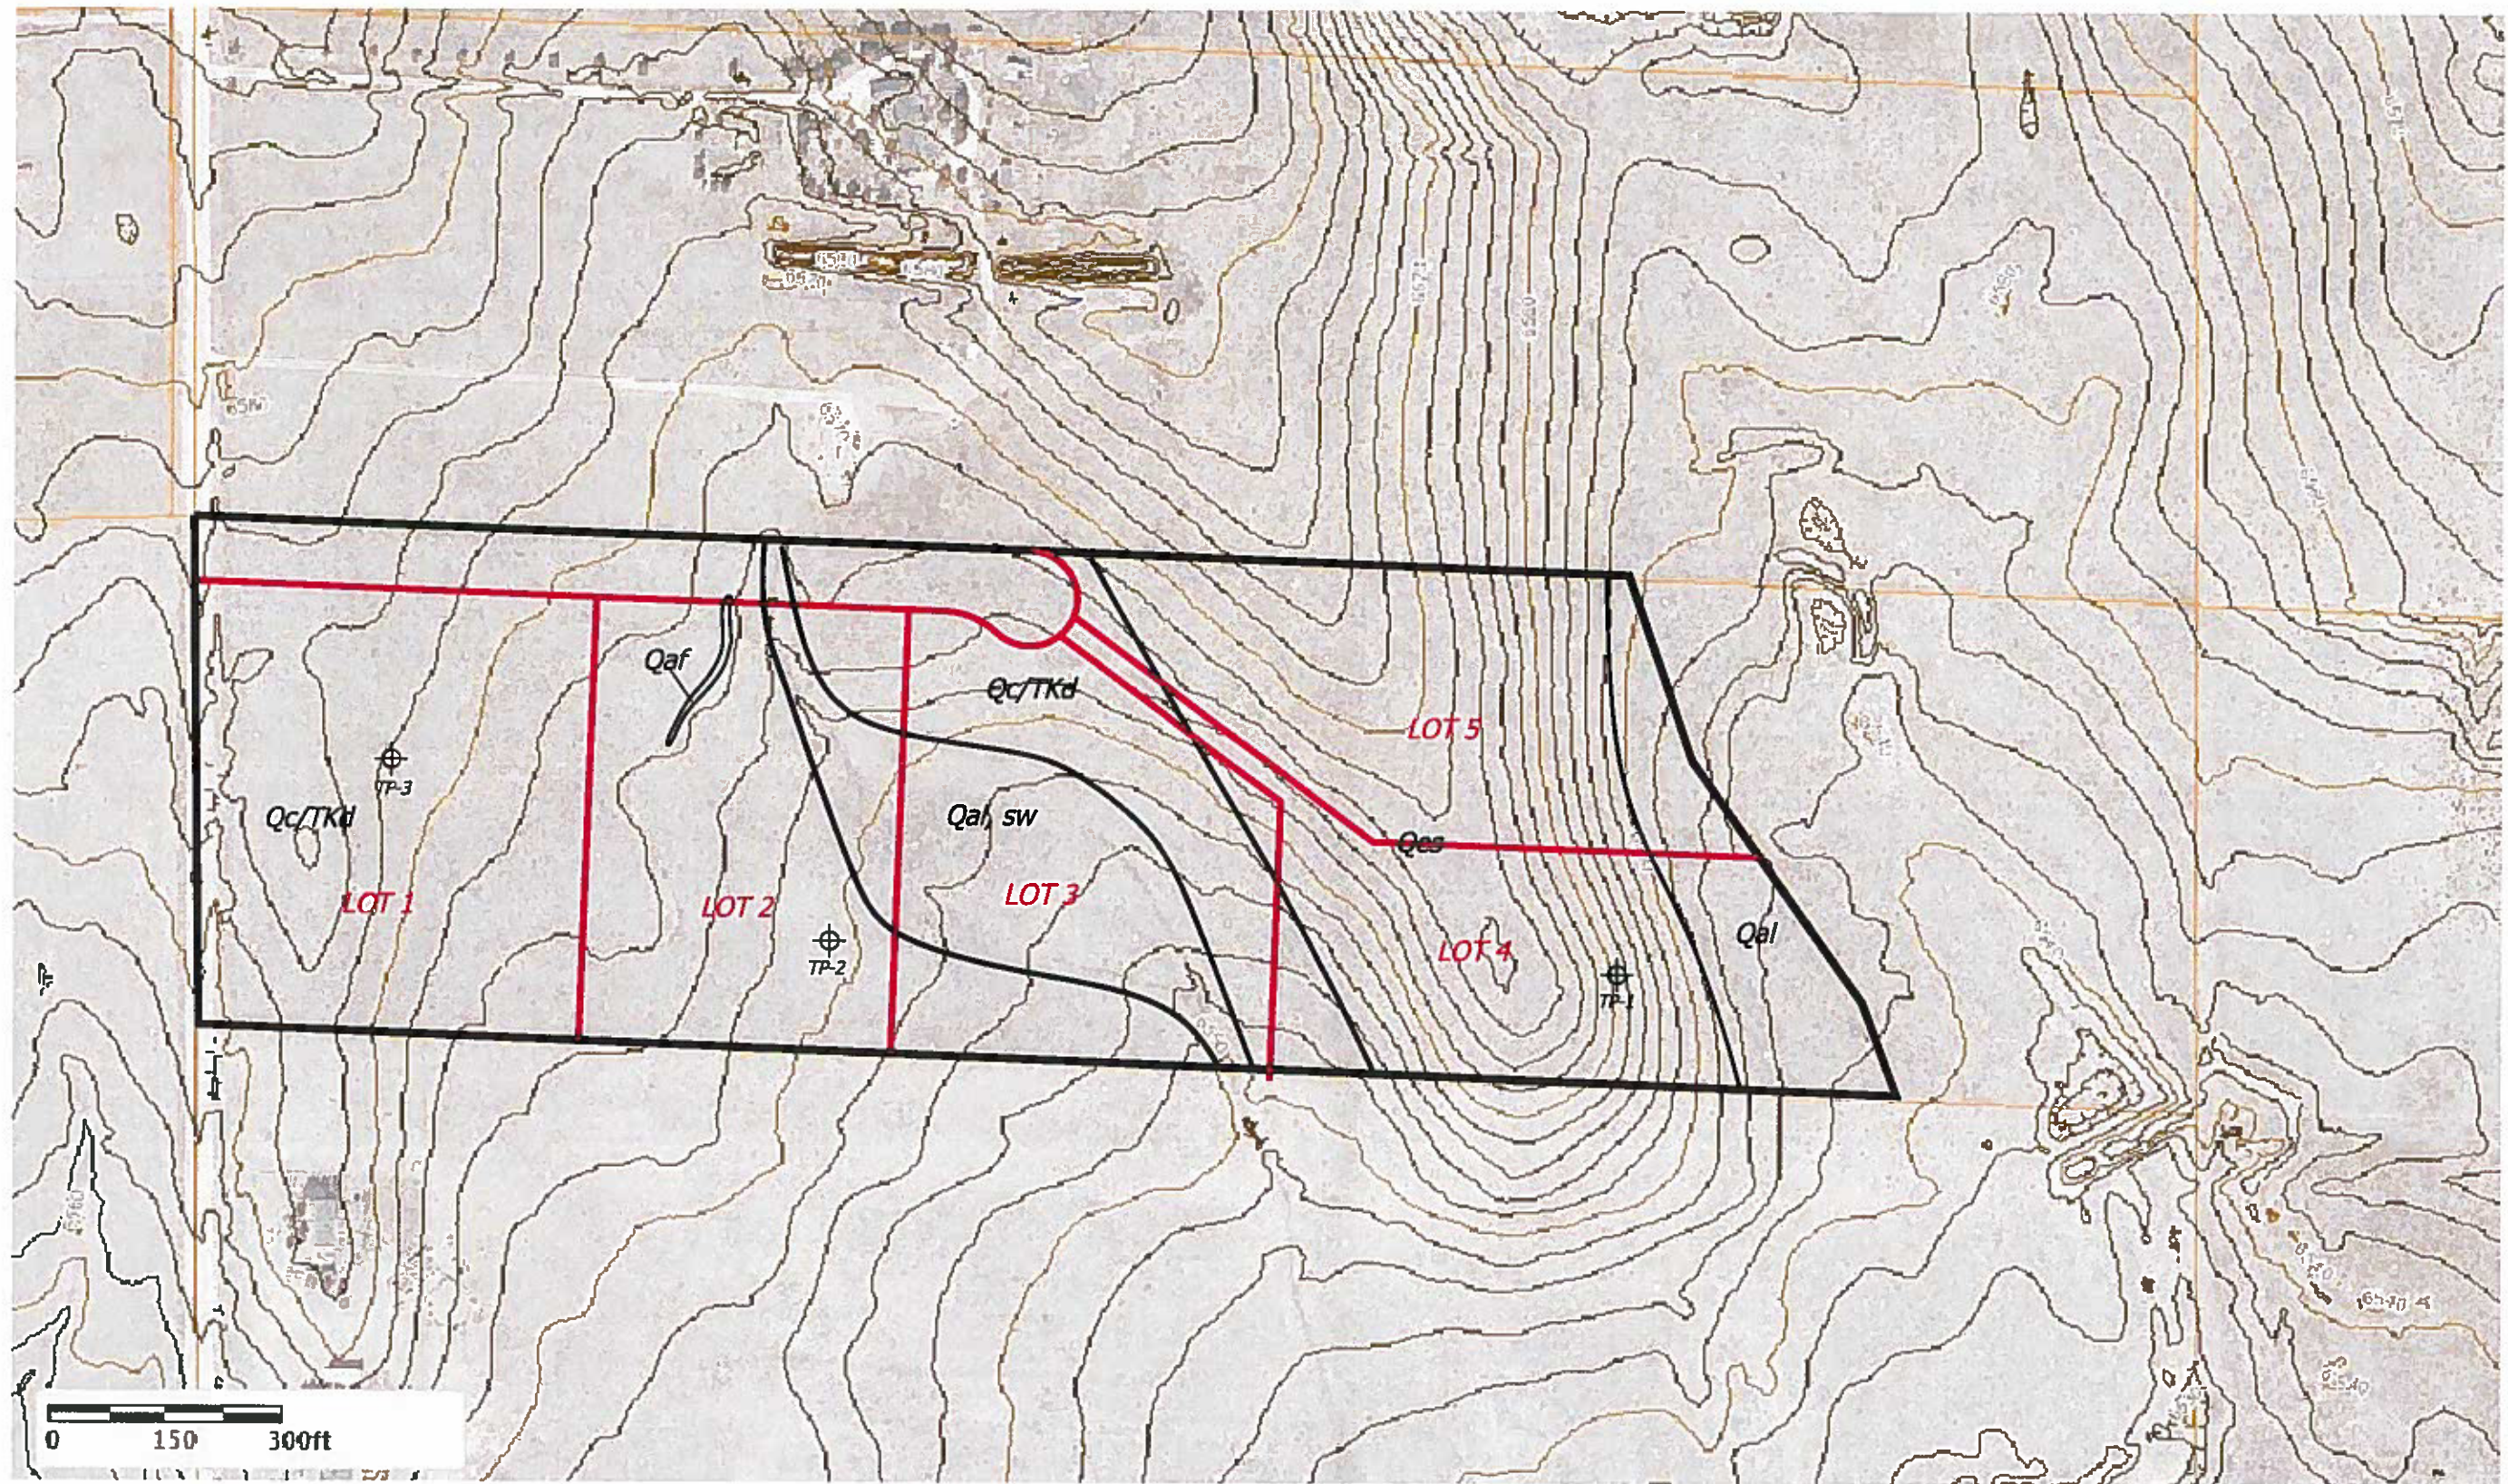
DRAWN  
LIT  
CHECKED  
DATE  
8/1/20  
SCALE  
AS SHOWN  
JOB NO.  
2000000  
FIGURE NO.  
6

- Qaf Artificial Fill of Holocene Age:** These consist of man-made fill deposits associated with erosion berm on Lot 2.
- Qal Alluvium of Quaternary Age:** These are recent deposits that have been deposited along the drainages and low-lying areas that exist on-site. These materials consist of silty to clayey sands. Some of these alluviums can contain highly organic soils.

- Qes Eolian Sands of Quaternary Age:** These are wind-blown sands deposited by the action of prevailing winds. The materials typically consist of silty sands and may contain sandy silt layers.

- Qc/Tkd Colluvium of Quaternary Age overlying Dawson Formation of Tertiary to Cretaceous Age:** The materials consist of colluvial or residual soils overlying the bedrock materials on-site. The colluvial soils were deposited by the action of sheetwash and gravity. The residual soils were derived from the in-situ weathering of the bedrock on site. These materials typically consist of silty to clayey sand with

sw - shallow groundwater area

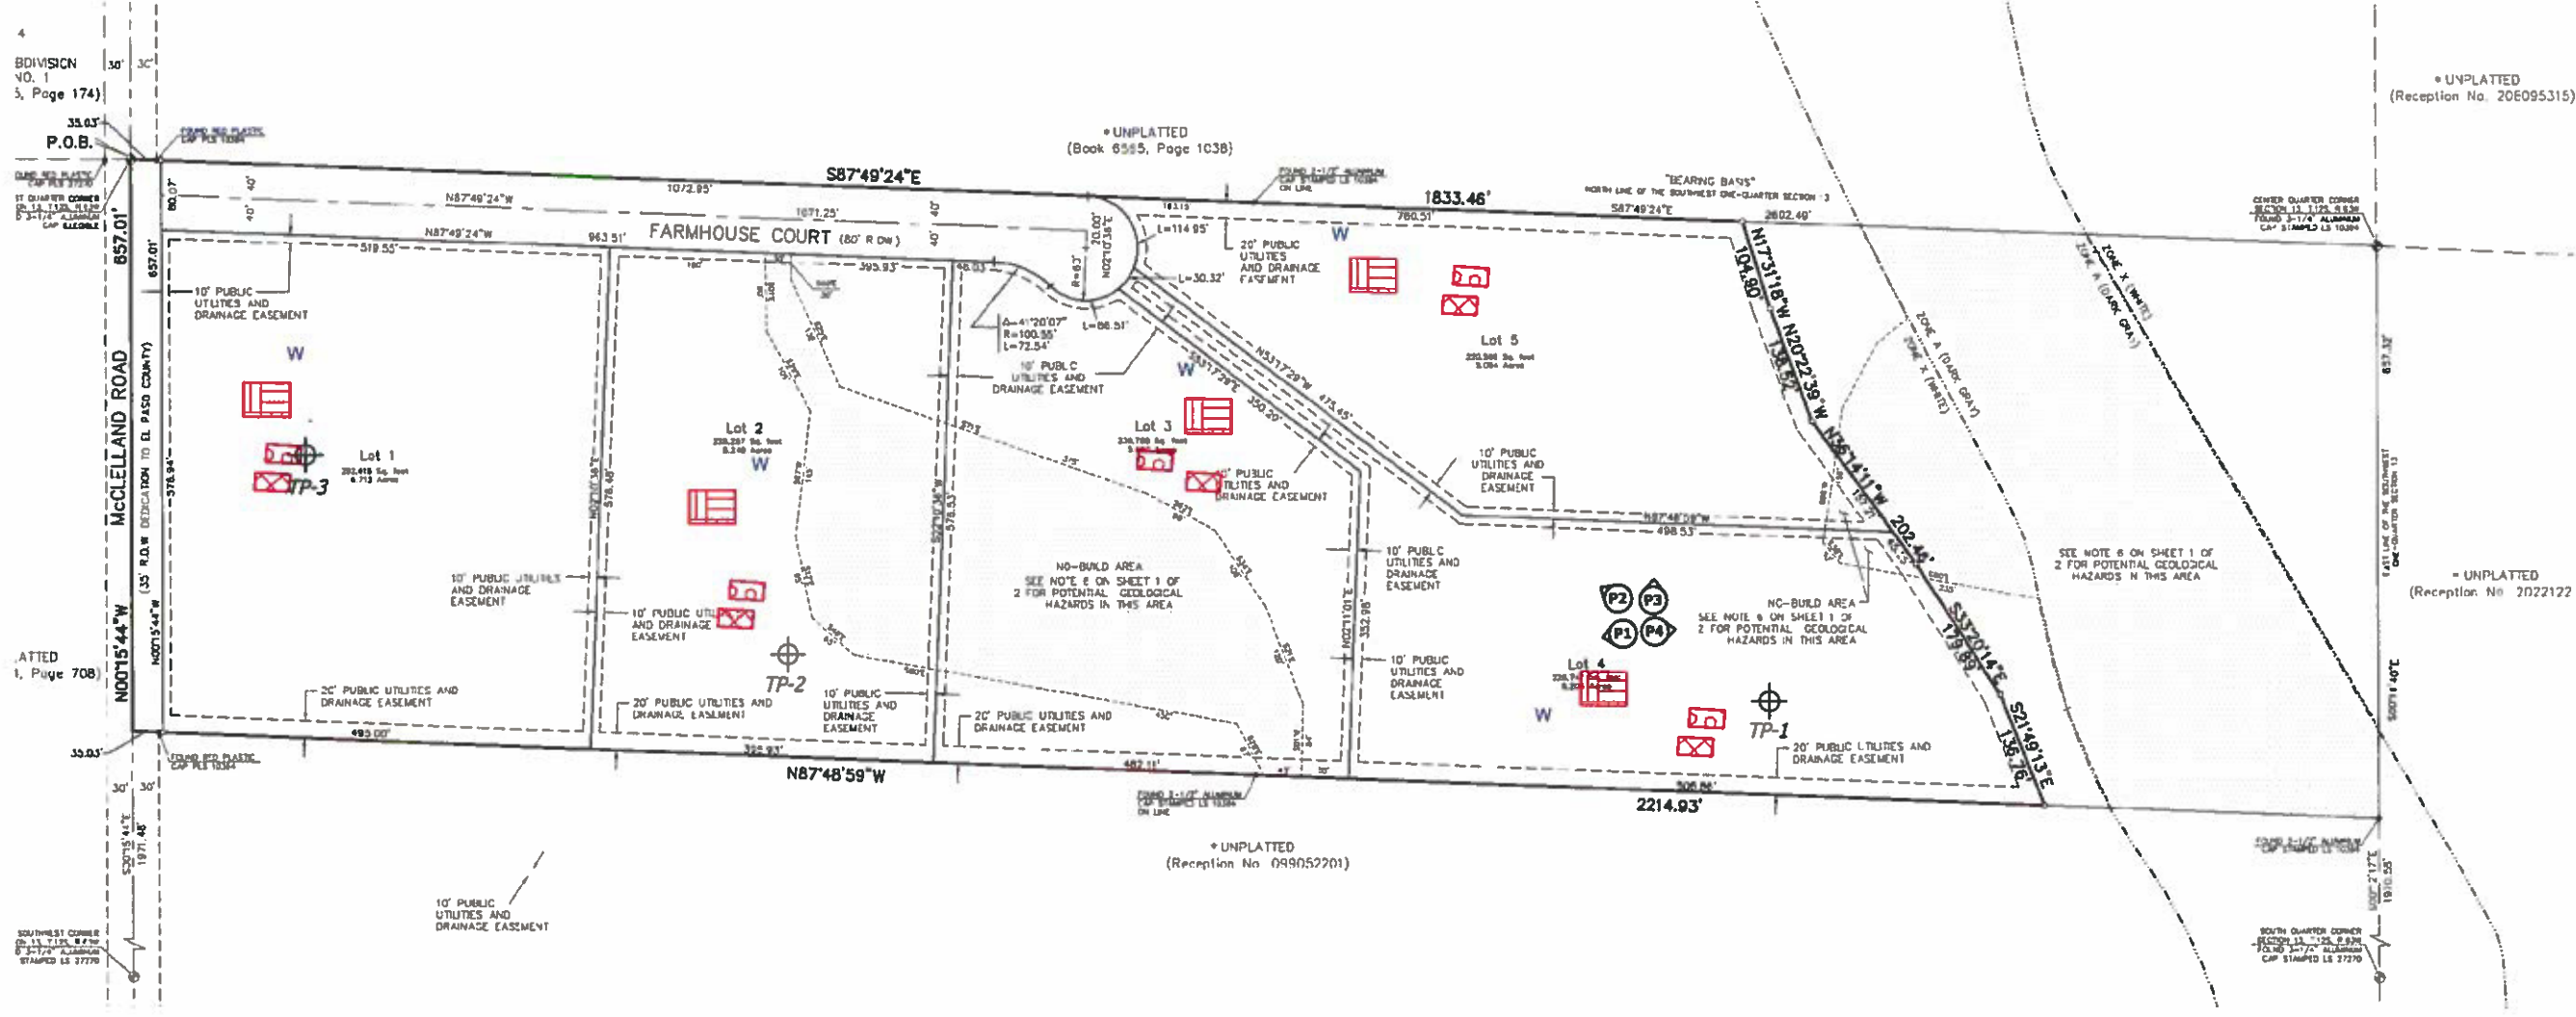
DATE 8/1/20
SCALE AS SHOWN
JOB NO. 200889
FIGURE NO. 8

In summary, it is our opinion the site is suitable for individual on-site wastewater treatment systems (OWTS) and that contamination of surface and subsurface water resources should not occur provided the OWTS sites are evaluated and installed according to El Paso County and State Guidelines and properly maintained. Based on the testing performed designed systems would likely be required for Lot 1, and the remaining lots would likely be suitable for conventional systems provided shallow bedrock, restrictive clay soils or groundwater are not encountered in the soil treatment areas. The Septic Suitability Map is presented in Figure 8. A possible house location, water well, and two septic sites for the lots are indicated on Figure 8. Areas that should be avoided by septic systems are indicated on the septic suitability map.

**Individual soil testing is required for proposed construction on each lot prior to construction.** Absorption fields must be located a minimum of 100 feet from any well, including those on adjacent properties. Absorption fields must also be located a minimum of 50 feet from any drainages, floodplains or ponded areas and 25 feet from dry gulches.

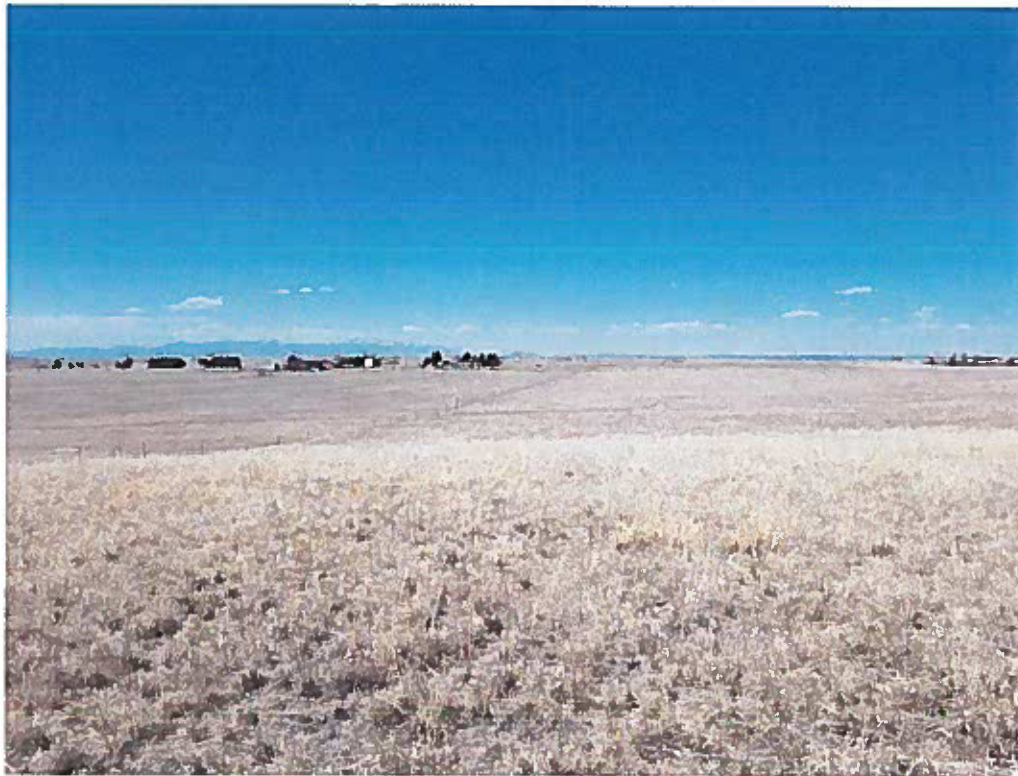
**Looking west from the  
central portion of Lot  
4.**

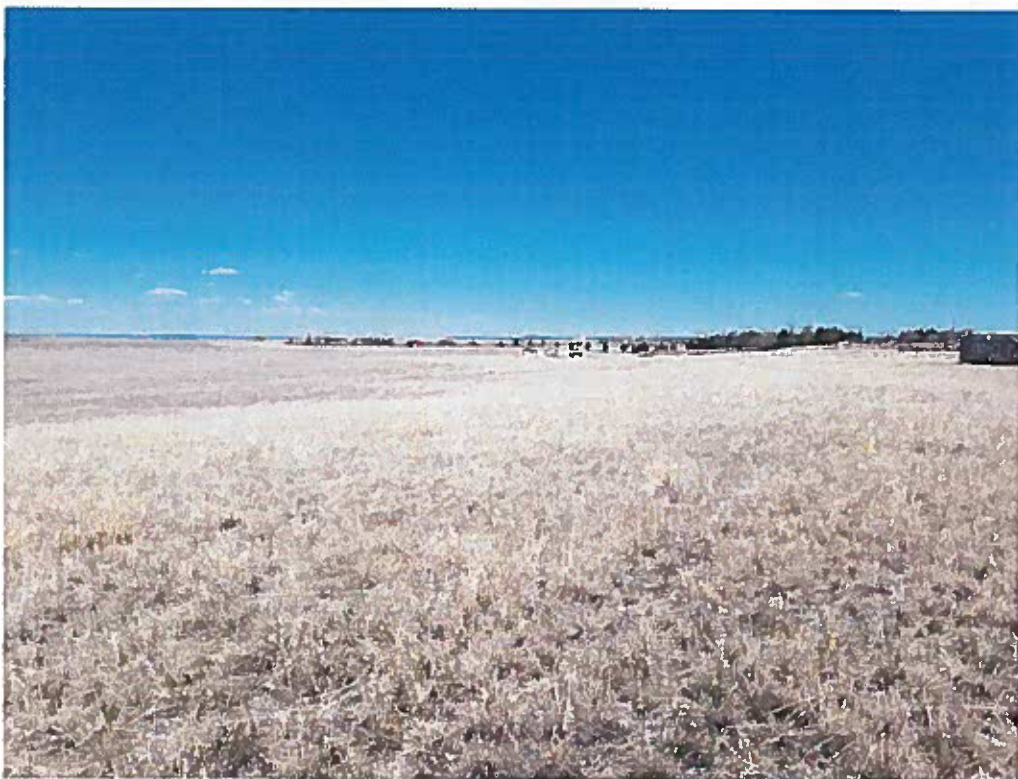
**Looking northwest  
from the central  
portion of Lot 4.**

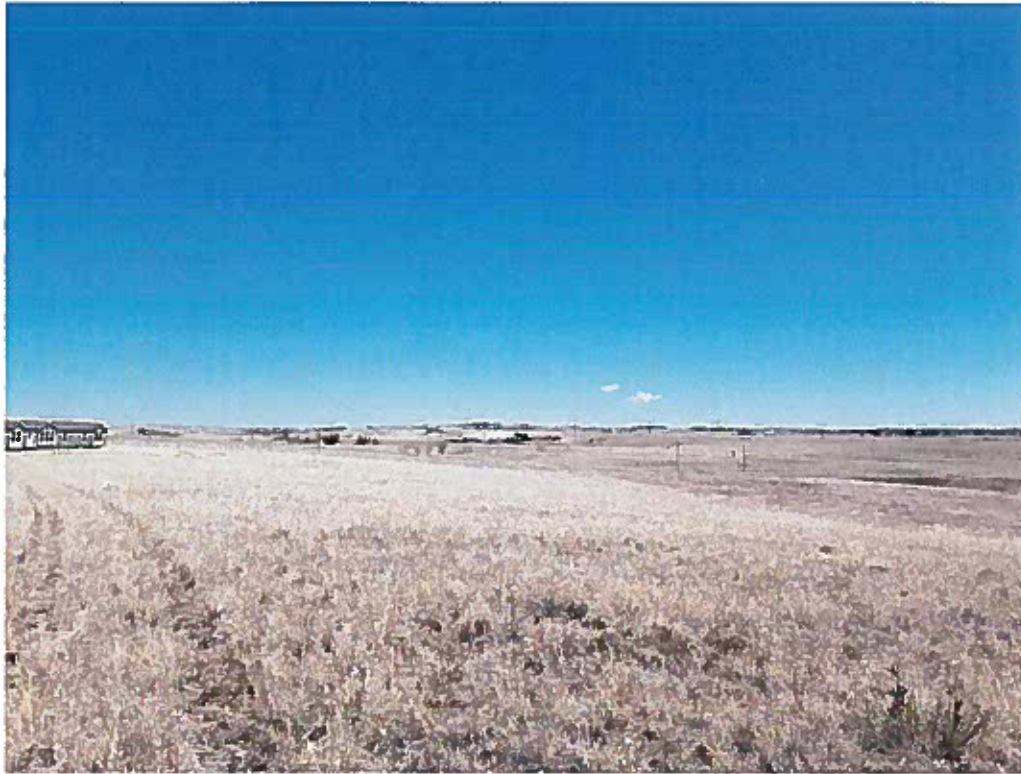
**Looking north from the  
central portion of Lot  
4.**

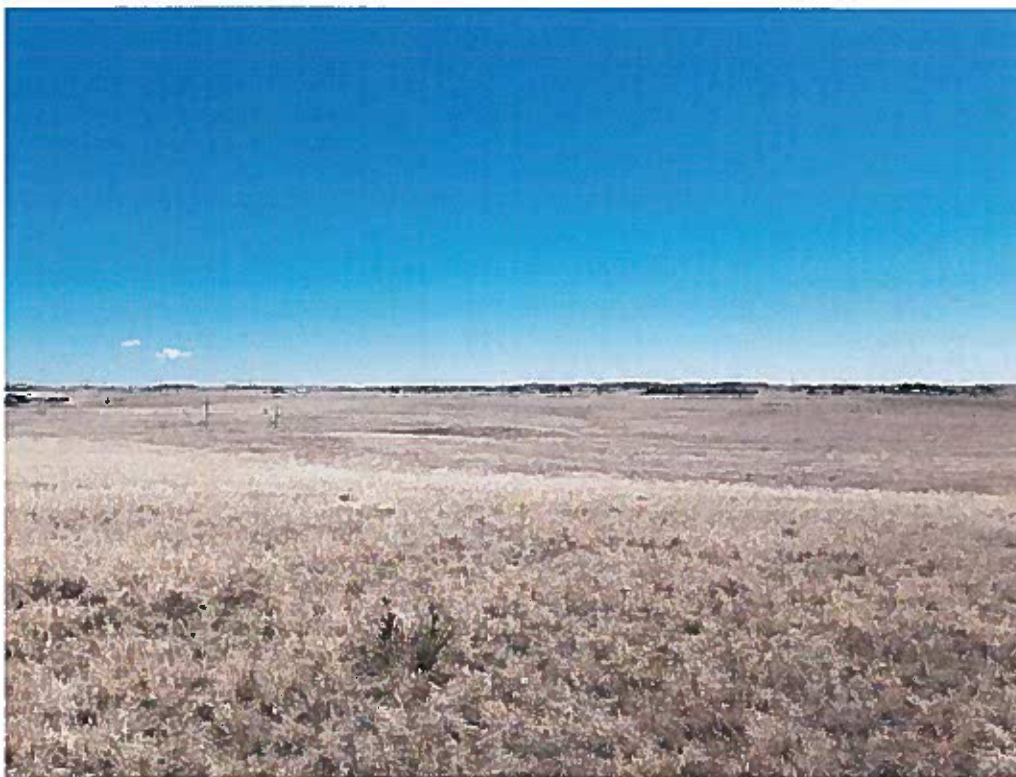
**Looking east towards  
drainage from the  
eastern portion of the  
site.**
