ENTECH
ENGINEERING, INC.

March 19, 2021
Revised April 27, 2021

Re: Soil, Geology and Geologic Hazard Evaluation
Mountain's Edge Subdivision
McClelland Road & Farmhouse Court
Parcel No. 32000-00-740
El Paso County, Colorado

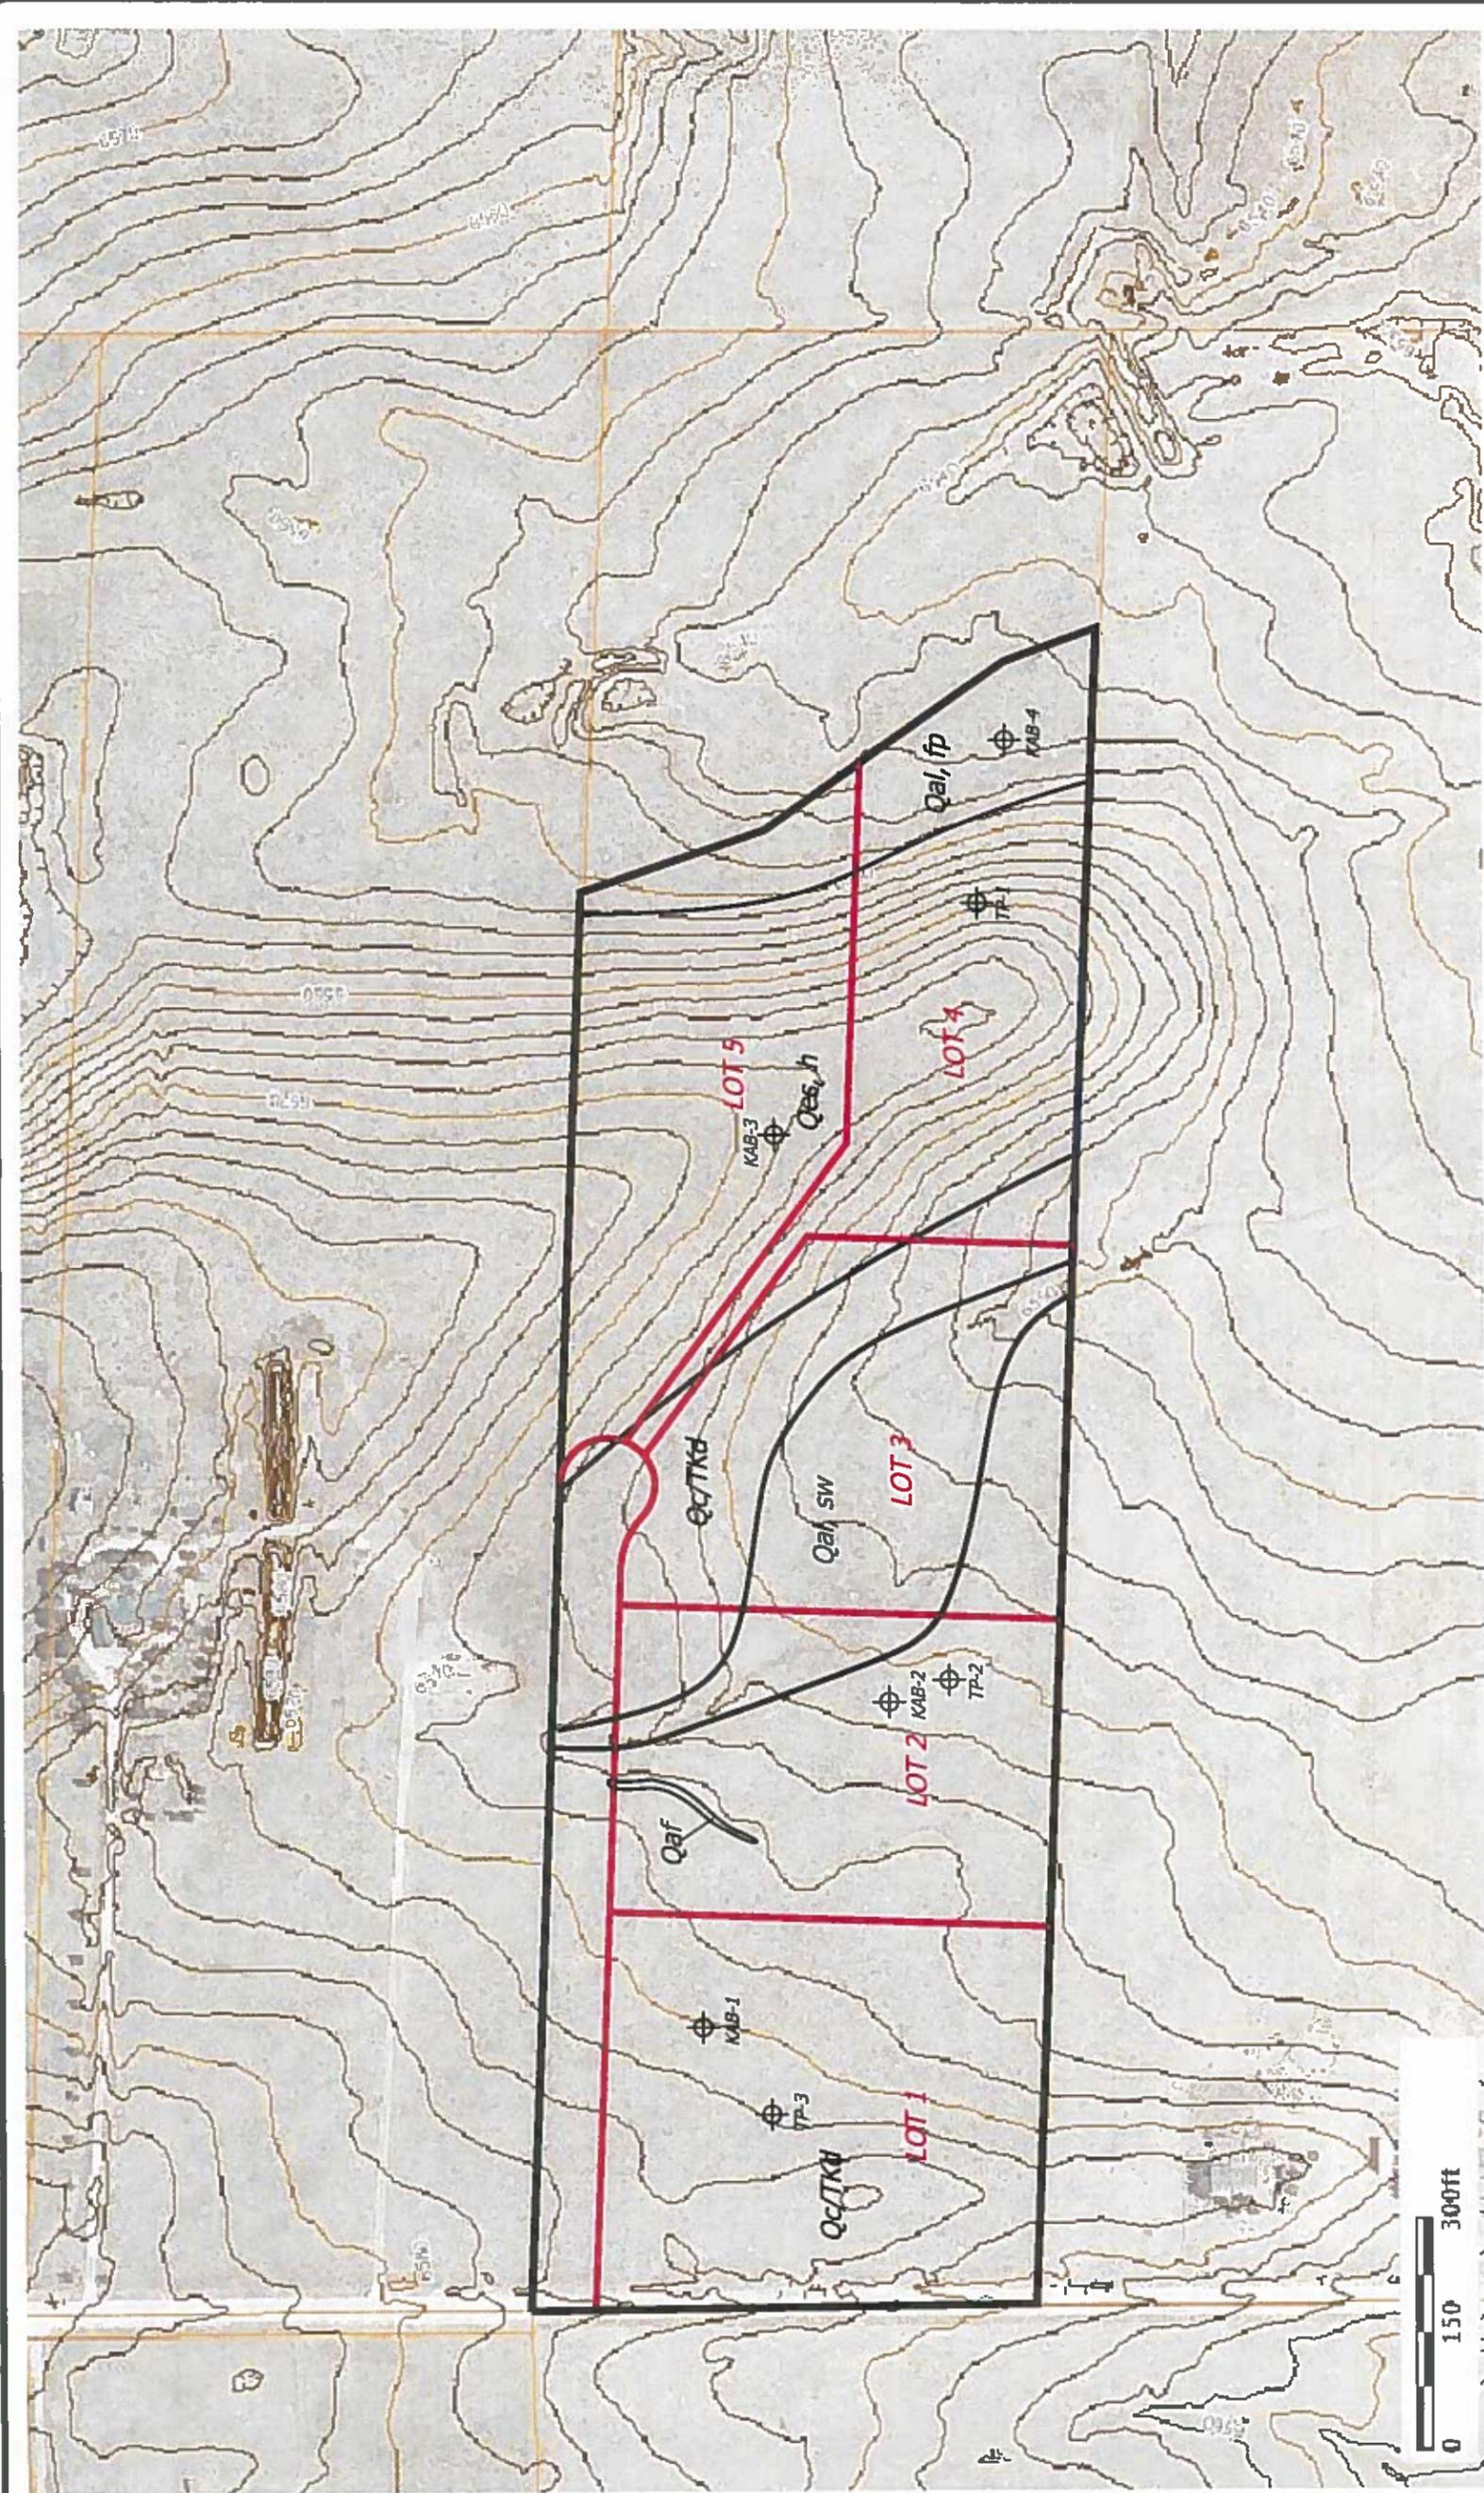
Minor drainages exist on-site that flow in southeasterly directions. No water was observed flowing in these drainages at the time of the investigation. Areas of seasonal shallow groundwater have been mapped along the drainages on the site (Figure 6) located on Lots 2 and 3. In this area the potential for flooding, bank erosion and sedimentation exist. These areas are designated as no-build areas on Figure 3, and will be avoided by any future construction.

sw – Seasonal shallow groundwater areas: In these areas, we would anticipate the potential for periodically high subsurface moisture conditions, frost heave potential, and highly organic soils. The seasonal shallow groundwater areas are located on Lot Nos. 2 and 3. In these areas the potential for flooding, bank erosion and sedimentation exist. Additionally, the potential for accelerated erosion exist on portions Lot 3. These areas are designated as no-build areas on Figure 3, and will be avoided by any future construction. Areas where perched water conditions are encountered should also follow these recommendations. Construction proposed in or adjacent to these areas, should follow these precautions:

Areas in which hydrocompaction have been identified are acceptable as building sites. In areas identified for this hazard classification, however, we anticipate a potential for settlement upon saturation of these surficial soils. The low density, uniform grain sized, windblown sand deposits are particularly susceptible to this type of phenomenon. Lots 4 and 5 are located in the area mapped as eolian sands (Qes) which have the potential for hydrocompaction.

Mitigation: In these locations, foundations are subject to severe frost heave and should penetrate to a sufficient depth so as to prevent the formation of ice lenses beneath foundations. At this location and elevation, a foundation depth for frost protection of 30-inches is recommended. In areas where high subsurface moisture conditions are anticipated periodically, a subsurface perimeter drain will be necessary to help prevent the seepage of water into areas below grade. A typical perimeter drain detail is presented in Figure 8. Any grading in these areas should be done in a manner that directs surface flow around construction to avoid areas of ponded water. Areas of organic material will require removal prior to any fill placement. Unstable soil conditions should be expected in areas of shallow groundwater. Where foundations approach the groundwater level, stabilization of the excavations utilizing shot rock may be necessary. Underslab drains or capillary breaks, and interceptor drains may be necessary to prevent intrusion of water into areas below grade. Typical drain details are presented in Figures 9 and 10.

Mitigation: The potential for settlement is directly related to saturation of the soils below the foundation areas. Therefore, good surface and subsurface drainage is extremely critical in these areas in order to minimize the potential for saturation of these soils. The ground surface around all permanent structures should be positively sloped away from the structure to all points, and water must not be allowed to stand or pond anywhere on the site. We recommend that the ground surface within 10 feet of the structures be sloped away with a minimum gradient of five percent. If this is not possible on the upslope side of the structures, then a well-defined swale should be created to intercept the surface water and carry it quickly and safely around and away from the structures. Roof drains should be made to discharge well away from the structures and into areas of positive drainage. Where several structures are involved, the overall drainage design should be such that water directed away from one structure is not directed against an adjacent building. Planting and watering in the immediate vicinity of the structures, as well as general lawn irrigation, should be minimized.

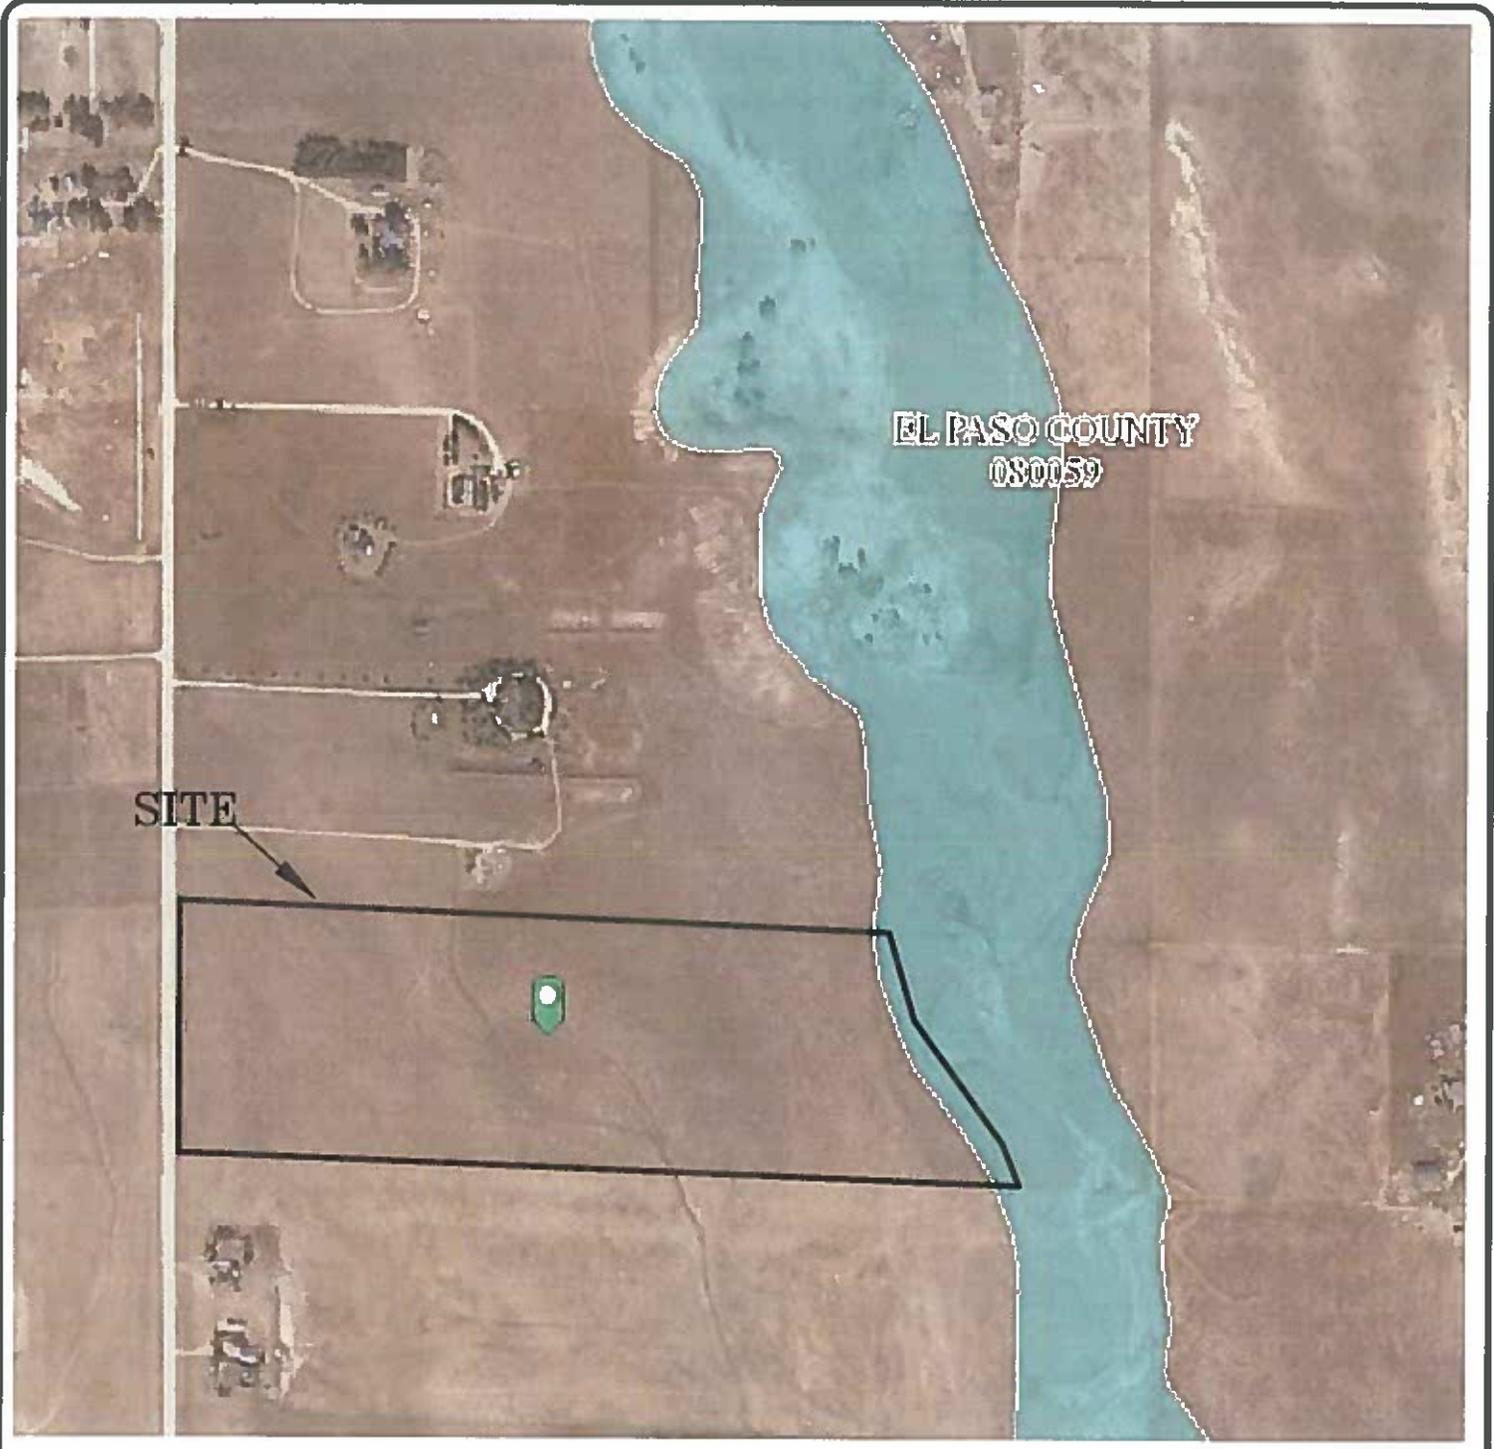
JOB NO.:
200989
FIG NO.:
7

fp – Floodplain: Areas of the site have been mapped as floodplains according to the FEMA Map No. 08041CO375G (Figure 7, Reference 7). The physiographic floodplains on site have been mapped on the Engineering Geology Map (Figure 6). The floodplain area has been designated as a no-build area and will be avoided by development. Finished floor levels must be a minimum

of one foot above the floodplain level. Structures should not block drainages. Specific floodplain locations and drainage studies are beyond the scope of this report.

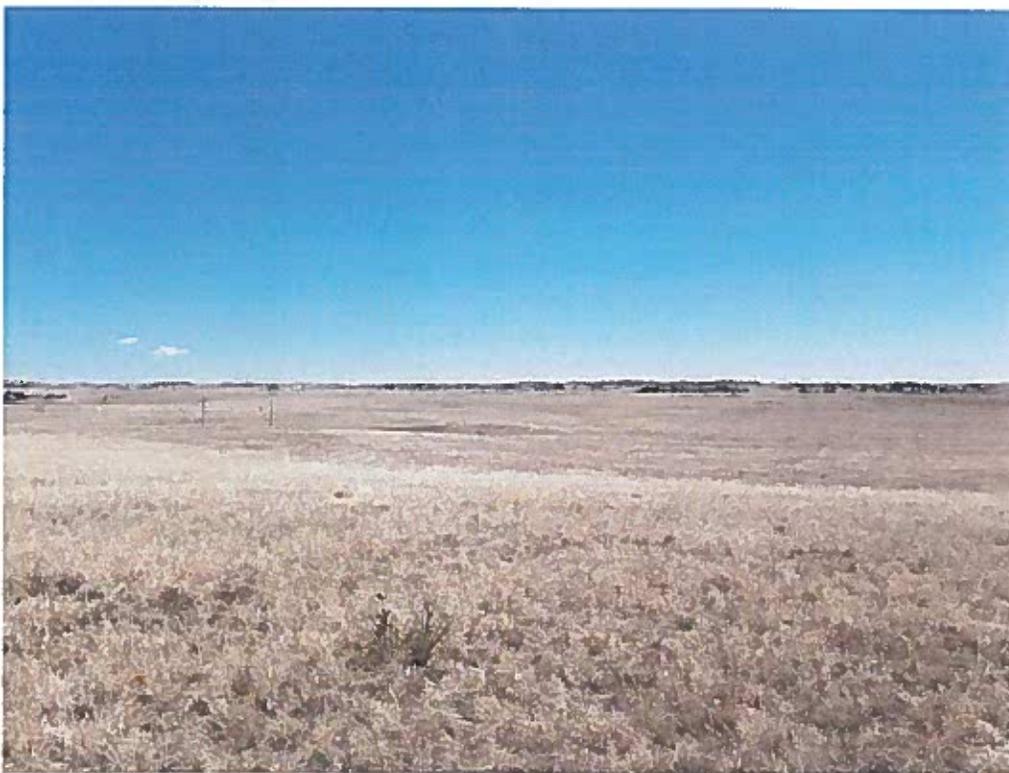
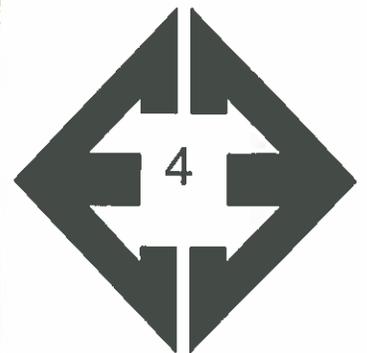
**Looking east towards
drainage from the
eastern portion of the
site.**
