June 2, 2020

**ENTECH**  
ENGINEERING, INC.

Re: Wastewater Study  
Mountain's Edge Subdivison  
McClelland Road & Farmhouse Court  
Parcel No. 32000-00-740  
El Paso County, Colorado

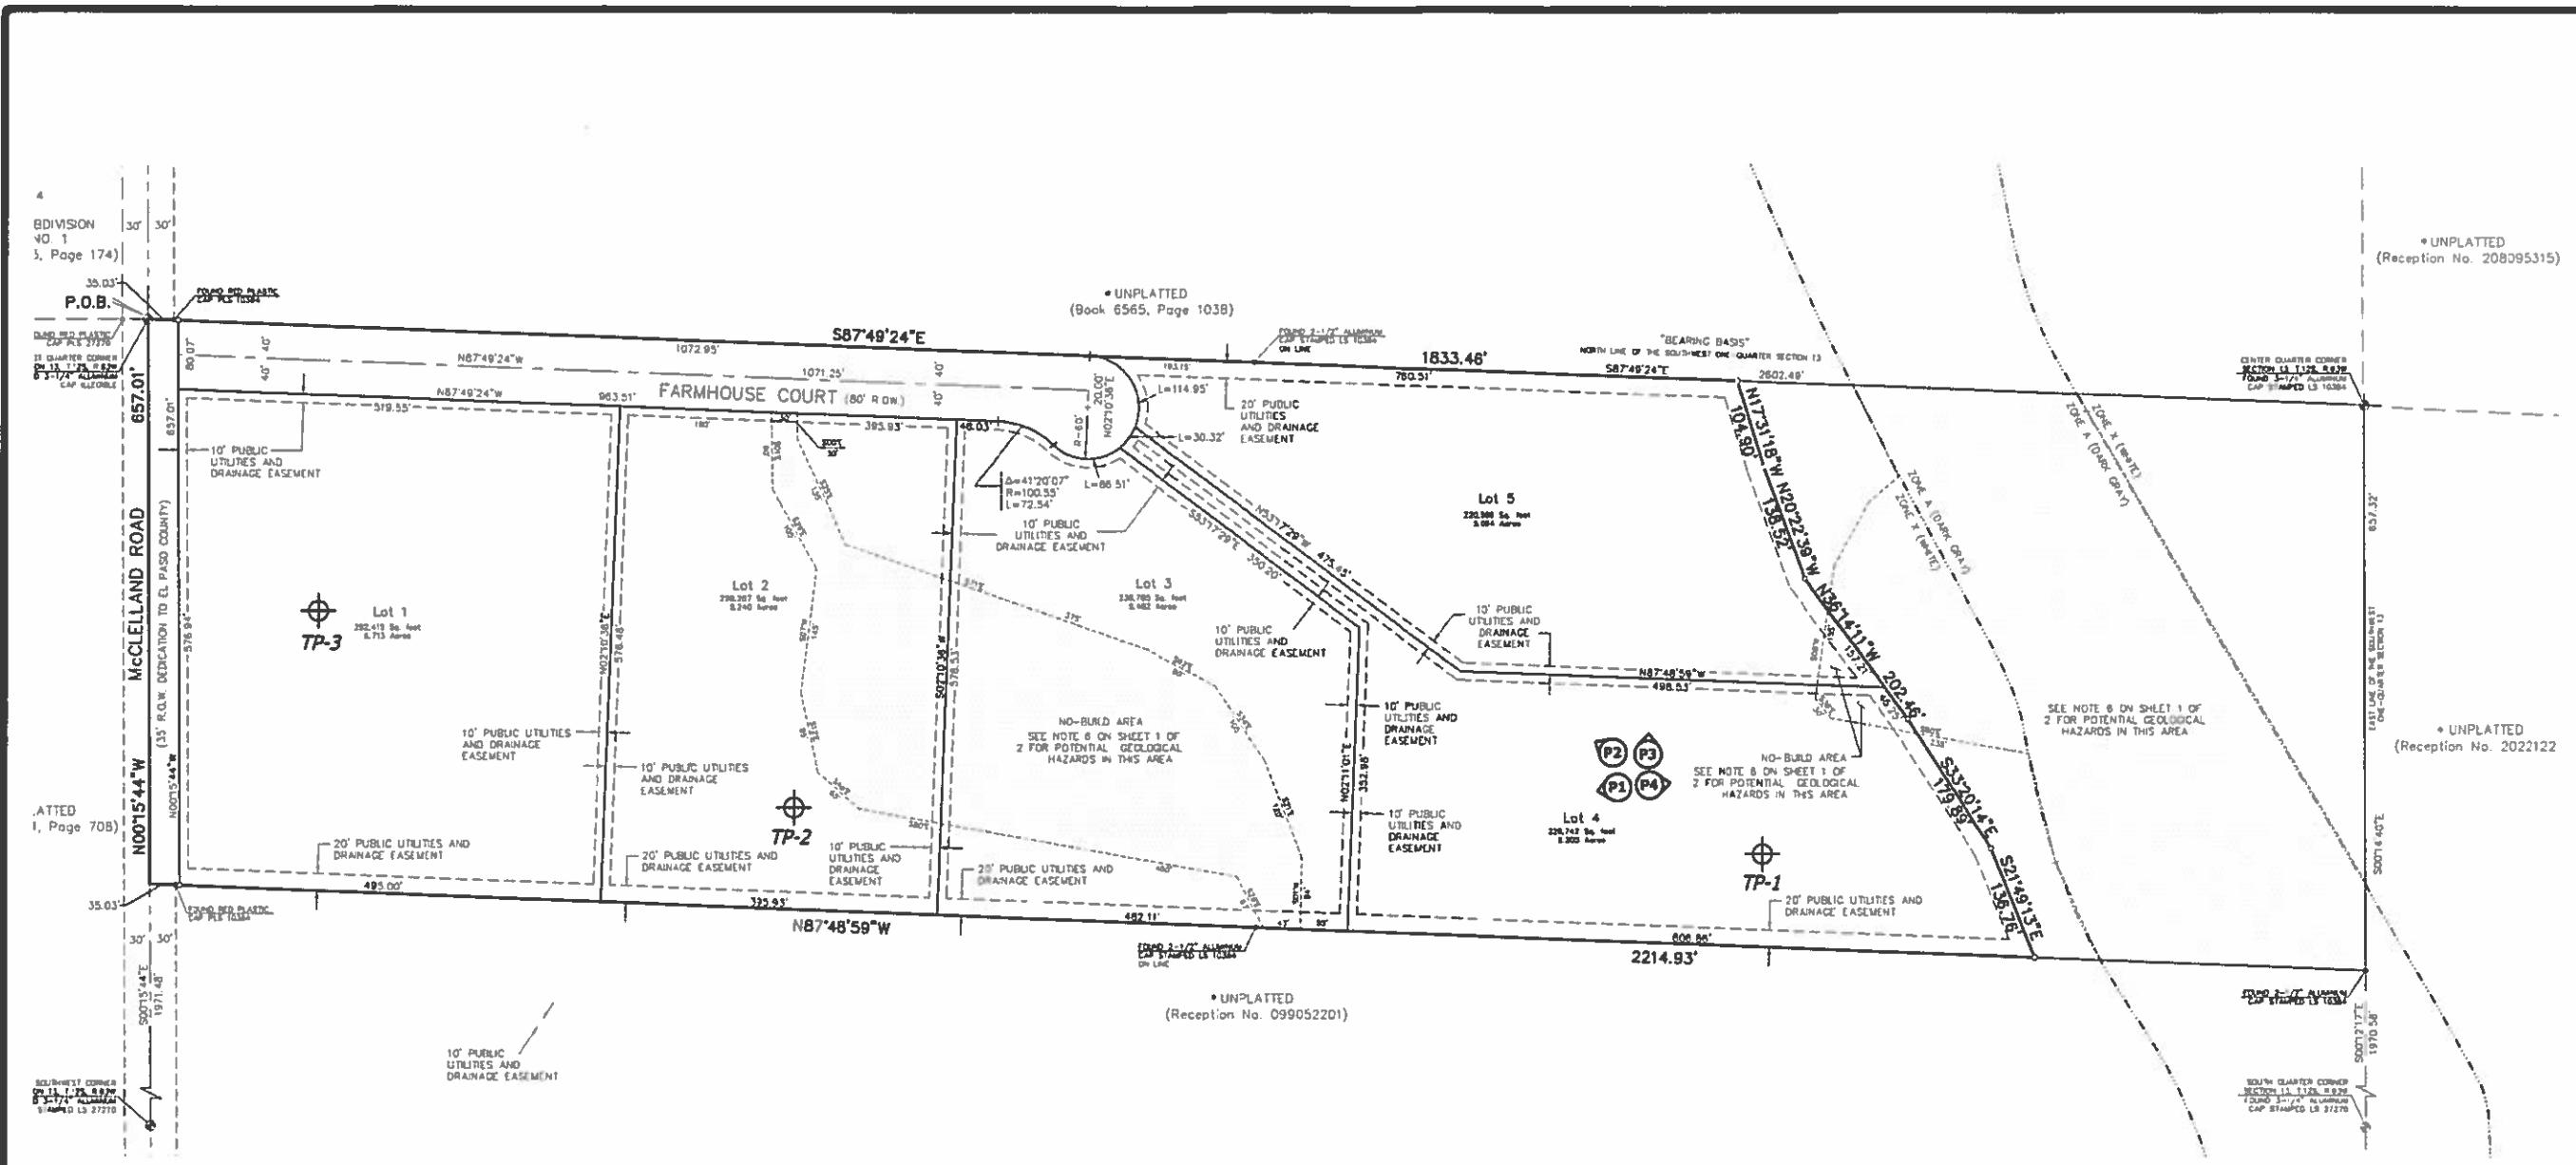
SITE PLAN/TESTING LOCATION MAP  
 MOUNTAIN'S EDGE SUBDIVISION  
 McCLELLAND ROAD & FARMHOUSE COURT  
 EL PASO COUNTY, CO.  
 FOR: WILLIAM GUMAN & ASSC. LTD

Minor drainages exist on-site that flow in southwesterly directions. No water was observed flowing in these drainages at the time of the investigation. Areas of seasonal shallow groundwater have been mapped along the drainages on the site (Figure 6). These areas are indicated as no-build areas on Figure 3, and will be avoided.

In these areas, we would anticipate the potential for periodically high subsurface moisture conditions, frost heave potential and highly organic soils. These areas lie within minor drainage areas which can be avoided by the proposed development. Due to the potential for seasonal high groundwater conditions, on-site wastewater treatment systems are not recommended in these areas. The eastern side of the site lies within any floodplain zones according to the FEMA Map No. 08041CO375G dated December 7, 2018 (Figure 7, Reference 7). Exact locations of floodplain and specific drainage studies are beyond the scope of this report. Individual wastewater treatment systems must be located a minimum of 25 feet from dry gulches and 50 feet from water courses or floodplains.

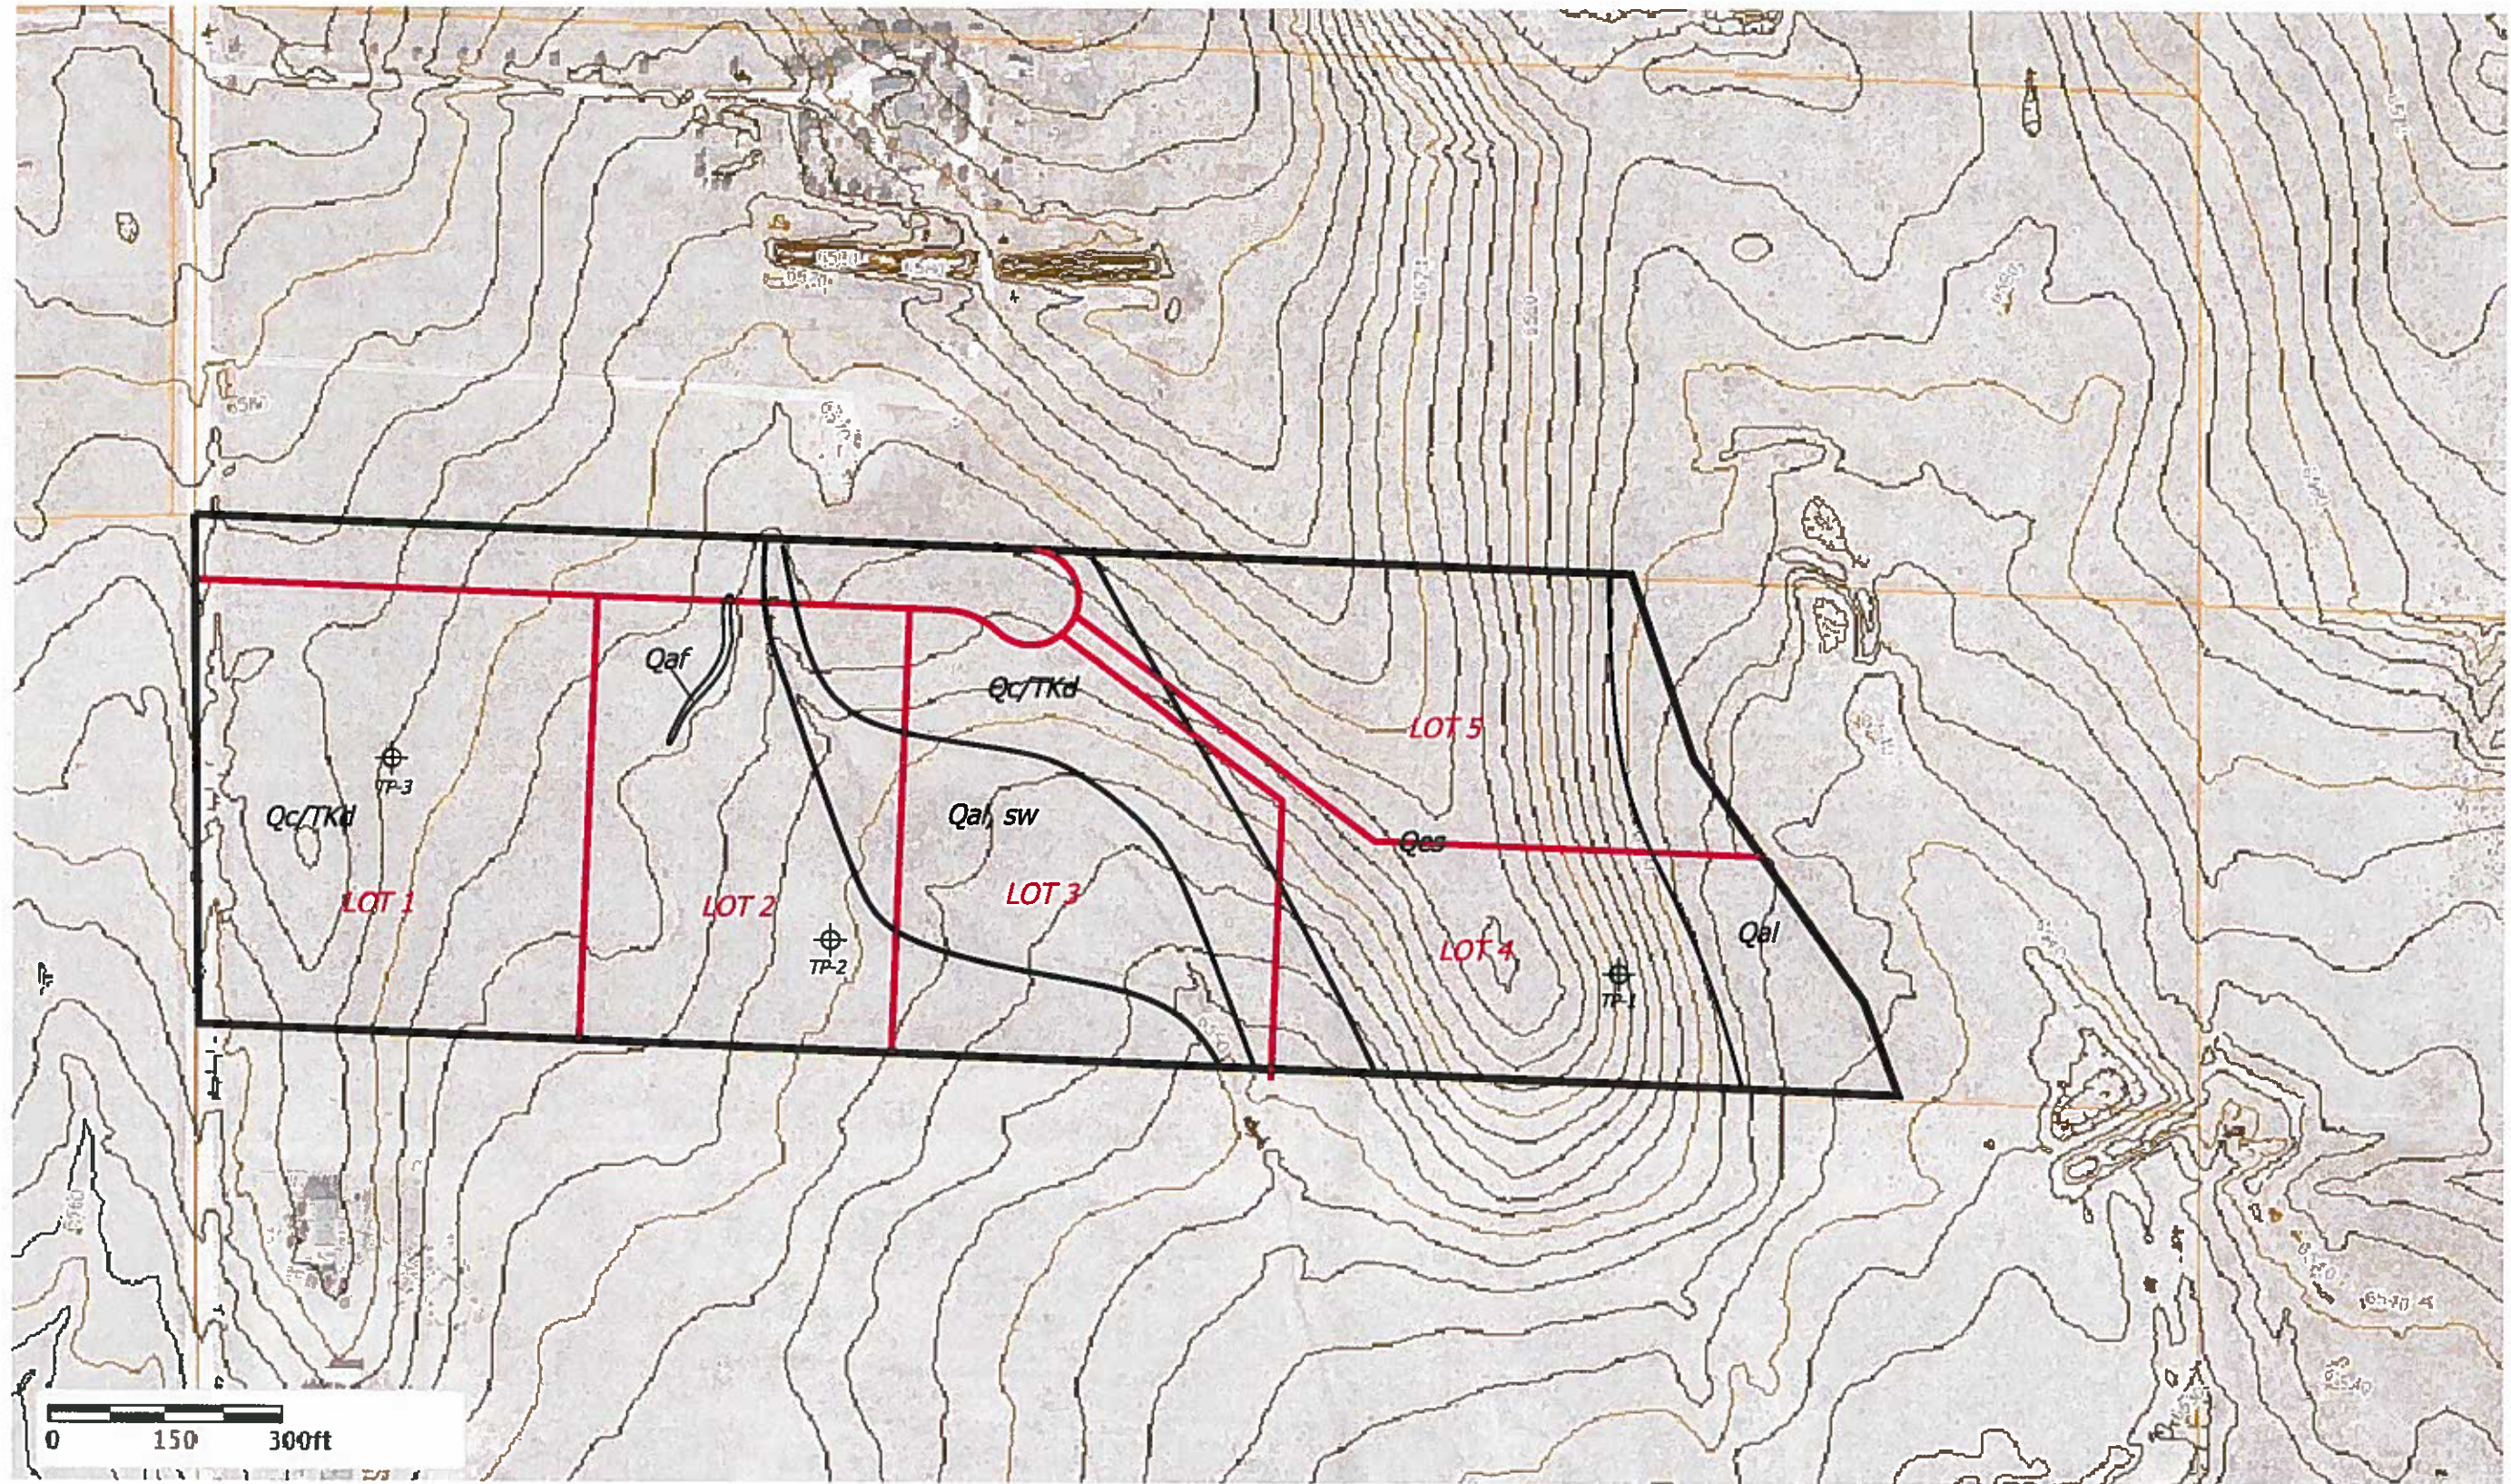
GEOLOGY MAP  
 MOUNTAIN'S EDGE SUBDIVISION  
 McCLELLAND ROAD & FARMHOUSE COURT  
 EL PASO COUNTY, CO.  
 WILLIAM GUMAN & ASSC. LTD

The geology of the site was evaluated using the *Geologic Map of the Black Forest*, by Thorson in 2003, (Reference 4, Figure 5). The Geology Map for the site is presented in Figure 6. Four mappable units were identified on this site which is described as follows:

- Qaf**      **Artificial Fill of Holocene Age:** These consist of man-made fill deposits associated with erosion berm on Lot 2.
- Qal**      **Alluvium of Quaternary Age:** These are recent deposits that have been deposited along the drainages and low-lying areas that exist on-site. These materials consist of silty to clayey sands. Some of these alluviums can contain highly organic soils.

- Qes**      **Eolian Sands of Quaternary Age:** These are wind-blown sands deposited by the action of prevailing winds. The materials typically consist of silty sands and may contain sandy silt layers.

- Qc/Tkd**      **Colluvium of Quaternary Age overlying Dawson Formation of Tertiary to Cretaceous Age:** The materials consist of colluvial or residual soils overlying the bedrock materials on-site. The colluvial soils were deposited by the action of sheetwash and gravity. The residual soils were derived from the in-situ weathering of the bedrock on site. These materials typically consist of silty to clayey sand with

The soils listed above were mapped from site-specific mapping, the *Bedrock Geologic Map of the Denver Basin* distributed by the Colorado Geologic Survey in 2011 (Reference 4, Figure 5), the *Surficial Geologic Map of the Denver 1° x 2° Quadrangle*, distributed by the US Geological Survey in 2001 (Reference 5), and the *Geologic Map of the Colorado Springs-Castle Rock Area*, distributed by the US Geological Survey in 1979 (Reference 6). The test pits were used in evaluating the site and are included in Appendix B. The Geology Map prepared for the site is presented in Figure 6.

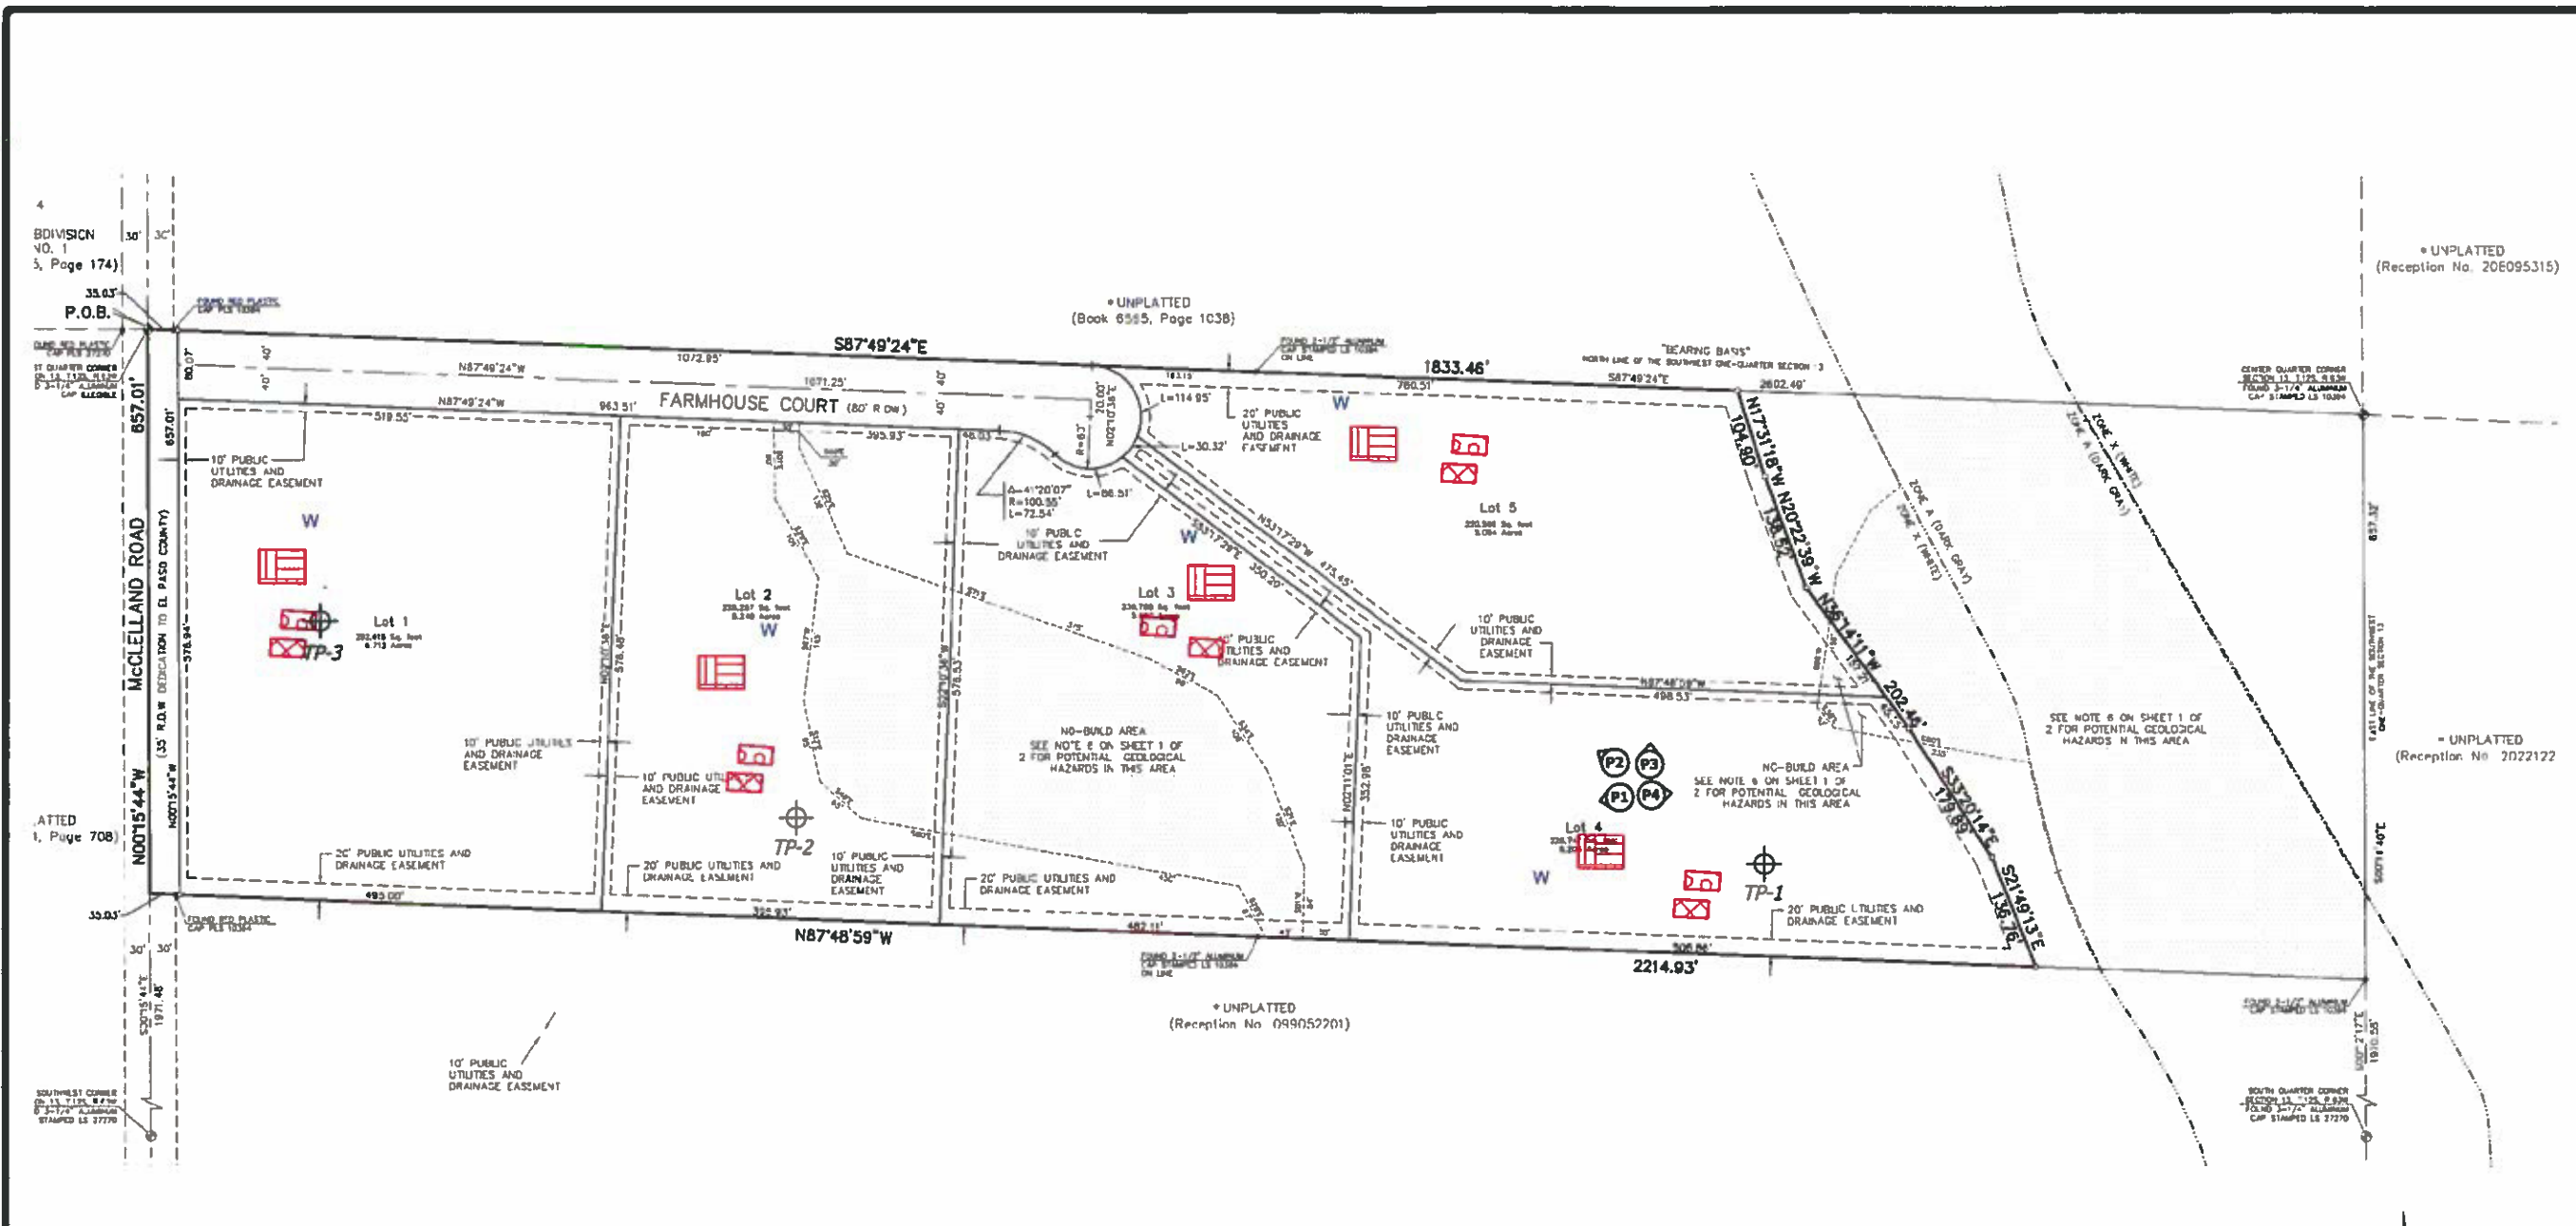
OWTS SUTABILITY MAP  
MOUNTAIN'S EDGE SUBDIVISION  
MCCLELLAND ROAD & FARMHOUSE COURT  
EL PASO COUNTY, CO.  
WILLIAM GUMAN & ASSC. LTD

In summary, it is our opinion the site is suitable for individual on-site wastewater treatment systems (OWTS) and that contamination of surface and subsurface water resources should not occur provided the OWTS sites are evaluated and installed according to El Paso County and State Guidelines and properly maintained. Based on the testing performed designed systems would likely be required for Lot 1, and the remaining lots would likely be suitable for conventional systems provided shallow bedrock, restrictive clay soils or groundwater are not encountered in the soil treatment areas. The Septic Suitability Map is presented in Figure 8. A possible house location, water well, and two septic sites for the lots are indicated on Figure 8. Areas that should be avoided by septic systems are indicated on the septic suitability map.

**Individual soil testing is required for proposed construction on each lot prior to construction.** Absorption fields must be located a minimum of 100 feet from any well, including those on adjacent properties. Absorption fields must also be located a minimum of 50 feet from any drainages, floodplains or ponded areas and 25 feet from dry gulches.

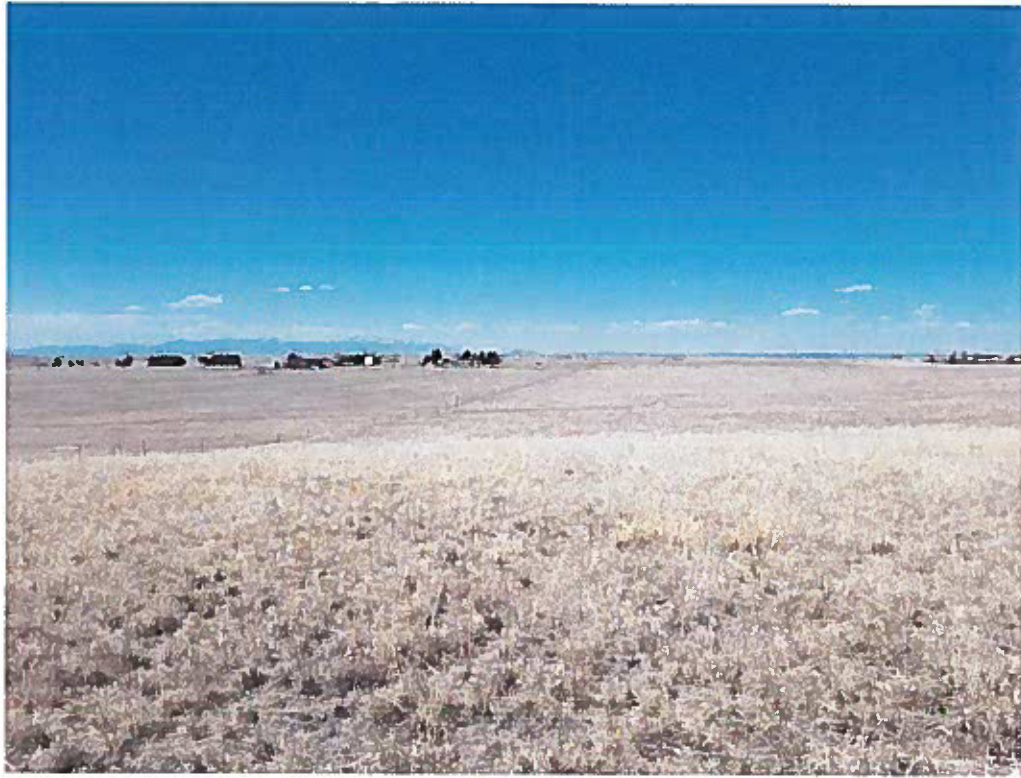
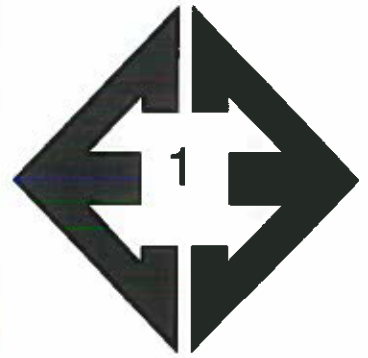
**Looking west from the  
central portion of Lot  
4.**

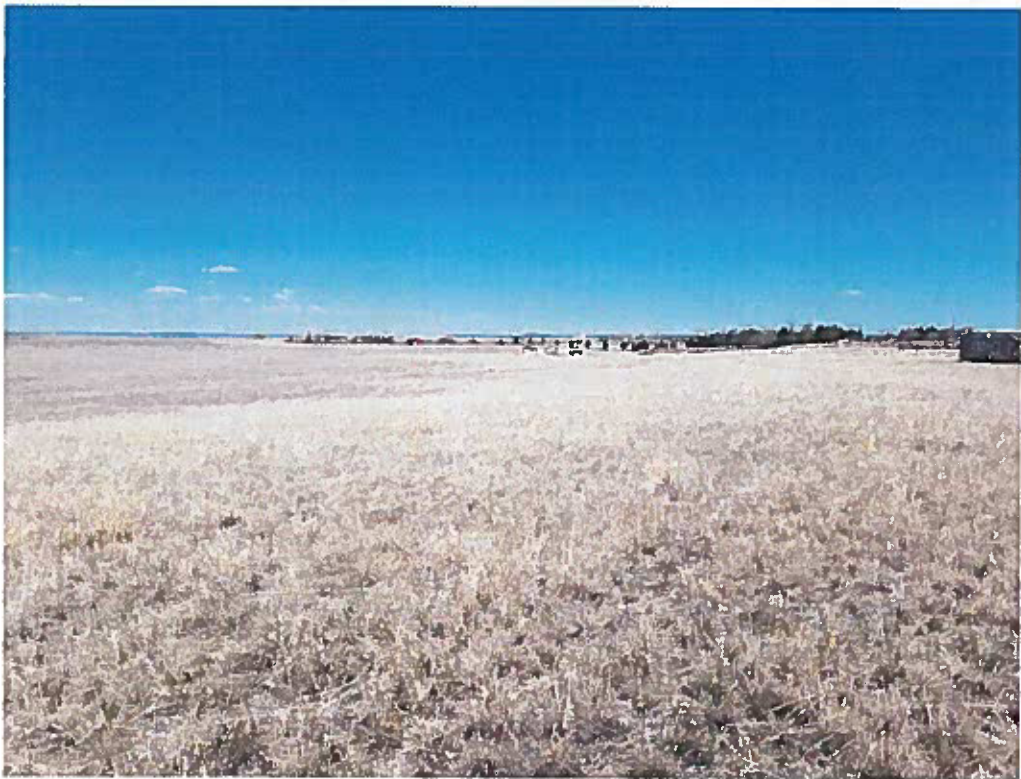
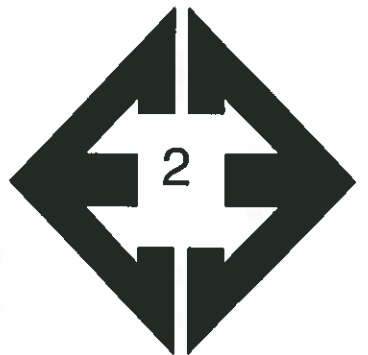
**Looking northwest  
from the central  
portion of Lot 4.**

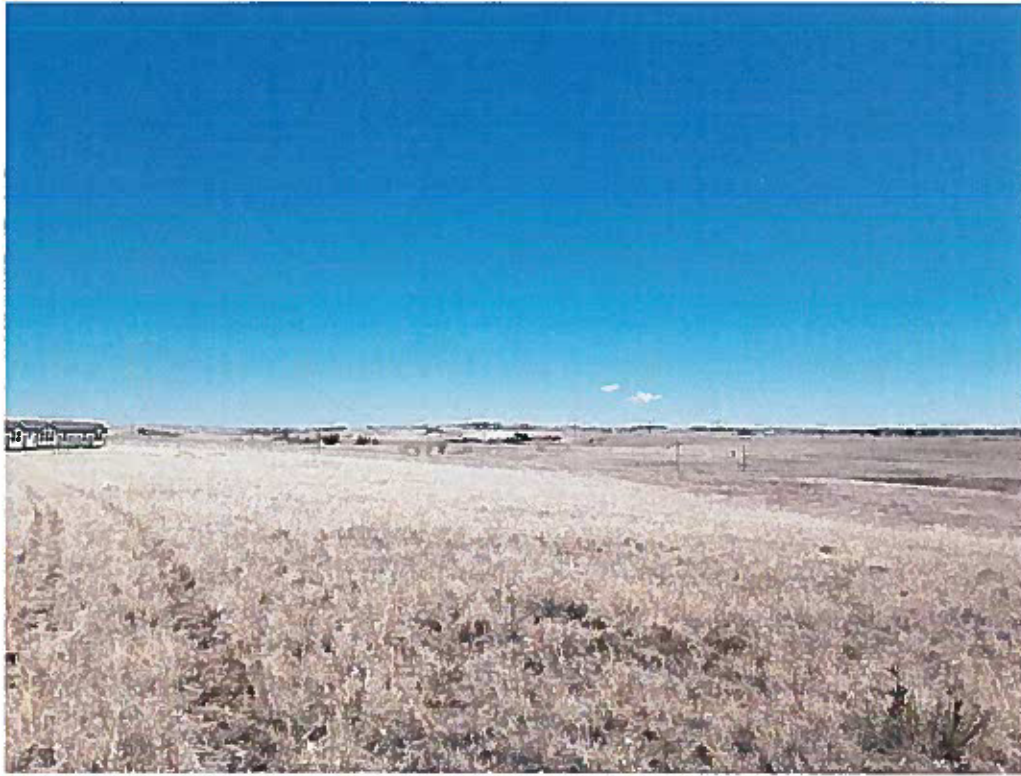
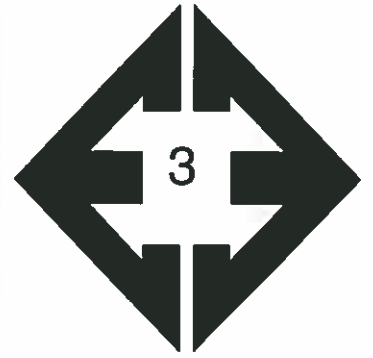
**Looking north from the  
central portion of Lot  
4.**

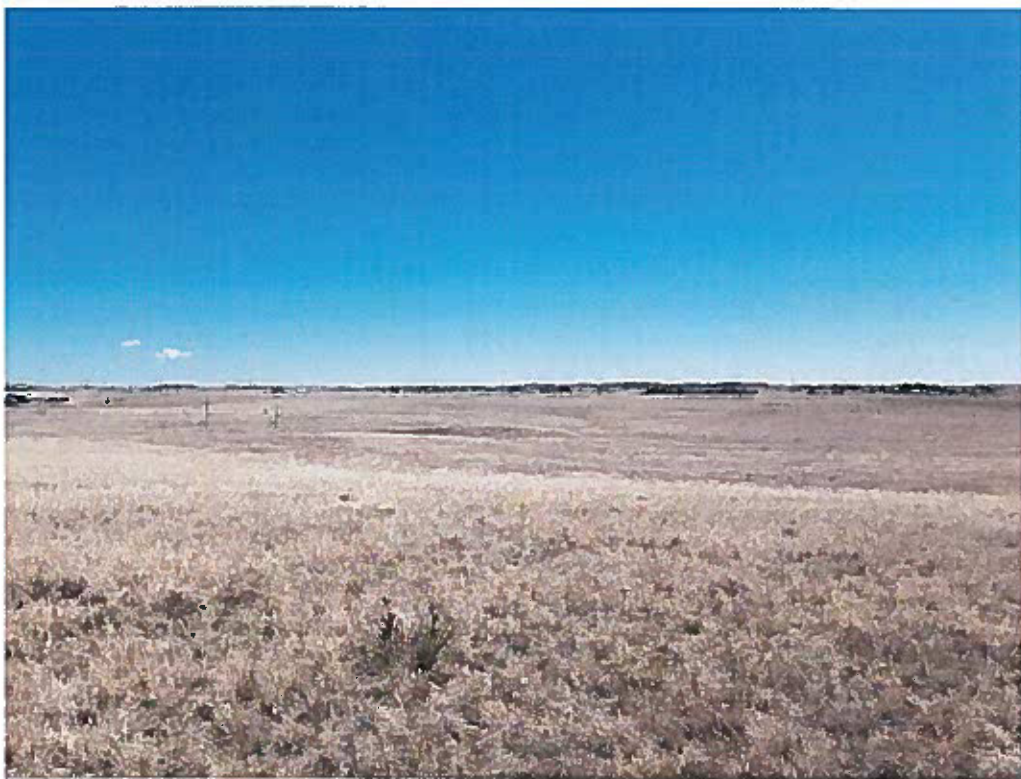
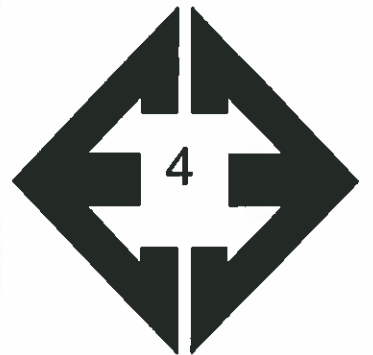
**Looking east towards  
drainage from the  
eastern portion of the  
site.**
