**SOIL, GEOLOGY, & GEOLOGIC HAZARD STUDY
FOURSQUARE AT STERLING RANCH EAST
PRELIMINARY PLAN NO. 2 – PARCEL NO. 19
EL PASO COUNTY, COLORADO**

April 14, 2022

Entech Job No. 220572

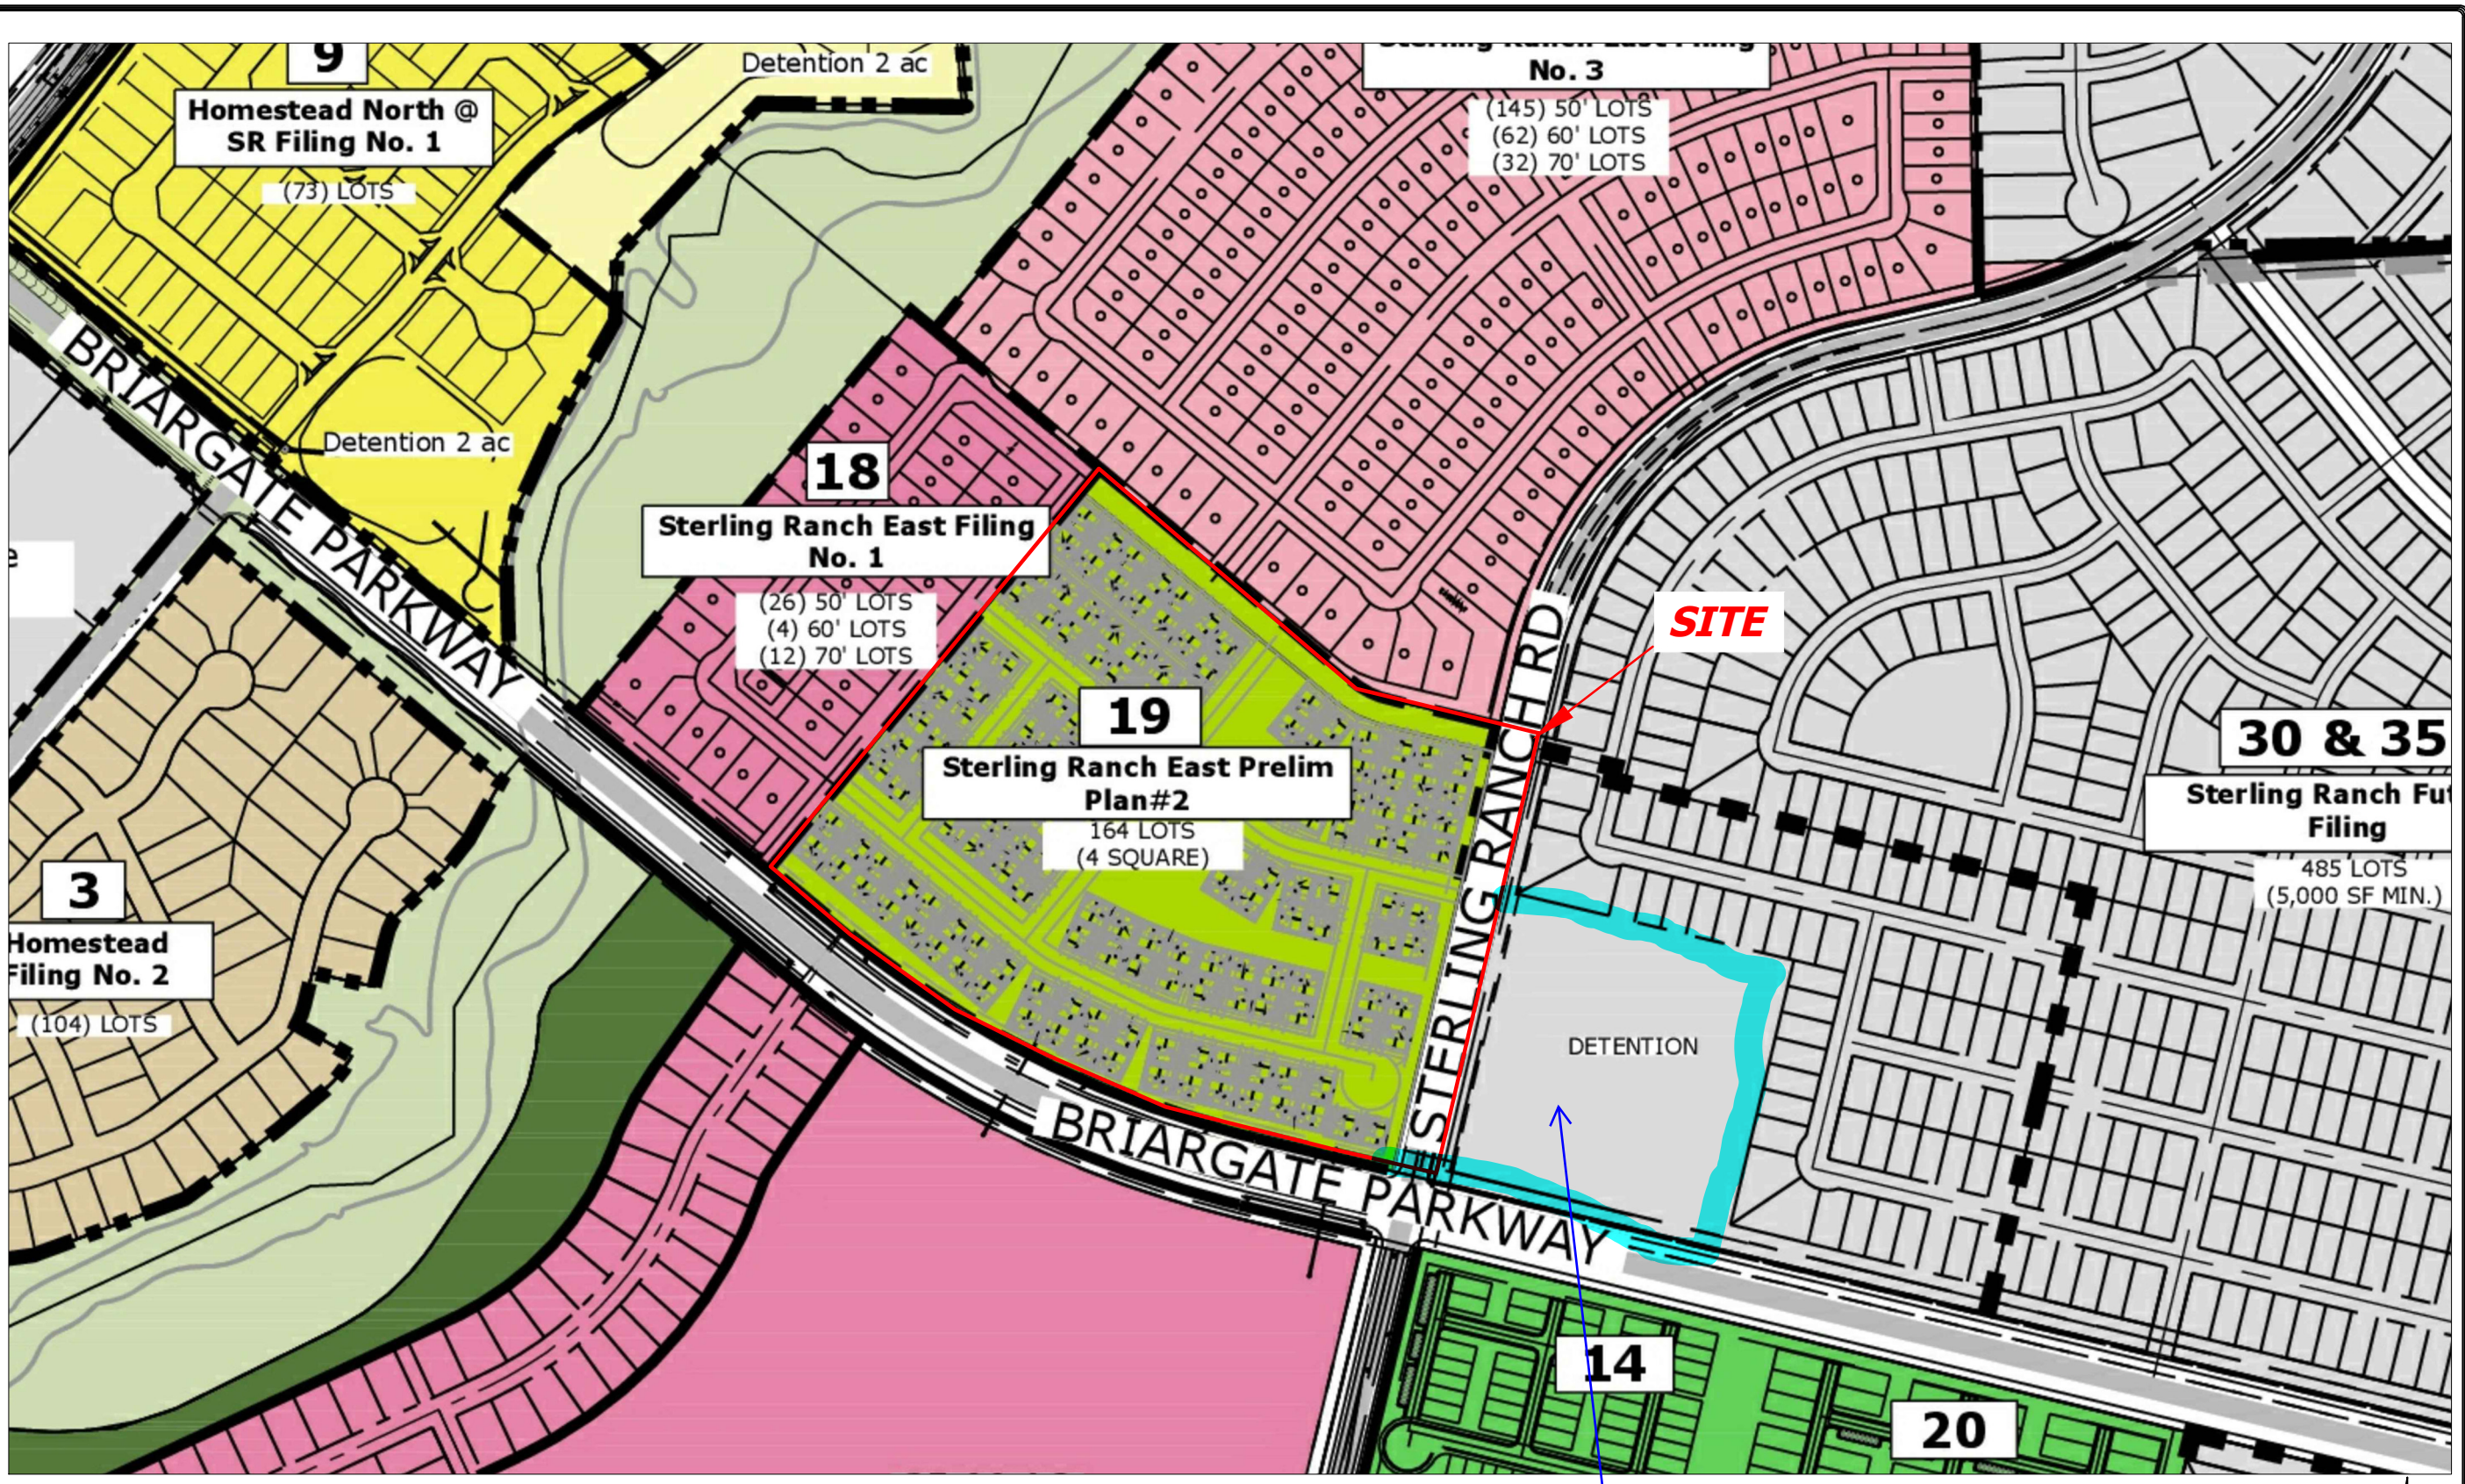
DRAWN L.L.L.
CHECKED
DATE 4/13/22
SCALE AS SHOWN
JOB NO. 220572
FIGURE No. 3

It appears that proposed cut for pond is up to 24 feet, plus depth for a micropool - address how groundwater is to be handled.

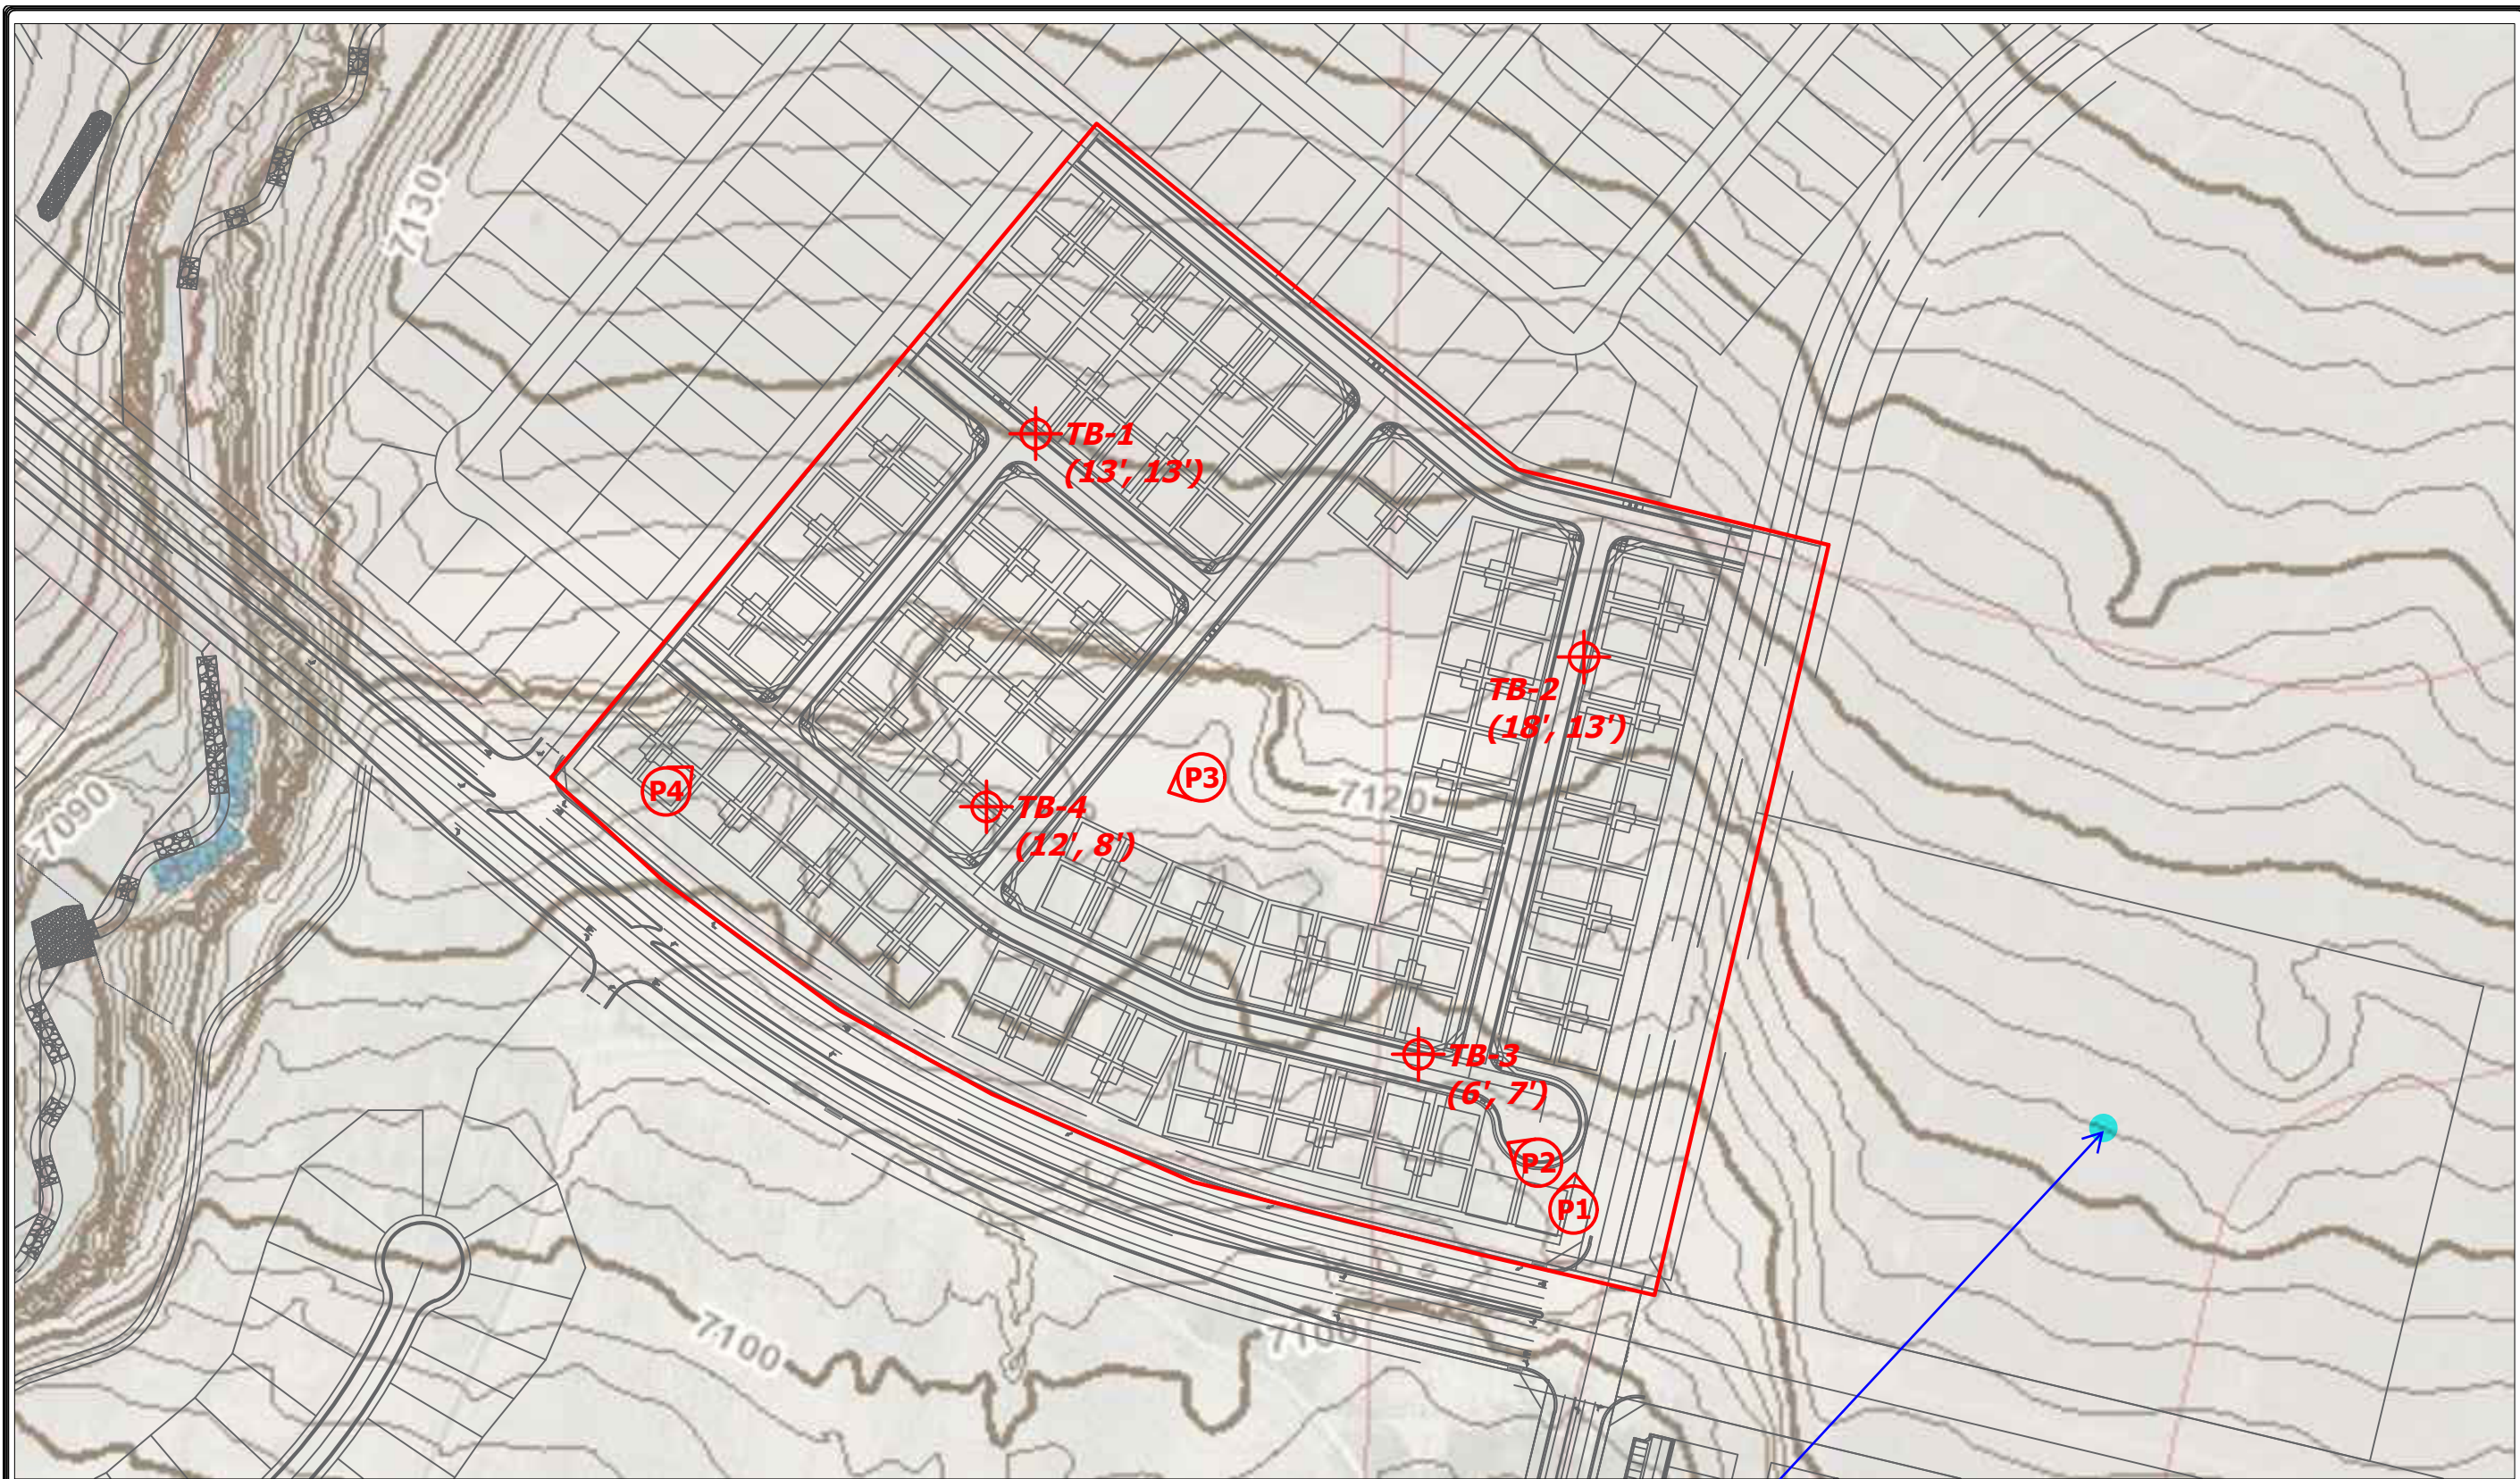
DRAWN L.L.
CHECKED
DATE 4/13/22
SCALE AS SHOWN
JOB NO. 220572
FIGURE No. 4

add a boring

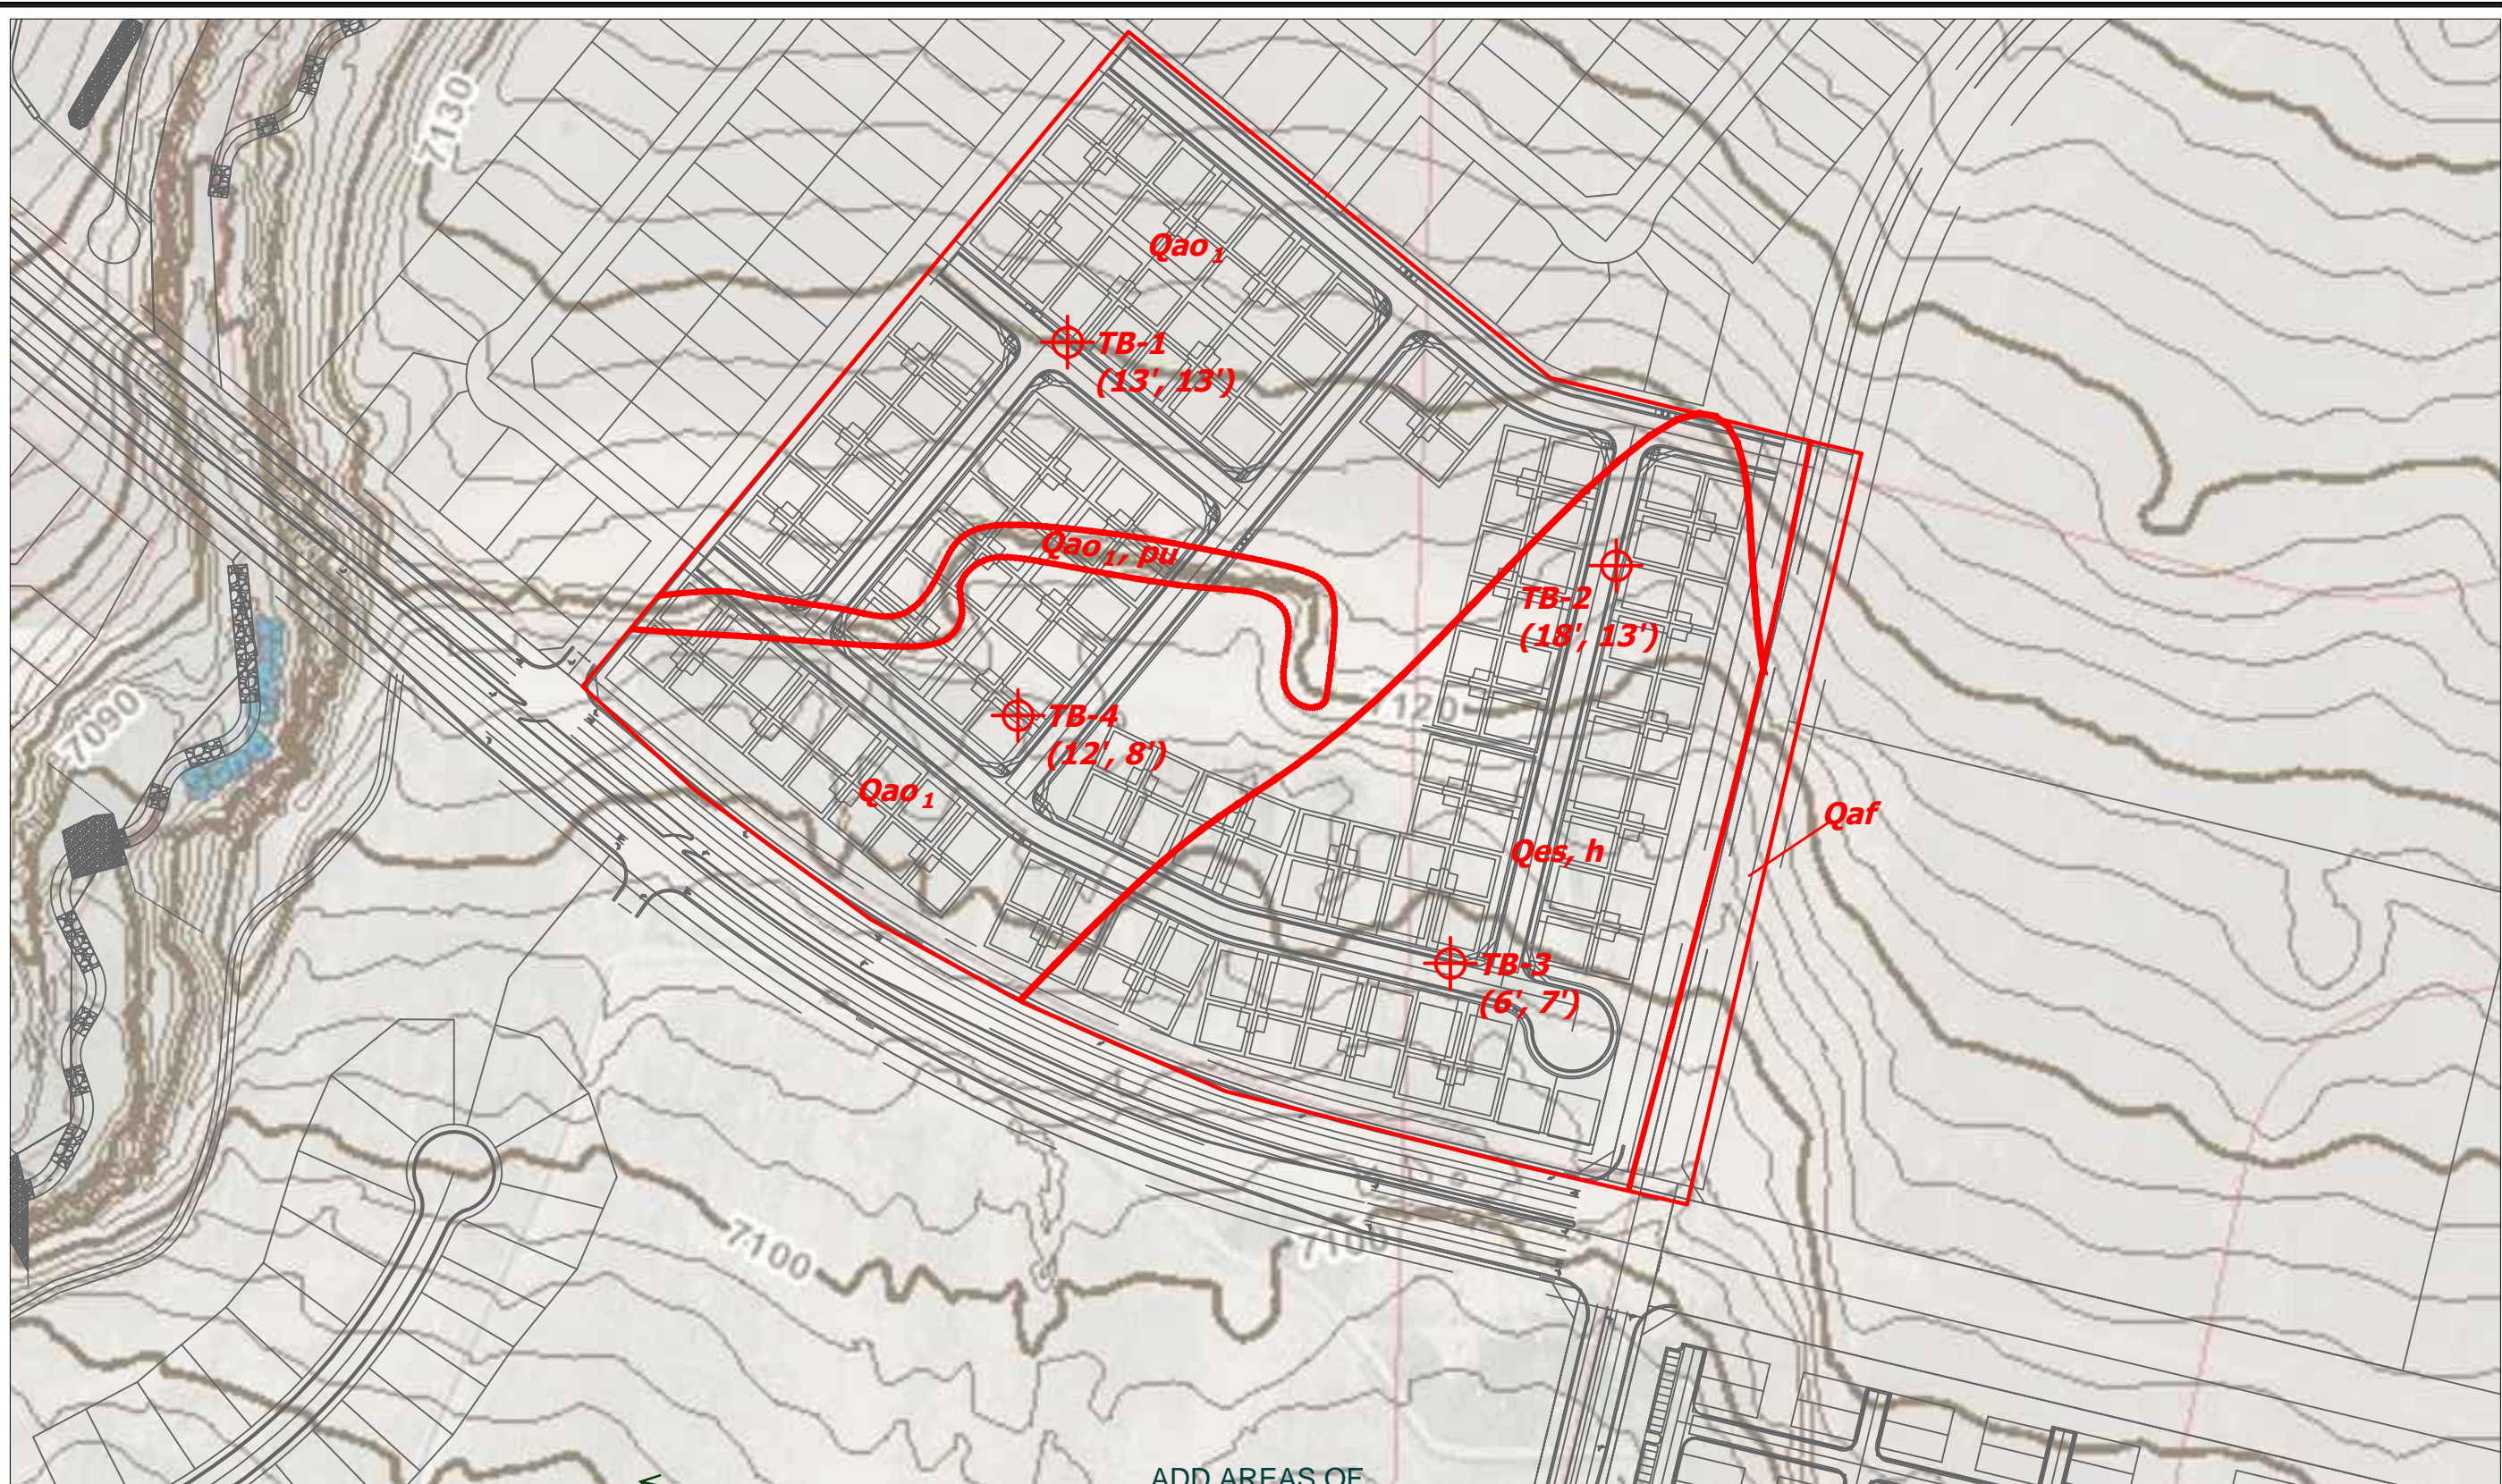
DRAWN L.L. CHECKED
DATE 4/13/22
SCALE AS SHOWN
JOB NO. 220572
FIGURE No. 7

As mentioned previously, detailed mapping has been performed on this site to produce an Engineering Geology Map Figure 7. This map shows the location of various geologic conditions of which the developers should be cognizant during the planning, design and construction stages of the project. These hazards and the recommended mitigation techniques are as follows:

Areas of fill were observed along the eastern side of the site associated with the existing water main within the proposed Sterling Ranch Road.

The majority of the soils encountered on-site do not exhibit collapsible characteristics, however, areas of loose soils were encountered in the test borings drilled on site. Additionally, areas mapped as Qes (eolian sand) have the potential for hydrocompaction.

These are areas that are undergoing erosion by water and sheetwash producing gullies and rill erosion. The areas significant erosion observed on the site are located in the former borrow areas where most of the vegetation had been removed.

Potentially Unstable Slope Areas - hazard

These slopes are considered stable in their present condition; however, considerable care must be exercised in these areas not to create a condition which would tend to activate instability. These areas are primarily located along the cut slope of the former borrow area in the central portion of the site.

Mitigation: Should loose or collapsible soils be encountered beneath foundations, recompaction and moisture conditioning of the upper 2 feet of soil at 95% of its maximum Modified Proctor Dry Density ASTM D-1557 will be required. Exterior flatwork and parking areas may also experience movement. Proofrolling and recompaction of soft areas should be performed during site work.

Mitigation: Due to the nature of the soils on this site, virtually all the soils are subject to erosion by wind and water. Other minor areas of erosion were observed on site other than those mapped, particularly where some rill erosion has occurred. Areas of erosion can occur across the entire site, particularly if the soils are disturbed during construction. Vegetation reduces the potential for erosion. The areas identified where erosion is actually taking place may require check dams, regrading and revegetation using channel lining mats to anchor vegetation. Further recommendations for erosion control are discussed under Section 8.0 "Erosion Control" of this report. Recommendations pertaining to revegetation may require input from a qualified landscape architect and/or the Natural Resource Conservation Service (previously Soil Conservation Service).

Mitigation: Building should be avoided in these areas unless properly mitigated. These areas will likely be regraded during the site development. Fill placed along these slopes should be properly benched into the slope as to not create unstable conditions.

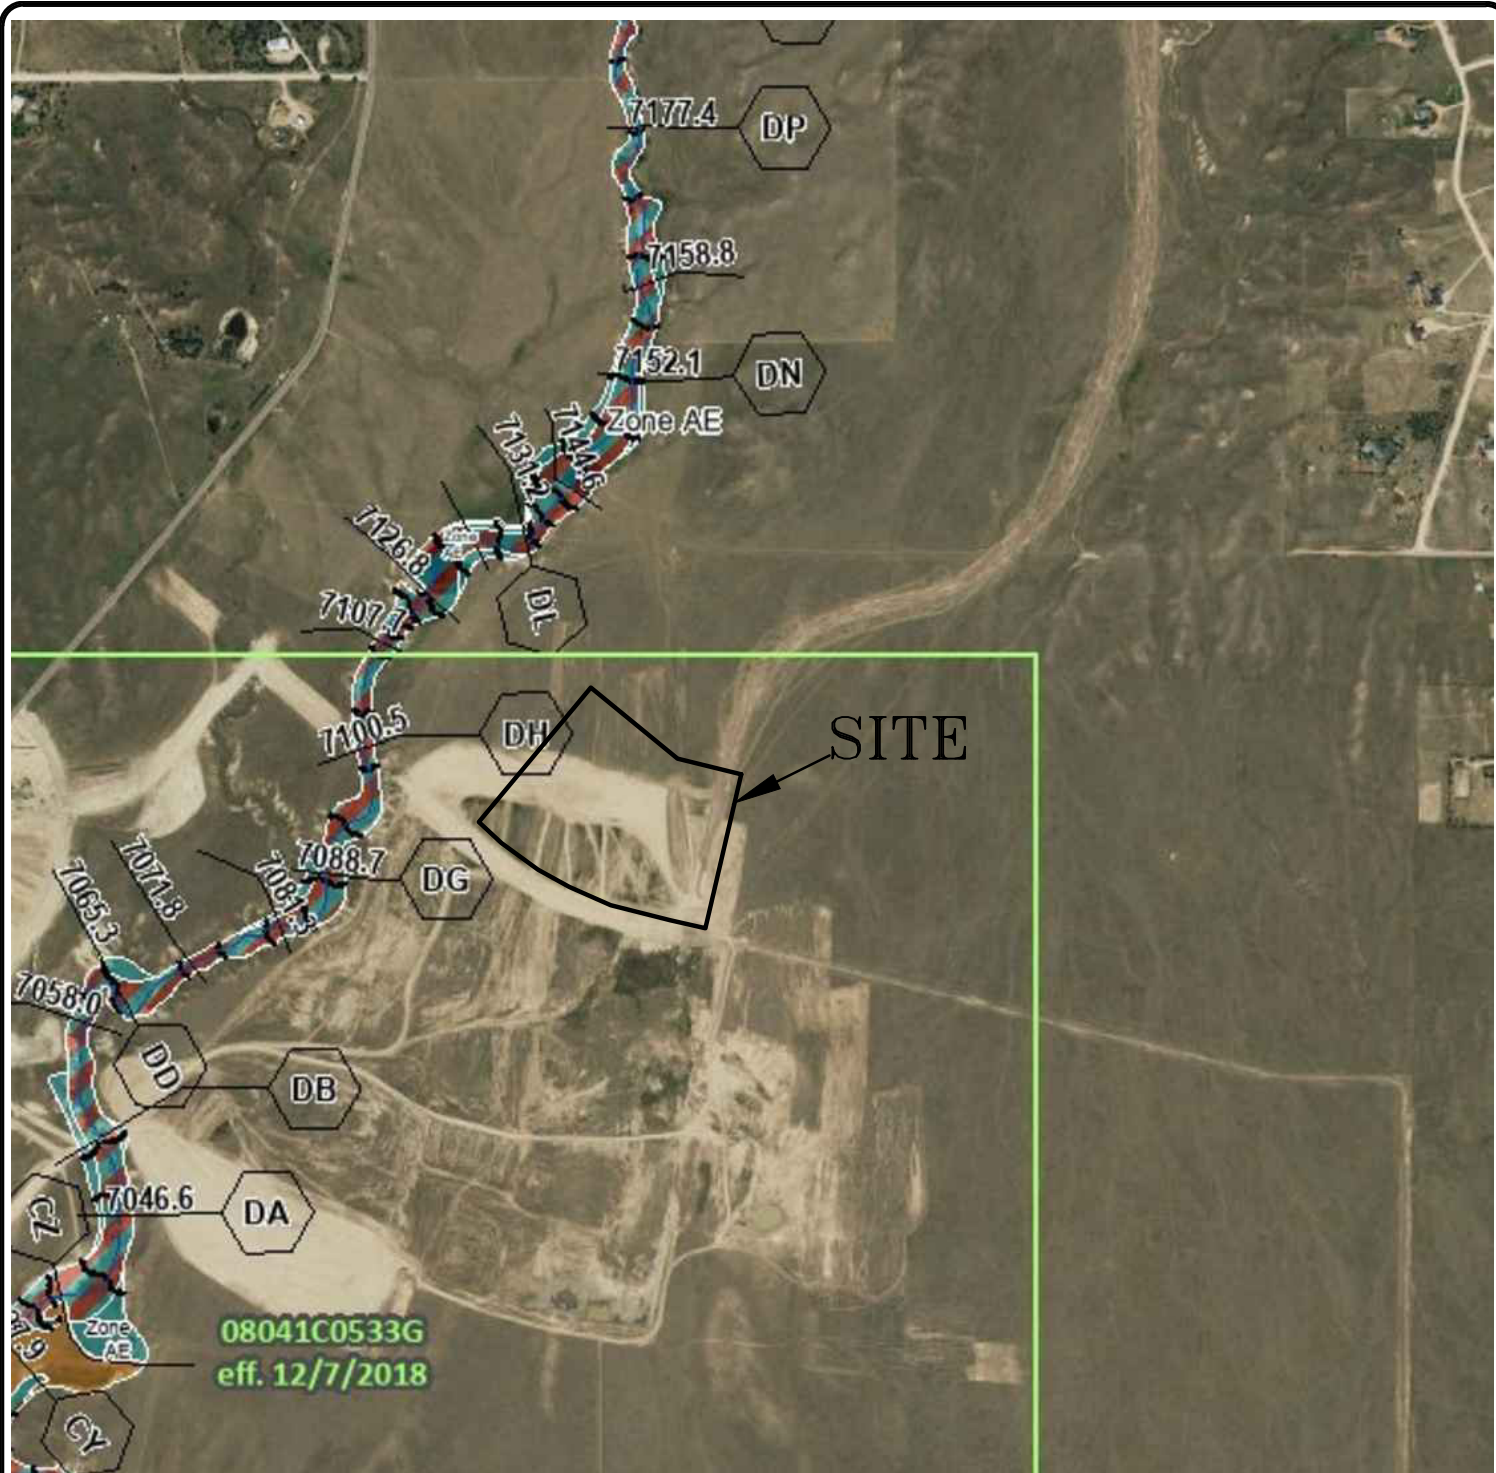
FIG NO.:
8

The site is not mapped within floodplain zones according to the FEMA Map No. 08041CO535G, Figure 8 (Reference 7). No drainages were observed on the site, however, standing water was observed to the south of the site at the northwest corner of future Briargate Parkway and

Mitigation: Foundations must have a minimum 30-inch depth for frost protection. In areas where high subsurface moisture conditions are anticipated periodically, subsurface perimeter drains are recommended to help prevent the intrusion of water into areas below grade. Typical drain details are presented in Figures 9 through 11. Any grading in these areas should be done to direct surface flow around construction to avoid areas of ponded water. Structures should not block drainages. All organic material should be completely removed prior to any fill placement. Finished floor levels must be located a minimum of one foot above floodplain levels.
